Profile/Photo Observation Report

Street:	N WASHINGTON ST & W CLEVELAND	Flow Control:	Not Controlled
City:	Hobart, IN	Year Renewed:	
Location:	Light Highway	Tape/Media #:	
Purpose:	Not Known	Dia/Height:	12"
Use:	Sanitary	Material:	VCP
Drain Area:	NA	Lining:	
Category:	NA		
Comment:

Location Details:		Direction of Survey:	Upstream
US MH:	M-604-070	DS MH:	M-605-046
		Total Length Surveyed (ft):	39.6

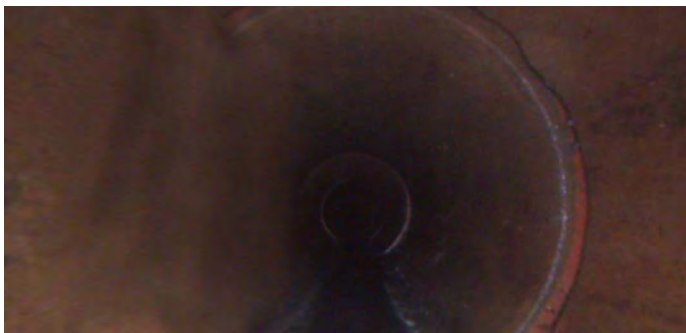
Code: **AMH**
Description: **Manhole**

Distance (ft): **.0**
Structural Grade: **0**
O&M Grade: **0**
Clock Start/From:
Clock To:
1st Value:
2nd Value:
Value Percent:
Continuous Index:
Within 8" of Joint: **NO**
Remarks: **M-604-070**

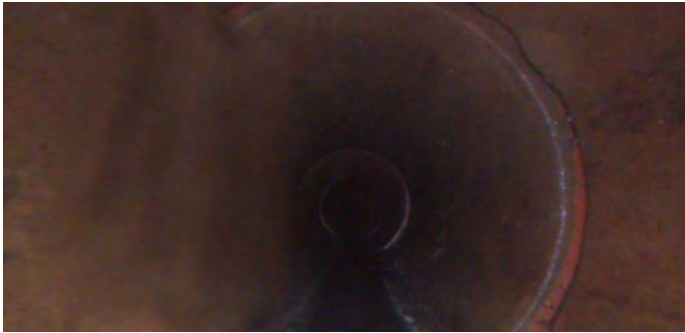
Code:	MWL
Description:	Water Level

Distance (ft):	.0
Structural Grade:	0
O&M Grade:	0
Clock Start/From:	
Clock To:	
1st Value:	
2nd Value:	
Value Percent:	5.000
Continuous Index:	
Within 8" of Joint:	NO
Remarks:

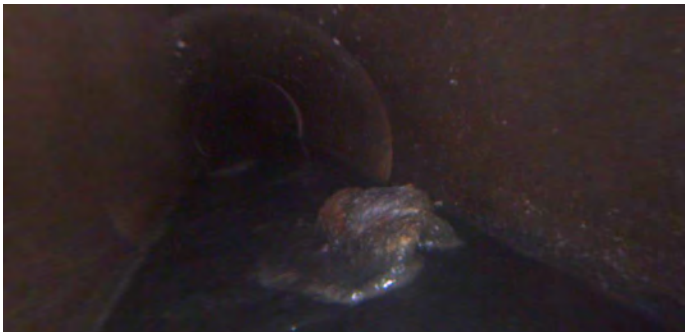
Code:	OBB
Description:	Obstacle Brick

Distance (ft):	18.5
Structural Grade:	0
O&M Grade:	2
Clock Start/From:	5
Clock To:	6
1st Value:	
2nd Value:	
Value Percent:	5.000
Continuous Index:	
Within 8" of Joint:	NO
Remarks:

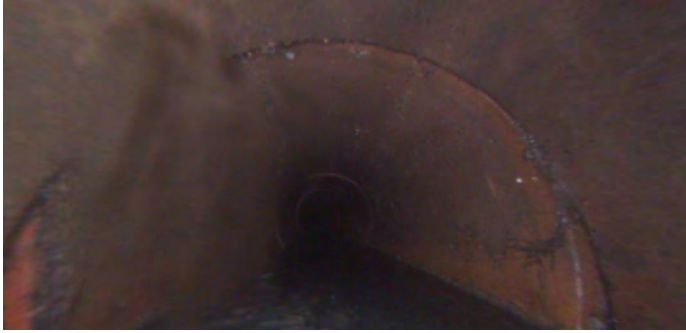
Code: **RFJ**
Description: **Roots Fine Joint**

Distance (ft): **23.2**
Structural Grade: **0**
O&M Grade: **1**
Clock Start/From: **8**
Clock To: **4**
1st Value:
2nd Value:
Value Percent:
Continuous Index:
Within 8" of Joint: **YES**
Remarks:

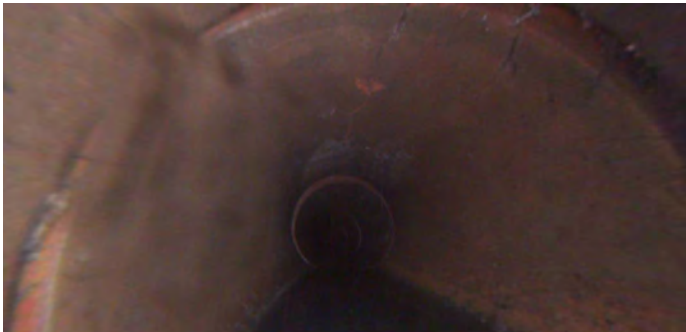
Code: **FM**
Description: **Fracture Multiple**

Distance (ft): **25.4**
Structural Grade: **4**
O&M Grade: **0**
Clock Start/From: **8**
Clock To: **4**
1st Value:
2nd Value:
Value Percent:
Continuous Index:
Within 8" of Joint: **YES**
Remarks:

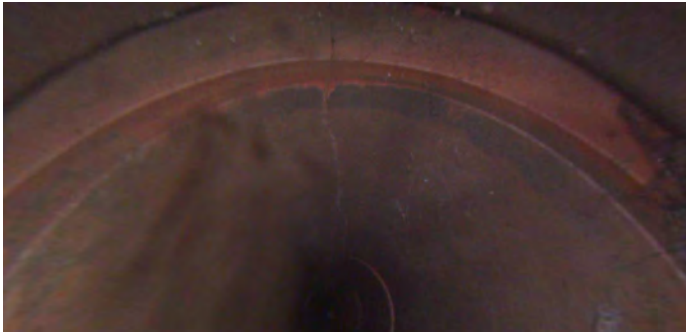
Code: **FL**
Description: **Fracture Longitudinal**

Distance (ft): **27.4**
Structural Grade: **3**
O&M Grade: **0**
Clock Start/From: **12**
Clock To:
1st Value:
2nd Value:
Value Percent:
Continuous Index:
Within 8" of Joint: **YES**
Remarks:

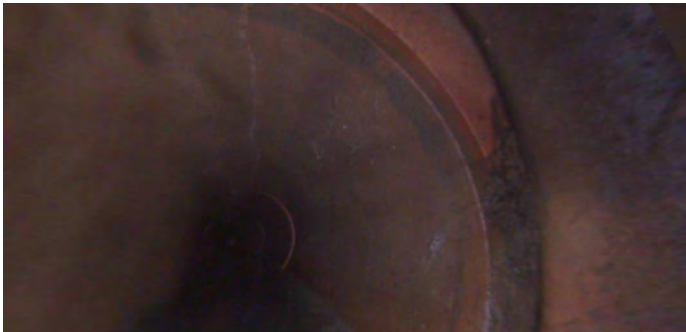
Code: **RFJ**
Description: **Roots Fine Joint**

Distance (ft): **27.4**
Structural Grade: **0**
O&M Grade: **1**
Clock Start/From: **2**
Clock To: **3**
1st Value:
2nd Value:
Value Percent:
Continuous Index:
Within 8" of Joint: **YES**
Remarks:

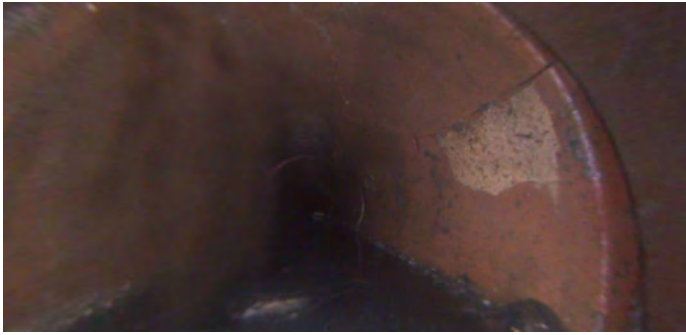
Code: **FM**
Description: **Fracture Multiple**

Distance (ft): **31.5**
Structural Grade: **4**
O&M Grade: **0**
Clock Start/From: **12**
Clock To: **2**
1st Value:
2nd Value:
Value Percent:
Continuous Index:
Within 8" of Joint: **YES**
Remarks:

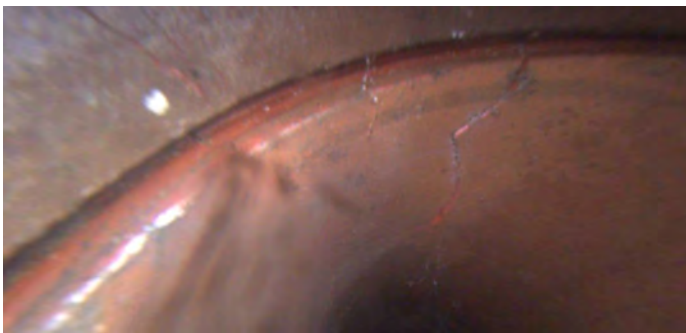
Code: **FM**
Description: **Fracture Multiple**

Distance (ft): **33.7**
Structural Grade: **4**
O&M Grade: **0**
Clock Start/From: **11**
Clock To: **12**
1st Value:
2nd Value:
Value Percent:
Continuous Index:
Within 8" of Joint: **YES**
Remarks:

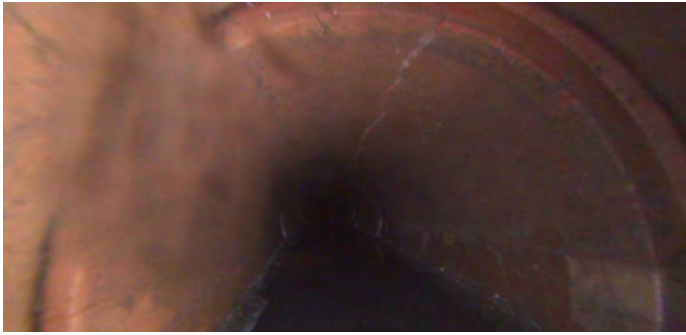
Code: **FM**
Description: **Fracture Multiple**

Distance (ft): **37.6**
Structural Grade: **4**
O&M Grade: **0**
Clock Start/From: **8**
Clock To: **4**
1st Value:
2nd Value:
Value Percent:
Continuous Index:
Within 8" of Joint: **YES**
Remarks:

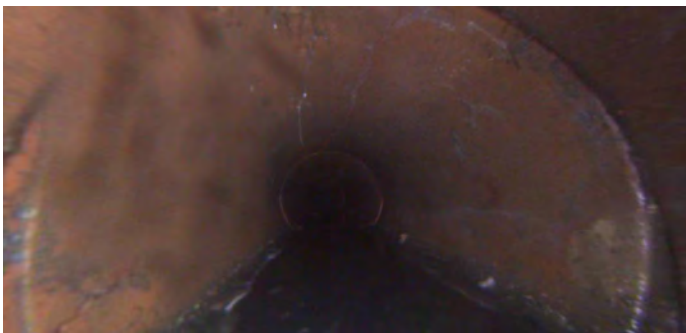
Code: **MSA**
Description: **Abandoned Survey**

Distance (ft): **39.6**
Structural Grade: **0**
O&M Grade: **0**
Clock Start/From:
Clock To:
1st Value:
2nd Value:
Value Percent:
Continuous Index:
Within 8" of Joint: **NO**
Remarks: **debris under water**
