## Profile/Photo Observation Report

Street:	<b>Summerlin</b>	Flow Control:	<b>Not Controlled</b>
City:	<b>Hobart, IN</b>	Year Renewed:	
Location:	<b>Light Highway</b>	Tape/Media #:	
Purpose:	<b>Not Known</b>	Dia/Height:	<b>12"</b>
Use:	<b>Sanitary</b>	Material:	<b>VCP</b>
Drain Area:	<b>NA</b>	Lining:	
Category:	<b>NA</b>		
Comment:

Location Details:		Direction of Survey:	<b>Upstream</b>
US MH:	<b>M-604-070</b>	DS MH:	<b>M-605-046</b>
		Total Length Surveyed (ft):	<b>39.6</b>

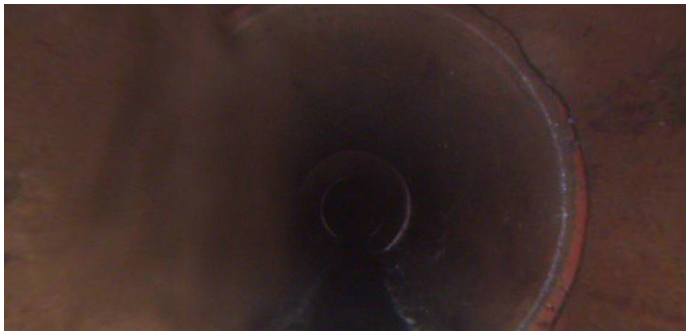
Code: **AMH**  
Description: **Manhole**

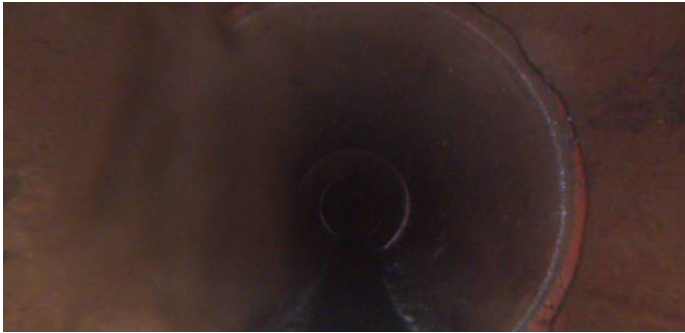
Code:	<b>MWL</b>
Description:	<b>Water Level</b>

Distance (ft):	<b>.0</b>
Structural Grade:	<b>0</b>
O&M Grade:	<b>0</b>
Clock Start/From:	
Clock To:	
1st Value:	
2nd Value:	
Value Percent:	<b>5.000</b>
Continuous Index:	
Within 8" of Joint:	<b>NO</b>
Remarks:

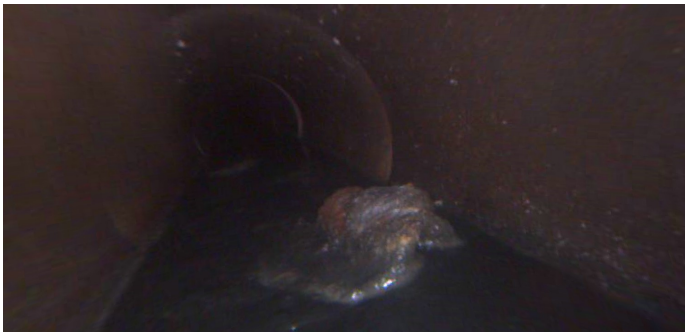
Code:	<b>OBB</b>
Description:	<b>Obstacle Brick</b>

Distance (ft):	<b>18.5</b>
Structural Grade:	<b>0</b>
O&M Grade:	<b>2</b>
Clock Start/From:	<b>5</b>
Clock To:	<b>6</b>
1st Value:	
2nd Value:	
Value Percent:	<b>5.000</b>
Continuous Index:	
Within 8" of Joint:	<b>NO</b>
Remarks:

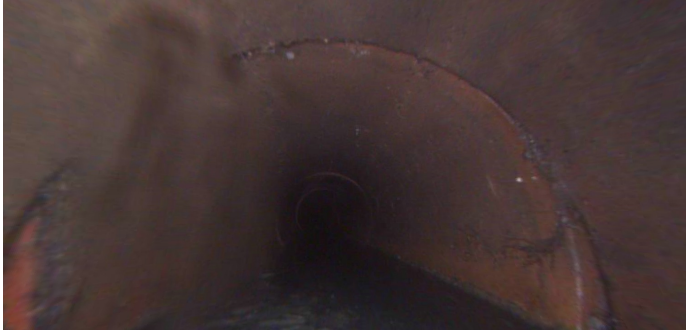
Code: **RFJ**  
Description: **Roots Fine Joint**

Distance (ft): **23.2**  
Structural Grade: **0**  
O&M Grade: **1**  
Clock Start/From: **8**  
Clock To: **4**  
1st Value:  
2nd Value:  
Value Percent:  
Continuous Index:  
Within 8" of Joint: **YES**  
Remarks:

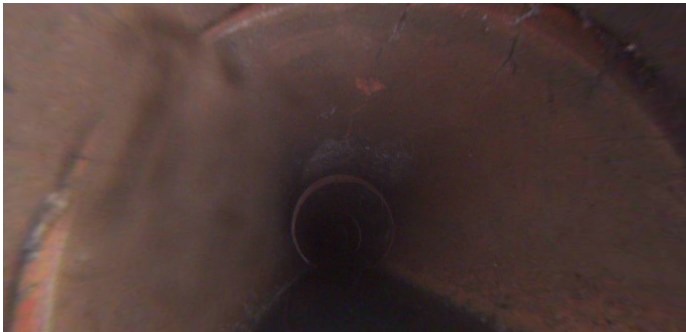
Code: **FM**  
Description: **Fracture Multiple**

Distance (ft): **25.4**  
Structural Grade: **4**  
O&M Grade: **0**  
Clock Start/From: **8**  
Clock To: **4**  
1st Value:  
2nd Value:  
Value Percent:  
Continuous Index:  
Within 8" of Joint: **YES**  
Remarks:

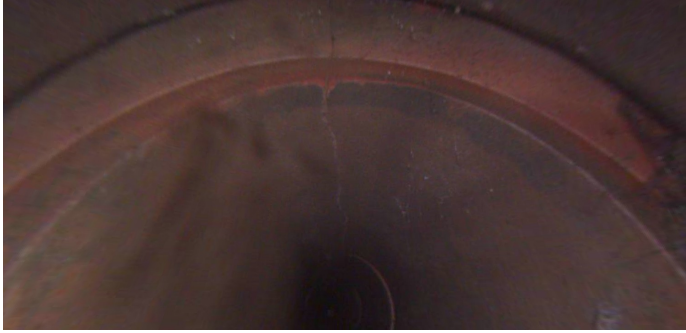
Code: **FL**  
Description: **Fracture Longitudinal**

Distance (ft): **27.4**  
Structural Grade: **3**  
O&M Grade: **0**  
Clock Start/From: **12**  
Clock To:  
1st Value:  
2nd Value:  
Value Percent:  
Continuous Index:  
Within 8" of Joint: **YES**  
Remarks:

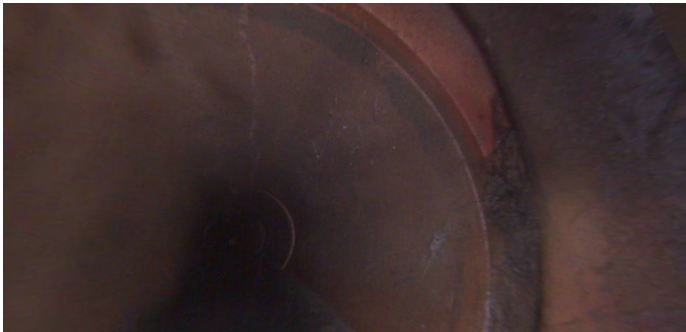
Code: **RFJ**  
Description: **Roots Fine Joint**

Distance (ft): **27.4**  
Structural Grade: **0**  
O&M Grade: **1**  
Clock Start/From: **2**  
Clock To: **3**  
1st Value:  
2nd Value:  
Value Percent:  
Continuous Index:  
Within 8" of Joint: **YES**  
Remarks:

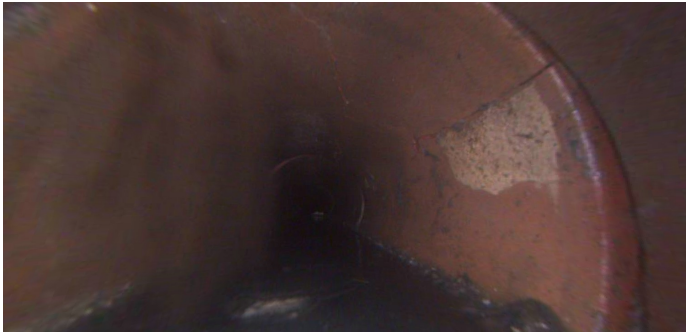
Code: **FM**  
Description: **Fracture Multiple**

Distance (ft): **31.5**  
Structural Grade: **4**  
O&M Grade: **0**  
Clock Start/From: **12**  
Clock To: **2**  
1st Value:  
2nd Value:  
Value Percent:  
Continuous Index:  
Within 8" of Joint: **YES**  
Remarks:

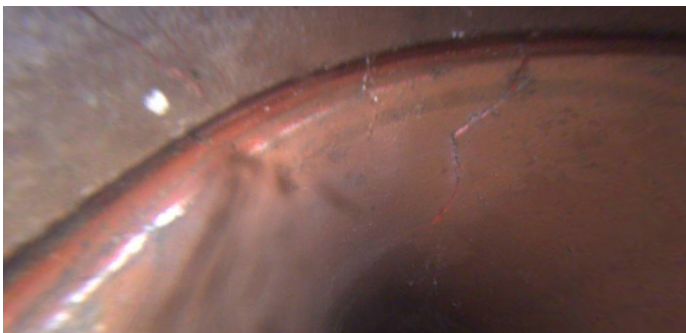
Code: **FM**  
Description: **Fracture Multiple**

Distance (ft): **33.7**  
Structural Grade: **4**  
O&M Grade: **0**  
Clock Start/From: **11**  
Clock To: **12**  
1st Value:  
2nd Value:  
Value Percent:  
Continuous Index:  
Within 8" of Joint: **YES**  
Remarks:

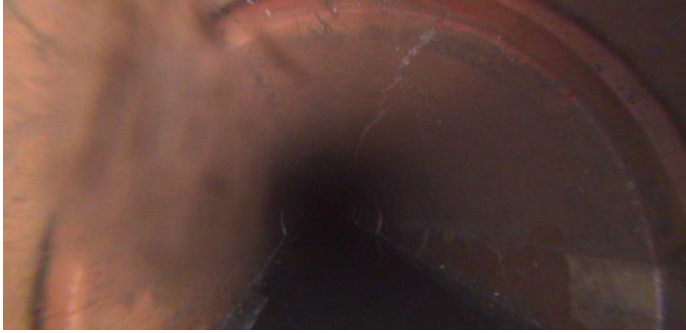
Code: **FM**  
Description: **Fracture Multiple**

Distance (ft): **37.6**  
Structural Grade: **4**  
O&M Grade: **0**  
Clock Start/From: **8**  
Clock To: **4**  
1st Value:  
2nd Value:  
Value Percent:  
Continuous Index:  
Within 8" of Joint: **YES**  
Remarks:

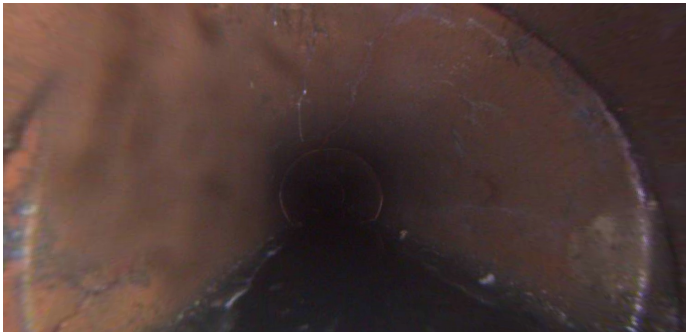
Code: **MSA**  
Description: **Abandoned Survey**

Distance (ft): **39.6**  
Structural Grade: **0**  
O&M Grade: **0**  
Clock Start/From:  
Clock To:  
1st Value:  
2nd Value:  
Value Percent:  
Continuous Index:  
Within 8" of Joint: **NO**  
Remarks: **debris under water**
