Profile/Photo Observation Report

Street:	N WASHINGTON ST & W CLEVELAND	Flow Control:	Not Controlled
City:	Hobart, IN	Year Renewed:	
Location:	Light Highway	Tape/Media #:	
Purpose:	Not Known	Dia/Height:	12"
Use:	Sanitary	Material:	VCP
Drain Area:	NA	Lining:	
Category:	NA		
Comment:

Location Details:		Direction of Survey:	Downstream
US MH:	M-604-071	DS MH:	M-604-070
		Total Length Surveyed (ft):	15.2

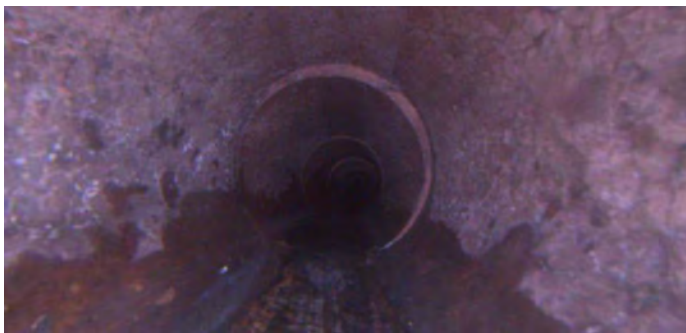
Code: **AMH**
Description: **Manhole**

Distance (ft): **.0**
Structural Grade: **0**
O&M Grade: **0**
Clock Start/From:
Clock To:
1st Value:
2nd Value:
Value Percent:
Continuous Index:
Within 8" of Joint: **NO**
Remarks: **M-604-071**

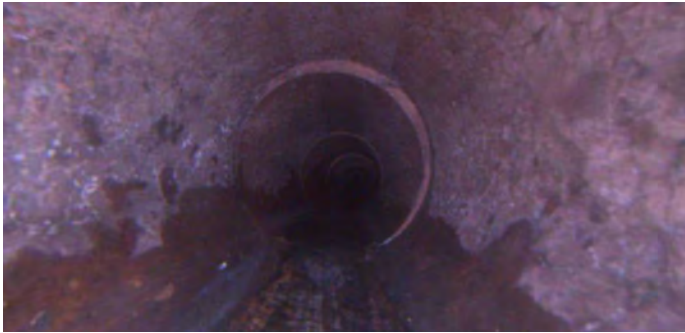
Code:	MWL
Description:	Water Level

Distance (ft):	.0
Structural Grade:	0
O&M Grade:	0
Clock Start/From:	
Clock To:	
1st Value:	
2nd Value:	
Value Percent:	5.000
Continuous Index:	
Within 8" of Joint:	NO
Remarks:

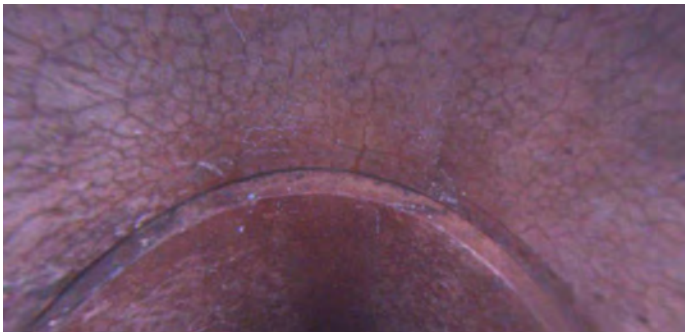
Code:	CM
Description:	Crack Multiple

Distance (ft):	1.8
Structural Grade:	3
O&M Grade:	0
Clock Start/From:	8
Clock To:	4
1st Value:	
2nd Value:	
Value Percent:	
Continuous Index:	
Within 8" of Joint:	YES
Remarks:

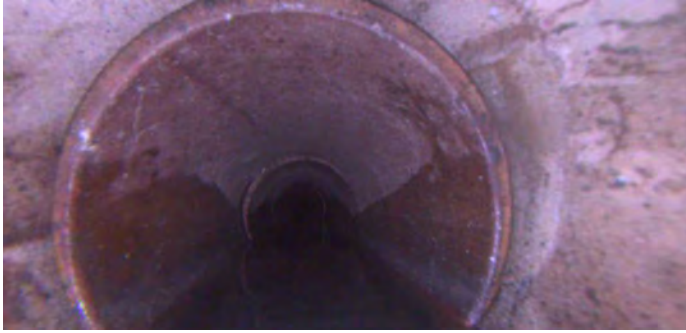
Code: **CM**
Description: **Crack Multiple**

Distance (ft): **7.5**
Structural Grade: **3**
O&M Grade: **0**
Clock Start/From: **8**
Clock To: **4**
1st Value:
2nd Value:
Value Percent:
Continuous Index:
Within 8" of Joint: **YES**
Remarks:

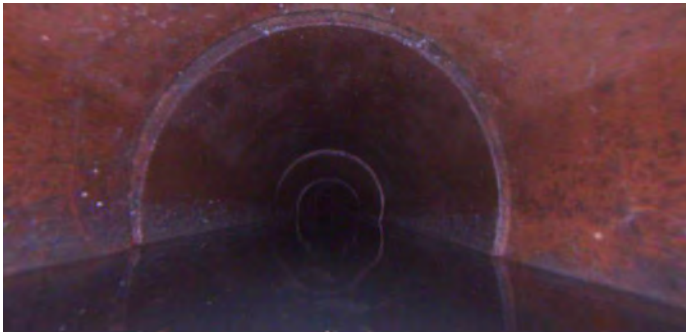
Code: **CM**
Description: **Crack Multiple**

Distance (ft): **15.2**
Structural Grade: **3**
O&M Grade: **0**
Clock Start/From: **8**
Clock To: **4**
1st Value:
2nd Value:
Value Percent:
Continuous Index:
Within 8" of Joint: **YES**
Remarks:

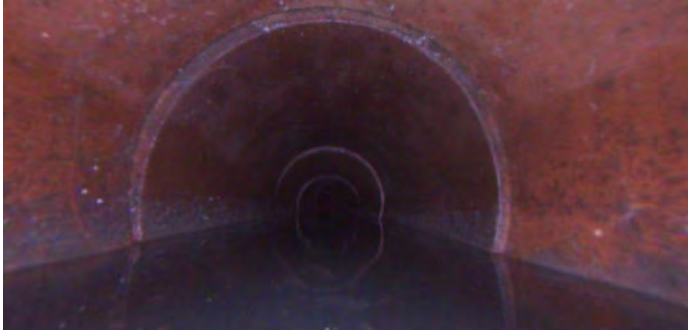
Code:	MSA
Description:	Abandoned Survey
Distance (ft):	15.2
Structural Grade:	0
O&M Grade:	0
Clock Start/From:	
Clock To:	
1st Value:	
2nd Value:	
Value Percent:	
Continuous Index:	
Within 8" of Joint:	NO
Remarks:	debris under water
