## Profile/Photo Observation Report

Street:	<b>Summerlin</b>	Flow Control:	<b>Not Controlled</b>
City:	<b>Hobart, IN</b>	Year Renewed:	
Location:	<b>Light Highway</b>	Tape/Media #:	
Purpose:	<b>Not Known</b>	Dia/Height:	<b>12"</b>
Use:	<b>Sanitary</b>	Material:	<b>VCP</b>
Drain Area:	<b>NA</b>	Lining:	
Category:	<b>NA</b>		
Comment:

Location Details:		Direction of Survey:	<b>Downstream</b>
US MH:	<b>M-604-071</b>	DS MH:	<b>M-604-070</b>
		Total Length Surveyed (ft):	<b>15.2</b>

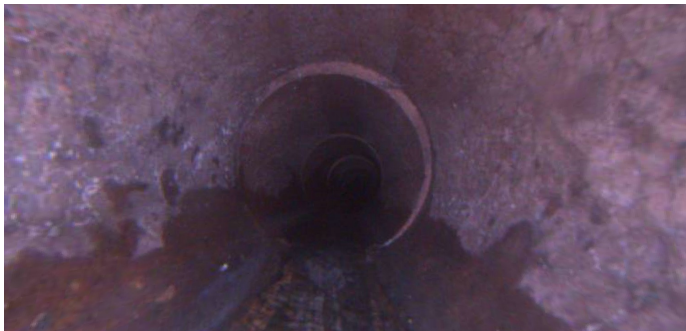
Code: **AMH**  
Description: **Manhole**

Distance (ft): **.0**  
Structural Grade: **0**  
O&M Grade: **0**  
Clock Start/From:  
Clock To:  
1st Value:  
2nd Value:  
Value Percent:  
Continuous Index:  
Within 8" of Joint: **NO**  
Remarks: **M-604-071**

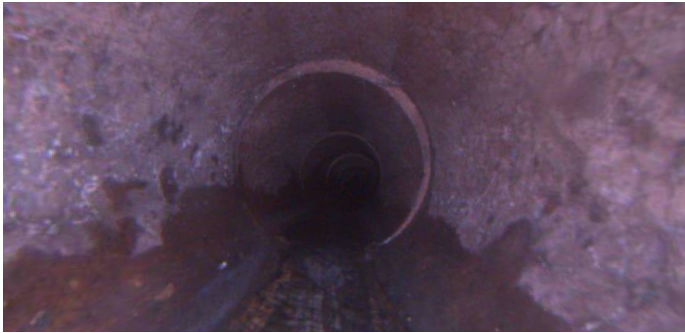
Code:	<b>MWL</b>
Description:	<b>Water Level</b>

Distance (ft):	<b>.0</b>
Structural Grade:	<b>0</b>
O&M Grade:	<b>0</b>
Clock Start/From:	
Clock To:	
1st Value:	
2nd Value:	
Value Percent:	<b>5.000</b>
Continuous Index:	
Within 8" of Joint:	<b>NO</b>
Remarks:

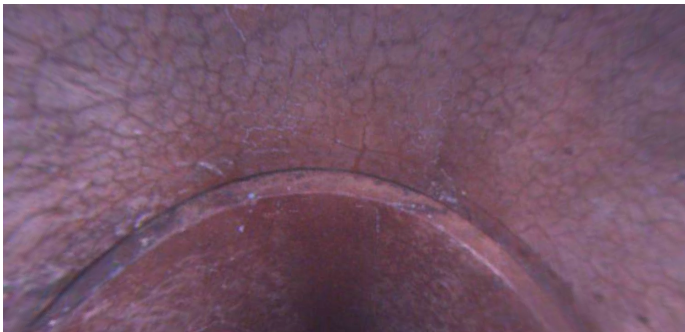
Code:	<b>CM</b>
Description:	<b>Crack Multiple</b>

Distance (ft):	<b>1.8</b>
Structural Grade:	<b>3</b>
O&M Grade:	<b>0</b>
Clock Start/From:	<b>8</b>
Clock To:	<b>4</b>
1st Value:	
2nd Value:	
Value Percent:	
Continuous Index:	
Within 8" of Joint:	<b>YES</b>
Remarks:

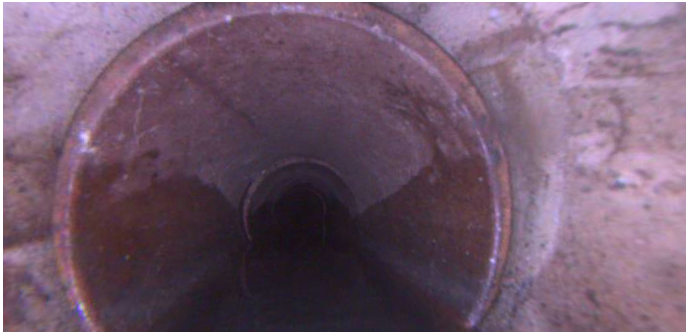
Code: **CM**  
Description: **Crack Multiple**

Distance (ft): **7.5**  
Structural Grade: **3**  
O&M Grade: **0**  
Clock Start/From: **8**  
Clock To: **4**  
1st Value:  
2nd Value:  
Value Percent:  
Continuous Index:  
Within 8" of Joint: **YES**  
Remarks:

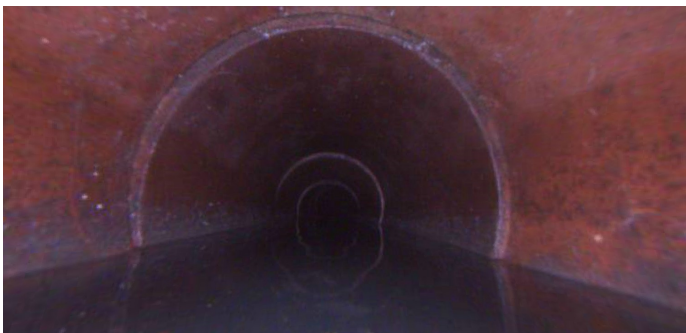
Code: **CM**  
Description: **Crack Multiple**

Distance (ft): **15.2**  
Structural Grade: **3**  
O&M Grade: **0**  
Clock Start/From: **8**  
Clock To: **4**  
1st Value:  
2nd Value:  
Value Percent:  
Continuous Index:  
Within 8" of Joint: **YES**  
Remarks:

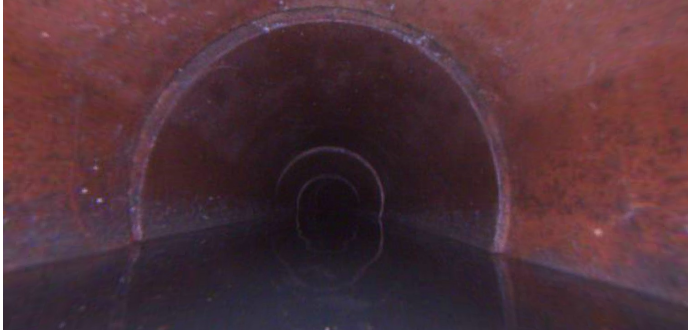
Code:	<b>MSA</b>
Description:	<b>Abandoned Survey</b>
Distance (ft):	<b>15.2</b>
Structural Grade:	<b>0</b>
O&M Grade:	<b>0</b>
Clock Start/From:	
Clock To:	
1st Value:	
2nd Value:	
Value Percent:	
Continuous Index:	
Within 8" of Joint:	<b>NO</b>
Remarks:	<b>debris under water</b>
