Profile/Photo Observation Report

Street:	N WASHINGTON ST & W HOME AVE	Flow Control:	Not Controlled
City:	Hobart, IN	Year Renewed:	
Location:	Light Highway	Tape/Media #:	
Purpose:	Not Known	Dia/Height:	12"
Use:	Sanitary	Material:	VCP
Drain Area:	NA	Lining:	
Category:	NA		
Comment:

Location Details:		Direction of Survey:	Downstream
US MH:	M-604-074	DS MH:	M-604-073
		Total Length Surveyed (ft):	10.4

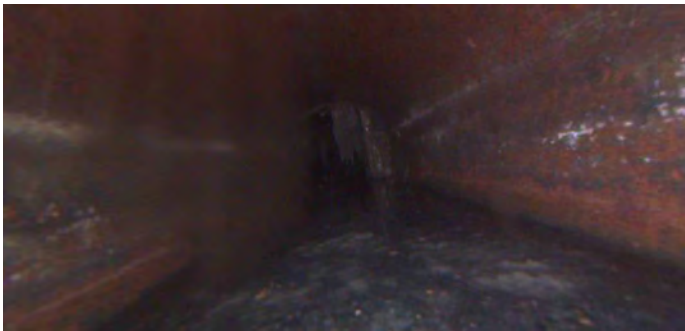
Code: **AMH**
Description: **Manhole**

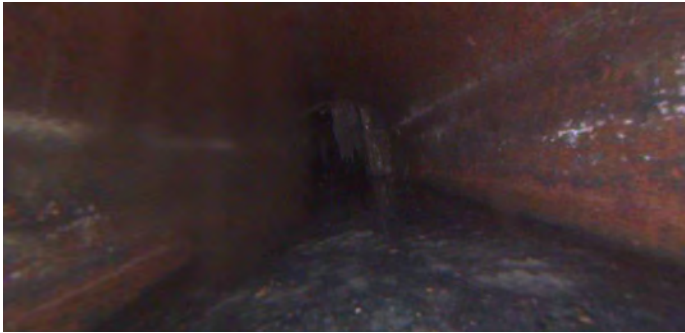
Code:	MWL
Description:	Water Level

Distance (ft):	.0
Structural Grade:	0
O&M Grade:	0
Clock Start/From:	
Clock To:	
1st Value:	
2nd Value:	
Value Percent:	40.000
Continuous Index:	
Within 8" of Joint:	NO
Remarks:

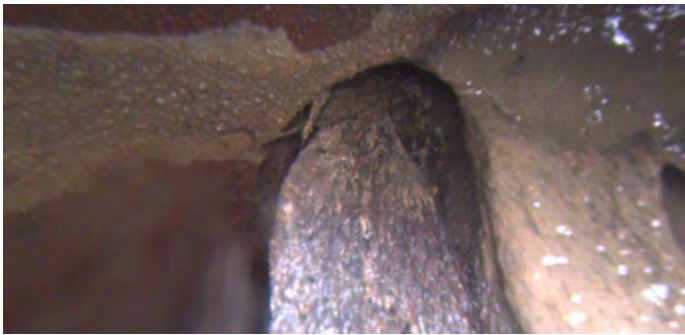
Code:	TFD
Description:	Tap Factory Defective

Distance (ft):	3.3
Structural Grade:	0
O&M Grade:	2
Clock Start/From:	1
Clock To:	
1st Value:	4.000
2nd Value:	
Value Percent:	
Continuous Index:	
Within 8" of Joint:	
Remarks:	roots

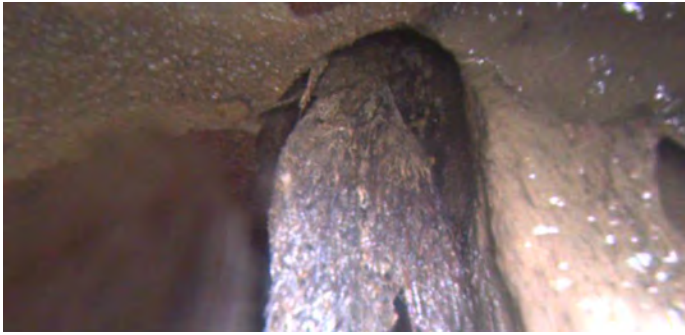
Code: **RML**
Description: **Roots Medium Lateral**

Distance (ft): **3.3**
Structural Grade: **0**
O&M Grade: **3**
Clock Start/From: **12**
Clock To: **4**
1st Value:
2nd Value:
Value Percent: **40.000**
Continuous Index:
Within 8" of Joint: **NO**
Remarks:

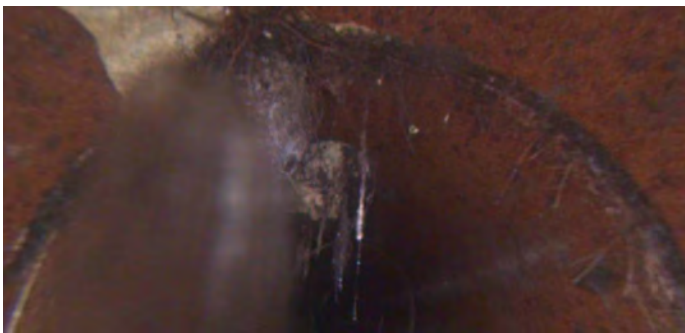
Code: **RMJ**
Description: **Roots Medium Joint**

Distance (ft): **4.6**
Structural Grade: **0**
O&M Grade: **3**
Clock Start/From: **8**
Clock To: **4**
1st Value:
2nd Value:
Value Percent: **10.000**
Continuous Index:
Within 8" of Joint: **YES**
Remarks:

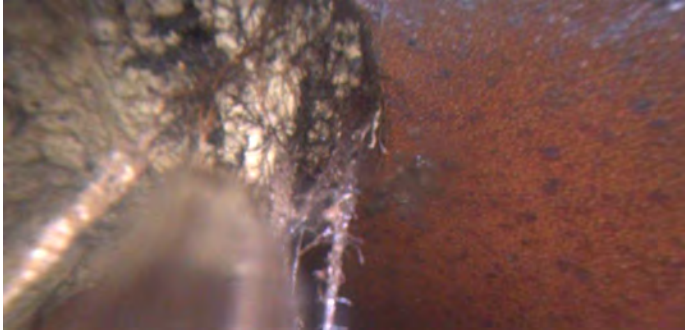
Code: **TFD**
Description: **Tap Factory Defective**

Distance (ft): **5.6**
Structural Grade: **0**
O&M Grade: **2**
Clock Start/From: **11**
Clock To:
1st Value: **4.000**
2nd Value:
Value Percent:
Continuous Index:
Within 8" of Joint:
Remarks: **roots**

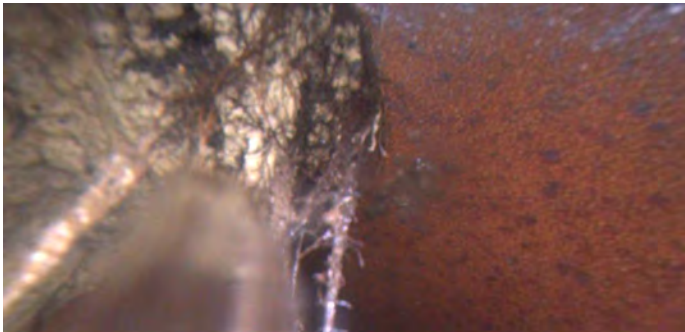
Code: **RML**
Description: **Roots Medium Lateral**

Distance (ft): **5.6**
Structural Grade: **0**
O&M Grade: **3**
Clock Start/From: **11**
Clock To: **12**
1st Value:
2nd Value:
Value Percent: **10.000**
Continuous Index:
Within 8" of Joint: **NO**
Remarks:

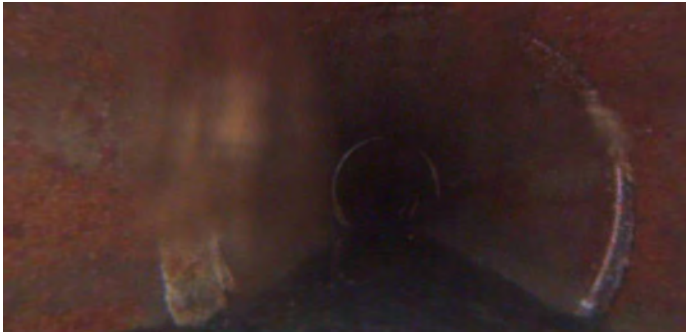
Code: **DAE**
Description: **Deposits Attached Encrustation**

Distance (ft): **10.4**
Structural Grade: **0**
O&M Grade: **2**
Clock Start/From: **8**
Clock To: **4**
1st Value:
2nd Value:
Value Percent: **5.000**
Continuous Index:
Within 8" of Joint: **YES**
Remarks:

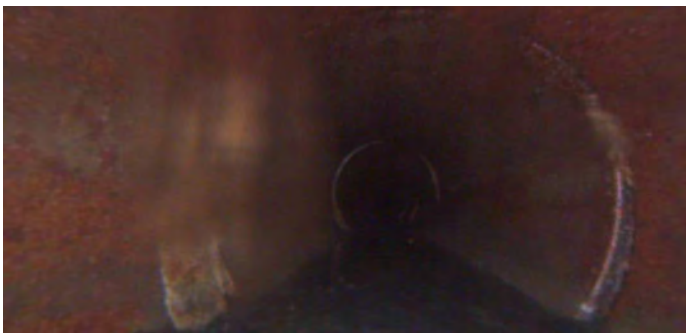
Code: **MSA**
Description: **Abandoned Survey**

Distance (ft): **10.4**
Structural Grade: **0**
O&M Grade: **0**
Clock Start/From:
Clock To:
1st Value:
2nd Value:
Value Percent:
Continuous Index:
Within 8" of Joint: **NO**
Remarks: **dae**
