Profile/Photo Observation Report

Date:	11/17/2021	Weather:		Coding:	PACP 7.0
Pipe Length (ft):	223.5	Owner:	City of Hobart	Pre Clean:	Heavy Cleaning
P.O.#:	YES502259	Surveyor:	S. Bucklin	PSR:	P-604-074-073
Customer:	City of Hobart	Clean Date:	11/17/2021	Shape:	C

Street:	North Washington Street	Flow Control:	Not Controlled
City:	Hobart, IN	Year Renewed:	
Location:	Easement/Right of Way	Tape/Media #:	
Purpose:	Routine Assessment	Dia/Height:	12"
Use:	Sanitary Sewage Pipe	Material:	VCP
Drain Area:		Lining:	None
Category:	NA		
Comment:			
Location Details:		Direction of Survey:	Downstream
US MH:	M-604-074	DS MH:	M-604-073
		Total Length Surveyed (ft):	223.5

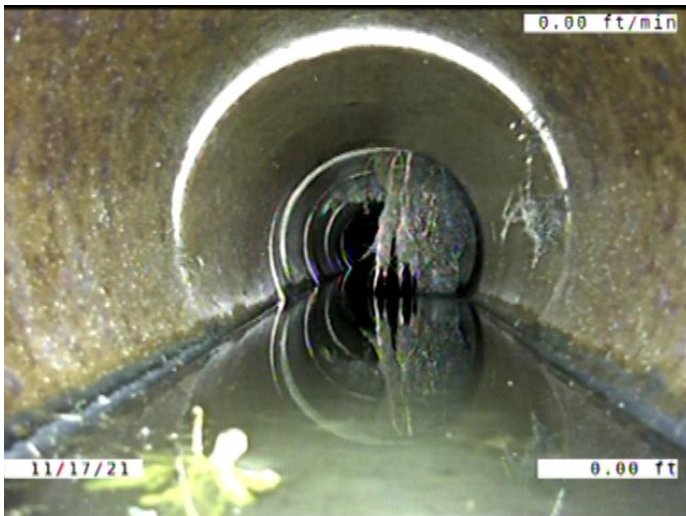
Code: **MWL**
Description: **Miscellaneous Water Level**

Distance (ft): **.0**
Structural Grade: **0**
O&M Grade: **0**
Clock Start/From:
Clock To:
1st Value:
2nd Value:
Value Percent: **5.000**
Continuous Index:
Within 8" of Joint: **NO**
Remarks:

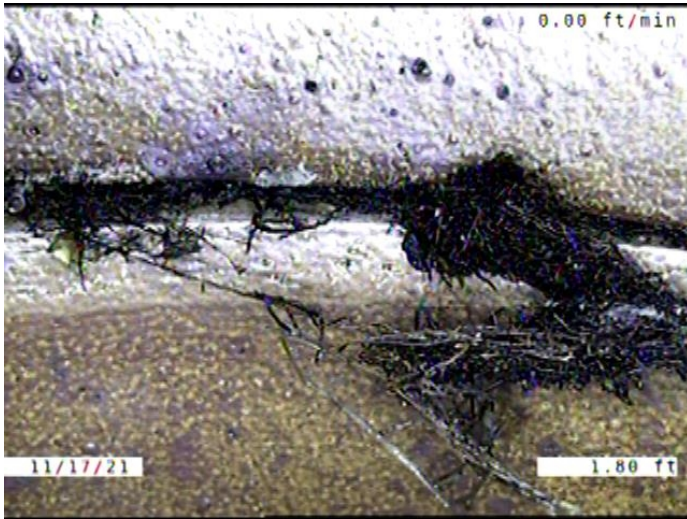
Code: **RFJ**
 Description: **Roots Fine Joint**

Distance (ft): **1.8**
 Structural Grade: **0**
 O&M Grade: **1**
 Clock Start/From: **9**
 Clock To: **3**
 1st Value:
 2nd Value:
 Value Percent:
 Continuous Index:
 Within 8" of Joint: **YES**
 Remarks:

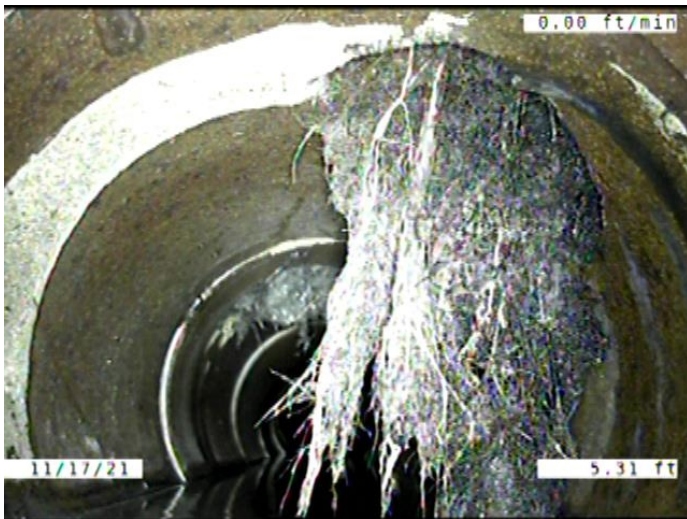
Code: **RML**
 Description: **Roots Medium Lateral**

Distance (ft): **5.3**
 Structural Grade: **0**
 O&M Grade: **3**
 Clock Start/From: **12**
 Clock To: **3**
 1st Value:
 2nd Value:
 Value Percent: **35.000**
 Continuous Index:
 Within 8" of Joint: **NO**
 Remarks:

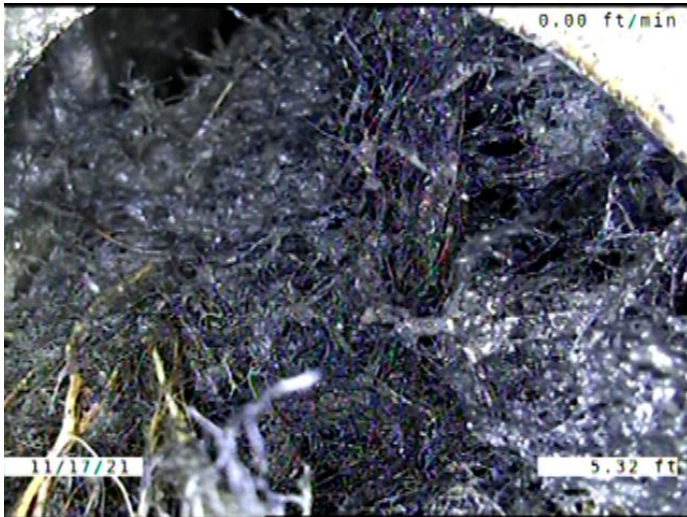
Code: **TFD**
Description: **Tap Factory Defective**

Distance (ft): **5.3**
Structural Grade: **0**
O&M Grade: **3**
Clock Start/From: **1**
Clock To:
1st Value: **4.000**
2nd Value:
Value Percent:
Continuous Index:
Within 8" of Joint: **YES**
Remarks: **95% PLUGGED WITH ROOTS.
CONSTANTLY RUNNING WATER.**

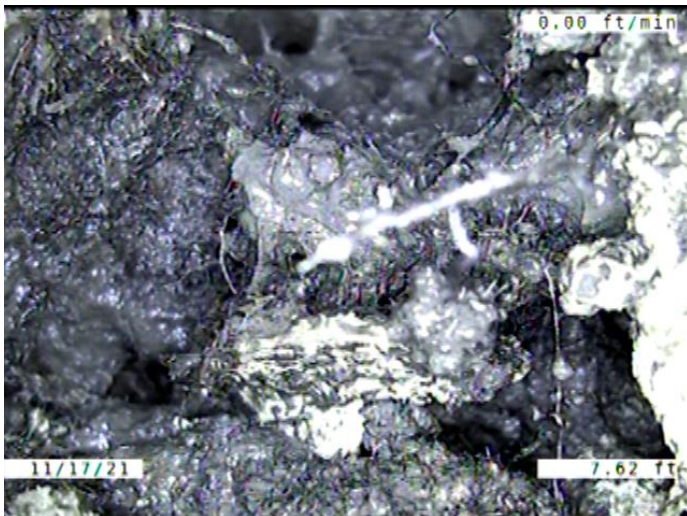
Code: **TFD**
Description: **Tap Factory Defective**

Distance (ft): **7.6**
Structural Grade: **0**
O&M Grade: **3**
Clock Start/From: **11**
Clock To:
1st Value: **4.000**
2nd Value:
Value Percent:
Continuous Index:
Within 8" of Joint: **YES**
Remarks: **LOOKS TO BE 95 % PLUGGED WITH
ROOTS**

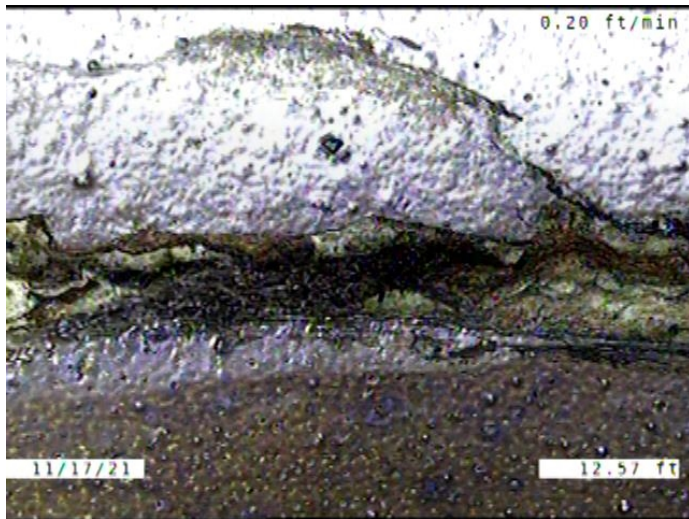
Code: **RFJ**
 Description: **Roots Fine Joint**

Distance (ft): **12.6**
 Structural Grade: **0**
 O&M Grade: **1**
 Clock Start/From: **10**
 Clock To: **3**
 1st Value:
 2nd Value:
 Value Percent:
 Continuous Index:
 Within 8" of Joint: **YES**
 Remarks:

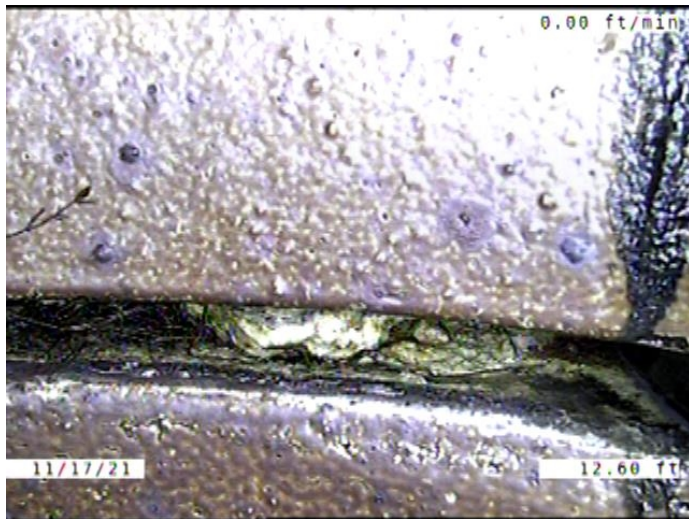
Code: **DAE**
 Description: **Deposits Attached Encrustation**

Distance (ft): **12.6**
 Structural Grade: **0**
 O&M Grade: **2**
 Clock Start/From: **8**
 Clock To: **4**
 1st Value:
 2nd Value:
 Value Percent: **5.000**
 Continuous Index: **S01**
 Within 8" of Joint: **YES**
 Remarks:

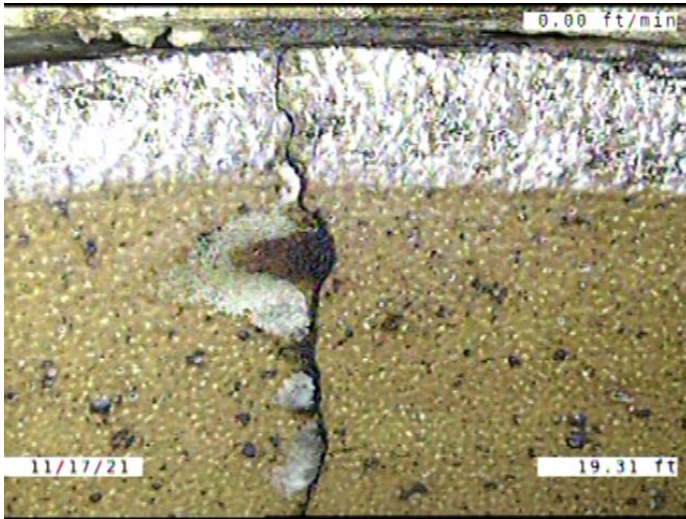
Code: **CL**
Description: **Crack Longitudinal**

Distance (ft): **19.3**
Structural Grade: **2**
O&M Grade: **0**
Clock Start/From: **10**
Clock To:
1st Value:
2nd Value:
Value Percent:
Continuous Index:
Within 8" of Joint: **YES**
Remarks:

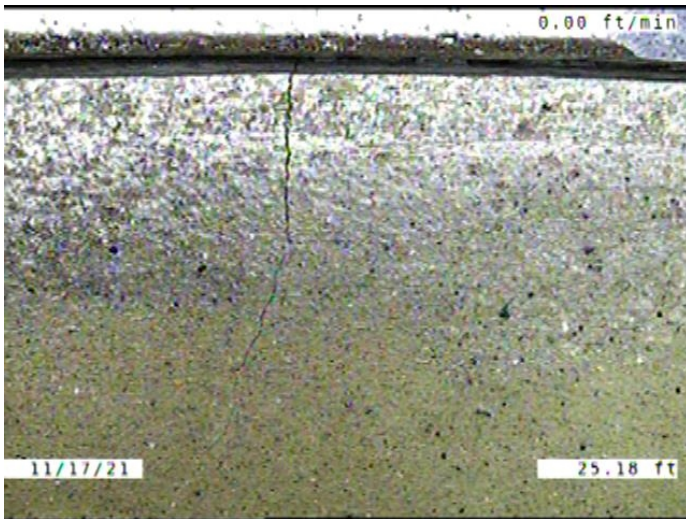
Code: **CS**
Description: **Crack Spiral**

Distance (ft): **25.2**
Structural Grade: **2**
O&M Grade: **0**
Clock Start/From: **10**
Clock To: **12**
1st Value:
2nd Value:
Value Percent:
Continuous Index:
Within 8" of Joint: **YES**
Remarks:

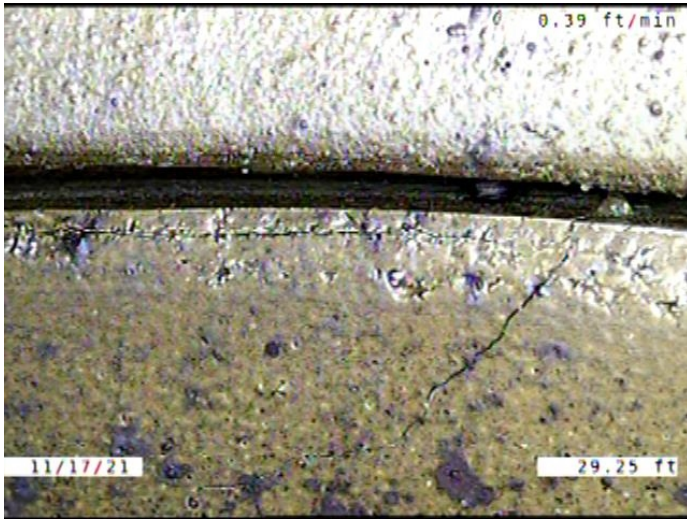
Code: **CM**
 Description: **Crack Multiple**

Distance (ft): **29.2**
 Structural Grade: **3**
 O&M Grade: **0**
 Clock Start/From: **2**
 Clock To: **4**
 1st Value:
 2nd Value:
 Value Percent:
 Continuous Index:
 Within 8" of Joint: **YES**
 Remarks:

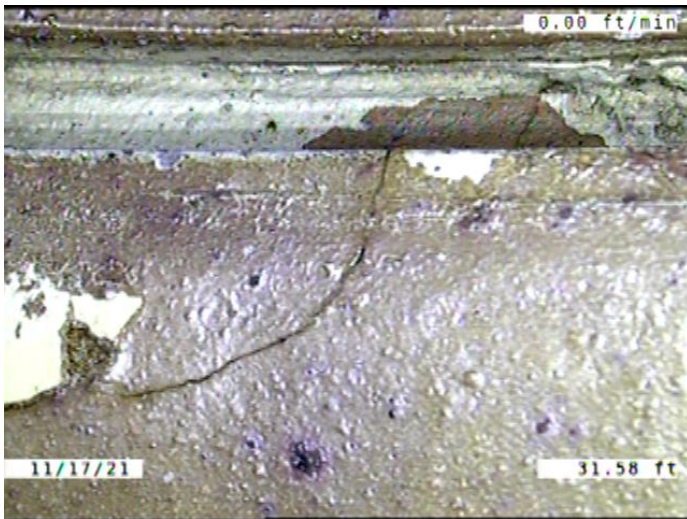
Code: **CM**
 Description: **Crack Multiple**

Distance (ft): **31.6**
 Structural Grade: **3**
 O&M Grade: **0**
 Clock Start/From: **1**
 Clock To: **3**
 1st Value:
 2nd Value:
 Value Percent:
 Continuous Index:
 Within 8" of Joint: **YES**
 Remarks:

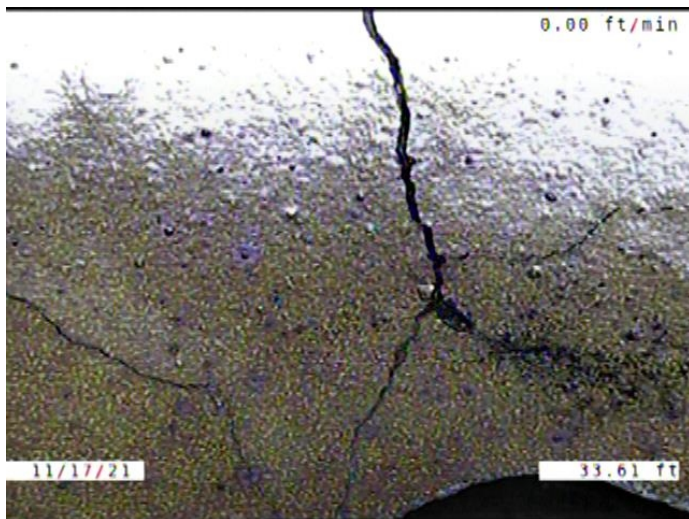
Code: **FM**
 Description: **Fracture Multiple**

Distance (ft): **33.6**
 Structural Grade: **4**
 O&M Grade: **0**
 Clock Start/From: **12**
 Clock To: **12**
 1st Value:
 2nd Value:
 Value Percent:
 Continuous Index: **S02**
 Within 8" of Joint: **YES**
 Remarks:

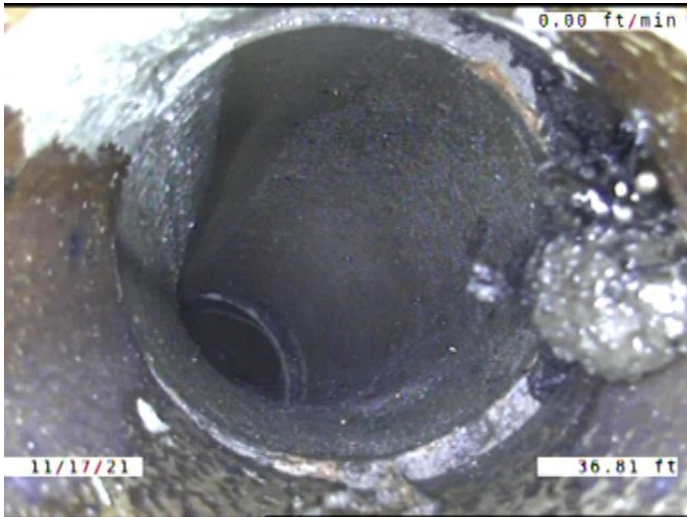
Code: **TF**
Description: **Tap Factory**

Distance (ft): **36.8**
Structural Grade: **0**
O&M Grade: **0**
Clock Start/From: **11**
Clock To:
1st Value: **4.000**
2nd Value:
Value Percent:
Continuous Index:
Within 8" of Joint: **YES**
Remarks: **ROOTS GROWING OUT OF THE JOINT.**

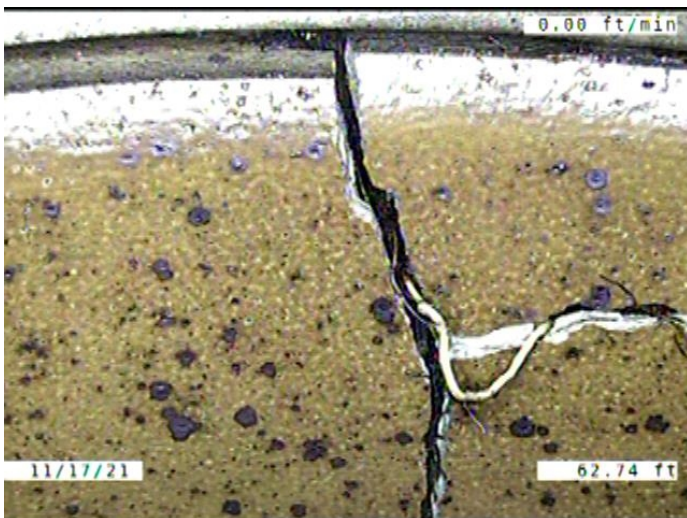
Code: **B**
Description: **Broken**

Distance (ft): **62.7**
Structural Grade: **4**
O&M Grade: **0**
Clock Start/From: **8**
Clock To: **4**
1st Value:
2nd Value:
Value Percent:
Continuous Index:
Within 8" of Joint: **YES**
Remarks:

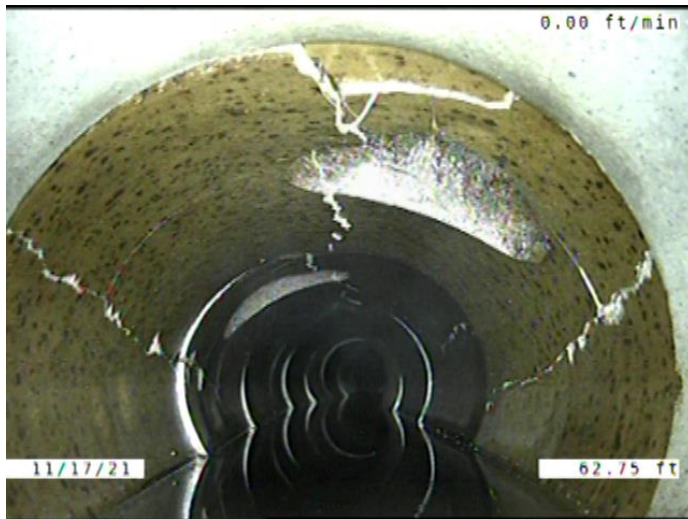
Code: **DR**
 Description: **Deformed Rigid**

Distance (ft): **62.7**
 Structural Grade: **4**
 O&M Grade: **0**
 Clock Start/From:
 Clock To:
 1st Value:
 2nd Value:
 Value Percent: **5.000**
 Continuous Index:
 Within 8" of Joint: **NO**
 Remarks:

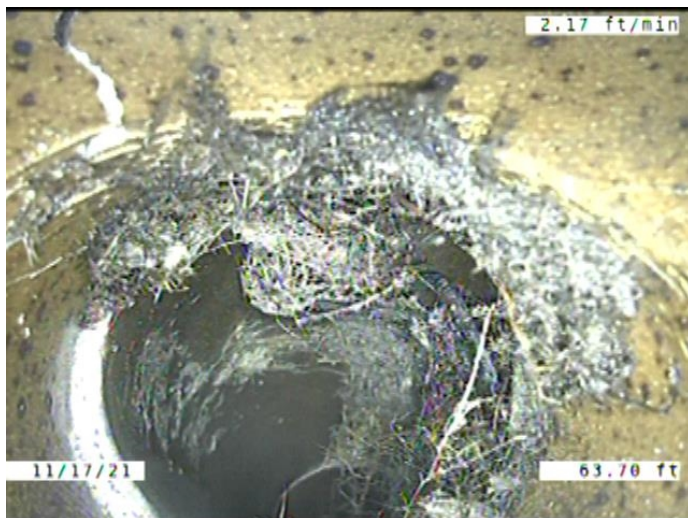
Code: **RFL**
 Description: **Roots Fine Lateral**

Distance (ft): **63.6**
 Structural Grade: **0**
 O&M Grade: **1**
 Clock Start/From: **1**
 Clock To:
 1st Value:
 2nd Value:
 Value Percent:
 Continuous Index:
 Within 8" of Joint: **NO**
 Remarks:

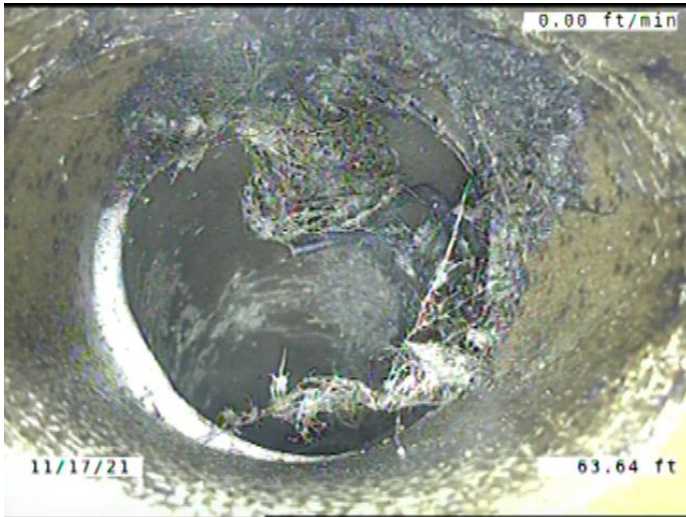
Code:	TF
Description:	Tap Factory
Distance (ft):	63.6
Structural Grade:	0
O&M Grade:	0
Clock Start/From:	1
Clock To:	
1st Value:	4.000
2nd Value:	
Value Percent:	
Continuous Index:	
Within 8" of Joint:	YES
Remarks:	ROOTS GROWING OUT OF THE JOINTS

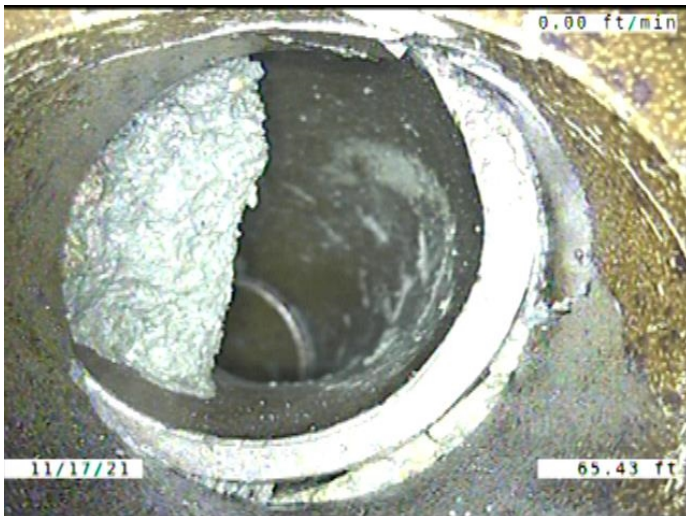
Code:	TFD
Description:	Tap Factory Defective
Distance (ft):	65.4
Structural Grade:	0
O&M Grade:	3
Clock Start/From:	11
Clock To:	
1st Value:	4.000
2nd Value:	
Value Percent:	
Continuous Index:	
Within 8" of Joint:	YES
Remarks:	BROKEN. OFFSET.

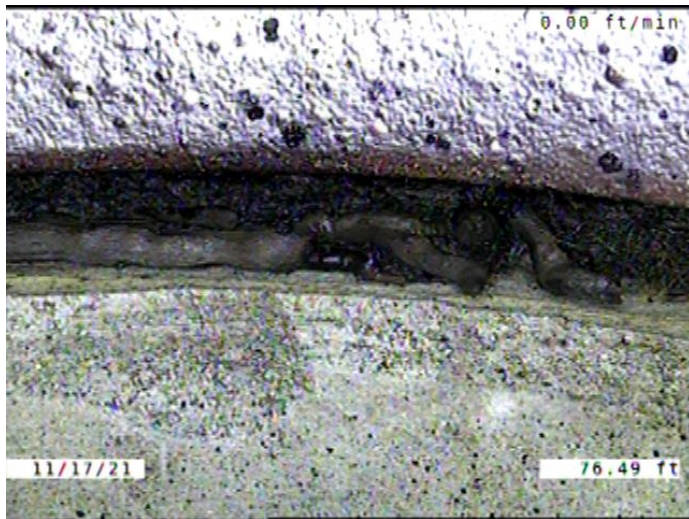
Code: **RFJ**
 Description: **Roots Fine Joint**

Distance (ft): **76.5**
 Structural Grade: **0**
 O&M Grade: **1**
 Clock Start/From: **9**
 Clock To: **3**
 1st Value:
 2nd Value:
 Value Percent:
 Continuous Index: **S04**
 Within 8" of Joint: **YES**
 Remarks:

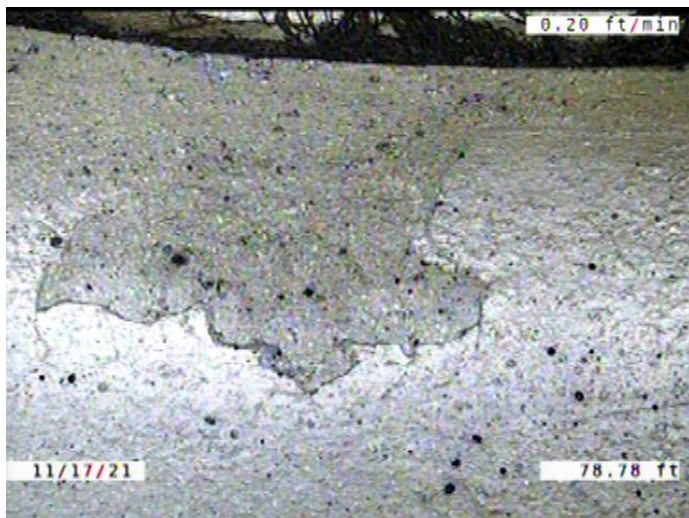
Code: **SSS**
 Description: **Surface Damage Surface Spalling**

Distance (ft): **78.8**
 Structural Grade: **2**
 O&M Grade: **0**
 Clock Start/From: **12**
 Clock To:
 1st Value:
 2nd Value:
 Value Percent:
 Continuous Index:
 Within 8" of Joint: **YES**
 Remarks:

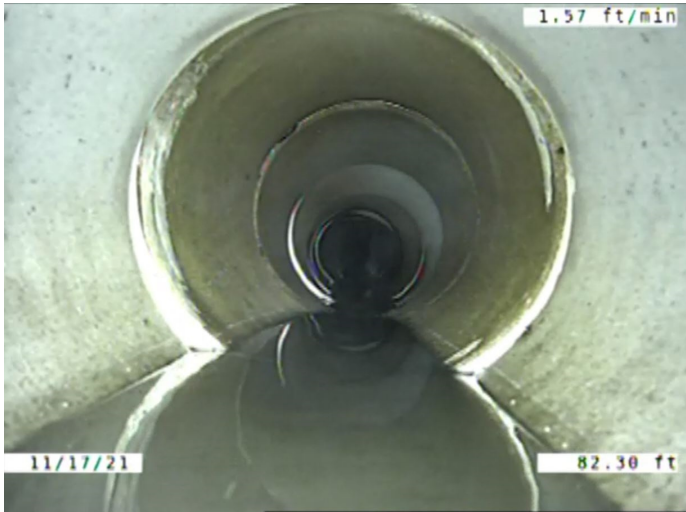
Code: **FM**
Description: **Fracture Multiple**

Distance (ft): **82.3**
Structural Grade: **4**
O&M Grade: **0**
Clock Start/From: **12**
Clock To: **12**
1st Value:
2nd Value:
Value Percent:
Continuous Index: **F02**
Within 8" of Joint: **YES**
Remarks:

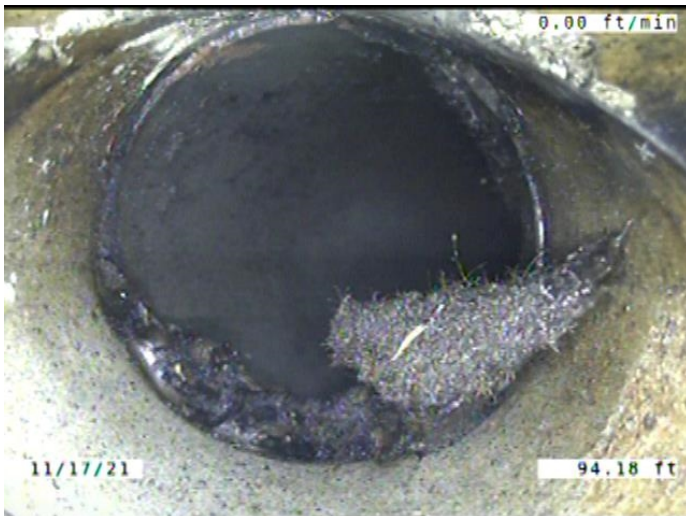
Code: **TFD**
Description: **Tap Factory Defective**

Distance (ft): **94.2**
Structural Grade: **0**
O&M Grade: **3**
Clock Start/From: **1**
Clock To:
1st Value: **4.000**
2nd Value:
Value Percent:
Continuous Index:
Within 8" of Joint: **YES**
Remarks: **BROKEN. ROOTS GROWING OUT OF THE JOINT**

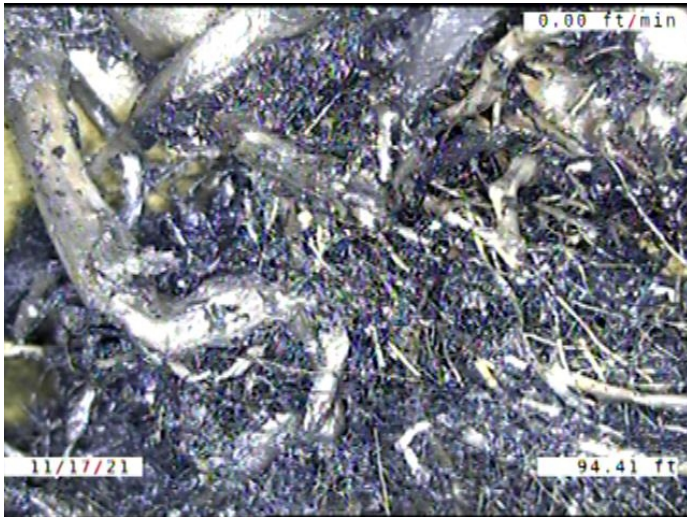
Code: **RMJ**
Description: **Roots Medium Joint**

Distance (ft): **94.4**
Structural Grade: **0**
O&M Grade: **3**
Clock Start/From: **12**
Clock To: **4**
1st Value:
2nd Value:
Value Percent: **10.000**
Continuous Index:
Within 8" of Joint: **YES**
Remarks:

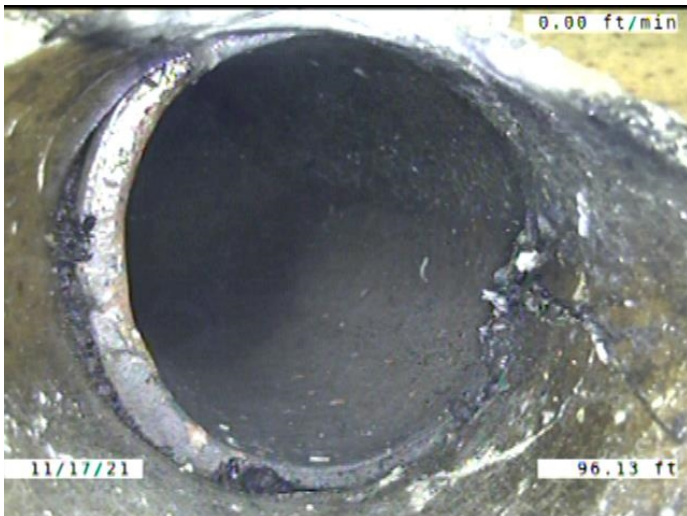
Code: **TFD**
Description: **Tap Factory Defective**

Distance (ft): **96.1**
Structural Grade: **0**
O&M Grade: **3**
Clock Start/From: **1**
Clock To:
1st Value: **4.000**
2nd Value:
Value Percent:
Continuous Index:
Within 8" of Joint: **YES**
Remarks: **BROKEN. OFFSET.**

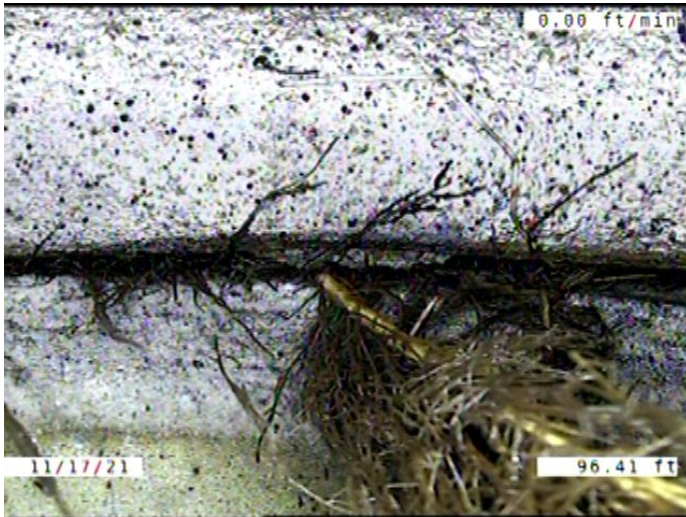
Code: **RMJ**
Description: **Roots Medium Joint**

Distance (ft): **96.4**
Structural Grade: **0**
O&M Grade: **3**
Clock Start/From: **8**
Clock To: **4**
1st Value:
2nd Value:
Value Percent: **5.000**
Continuous Index:
Within 8" of Joint: **YES**
Remarks:

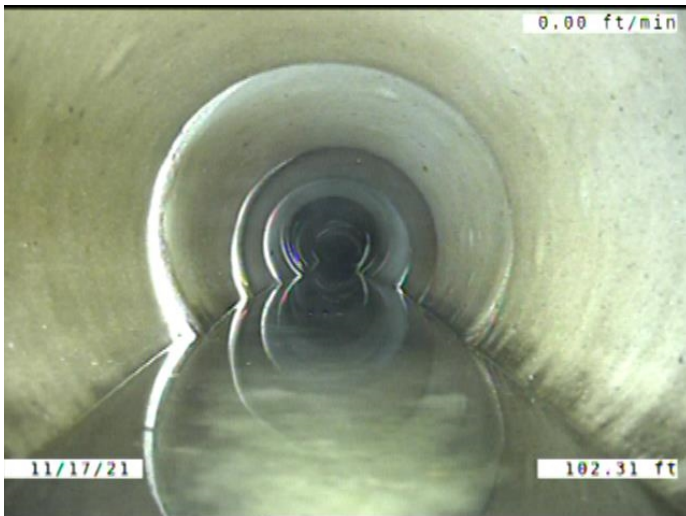
Code: **RFJ**
Description: **Roots Fine Joint**

Distance (ft): **102.3**
Structural Grade: **0**
O&M Grade: **1**
Clock Start/From: **9**
Clock To: **3**
1st Value:
2nd Value:
Value Percent:
Continuous Index: **F04**
Within 8" of Joint: **YES**
Remarks:

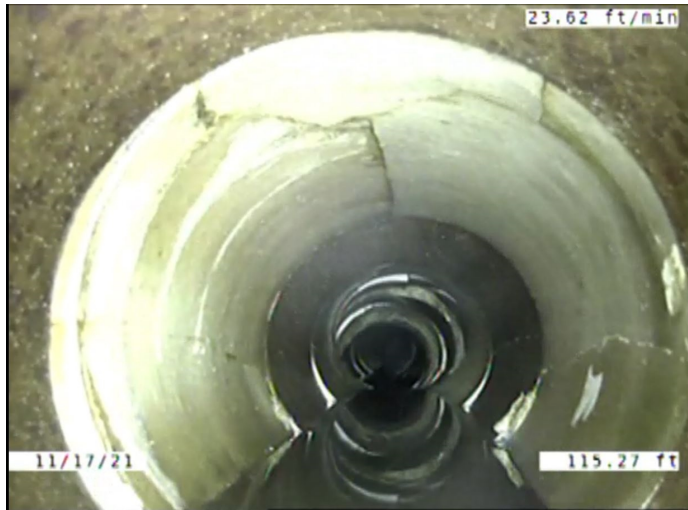
Code: **FM**
 Description: **Fracture Multiple**

Distance (ft): **115.3**
 Structural Grade: **4**
 O&M Grade: **0**
 Clock Start/From: **8**
 Clock To: **4**
 1st Value:
 2nd Value:
 Value Percent:
 Continuous Index: **S10**
 Within 8" of Joint: **YES**
 Remarks: **Wandering**

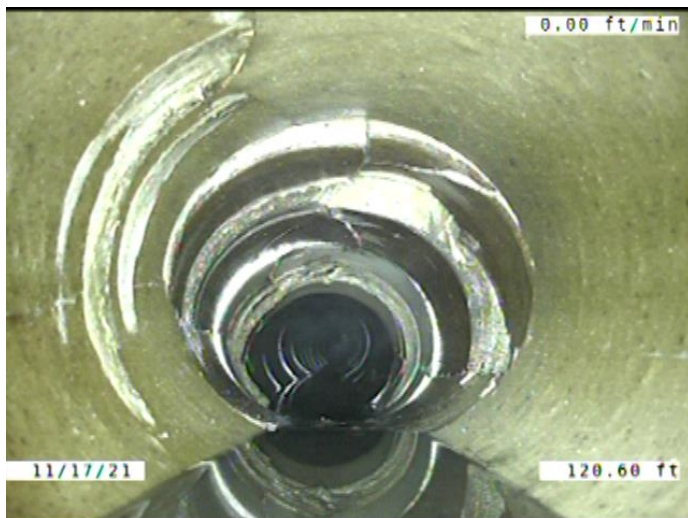
Code: **B**
 Description: **Broken**

Distance (ft): **120.6**
 Structural Grade: **4**
 O&M Grade: **0**
 Clock Start/From: **8**
 Clock To: **4**
 1st Value:
 2nd Value:
 Value Percent:
 Continuous Index: **S05**
 Within 8" of Joint: **YES**
 Remarks:

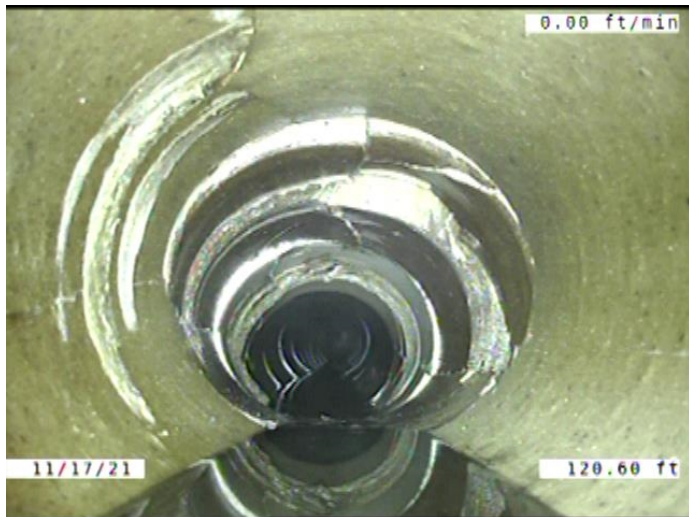
Code: **DR**
 Description: **Deformed Rigid**

Distance (ft): **120.6**
 Structural Grade: **4**
 O&M Grade: **0**
 Clock Start/From:
 Clock To:
 1st Value:
 2nd Value:
 Value Percent: **5.000**
 Continuous Index: **S06**
 Within 8" of Joint: **NO**
 Remarks:

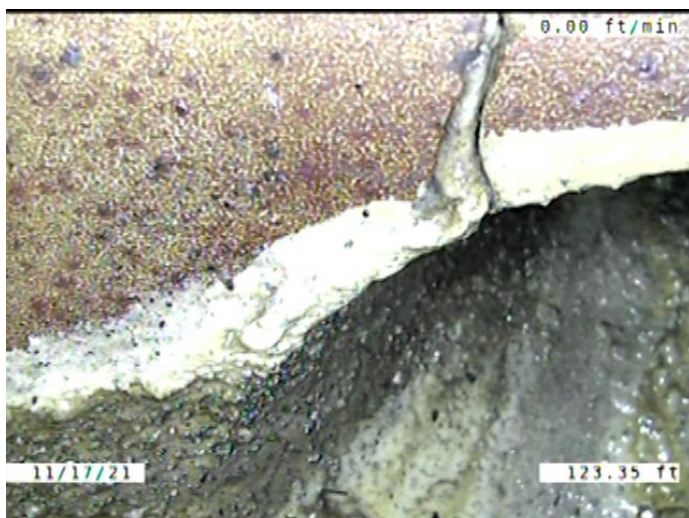
Code: **IDC**
 Description: **Infiltration Dripper Connection**

Distance (ft): **123.3**
 Structural Grade: **0**
 O&M Grade: **3**
 Clock Start/From: **12**
 Clock To:
 1st Value:
 2nd Value:
 Value Percent:
 Continuous Index:
 Within 8" of Joint: **YES**
 Remarks:

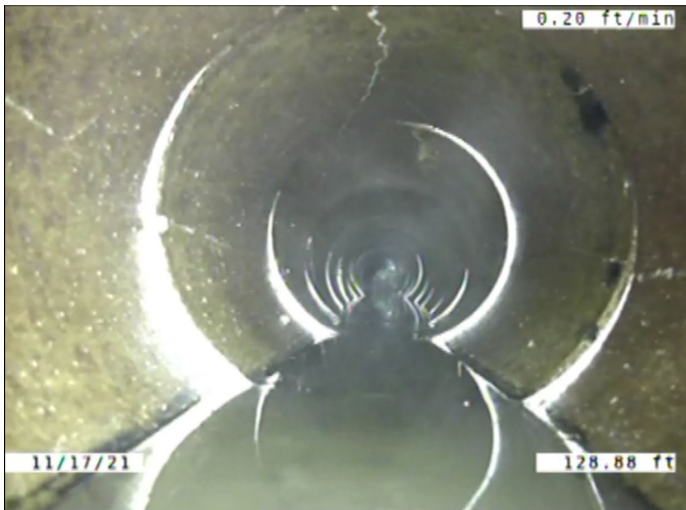
Code:	DR
Description:	Deformed Rigid
Distance (ft):	128.9
Structural Grade:	4
O&M Grade:	0
Clock Start/From:	
Clock To:	
1st Value:	
2nd Value:	
Value Percent:	5.000
Continuous Index:	F06
Within 8" of Joint:	NO
Remarks:

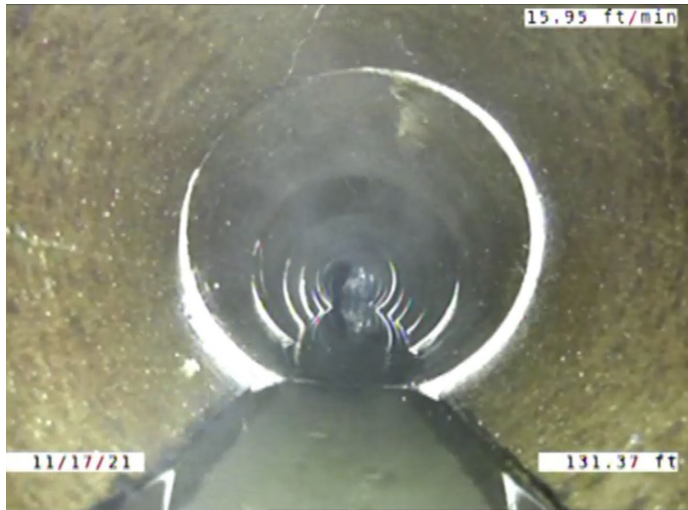
Code: **B**
Description: **Broken**

Distance (ft): **131.4**
Structural Grade: **4**
O&M Grade: **0**
Clock Start/From: **8**
Clock To: **4**
1st Value:
2nd Value:
Value Percent:
Continuous Index: **F05**
Within 8" of Joint: **YES**
Remarks:

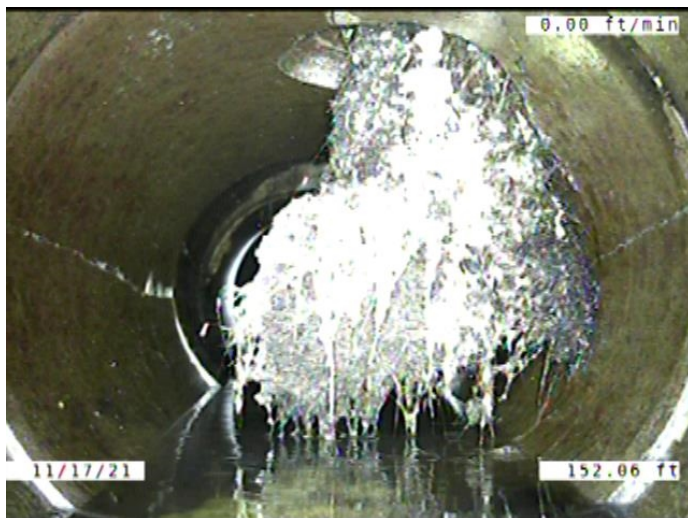
Code: **RBL**
Description: **Roots Ball Lateral**

Distance (ft): **152.1**
Structural Grade: **0**
O&M Grade: **4**
Clock Start/From: **12**
Clock To: **2**
1st Value:
2nd Value:
Value Percent: **55.000**
Continuous Index:
Within 8" of Joint: **NO**
Remarks:

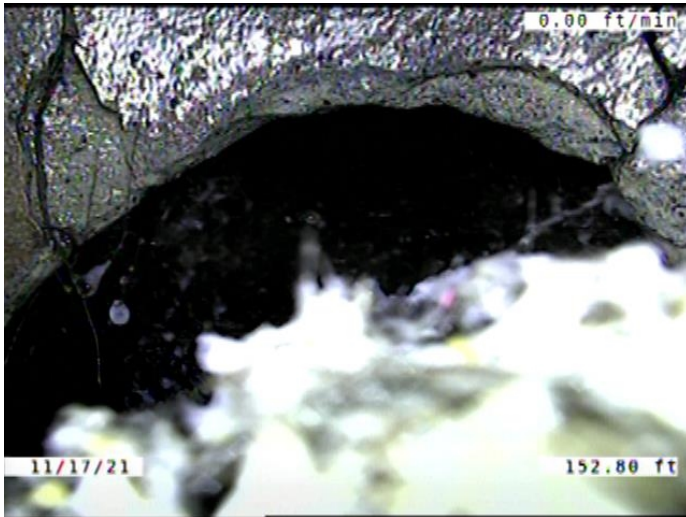
Code:	TFD
Description:	Tap Factory Defective
Distance (ft):	152.8
Structural Grade:	0
O&M Grade:	3
Clock Start/From:	1
Clock To:	
1st Value:	4.000
2nd Value:	
Value Percent:	
Continuous Index:	
Within 8" of Joint:	YES
Remarks:	BROKEN. ROOTS GROWING OUT OF THE TAP AND INTO THE MAIN. CONS

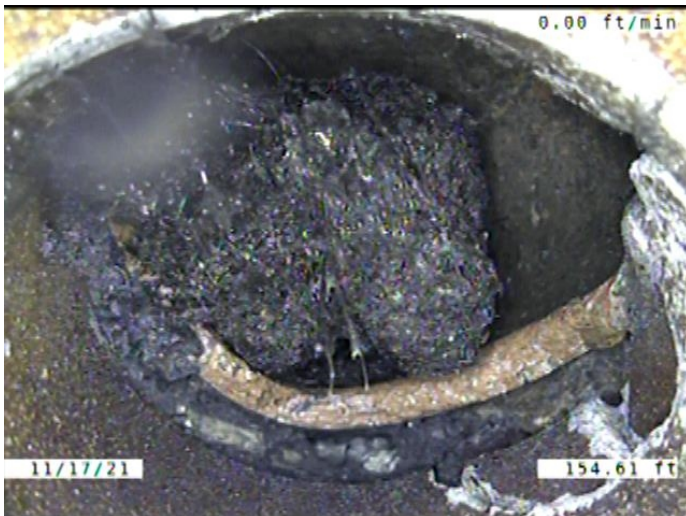
Code:	TFD
Description:	Tap Factory Defective
Distance (ft):	154.6
Structural Grade:	0
O&M Grade:	3
Clock Start/From:	11
Clock To:	
1st Value:	4.000
2nd Value:	
Value Percent:	
Continuous Index:	
Within 8" of Joint:	YES
Remarks:	BROKEN. OFFSET. ROOTS GROWING IN THE TAP. SOIL VISIBLE. CONSTAN

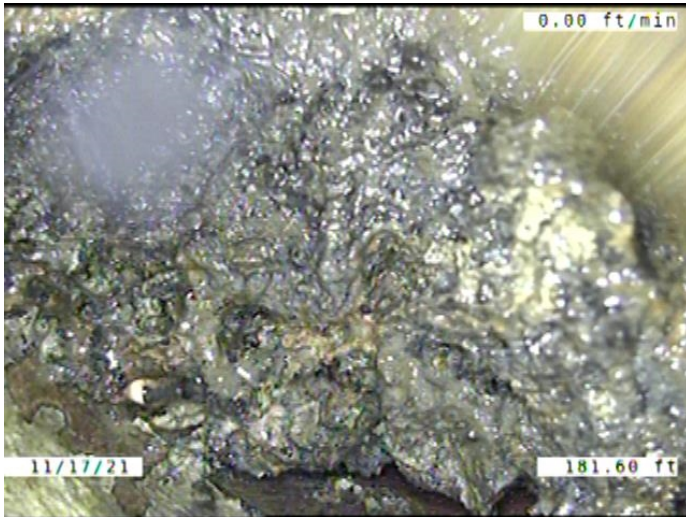
Code: **TFD**
Description: **Tap Factory Defective**

Distance (ft): **181.6**
Structural Grade: **0**
O&M Grade: **3**
Clock Start/From: **1**
Clock To:
1st Value: **4.000**
2nd Value:
Value Percent:
Continuous Index:
Within 8" of Joint: **YES**
Remarks: **LOOKS TO BE 100% PLUGGED.**

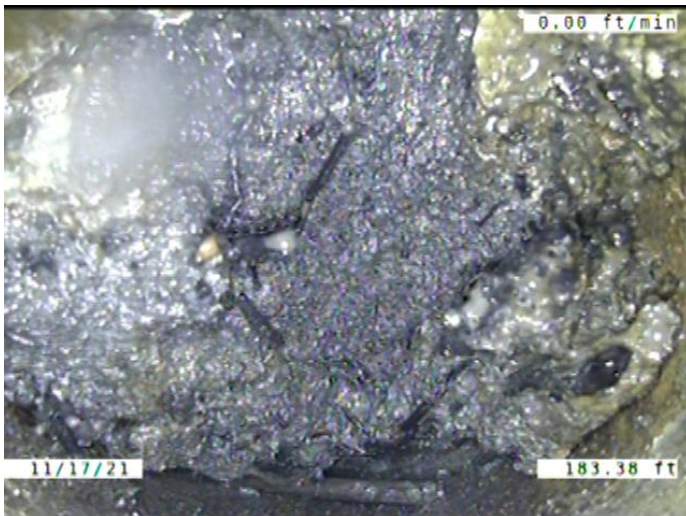
Code: **TFD**
Description: **Tap Factory Defective**

Distance (ft): **183.4**
Structural Grade: **0**
O&M Grade: **3**
Clock Start/From: **11**
Clock To:
1st Value: **4.000**
2nd Value:
Value Percent:
Continuous Index:
Within 8" of Joint: **YES**
Remarks: **BROKEN. ENCRUSTATION IN THE TAP. ROOTS GROWING IN THE TAP.**

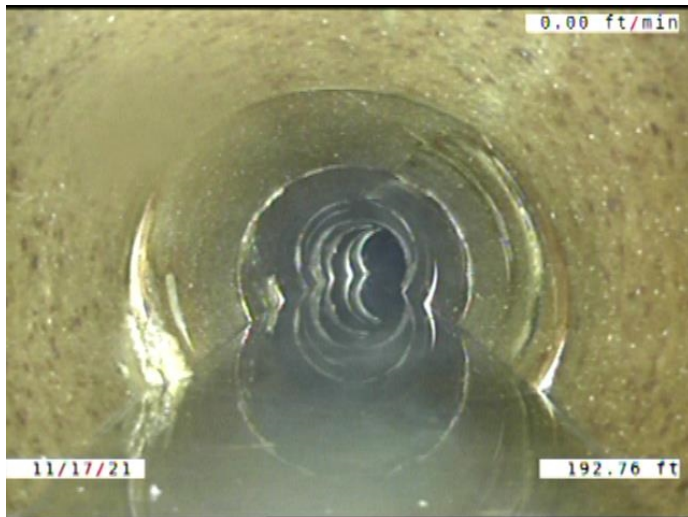
Code: **MWLS**
 Description: **Miscellaneous Water Level Sag**

Distance (ft): **192.8**
 Structural Grade: **2**
 O&M Grade: **0**
 Clock Start/From:
 Clock To:
 1st Value:
 2nd Value:
 Value Percent: **15.000**
 Continuous Index: **S08**
 Within 8" of Joint: **NO**
 Remarks:

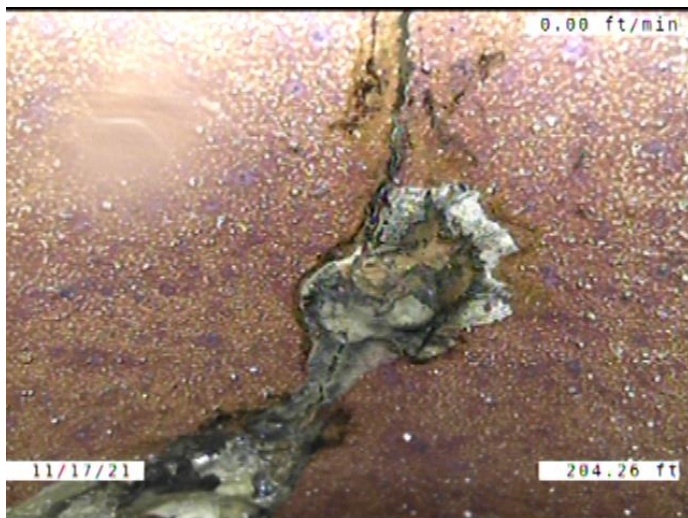
Code: **IWB**
 Description: **Infiltration Weeper Barrel**

Distance (ft): **204.3**
 Structural Grade: **0**
 O&M Grade: **2**
 Clock Start/From: **11**
 Clock To: **1**
 1st Value:
 2nd Value:
 Value Percent:
 Continuous Index: **S09**
 Within 8" of Joint: **YES**
 Remarks:

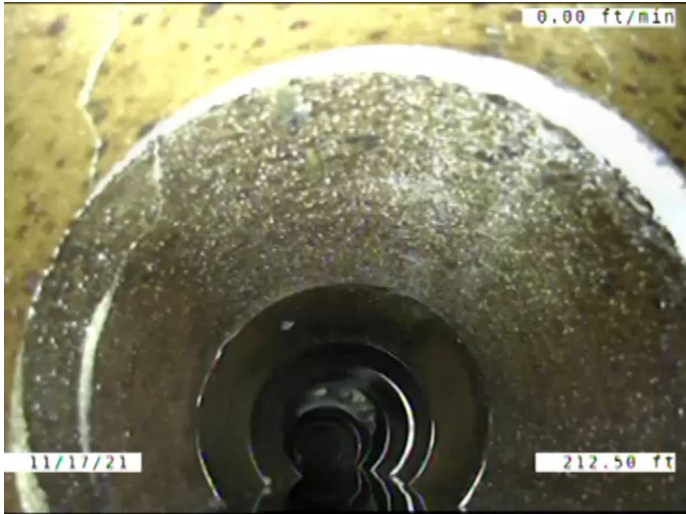
Code: **FM**
Description: **Fracture Multiple**

Distance (ft): **212.5**
Structural Grade: **4**
O&M Grade: **0**
Clock Start/From: **8**
Clock To: **4**
1st Value:
2nd Value:
Value Percent:
Continuous Index: **F10**
Within 8" of Joint: **YES**
Remarks: **Picture\Sec**

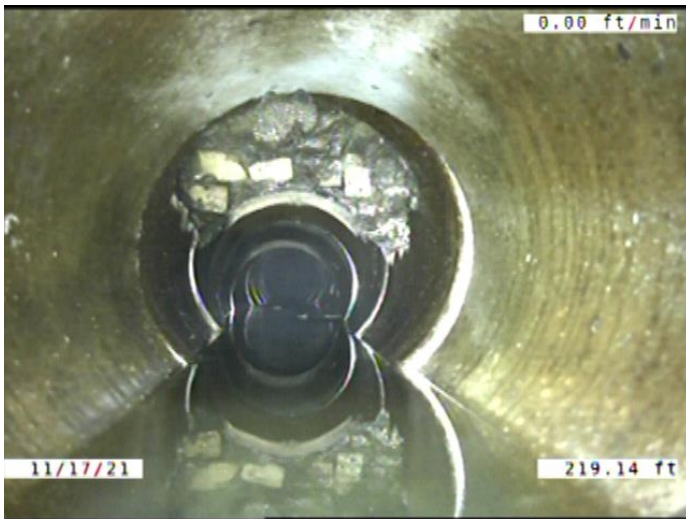
Code: **IWB**
Description: **Infiltration Weeper Barrel**

Distance (ft): **219.1**
Structural Grade: **0**
O&M Grade: **2**
Clock Start/From: **11**
Clock To: **1**
1st Value:
2nd Value:
Value Percent:
Continuous Index: **F09**
Within 8" of Joint: **YES**
Remarks:

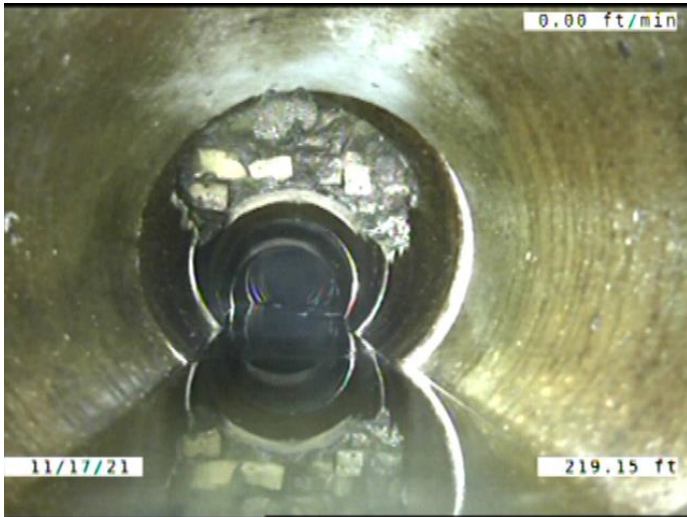
Code: **MWLS**
 Description: **Miscellaneous Water Level Sag**

Distance (ft): **219.1**
 Structural Grade: **2**
 O&M Grade: **0**
 Clock Start/From:
 Clock To:
 1st Value:
 2nd Value:
 Value Percent: **15.000**
 Continuous Index: **F08**
 Within 8" of Joint: **NO**
 Remarks:

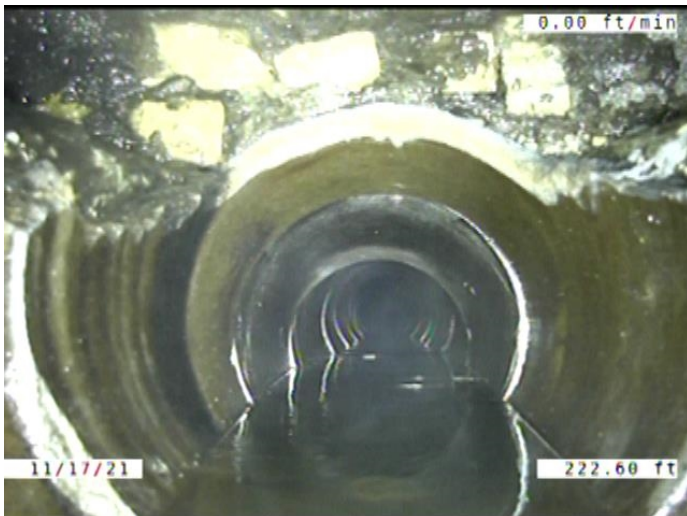
Code: **DAE**
 Description: **Deposits Attached Encrustation**

Distance (ft): **222.6**
 Structural Grade: **0**
 O&M Grade: **2**
 Clock Start/From: **8**
 Clock To: **4**
 1st Value:
 2nd Value:
 Value Percent: **5.000**
 Continuous Index: **F01**
 Within 8" of Joint: **YES**
 Remarks:
