Profile/Photo Observation Report

| Pipe Length (ft): | 223.5 | Owner: | City of Hobart | Pre Clean: | Heavy Cleaning |

| Street: | North Washington Street | Flow Control: | Not Controlled |
| US MH: | M-604-074 | DS MH: | M-604-073 |

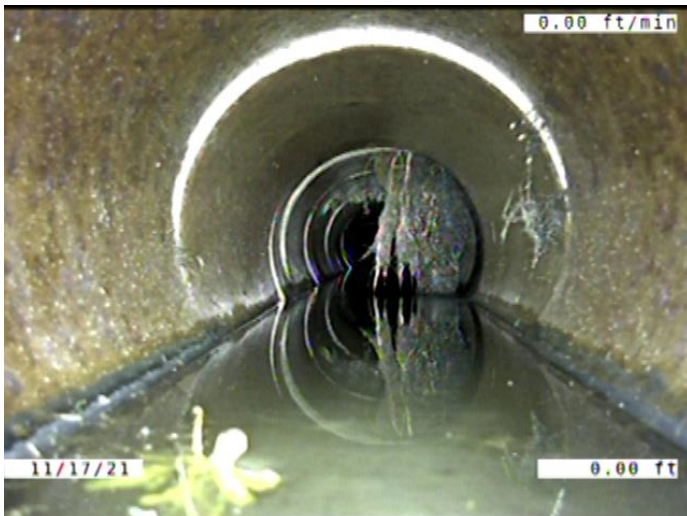
Code: **MWL**
Description: **Miscellaneous Water Level**

Distance (ft): **.0**
Structural Grade: **0**
O&M Grade: **0**
Clock Start/From:
Clock To:
1st Value:
2nd Value:
Value Percent: **5.000**
Continuous Index:
Within 8" of Joint: **NO**
Remarks:

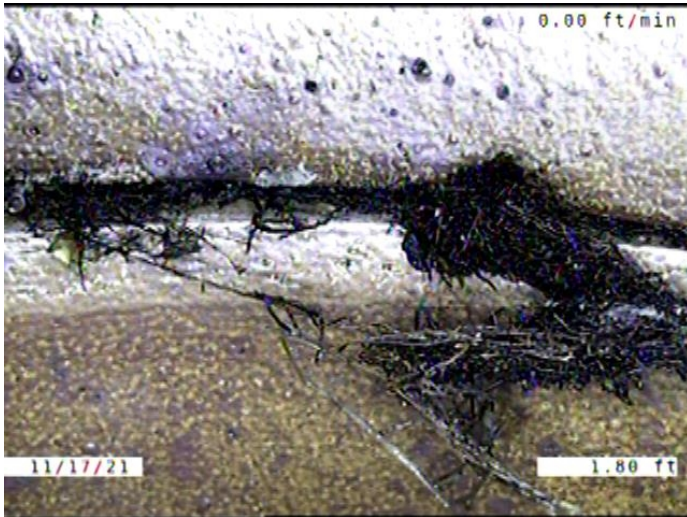
Code: **RFJ**
 Description: **Roots Fine Joint**

Distance (ft): **1.8**
 Structural Grade: **0**
 O&M Grade: **1**
 Clock Start/From: **9**
 Clock To: **3**
 1st Value:
 2nd Value:
 Value Percent:
 Continuous Index:
 Within 8" of Joint: **YES**
 Remarks:

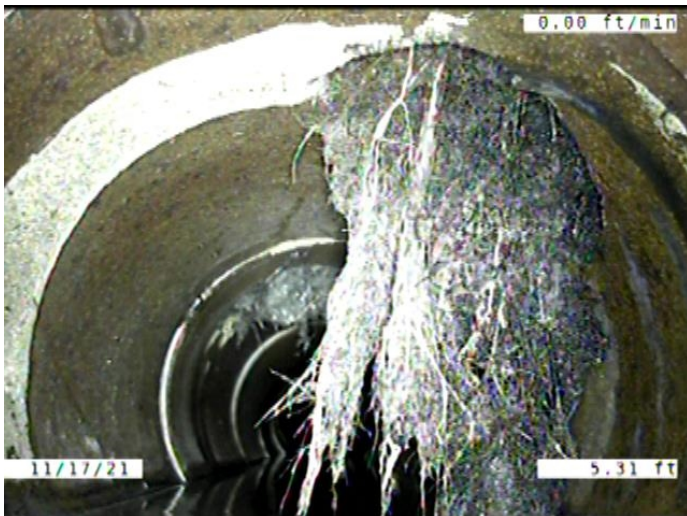
Code: **RML**
 Description: **Roots Medium Lateral**

Distance (ft): **5.3**
 Structural Grade: **0**
 O&M Grade: **3**
 Clock Start/From: **12**
 Clock To: **3**
 1st Value:
 2nd Value:
 Value Percent: **35.000**
 Continuous Index:
 Within 8" of Joint: **NO**
 Remarks:

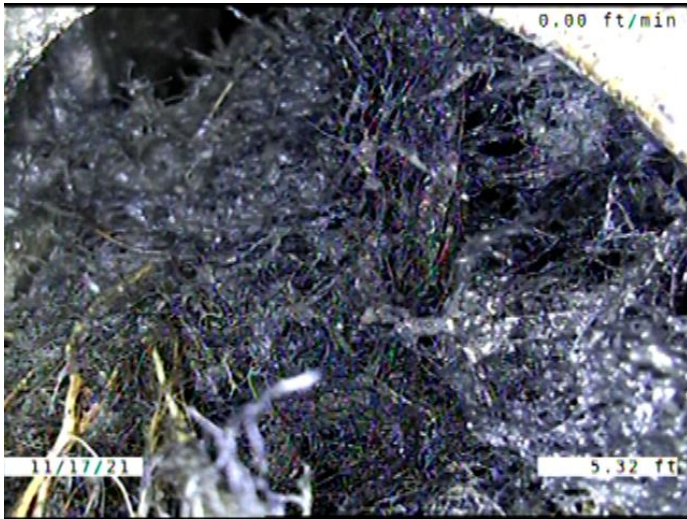
Code: **TFD**
 Description: **Tap Factory Defective**

Distance (ft): **5.3**
 Structural Grade: **0**
 O&M Grade: **3**
 Clock Start/From: **1**
 Clock To:
 1st Value: **4.000**
 2nd Value:
 Value Percent:
 Continuous Index:
 Within 8" of Joint: **YES**
 Remarks: **95% PLUGGED WITH ROOTS.
 CONSTANTLY RUNNING WATER.**

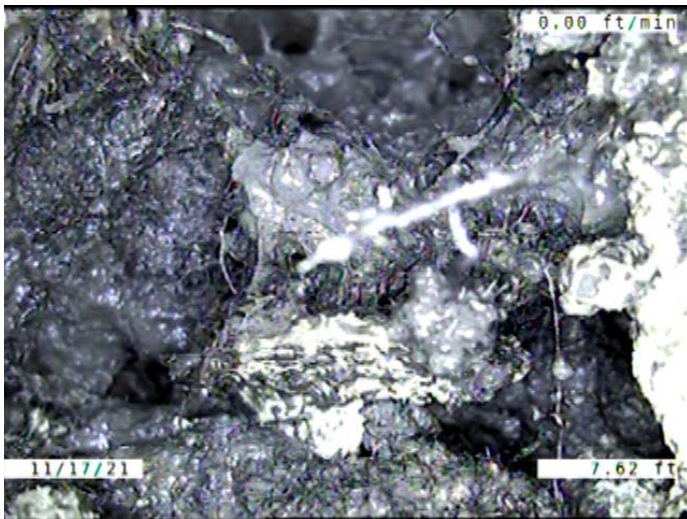
Code: **TFD**
 Description: **Tap Factory Defective**

Distance (ft): **7.6**
 Structural Grade: **0**
 O&M Grade: **3**
 Clock Start/From: **11**
 Clock To:
 1st Value: **4.000**
 2nd Value:
 Value Percent:
 Continuous Index:
 Within 8" of Joint: **YES**
 Remarks: **LOOKS TO BE 95 % PLUGGED WITH
 ROOTS**

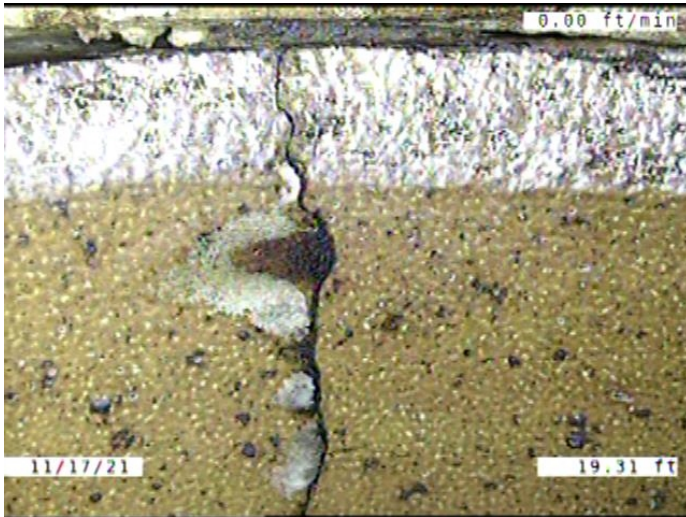
Code: **CL**
 Description: **Crack Longitudinal**

Distance (ft): **19.3**
 Structural Grade: **2**
 O&M Grade: **0**
 Clock Start/From: **10**
 Clock To:
 1st Value:
 2nd Value:
 Value Percent:
 Continuous Index:
 Within 8" of Joint: **YES**
 Remarks:

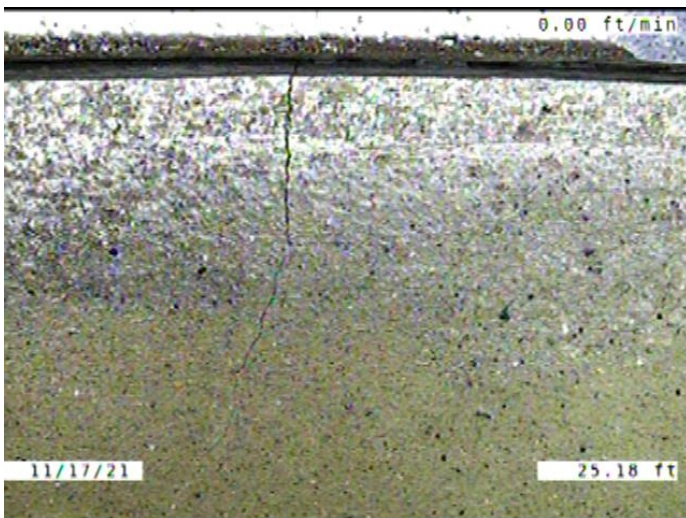
Code: **CS**
 Description: **Crack Spiral**

Distance (ft): **25.2**
 Structural Grade: **2**
 O&M Grade: **0**
 Clock Start/From: **10**
 Clock To: **12**
 1st Value:
 2nd Value:
 Value Percent:
 Continuous Index:
 Within 8" of Joint: **YES**
 Remarks:

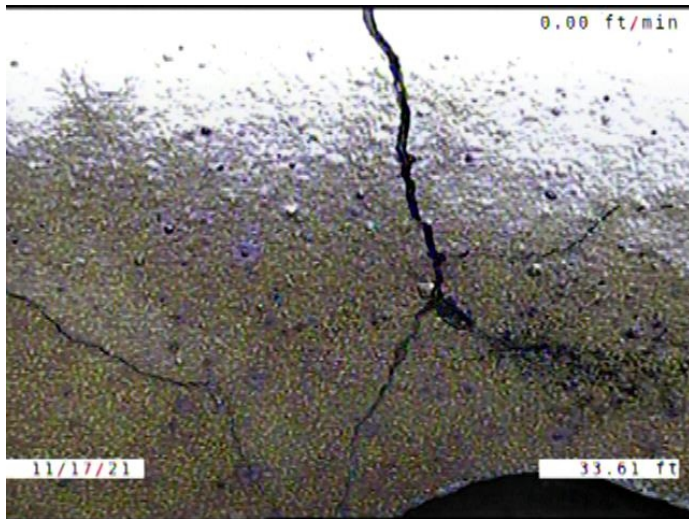
Code: **FM**
Description: **Fracture Multiple**

Distance (ft): **33.6**
Structural Grade: **4**
O&M Grade: **0**
Clock Start/From: **12**
Clock To: **12**
1st Value:
2nd Value:
Value Percent:
Continuous Index: **S02**
Within 8" of Joint: **YES**
Remarks:

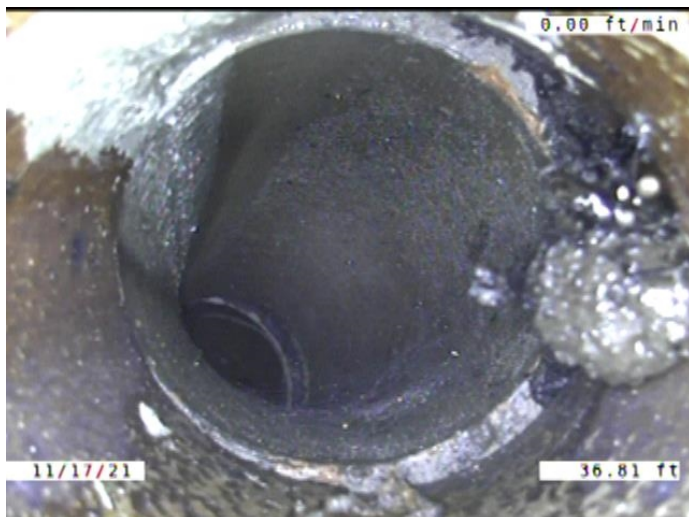
Code: **TF**
Description: **Tap Factory**

Distance (ft): **36.8**
Structural Grade: **0**
O&M Grade: **0**
Clock Start/From: **11**
Clock To:
1st Value: **4.000**

Remarks: **ROOTS GROWING OUT OF THE JOINT.**

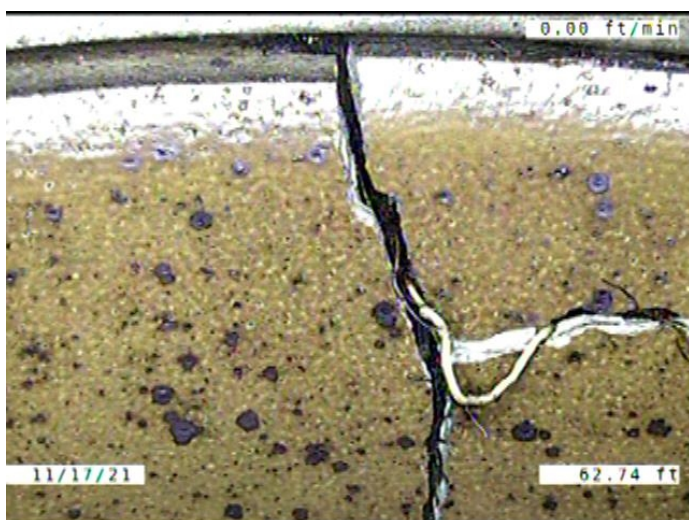
Code: **B**
Description: **Broken**

Distance (ft): **62.7**
Structural Grade: **4**
O&M Grade: **0**
Clock Start/From: **8**
Clock To: **4**

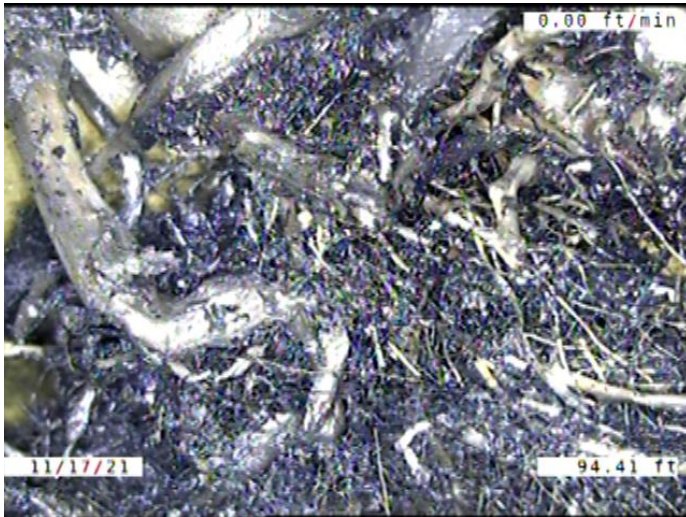
Code: **RMJ**
 Description: **Roots Medium Joint**

Distance (ft): **94.4**
 Structural Grade: **0**
 O&M Grade: **3**
 Clock Start/From: **12**
 Clock To: **4**
 1st Value:
 2nd Value:
 Value Percent: **10.000**
 Continuous Index:
 Within 8" of Joint: **YES**
 Remarks:

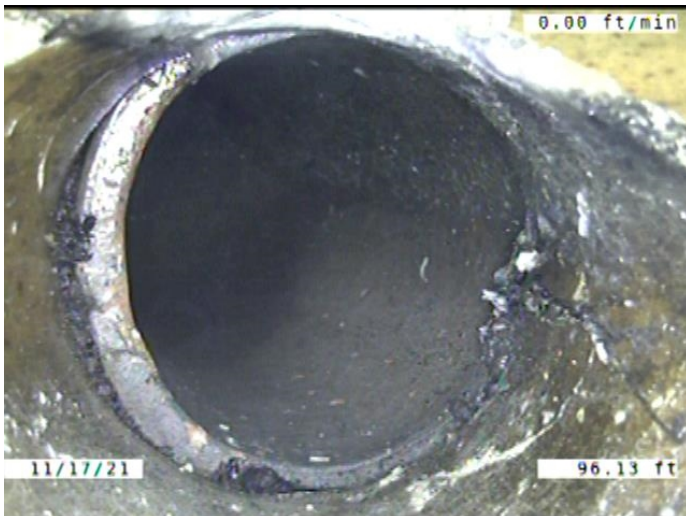
Code: **TFD**
 Description: **Tap Factory Defective**

Distance (ft): **96.1**
 Structural Grade: **0**
 O&M Grade: **3**
 Clock Start/From: **1**
 Clock To:
 1st Value: **4.000**
 2nd Value:
 Value Percent:
 Continuous Index:
 Within 8" of Joint: **YES**
 Remarks: **BROKEN. OFFSET.**

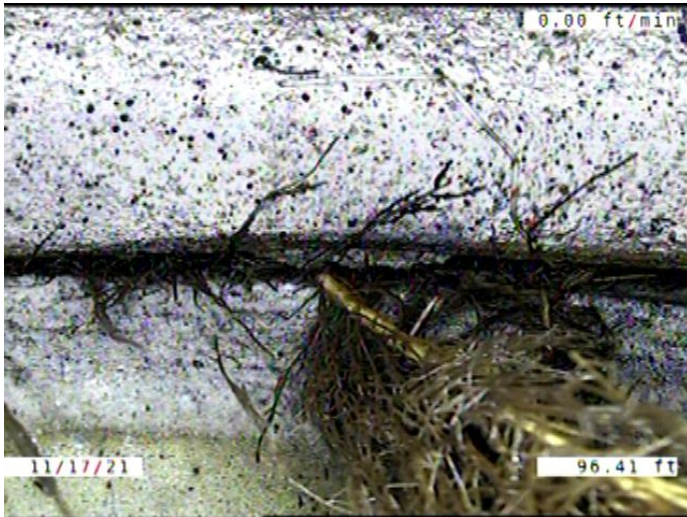
Code: **RMJ**
 Description: **Roots Medium Joint**

Distance (ft): **96.4**
 Structural Grade: **0**
 O&M Grade: **3**
 Clock Start/From: **8**
 Clock To: **4**
 1st Value:
 2nd Value:
 Value Percent: **5.000**
 Continuous Index:
 Within 8" of Joint: **YES**
 Remarks:

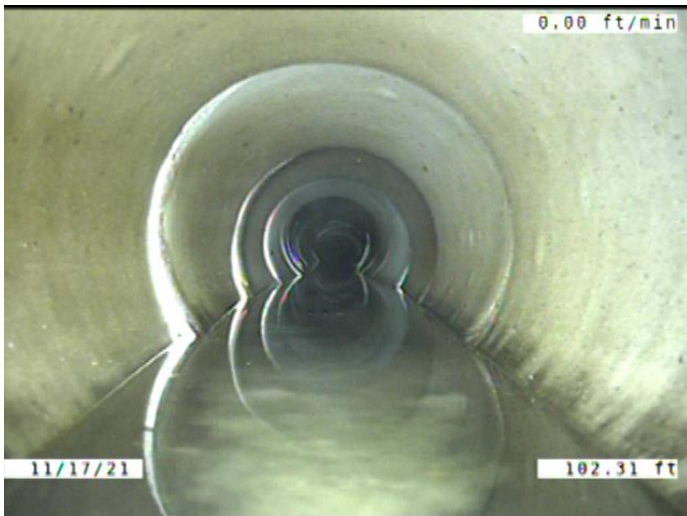
Code: **RFJ**
 Description: **Roots Fine Joint**

Distance (ft): **102.3**
 Structural Grade: **0**
 O&M Grade: **1**
 Clock Start/From: **9**
 Clock To: **3**
 1st Value:
 2nd Value:
 Value Percent:
 Continuous Index: **F04**
 Within 8" of Joint: **YES**
 Remarks:

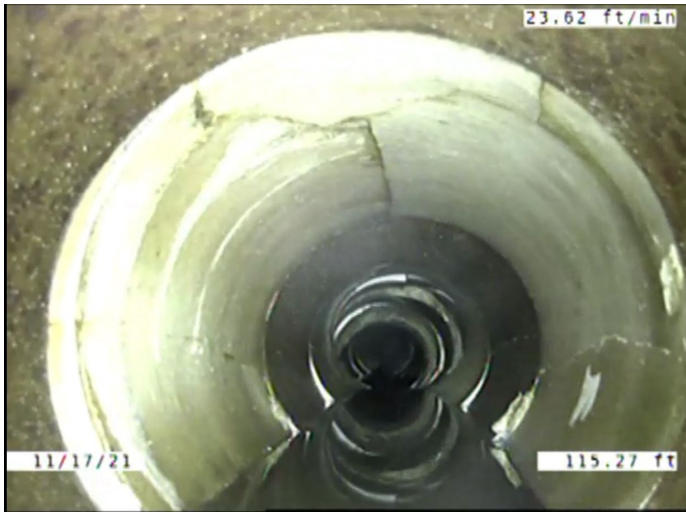
Code: **FM**
 Description: **Fracture Multiple**

Distance (ft): **115.3**
 Structural Grade: **4**
 O&M Grade: **0**
 Clock Start/From: **8**
 Clock To: **4**
 1st Value:
 2nd Value:
 Value Percent:
 Continuous Index: **S10**
 Within 8" of Joint: **YES**
 Remarks: **Wandering**

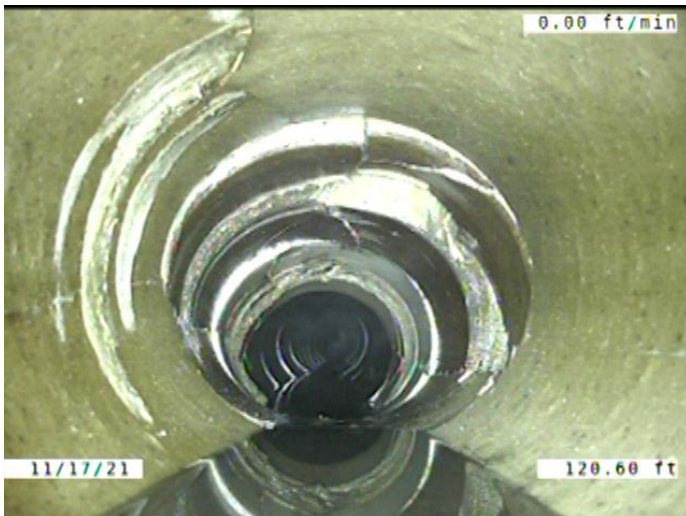
Code: **B**
 Description: **Broken**

Distance (ft): **120.6**
 Structural Grade: **4**
 O&M Grade: **0**
 Clock Start/From: **8**
 Clock To: **4**
 1st Value:
 2nd Value:
 Value Percent:
 Continuous Index: **S05**
 Within 8" of Joint: **YES**
 Remarks:

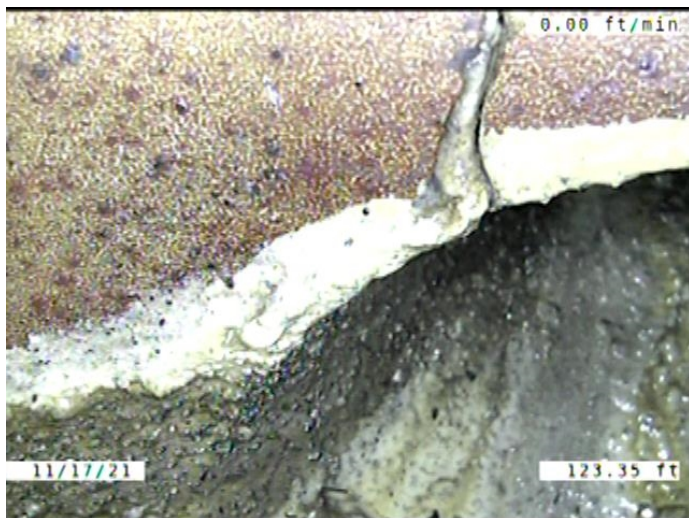
Code: **IDC**
 Description: **Infiltration Dripper Connection**

Distance (ft): **123.3**
 Structural Grade: **0**
 O&M Grade: **3**
 Clock Start/From: **12**
 Clock To:
 1st Value:
 2nd Value:
 Value Percent:
 Continuous Index:
 Within 8" of Joint: **YES**
 Remarks:

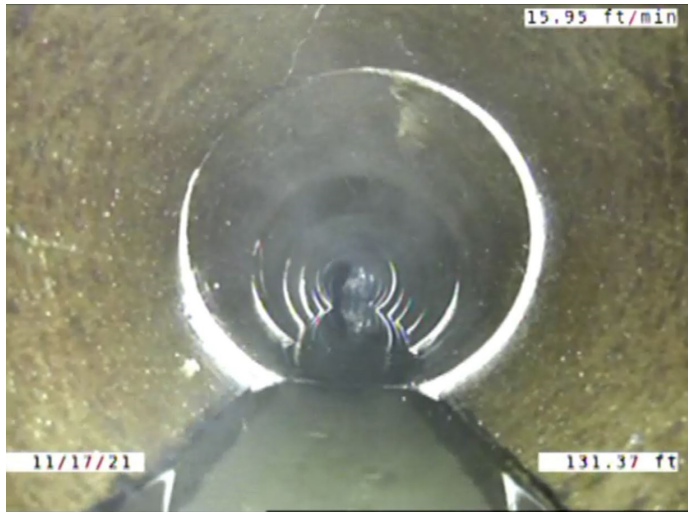
Code: **B**
 Description: **Broken**

Distance (ft): **131.4**
 Structural Grade: **4**
 O&M Grade: **0**
 Clock Start/From: **8**
 Clock To: **4**
 1st Value:
 2nd Value:
 Value Percent:
 Continuous Index: **F05**
 Within 8" of Joint: **YES**
 Remarks:

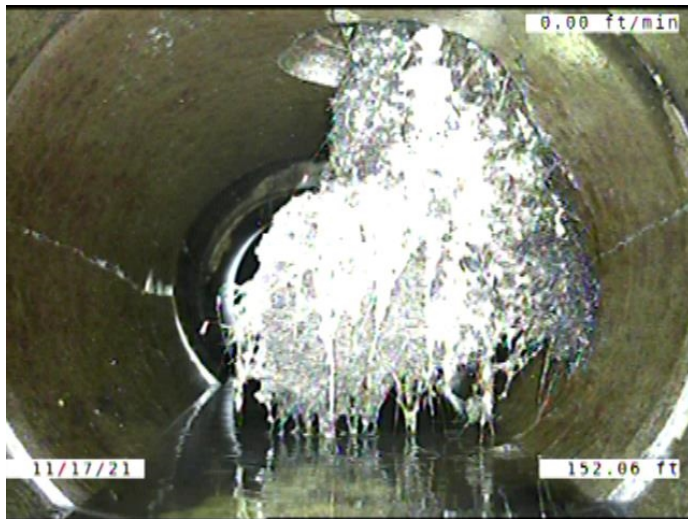
Code: **RBL**
 Description: **Roots Ball Lateral**

Distance (ft): **152.1**
 Structural Grade: **0**
 O&M Grade: **4**
 Clock Start/From: **12**
 Clock To: **2**
 1st Value:
 2nd Value:
 Value Percent: **55.000**
 Continuous Index:
 Within 8" of Joint: **NO**
 Remarks:

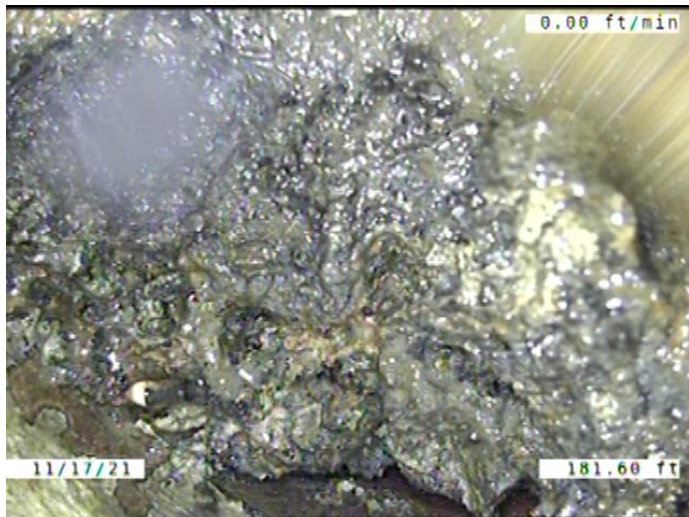
Code: **TFD**
 Description: **Tap Factory Defective**

Distance (ft): **181.6**
 Structural Grade: **0**
 O&M Grade: **3**
 Clock Start/From: **1**
 Clock To:
 1st Value: **4.000**
 2nd Value:
 Value Percent:
 Continuous Index:
 Within 8" of Joint: **YES**
 Remarks: **LOOKS TO BE 100% PLUGGED.**

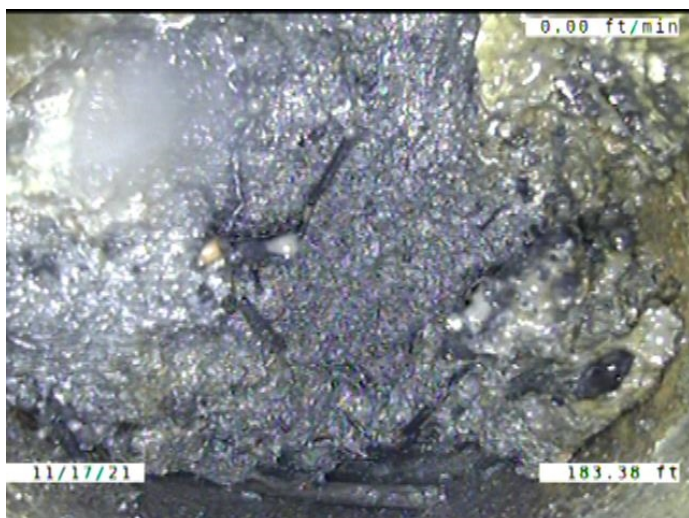
Code: **TFD**
 Description: **Tap Factory Defective**

Distance (ft): **183.4**
 Structural Grade: **0**
 O&M Grade: **3**
 Clock Start/From: **11**
 Clock To:
 1st Value: **4.000**
 2nd Value:
 Value Percent:
 Continuous Index:
 Within 8" of Joint: **YES**
 Remarks: **BROKEN. ENCRUSTATION IN THE TAP. ROOTS GROWING IN THE TAP.**

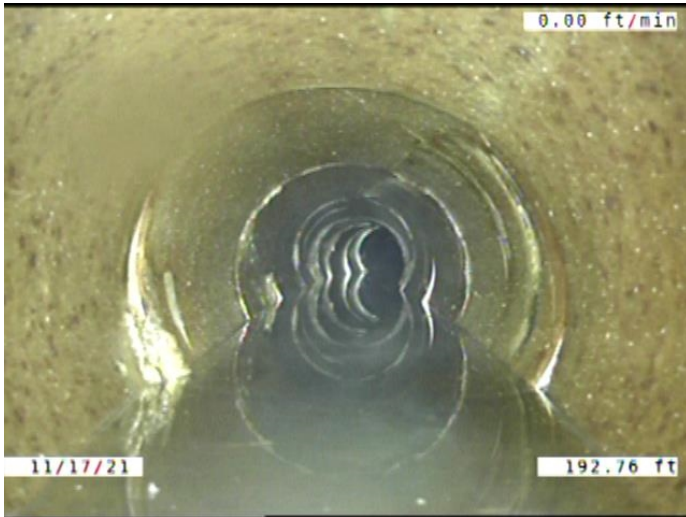
Code: **MWLS**
 Description: **Miscellaneous Water Level Sag**

Distance (ft): **192.8**
 Structural Grade: **2**
 O&M Grade: **0**
 Clock Start/From:
 Clock To:
 1st Value:
 2nd Value:
 Value Percent: **15.000**
 Continuous Index: **S08**
 Within 8" of Joint: **NO**
 Remarks:

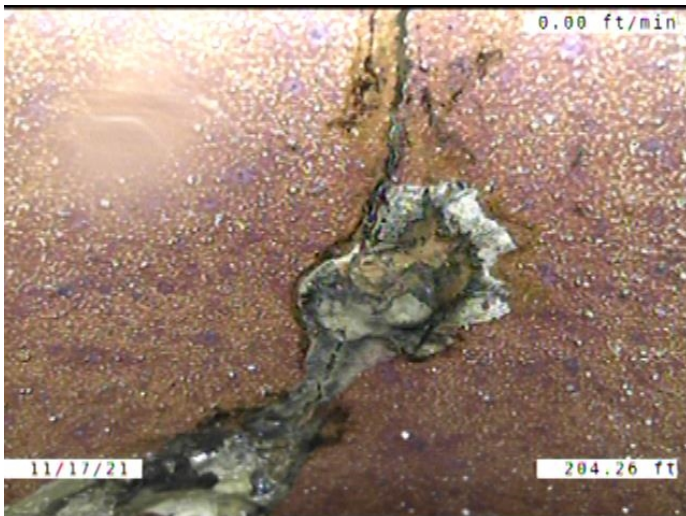
Code: **IWB**
 Description: **Infiltration Weeper Barrel**

Distance (ft): **204.3**
 Structural Grade: **0**
 O&M Grade: **2**
 Clock Start/From: **11**
 Clock To: **1**
 1st Value:
 2nd Value:
 Value Percent:
 Continuous Index: **S09**
 Within 8" of Joint: **YES**
 Remarks:
