## Profile/Photo Observation Report

| Street: | <b>N WASHINGTON ST</b> | Flow Control: | <b>Not Controlled</b> |
| City: | <b>Hobart, IN</b> | Year Renewed: | |

| US MH: | <b>M-604-075</b> | DS MH: | <b>M-604-074</b> |

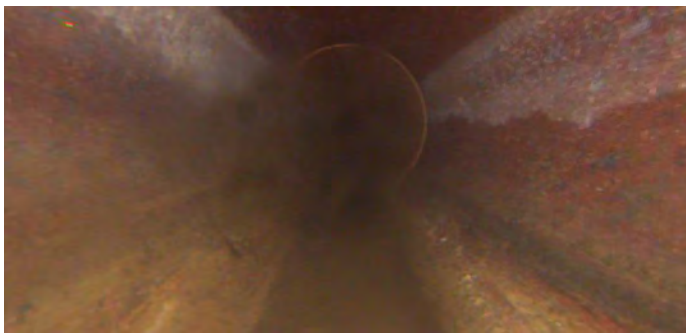
Code: **AMH**  
Description: **Manhole**

Distance (ft): **.0**  
Structural Grade: **0**  
O&M Grade: **0**  
Clock Start/From:  
Clock To:  
1st Value:  
2nd Value:  
Value Percent:  
Continuous Index:  
Within 8" of Joint: **NO**  
Remarks: **M-604-075**

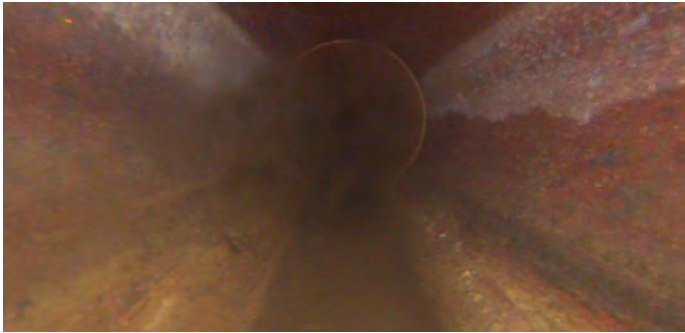
| Code: | <b>MWL</b> |
| Description: | <b>Water Level</b> |

| Value Percent: | <b>5.000</b> |

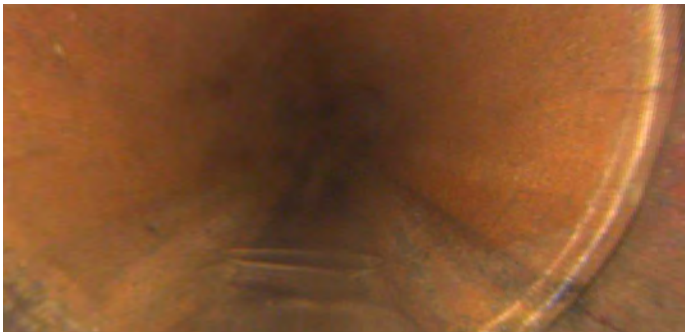
| Code: | <b>CL</b> |
| Description: | <b>Crack Longitudinal</b> |

| Distance (ft): | <b>2.5</b> |
| Structural Grade: | <b>2</b> |
| Clock Start/From: | <b>3</b> |
| Within 8" of Joint: | <b>YES</b> |
| Remarks: | <b>minor</b> |

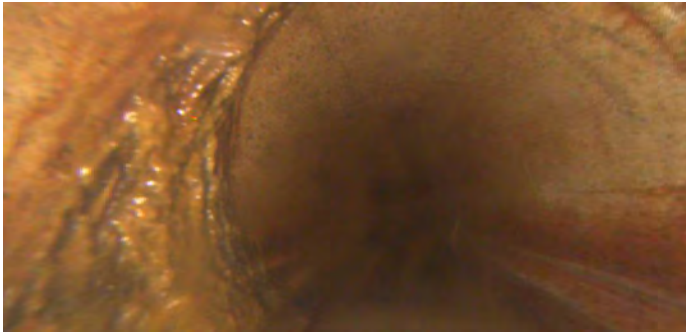
Code: **DAE**  
Description: **Deposits Attached Encrustation**

Distance (ft): **18.3**  
Structural Grade: **0**  
O&M Grade: **2**  
Clock Start/From: **7**  
Clock To: **11**  
1st Value:  
2nd Value:  
Value Percent: **5.000**  
Continuous Index:  
Within 8" of Joint: **YES**  
Remarks:

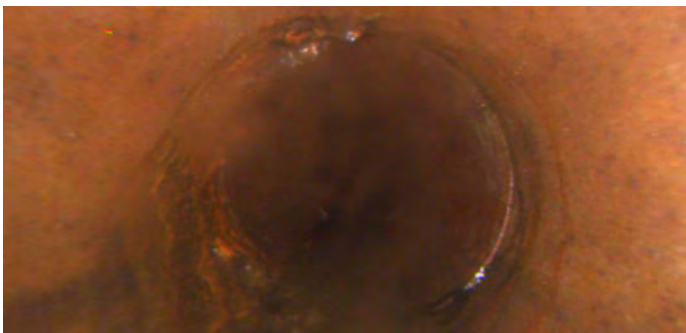
Code: **DAE**  
Description: **Deposits Attached Encrustation**

Distance (ft): **21.9**  
Structural Grade: **0**  
O&M Grade: **2**  
Clock Start/From: **7**  
Clock To: **12**  
1st Value:  
2nd Value:  
Value Percent: **5.000**  
Continuous Index: **S01**  
Within 8" of Joint: **YES**  
Remarks: **wandering**

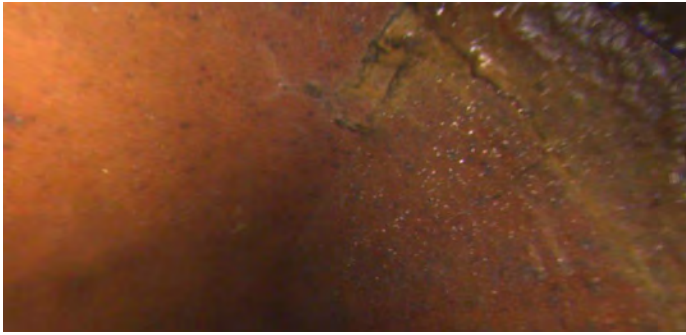
Code: **CM**  
Description: **Crack Multiple**

Distance (ft): **30.9**  
Structural Grade: **3**  
O&M Grade: **0**  
Clock Start/From: **7**  
Clock To: **5**  
1st Value:  
2nd Value:  
Value Percent:  
Continuous Index: **S02**  
Within 8" of Joint: **YES**  
Remarks: **wandering**

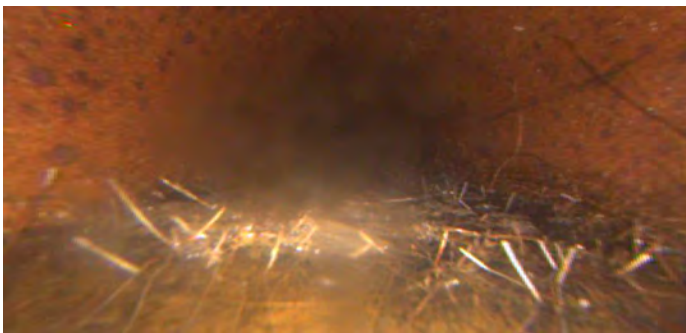
Code: **RMB**  
Description: **Roots Medium Barrel**

Distance (ft): **53.1**  
Structural Grade: **0**  
O&M Grade: **4**  
Clock Start/From: **6**  
Clock To:  
1st Value:  
2nd Value:  
Value Percent: **20.000**  
Continuous Index: **S03**  
Within 8" of Joint: **NO**  
Remarks:
