Profile/Photo Observation Report

Street:	N WASHINGTON ST	Flow Control:	Not Controlled
City:	Hobart, IN	Year Renewed:	
Location:	Light Highway	Tape/Media #:	
Purpose:	Not Known	Dia/Height:	12"
Use:	Sanitary	Material:	VCP
Drain Area:	NA	Lining:	
Category:	NA		
Comment:

Location Details:		Direction of Survey:	Upstream
US MH:	M-604-075	DS MH:	M-604-074
		Total Length Surveyed (ft):	153.3

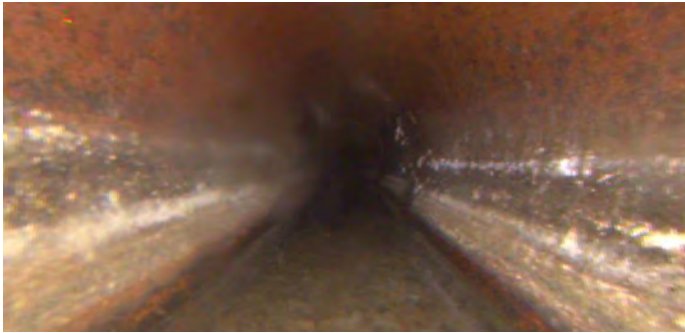
Code:	MWL
Description:	Water Level

Distance (ft):	.0
Structural Grade:	0
O&M Grade:	0
Clock Start/From:	
Clock To:	
1st Value:	
2nd Value:	
Value Percent:	5.000
Continuous Index:	
Within 8" of Joint:	NO
Remarks:

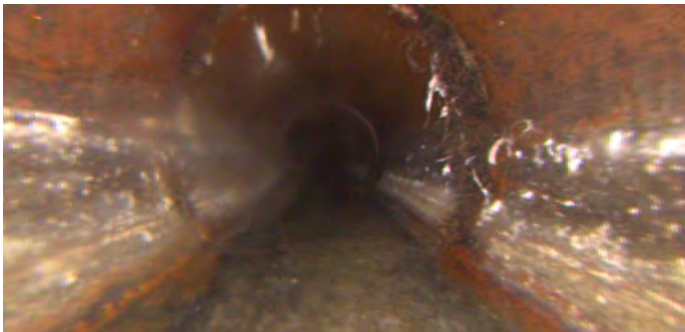
Code:	RFJ
Description:	Roots Fine Joint

Distance (ft):	1.9
Structural Grade:	0
O&M Grade:	1
Clock Start/From:	11
Clock To:	5
1st Value:	
2nd Value:	
Value Percent:	
Continuous Index:	S01
Within 8" of Joint:	YES
Remarks:	wandering

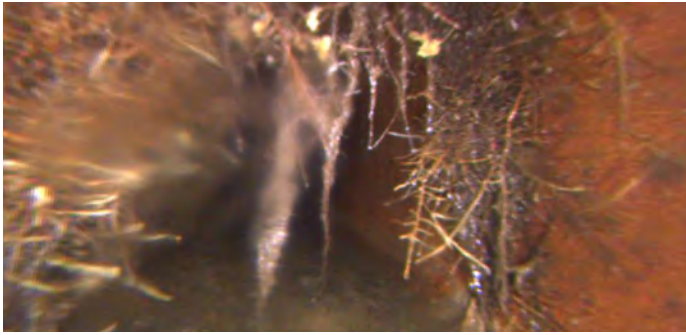
Code: **RMJ**
Description: **Roots Medium Joint**

Distance (ft): **12.3**
Structural Grade: **0**
O&M Grade: **3**
Clock Start/From: **7**
Clock To: **5**
1st Value:
2nd Value:
Value Percent: **15.000**
Continuous Index:
Within 8" of Joint: **YES**
Remarks:

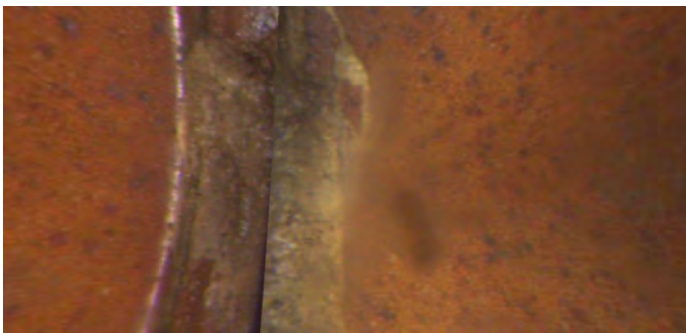
Code: **DAZ**
Description: **Deposits Attached Other**

Distance (ft): **14.7**
Structural Grade: **0**
O&M Grade: **2**
Clock Start/From: **2**
Clock To: **5**
1st Value:
2nd Value:
Value Percent: **5.000**
Continuous Index: **S02**
Within 8" of Joint: **YES**
Remarks: **wandering**

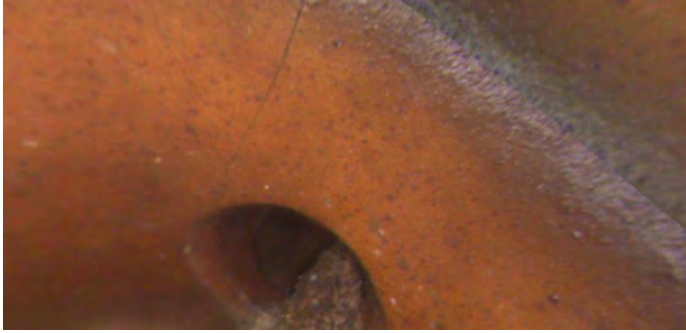
Code: **CL**
Description: **Crack Longitudinal**

Distance (ft): **19.6**
Structural Grade: **2**
O&M Grade: **0**
Clock Start/From: **1**
Clock To:
1st Value:
2nd Value:
Value Percent:
Continuous Index:
Within 8" of Joint:
Remarks:

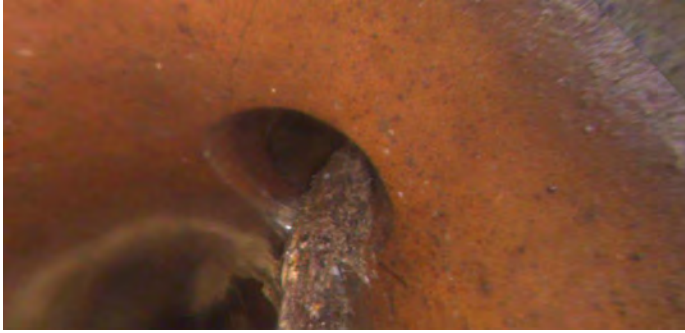
Code: **RML**
Description: **Roots Medium Lateral**

Distance (ft): **19.6**
Structural Grade: **0**
O&M Grade: **3**
Clock Start/From: **2**
Clock To:
1st Value:
2nd Value:
Value Percent: **5.000**
Continuous Index:
Within 8" of Joint: **NO**
Remarks:

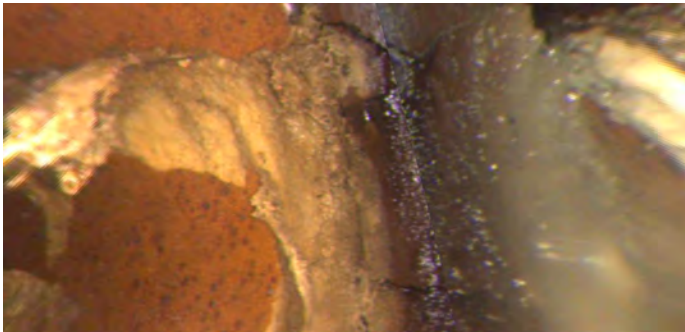
Code: **CM**
Description: **Crack Multiple**

Distance (ft): **20.8**
Structural Grade: **3**
O&M Grade: **0**
Clock Start/From: **2**
Clock To: **5**
1st Value:
2nd Value:
Value Percent:
Continuous Index: **S03**
Within 8" of Joint: **YES**
Remarks: **wandering**

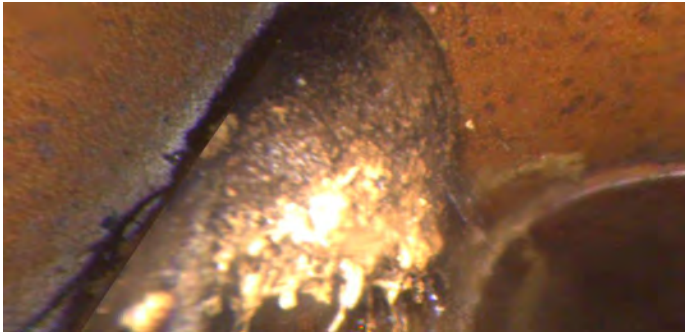
Code: **TFD**
Description: **Tap Factory Defective**

Distance (ft): **22.0**
Structural Grade: **0**
O&M Grade: **2**
Clock Start/From: **2**
Clock To:
1st Value: **4.000**
2nd Value:
Value Percent:
Continuous Index:
Within 8" of Joint: **YES**
Remarks: **blocked by roots**

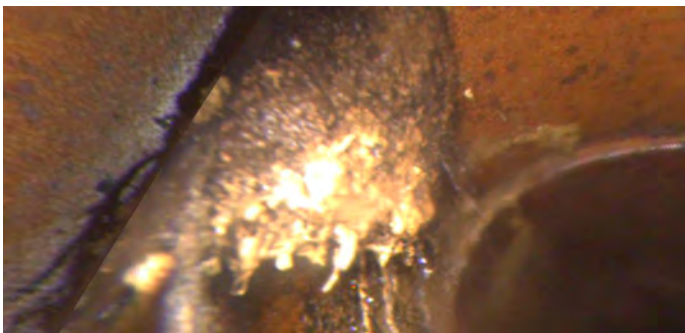
Code: **RML**
Description: **Roots Medium Lateral**

Distance (ft): **22.0**
Structural Grade: **0**
O&M Grade: **3**
Clock Start/From: **11**
Clock To:
1st Value:
2nd Value:
Value Percent: **5.000**
Continuous Index:
Within 8" of Joint: **NO**
Remarks:

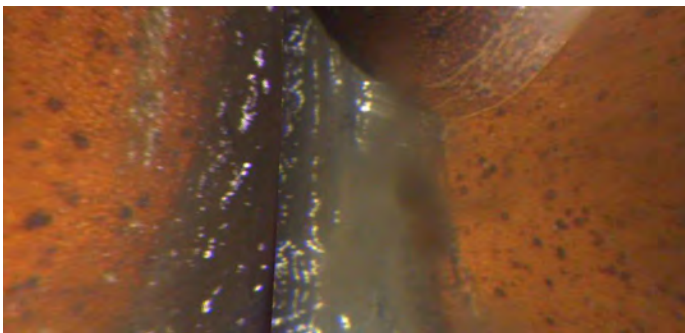
Code: **DAGS**
Description: **Deposits Attached Grease**

Distance (ft): **55.1**
Structural Grade: **0**
O&M Grade: **2**
Clock Start/From: **2**
Clock To: **5**
1st Value:
2nd Value:
Value Percent: **5.000**
Continuous Index:
Within 8" of Joint: **NO**
Remarks:

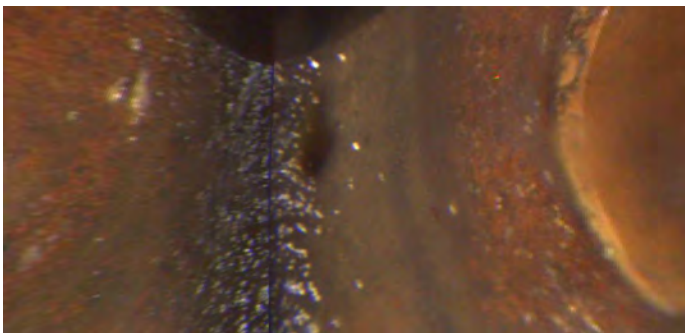
Code: **DAGS**
Description: **Deposits Attached Grease**

Distance (ft): **56.9**
Structural Grade: **0**
O&M Grade: **2**
Clock Start/From: **7**
Clock To: **10**
1st Value:
2nd Value:
Value Percent: **5.000**
Continuous Index:
Within 8" of Joint: **NO**
Remarks:

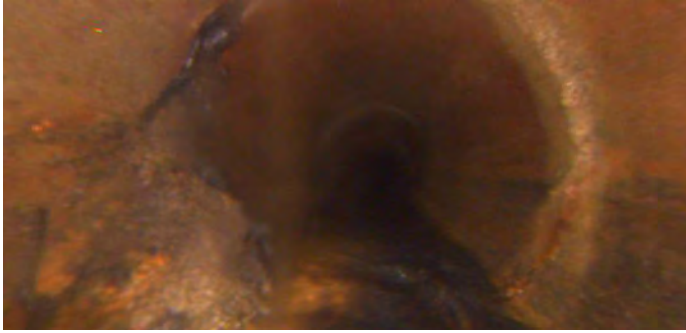
Code: **RMJ**
Description: **Roots Medium Joint**

Distance (ft): **73.3**
Structural Grade: **0**
O&M Grade: **3**
Clock Start/From: **7**
Clock To: **9**
1st Value:
2nd Value:
Value Percent: **5.000**
Continuous Index:
Within 8" of Joint: **YES**
Remarks:

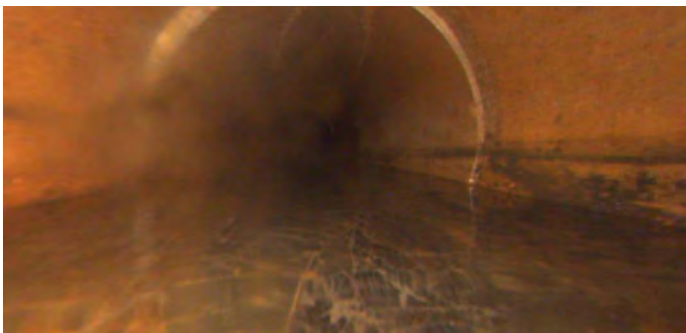
Code: **MGO**
Description: **General Observation**

Distance (ft): **140.2**
Structural Grade: **0**
O&M Grade: **0**
Clock Start/From:
Clock To:
1st Value:
2nd Value:
Value Percent:
Continuous Index:
Within 8" of Joint: **NO**
Remarks: **roots underwater**

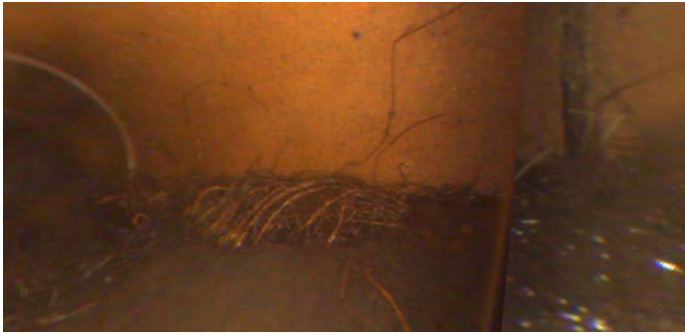
Code: **RMB**
Description: **Roots Medium Barrel**

Distance (ft): **149.3**
Structural Grade: **0**
O&M Grade: **4**
Clock Start/From: **4**
Clock To:
1st Value:
2nd Value:
Value Percent: **5.000**
Continuous Index:
Within 8" of Joint: **NO**
Remarks:

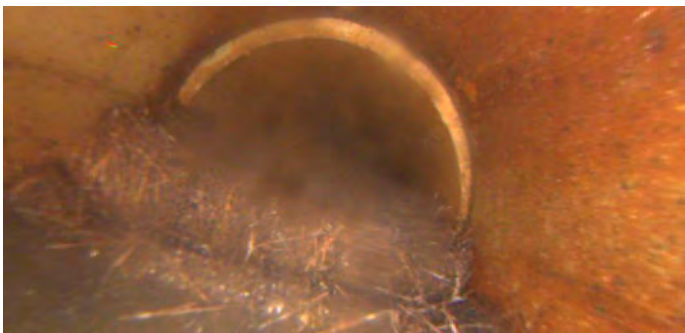
Code: **RBJ**
Description: **Roots Ball Joint**

Distance (ft): **152.2**
Structural Grade: **0**
O&M Grade: **4**
Clock Start/From: **3**
Clock To: **9**
1st Value:
2nd Value:
Value Percent: **55.000**
Continuous Index:
Within 8" of Joint: **YES**
Remarks:

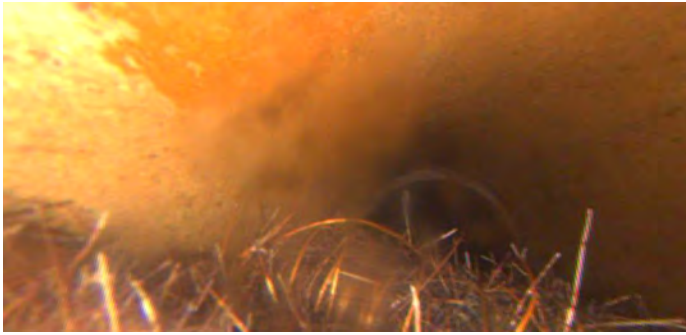
Code: **MSA**
Description: **Abandoned Survey**

Distance (ft): **153.3**
Structural Grade: **0**
O&M Grade: **0**
Clock Start/From:
Clock To:
1st Value:
2nd Value:
Value Percent:
Continuous Index:
Within 8" of Joint: **NO**
Remarks: **rbj**

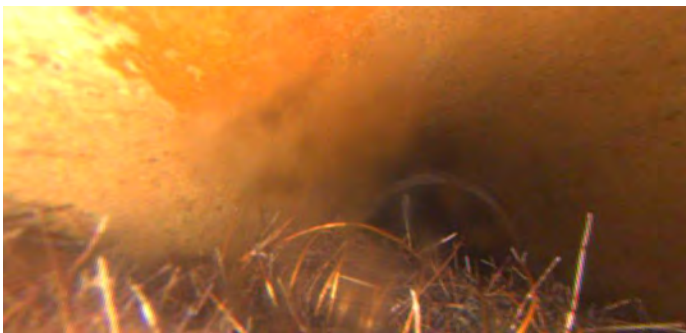
Code: **CM**
Description: **Crack Multiple**

Distance (ft): **153.3**
Structural Grade: **3**
O&M Grade: **0**
Clock Start/From: **2**
Clock To: **5**
1st Value:
2nd Value:
Value Percent:
Continuous Index: **F03**
Within 8" of Joint: **YES**
Remarks: **wandering**

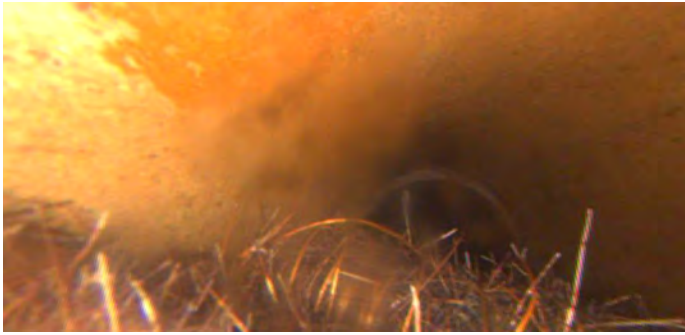
Code: **DAZ**
Description: **Deposits Attached Other**

Distance (ft): **153.3**
Structural Grade: **0**
O&M Grade: **2**
Clock Start/From: **2**
Clock To: **5**
1st Value:
2nd Value:
Value Percent: **5.000**
Continuous Index: **F02**
Within 8" of Joint: **YES**
Remarks: **wandering**

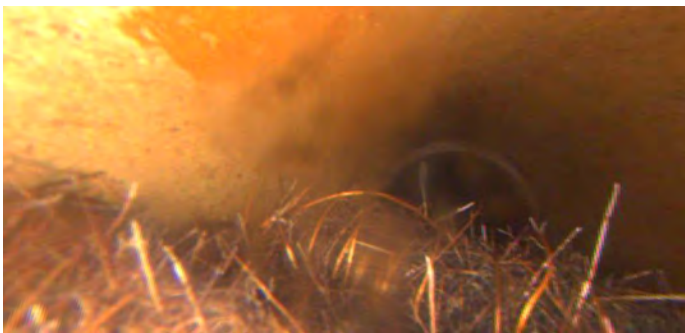
Code: **RFJ**
Description: **Roots Fine Joint**

Distance (ft): **153.3**
Structural Grade: **0**
O&M Grade: **1**
Clock Start/From: **11**
Clock To: **5**
1st Value:
2nd Value:
Value Percent:
Continuous Index: **F01**
Within 8" of Joint: **YES**
Remarks: **wandering**
