Profile/Photo Observation Report

Street:	N PENNSYLVANIA ST	Flow Control:	Not Controlled
City:	Hobart, IN	Year Renewed:	
Location:	Light Highway	Tape/Media #:	
Purpose:	Not Known	Dia/Height:	10"
Use:	Sanitary	Material:	VCP
Drain Area:	NA	Lining:	
Category:	NA		
Comment:

Location Details:		Direction of Survey:	Downstream
US MH:	M-604-088	DS MH:	M-604-087
		Total Length Surveyed (ft):	30.4

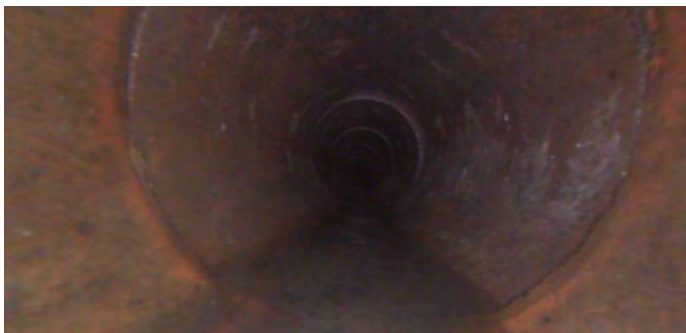
Code: **AMH**
Description: **Manhole**

Distance (ft): **.0**
Structural Grade: **0**
O&M Grade: **0**
Clock Start/From:
Clock To:
1st Value:
2nd Value:
Value Percent:
Continuous Index:
Within 8" of Joint: **NO**
Remarks: **M-604-088**

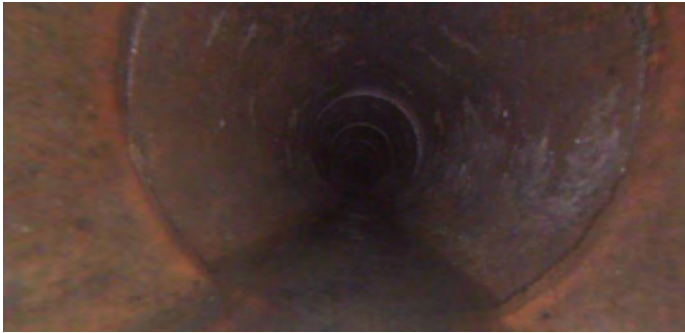
Code:	MWL
Description:	Water Level

Distance (ft):	.0
Structural Grade:	0
O&M Grade:	0
Clock Start/From:	
Clock To:	
1st Value:	
2nd Value:	
Value Percent:	5.000
Continuous Index:	
Within 8" of Joint:	NO
Remarks:

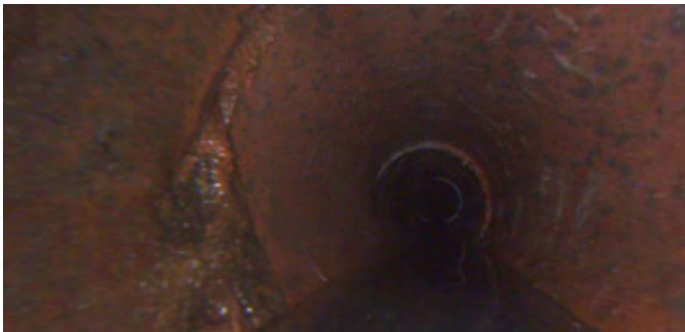
Code:	DAE
Description:	Deposits Attached Encrustation

Distance (ft):	13.0
Structural Grade:	0
O&M Grade:	2
Clock Start/From:	7
Clock To:	9
1st Value:	
2nd Value:	
Value Percent:	5.000
Continuous Index:	
Within 8" of Joint:	YES
Remarks:

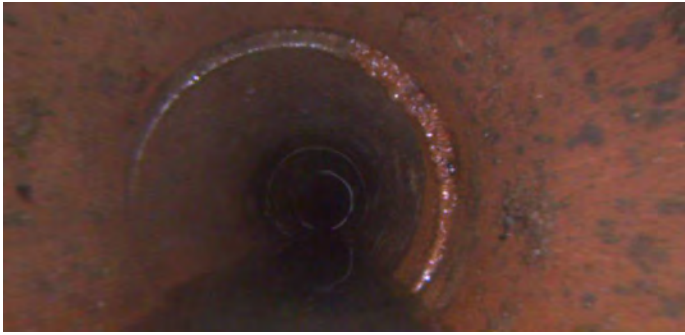
Code: **DAE**
Description: **Deposits Attached Encrustation**

Distance (ft): **14.8**
Structural Grade: **0**
O&M Grade: **2**
Clock Start/From: **1**
Clock To: **5**
1st Value:
2nd Value:
Value Percent: **5.000**
Continuous Index:
Within 8" of Joint: **YES**
Remarks:

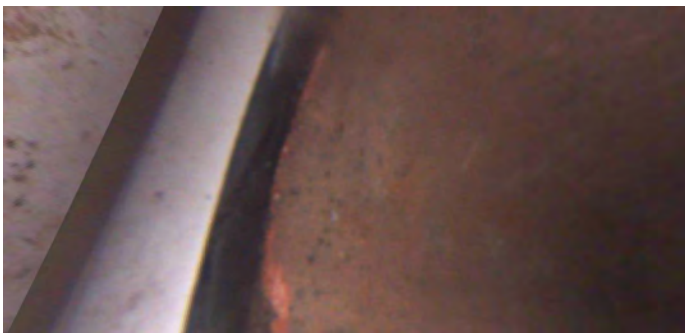
Code: **MMC**
Description: **Material Change**

Distance (ft): **19.7**
Structural Grade: **0**
O&M Grade: **0**
Clock Start/From:
Clock To:
1st Value:
2nd Value:
Value Percent:
Continuous Index:
Within 8" of Joint: **NO**
Remarks: **pvc**

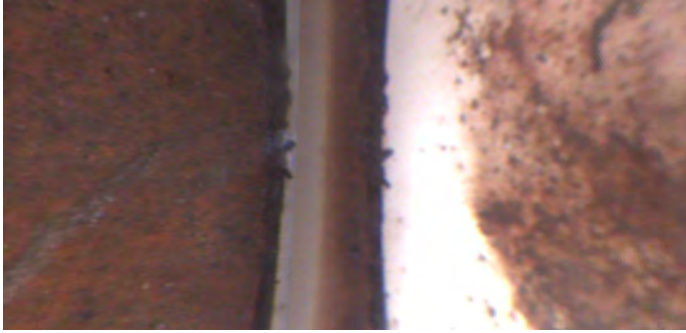
Code: **MMC**
Description: **Material Change**

Distance (ft): **26.6**
Structural Grade: **0**
O&M Grade: **0**
Clock Start/From:
Clock To:
1st Value:
2nd Value:
Value Percent:
Continuous Index:
Within 8" of Joint: **NO**
Remarks: **vcp**

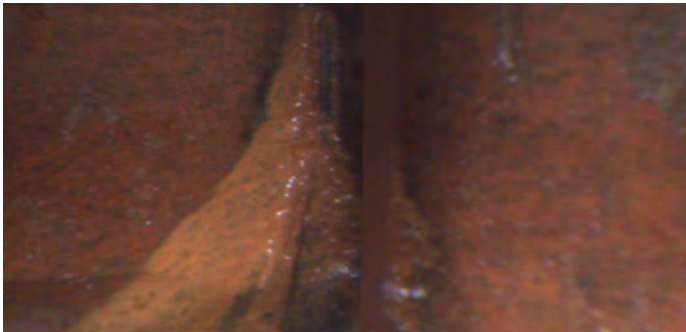
Code: **IS**
Description: **Infil Stain**

Distance (ft): **27.8**
Structural Grade: **0**
O&M Grade: **0**
Clock Start/From: **3**
Clock To: **5**
1st Value:
2nd Value:
Value Percent:
Continuous Index:
Within 8" of Joint: **YES**
Remarks:

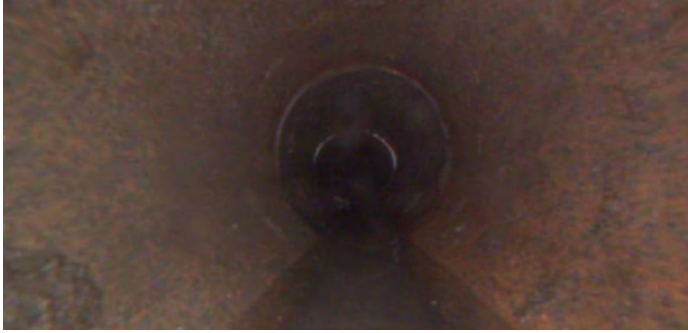
Code:	MSA
Description:	Abandoned Survey
Distance (ft):	30.4
Structural Grade:	0
O&M Grade:	0
Clock Start/From:	
Clock To:	
1st Value:	
2nd Value:	
Value Percent:	
Continuous Index:	
Within 8" of Joint:	NO
Remarks:	no blockage
