Profile/Photo Observation Report

Date:	04/22/2018	Weather:		Coding:	PACP 6.0
Pipe Length (ft):	129.5	Owner:	NA	Pre Clean:	Not Known
P.O.#:		Surveyor:	Byrd Fitzgerald	PSR:	P-604-087-088
Customer:		Clean Date:	01/01/1900	Shape:	C

Street:	Summerlin	Flow Control:	Not Controlled
City:	Hobart, IN	Year Renewed:	
Location:	Light Highway	Tape/Media #:	
Purpose:	Not Known	Dia/Height:	10"
Use:	Sanitary	Material:	VCP
Drain Area:	NA	Lining:	
Category:	NA		
Comment:

Location Details:		Direction of Survey:	Downstream
US MH:	M-604-088	DS MH:	M-604-087
		Total Length Surveyed (ft):	30.4

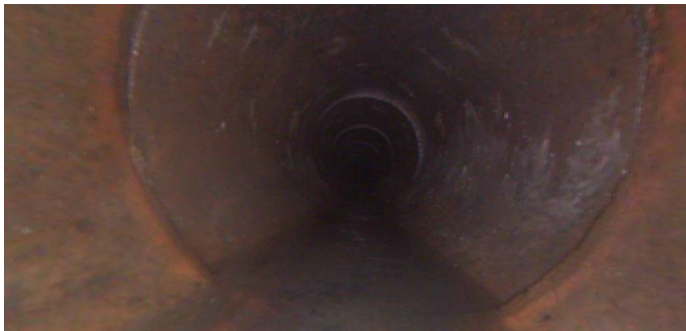
Code: **AMH**
Description: **Manhole**

Distance (ft): **.0**
Structural Grade: **0**
O&M Grade: **0**
Clock Start/From:
Clock To:
1st Value:
2nd Value:
Value Percent:
Continuous Index:
Within 8" of Joint: **NO**
Remarks: **M-604-088**

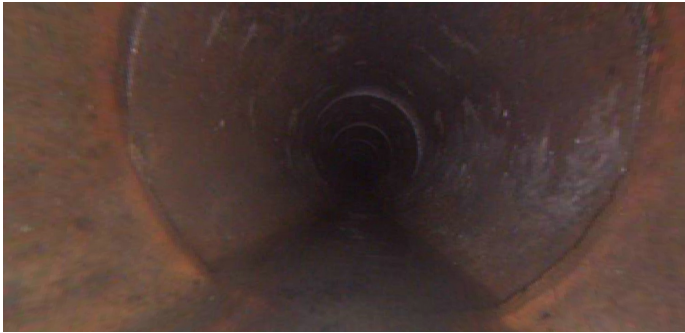
Code:	MWL
Description:	Water Level

Distance (ft):	.0
Structural Grade:	0
O&M Grade:	0
Clock Start/From:	
Clock To:	
1st Value:	
2nd Value:	
Value Percent:	5.000
Continuous Index:	
Within 8" of Joint:	NO
Remarks:

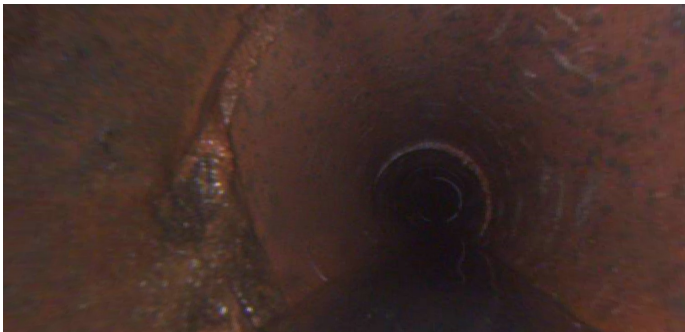
Code:	DAE
Description:	Deposits Attached Encrustation

Distance (ft):	13.0
Structural Grade:	0
O&M Grade:	2
Clock Start/From:	7
Clock To:	9
1st Value:	
2nd Value:	
Value Percent:	5.000
Continuous Index:	
Within 8" of Joint:	YES
Remarks:

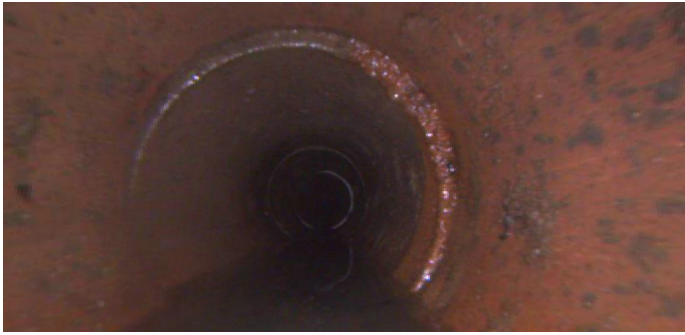
Code: **DAE**
Description: **Deposits Attached Encrustation**

Distance (ft): **14.8**
Structural Grade: **0**
O&M Grade: **2**
Clock Start/From: **1**
Clock To: **5**
1st Value:
2nd Value:
Value Percent: **5.000**
Continuous Index:
Within 8" of Joint: **YES**
Remarks:

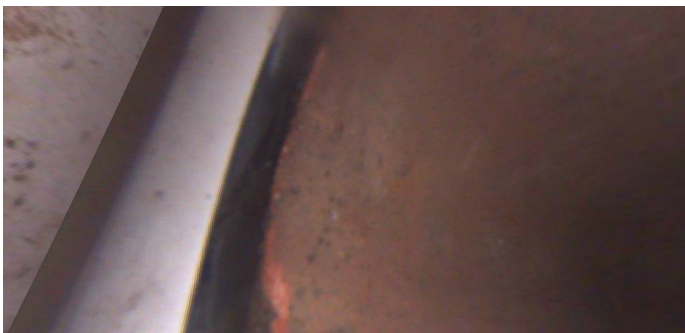
Code: **MMC**
Description: **Material Change**

Distance (ft): **19.7**
Structural Grade: **0**
O&M Grade: **0**
Clock Start/From:
Clock To:
1st Value:
2nd Value:
Value Percent:
Continuous Index:
Within 8" of Joint: **NO**
Remarks: **pvc**

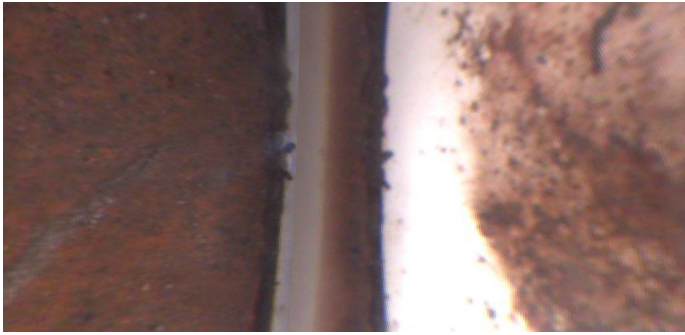
Code: **MMC**
Description: **Material Change**

Distance (ft): **26.6**
Structural Grade: **0**
O&M Grade: **0**
Clock Start/From:
Clock To:
1st Value:
2nd Value:
Value Percent:
Continuous Index:
Within 8" of Joint: **NO**
Remarks: **vcp**

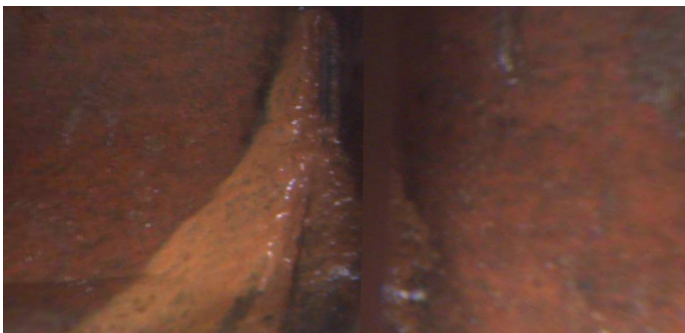
Code: **IS**
Description: **Infil Stain**

Distance (ft): **27.8**
Structural Grade: **0**
O&M Grade: **0**
Clock Start/From: **3**
Clock To: **5**
1st Value:
2nd Value:
Value Percent:
Continuous Index:
Within 8" of Joint: **YES**
Remarks:

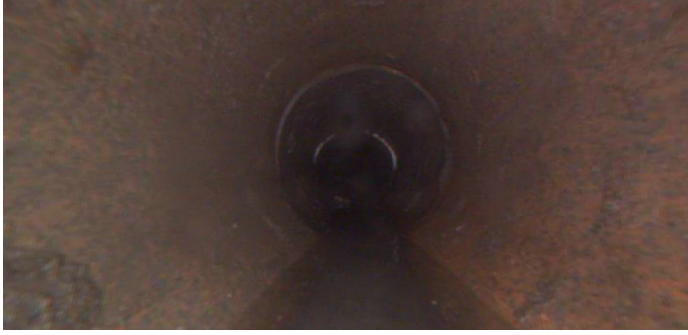
Code:	MSA
Description:	Abandoned Survey
Distance (ft):	30.4
Structural Grade:	0
O&M Grade:	0
Clock Start/From:	
Clock To:	
1st Value:	
2nd Value:	
Value Percent:	
Continuous Index:	
Within 8" of Joint:	NO
Remarks:	no blockage
