Profile/Photo Observation Report

Street:	Summerlin	Flow Control:	Not Controlled
City:	Hobart, IN	Year Renewed:	
Location:	Light Highway	Tape/Media #:	
Purpose:	Not Known	Dia/Height:	12"
Use:	Sanitary	Material:	VCP
Drain Area:	NA	Lining:	
Category:	NA		
Comment:

Location Details:		Direction of Survey:	Upstream
US MH:	M-604-088	DS MH:	M-604-087
		Total Length Surveyed (ft):	40.4

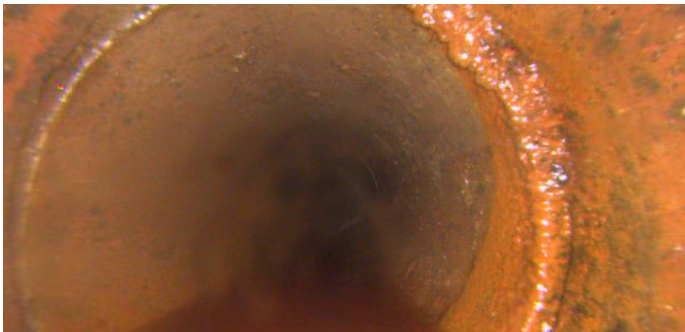
Code:	IW
Description:	Infil Weeper

Distance (ft):	16.5
Structural Grade:	0
O&M Grade:	2
Clock Start/From:	1
Clock To:	4
1st Value:	
2nd Value:	
Value Percent:	
Continuous Index:	
Within 8" of Joint:	YES
Remarks:

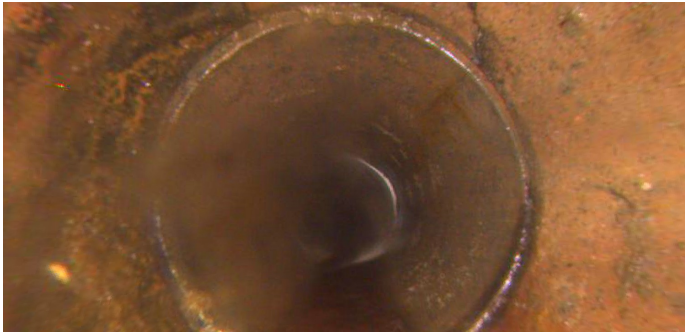
Code: **FM**
Description: **Fracture Multiple**

Distance (ft): **18.4**
Structural Grade: **4**
O&M Grade: **0**
Clock Start/From: **8**
Clock To: **4**
1st Value:
2nd Value:
Value Percent:
Continuous Index:
Within 8" of Joint: **YES**
Remarks:

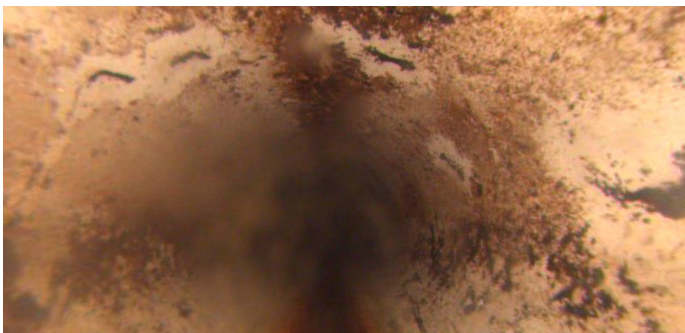
Code: **MMC**
Description: **Material Change**

Distance (ft): **21.4**
Structural Grade: **0**
O&M Grade: **0**
Clock Start/From:
Clock To:
1st Value:
2nd Value:
Value Percent:
Continuous Index:
Within 8" of Joint: **NO**
Remarks: **PVC**

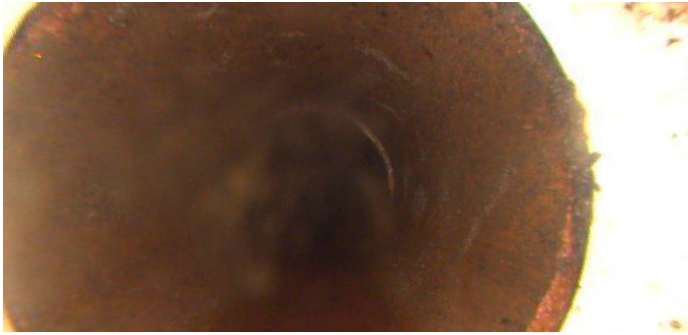
Code:	MMC
Description:	Material Change
Distance (ft):	27.6
Structural Grade:	0
O&M Grade:	0
Clock Start/From:	
Clock To:	
1st Value:	
2nd Value:	
Value Percent:	
Continuous Index:	
Within 8" of Joint:	NO
Remarks:	vcp

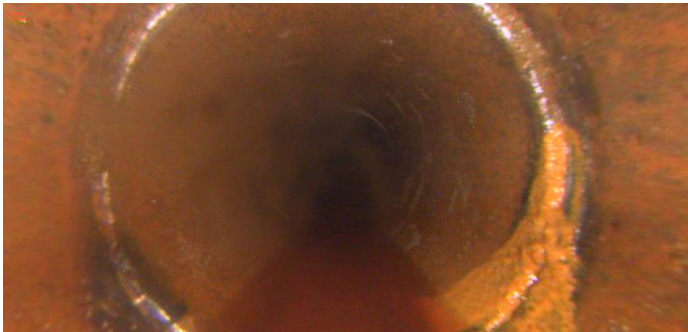
Code:	IW
Description:	Infil Weeper
Distance (ft):	28.8
Structural Grade:	0
O&M Grade:	2
Clock Start/From:	8
Clock To:	4
1st Value:	
2nd Value:	
Value Percent:	
Continuous Index:	
Within 8" of Joint:	YES
Remarks:

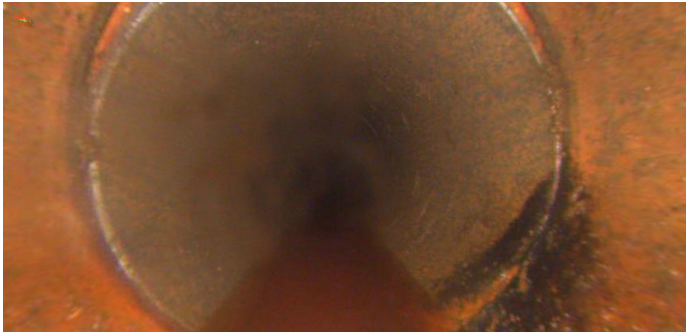
Code: **IW**
Description: **Infil Weeper**

Distance (ft): **30.9**
Structural Grade: **0**
O&M Grade: **2**
Clock Start/From: **3**
Clock To: **4**
1st Value:
2nd Value:
Value Percent:
Continuous Index:
Within 8" of Joint: **YES**
Remarks:

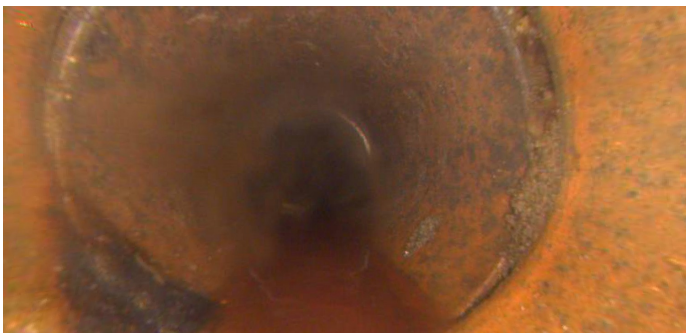
Code: **IW**
Description: **Infil Weeper**

Distance (ft): **32.9**
Structural Grade: **0**
O&M Grade: **2**
Clock Start/From: **8**
Clock To: **9**
1st Value:
2nd Value:
Value Percent:
Continuous Index:
Within 8" of Joint: **YES**
Remarks:

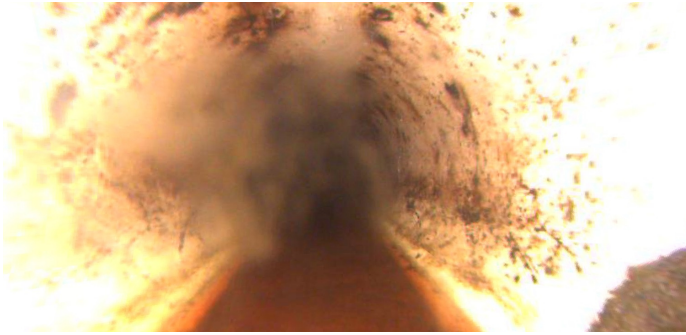
Code: **MMC**
Description: **Material Change**

Distance (ft): **35.0**
Structural Grade: **0**
O&M Grade: **0**
Clock Start/From:
Clock To:
1st Value:
2nd Value:
Value Percent:
Continuous Index:
Within 8" of Joint: **NO**
Remarks: **PVC**

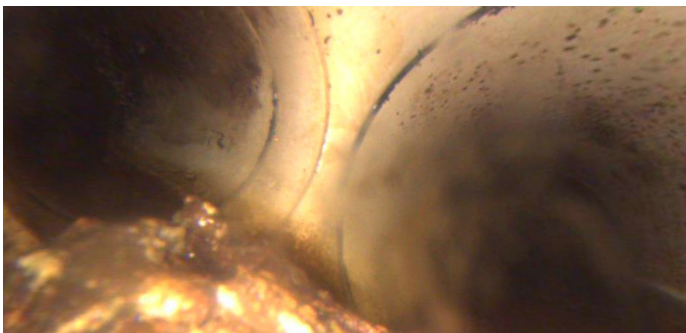
Code: **TFD**
Description: **Tap Factory Defective**

Distance (ft): **38.9**
Structural Grade: **0**
O&M Grade: **2**
Clock Start/From: **9**
Clock To:
1st Value: **4.000**
2nd Value:
Value Percent:
Continuous Index:
Within 8" of Joint:
Remarks: **DAE**

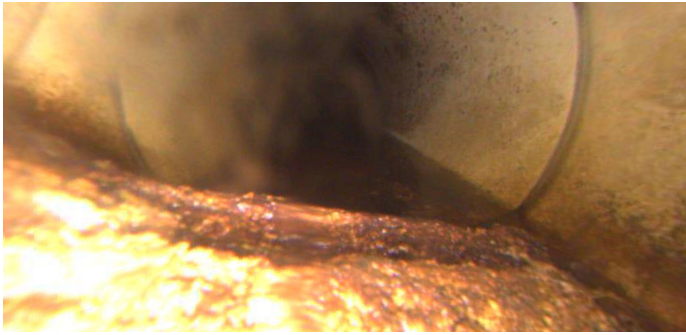
Code: **DSC**
Description: **Deposits Settled Compacted**

Distance (ft): **38.9**
Structural Grade: **0**
O&M Grade: **3**
Clock Start/From: **4**
Clock To: **9**
1st Value:
2nd Value:
Value Percent: **20.000**
Continuous Index:
Within 8" of Joint: **NO**
Remarks:

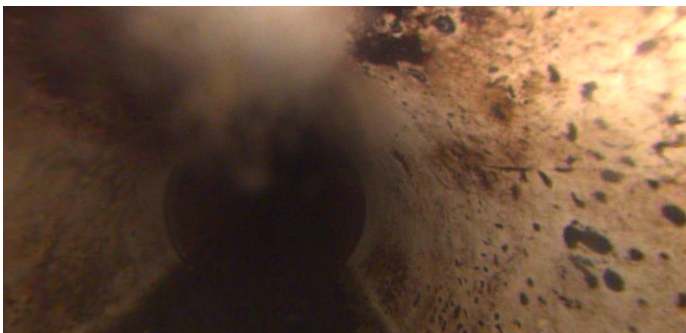
Code: **MSA**
Description: **Abandoned Survey**

Distance (ft): **40.4**
Structural Grade: **0**
O&M Grade: **0**
Clock Start/From:
Clock To:
1st Value:
2nd Value:
Value Percent:
Continuous Index:
Within 8" of Joint: **NO**
Remarks: **DSC**
