Profile/Photo Observation Report

Date:	04/22/2018	Weather:		Coding:	PACP 6.0
Pipe Length (ft):	174.3	Owner:	NA	Pre Clean:	Not Known
P.O.#:		Surveyor:	Mark Ruby	PSR:	P-604-094-088
Customer:		Clean Date:	01/01/1900	Shape:	C

Street:	N PENNSYLVANIA ST	Flow Control:	Not Controlled
City:	Hobart, IN	Year Renewed:	
Location:	Light Highway	Tape/Media #:	
Purpose:	Not Known	Dia/Height:	12"
Use:	Sanitary	Material:	VCP
Drain Area:	NA	Lining:	
Category:	NA		
Comment:

Location Details:		Direction of Survey:	Downstream
US MH:	M-604-088	DS MH:	M-604-094
		Total Length Surveyed (ft):	167.6

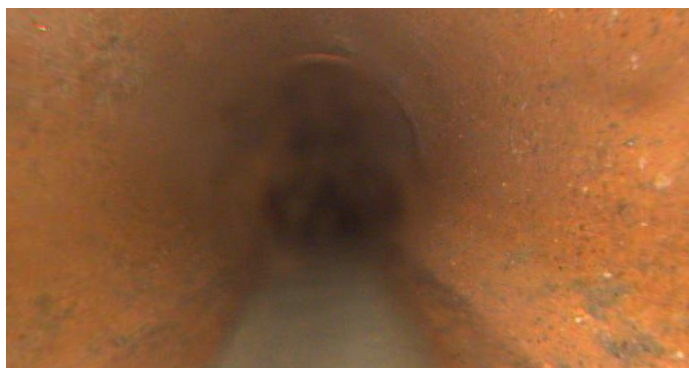
Code: **AMH**
 Description: **Manhole**

Distance (ft): **.0**
 Structural Grade: **0**
 O&M Grade: **0**
 Clock Start/From:
 Clock To:
 1st Value:
 2nd Value:
 Value Percent:
 Continuous Index:
 Within 8" of Joint: **NO**
 Remarks: **M-604-088**

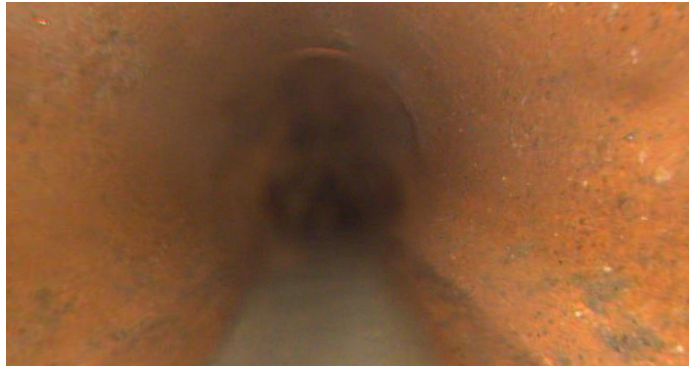
Code: **MWL**
Description: **Water Level**

Distance (ft): **.0**
Structural Grade: **0**
O&M Grade: **0**
Clock Start/From:
Clock To:
1st Value:
2nd Value:
Value Percent: **10.000**
Continuous Index:
Within 8" of Joint: **NO**
Remarks:

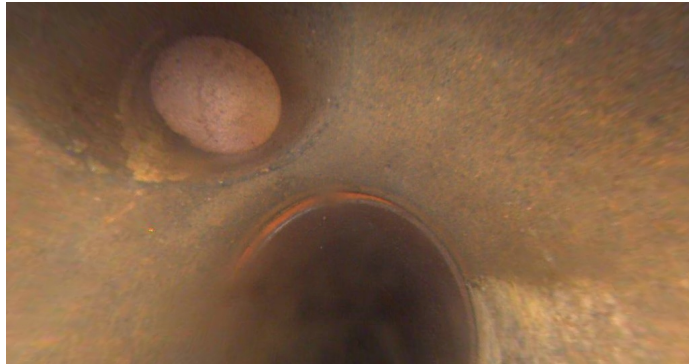
Code: **TFC**
Description: **Tap Factory Capped**

Distance (ft): **21.9**
Structural Grade: **0**
O&M Grade: **0**
Clock Start/From: **10**
Clock To:
1st Value: **4.000**
2nd Value:
Value Percent:
Continuous Index:
Within 8" of Joint:
Remarks:

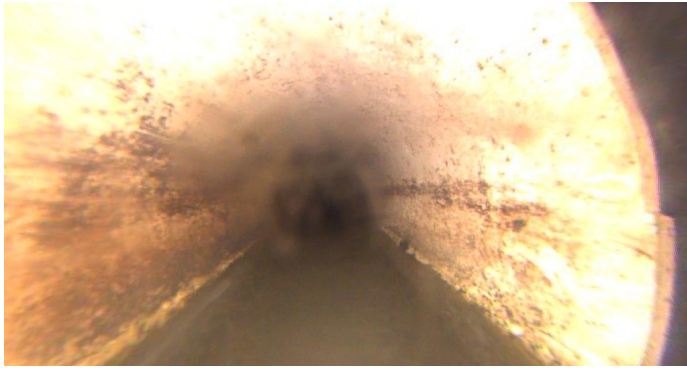
Code: **MMC**
Description: **Material Change**

Distance (ft): **34.6**
Structural Grade: **0**
O&M Grade: **0**
Clock Start/From:
Clock To:
1st Value:
2nd Value:
Value Percent:
Continuous Index:
Within 8" of Joint: **NO**
Remarks: **PVC**

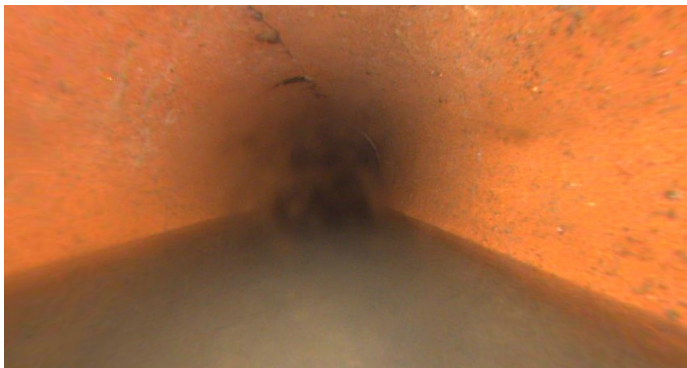
Code: **MMC**
Description: **Material Change**

Distance (ft): **47.4**
Structural Grade: **0**
O&M Grade: **0**
Clock Start/From:
Clock To:
1st Value:
2nd Value:
Value Percent:
Continuous Index:
Within 8" of Joint: **NO**
Remarks: **VCP**

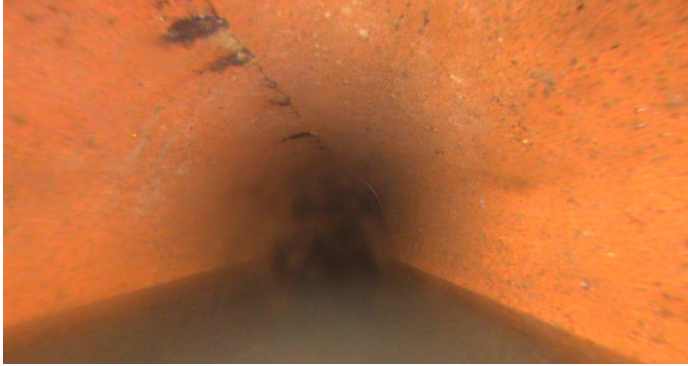
Code: **CL**
Description: **Crack Longitudinal**

Distance (ft): **47.4**
Structural Grade: **2**
O&M Grade: **0**
Clock Start/From: **12**
Clock To:
1st Value:
2nd Value:
Value Percent:
Continuous Index:
Within 8" of Joint:
Remarks:

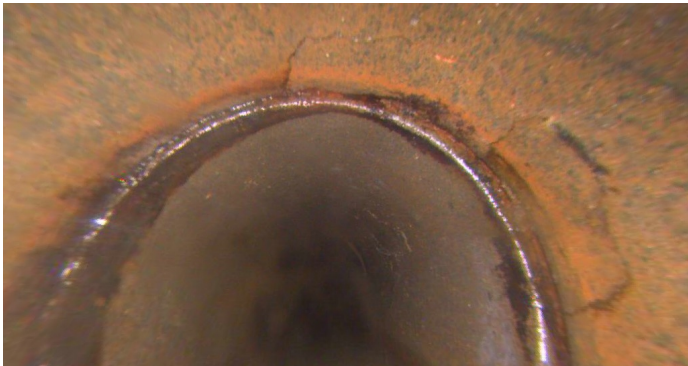
Code: **CM**
Description: **Crack Multiple**

Distance (ft): **73.5**
Structural Grade: **3**
O&M Grade: **0**
Clock Start/From: **1**
Clock To: **4**
1st Value:
2nd Value:
Value Percent:
Continuous Index:
Within 8" of Joint: **YES**
Remarks:

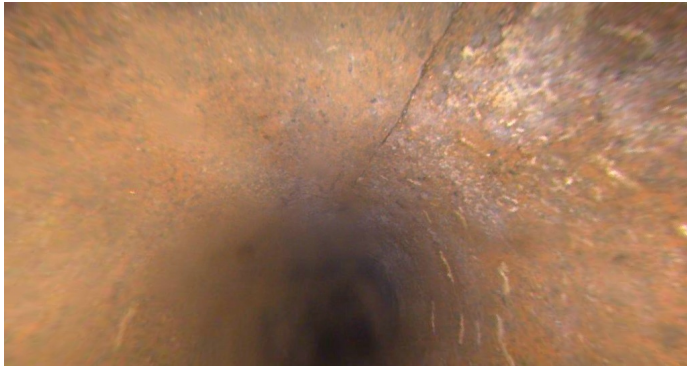
Code: **CL**
Description: **Crack Longitudinal**

Distance (ft): **78.0**
Structural Grade: **2**
O&M Grade: **0**
Clock Start/From: **1**
Clock To:
1st Value:
2nd Value:
Value Percent:
Continuous Index:
Within 8" of Joint: **YES**
Remarks:

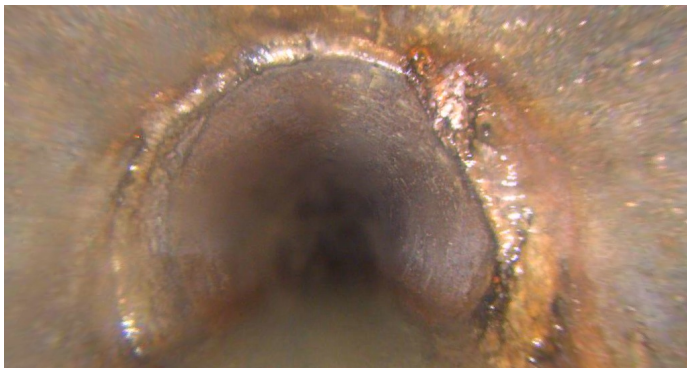
Code: **DAZ**
Description: **Deposits Attached Other**

Distance (ft): **81.6**
Structural Grade: **0**
O&M Grade: **2**
Clock Start/From: **7**
Clock To: **5**
1st Value:
2nd Value:
Value Percent: **5.000**
Continuous Index:
Within 8" of Joint: **YES**
Remarks:

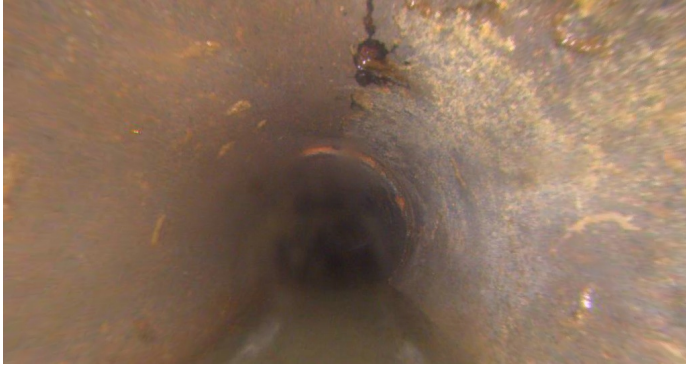
Code: **CL**
Description: **Crack Longitudinal**

Distance (ft): **86.8**
Structural Grade: **2**
O&M Grade: **0**
Clock Start/From: **1**
Clock To:
1st Value:
2nd Value:
Value Percent:
Continuous Index:
Within 8" of Joint:
Remarks:

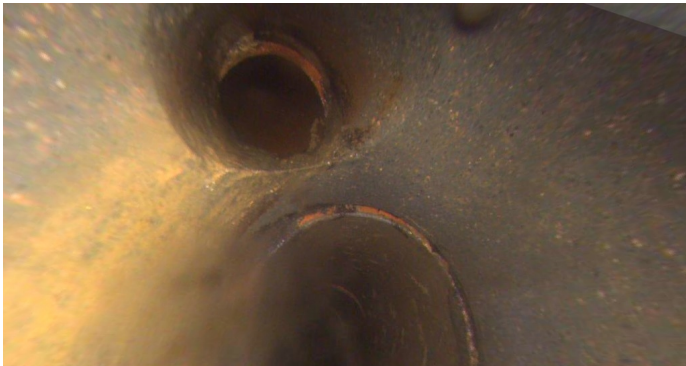
Code: **TF**
Description: **Tap Factory**

Distance (ft): **97.4**
Structural Grade: **0**
O&M Grade: **0**
Clock Start/From: **11**
Clock To:
1st Value: **4.000**
2nd Value:
Value Percent:
Continuous Index:
Within 8" of Joint:
Remarks:

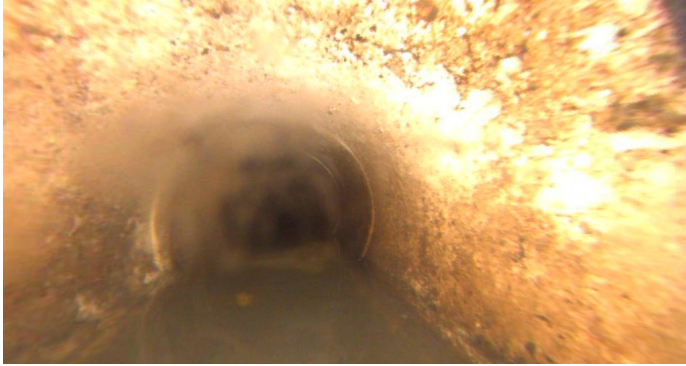
Code: **MMC**
Description: **Material Change**

Distance (ft): **102.4**
Structural Grade: **0**
O&M Grade: **0**
Clock Start/From:
Clock To:
1st Value:
2nd Value:
Value Percent:
Continuous Index:
Within 8" of Joint: **NO**
Remarks: **PVC**

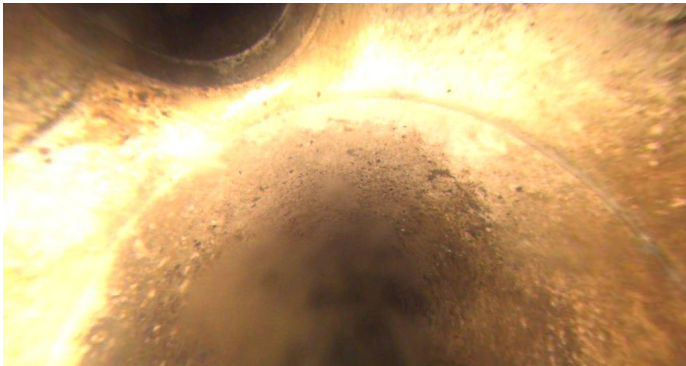
Code: **TF**
Description: **Tap Factory**

Distance (ft): **103.7**
Structural Grade: **0**
O&M Grade: **0**
Clock Start/From: **11**
Clock To:
1st Value: **4.000**
2nd Value:
Value Percent:
Continuous Index:
Within 8" of Joint:
Remarks:

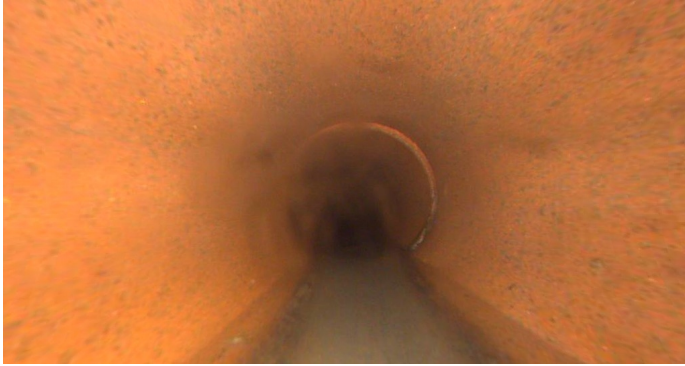
Code: **MMC**
Description: **Material Change**

Distance (ft): **107.4**
Structural Grade: **0**
O&M Grade: **0**
Clock Start/From:
Clock To:
1st Value:
2nd Value:
Value Percent:
Continuous Index:
Within 8" of Joint: **NO**
Remarks: **VCP**

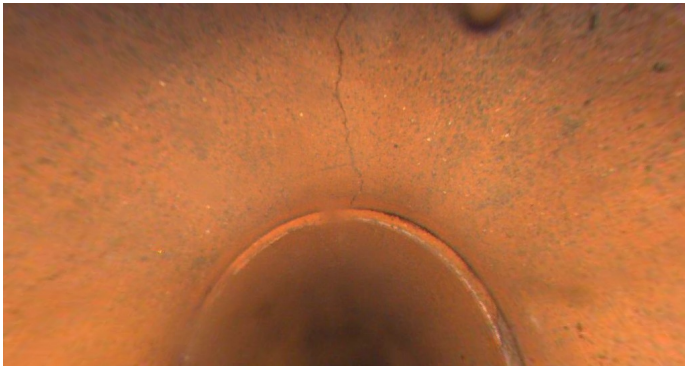
Code: **CL**
Description: **Crack Longitudinal**

Distance (ft): **107.9**
Structural Grade: **2**
O&M Grade: **0**
Clock Start/From: **12**
Clock To:
1st Value:
2nd Value:
Value Percent:
Continuous Index:
Within 8" of Joint: **YES**
Remarks:

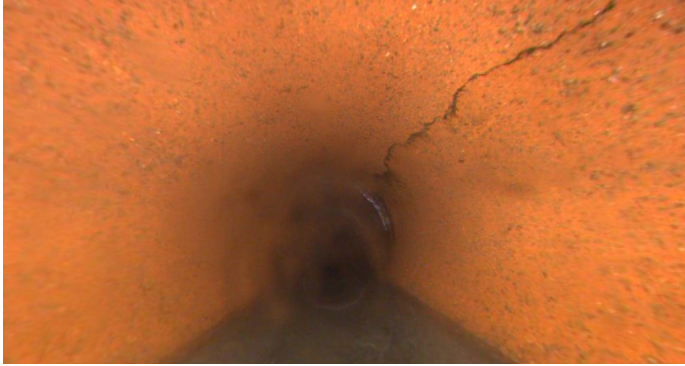
Code: **CL**
Description: **Crack Longitudinal**

Distance (ft): **127.4**
Structural Grade: **2**
O&M Grade: **0**
Clock Start/From: **2**
Clock To:
1st Value:
2nd Value:
Value Percent:
Continuous Index:
Within 8" of Joint:
Remarks:

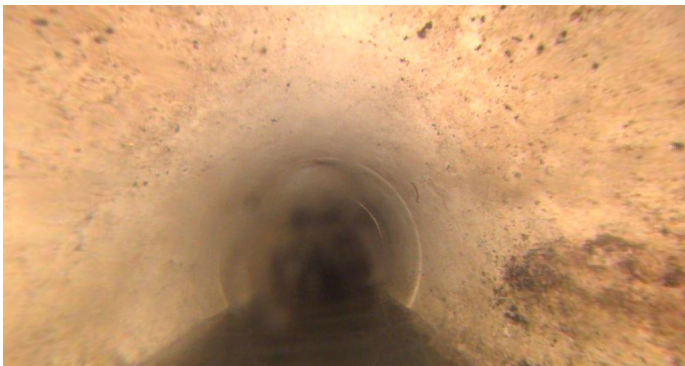
Code: **MMC**
Description: **Material Change**

Distance (ft): **131.5**
Structural Grade: **0**
O&M Grade: **0**
Clock Start/From:
Clock To:
1st Value:
2nd Value:
Value Percent:
Continuous Index:
Within 8" of Joint: **NO**
Remarks: **PVC**

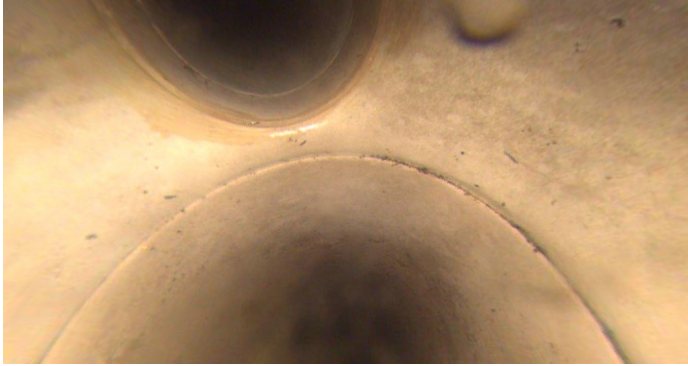
Code: **TF**
Description: **Tap Factory**

Distance (ft): **132.8**
Structural Grade: **0**
O&M Grade: **0**
Clock Start/From: **11**
Clock To:
1st Value: **4.000**
2nd Value:
Value Percent:
Continuous Index:
Within 8" of Joint:
Remarks:

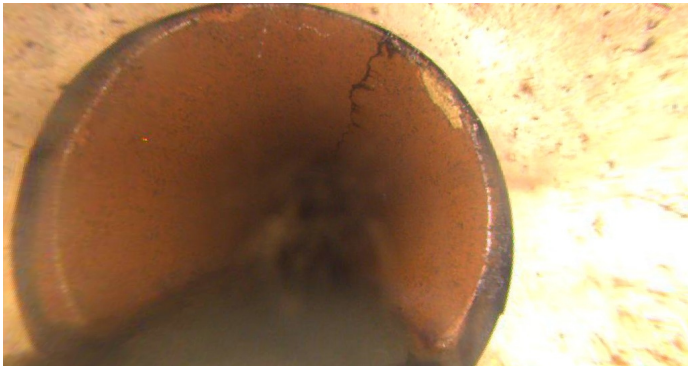
Code: **MMC**
Description: **Material Change**

Distance (ft): **145.9**
Structural Grade: **0**
O&M Grade: **0**
Clock Start/From:
Clock To:
1st Value:
2nd Value:
Value Percent:
Continuous Index:
Within 8" of Joint: **NO**
Remarks: **VCP**

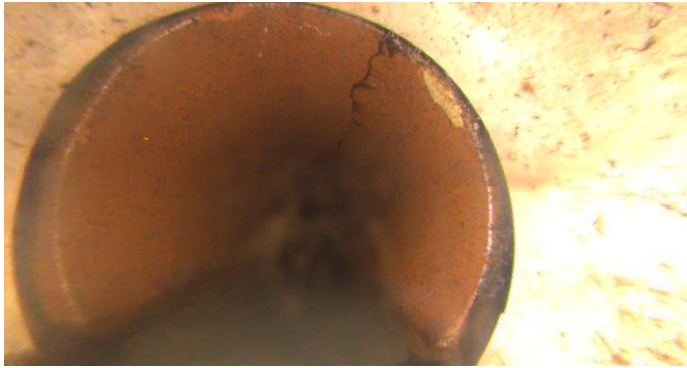
Code: **CL**
Description: **Crack Longitudinal**

Distance (ft): **145.9**
Structural Grade: **2**
O&M Grade: **0**
Clock Start/From: **2**
Clock To:
1st Value:
2nd Value:
Value Percent:
Continuous Index:
Within 8" of Joint:
Remarks:

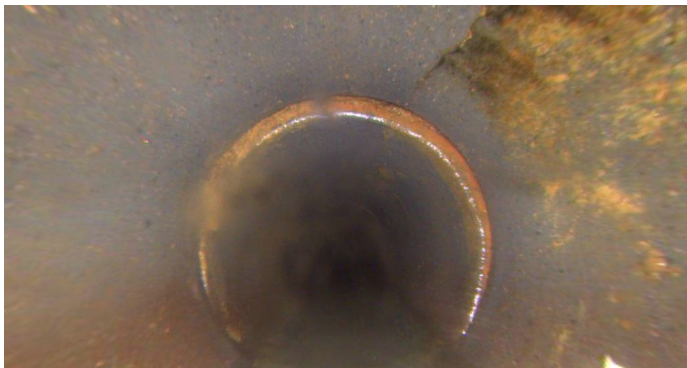
Code: **CL**
Description: **Crack Longitudinal**

Distance (ft): **157.4**
Structural Grade: **2**
O&M Grade: **0**
Clock Start/From: **2**
Clock To:
1st Value:
2nd Value:
Value Percent:
Continuous Index:
Within 8" of Joint: **YES**
Remarks:

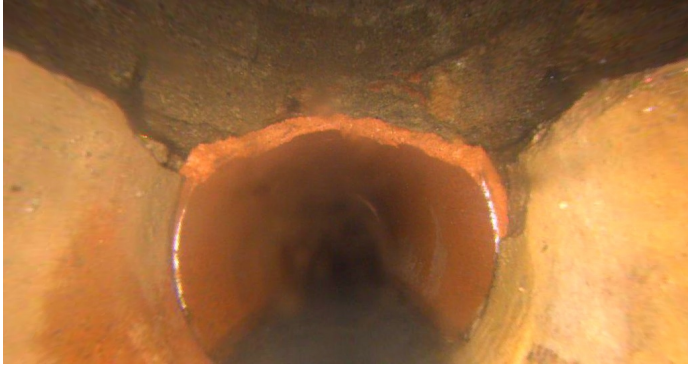
Code:	AMH
Description:	Manhole
Distance (ft):	167.6
Structural Grade:	0
O&M Grade:	0
Clock Start/From:	
Clock To:	
1st Value:	
2nd Value:	
Value Percent:	
Continuous Index:	
Within 8" of Joint:	NO
Remarks:	M-604-094
