Profile/Photo Observation Report

Date:	04/22/2018	Weather:		Coding:	PACP 6.0
Pipe Length (ft):	174.3	Owner:	NA	Pre Clean:	Not Known
P.O.#:		Surveyor:	Mark Ruby	PSR:	P-604-094-088
Customer:		Clean Date:	01/01/1900	Shape:	C

Street:	Summerlin	Flow Control:	Not Controlled
City:	Hobart, IN	Year Renewed:	
Location:	Light Highway	Tape/Media #:	
Purpose:	Not Known	Dia/Height:	12"
Use:	Sanitary	Material:	VCP
Drain Area:	NA	Lining:	
Category:	NA		
Comment:

Location Details:		Direction of Survey:	Downstream
US MH:	M-604-088	DS MH:	M-604-094
		Total Length Surveyed (ft):	167.6

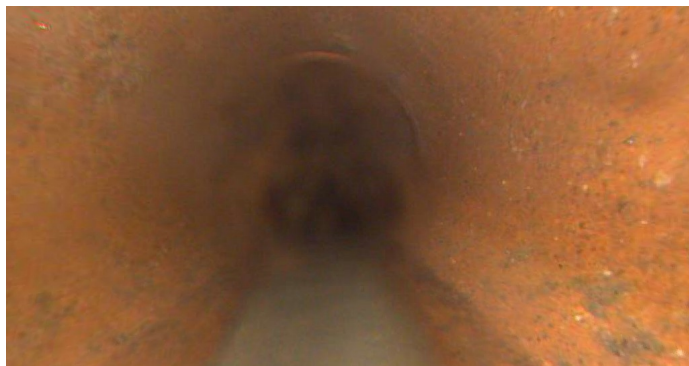
Code: **AMH**
Description: **Manhole**

Distance (ft): **.0**
Structural Grade: **0**
O&M Grade: **0**
Clock Start/From:
Clock To:
1st Value:
2nd Value:
Value Percent:
Continuous Index:
Within 8" of Joint: **NO**
Remarks: **M-604-088**

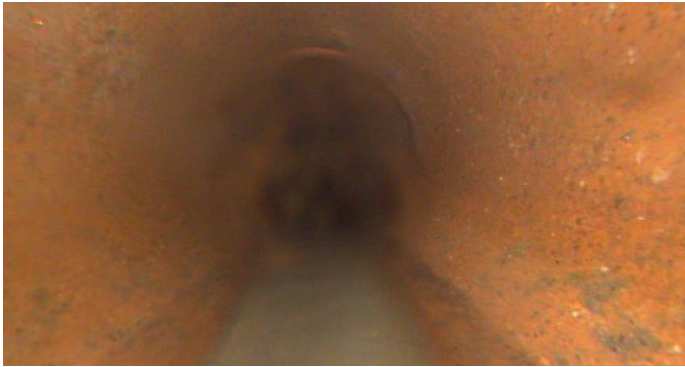
Code:	MWL
Description:	Water Level

Distance (ft):	.0
Structural Grade:	0
O&M Grade:	0
Clock Start/From:	
Clock To:	
1st Value:	
2nd Value:	
Value Percent:	10.000
Continuous Index:	
Within 8" of Joint:	NO
Remarks:

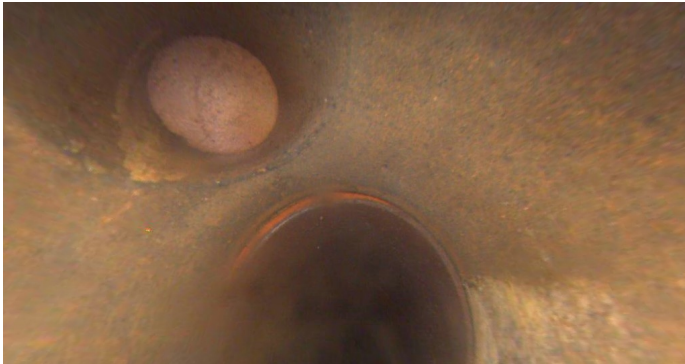
Code:	TFC
Description:	Tap Factory Capped

Distance (ft):	21.9
Structural Grade:	0
O&M Grade:	0
Clock Start/From:	10
Clock To:	
1st Value:	4.000
2nd Value:	
Value Percent:	
Continuous Index:	
Within 8" of Joint:	
Remarks:

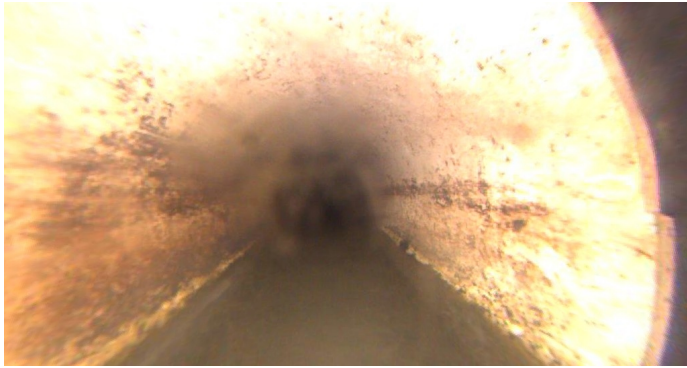
Code: **MMC**
Description: **Material Change**

Distance (ft): **34.6**
Structural Grade: **0**
O&M Grade: **0**
Clock Start/From:
Clock To:
1st Value:
2nd Value:
Value Percent:
Continuous Index:
Within 8" of Joint: **NO**
Remarks: **PVC**

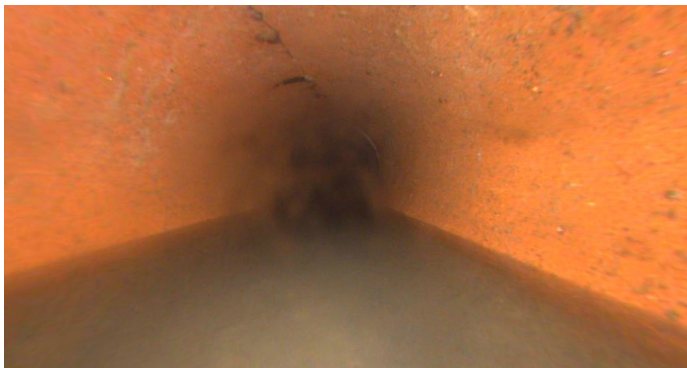
Code: **MMC**
Description: **Material Change**

Distance (ft): **47.4**
Structural Grade: **0**
O&M Grade: **0**
Clock Start/From:
Clock To:
1st Value:
2nd Value:
Value Percent:
Continuous Index:
Within 8" of Joint: **NO**
Remarks: **VCP**

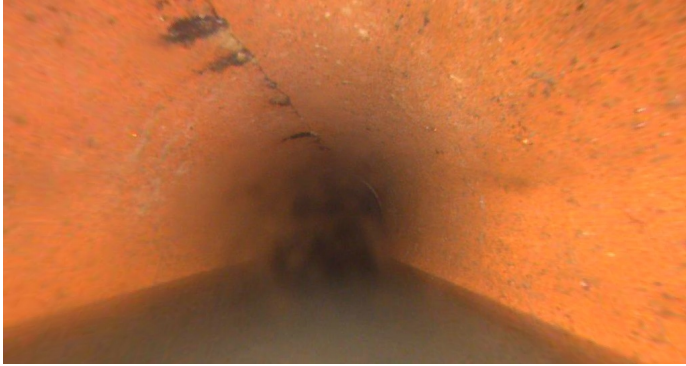
Code: **CL**
Description: **Crack Longitudinal**

Distance (ft): **47.4**
Structural Grade: **2**
O&M Grade: **0**
Clock Start/From: **12**
Clock To:
1st Value:
2nd Value:
Value Percent:
Continuous Index:
Within 8" of Joint:
Remarks:

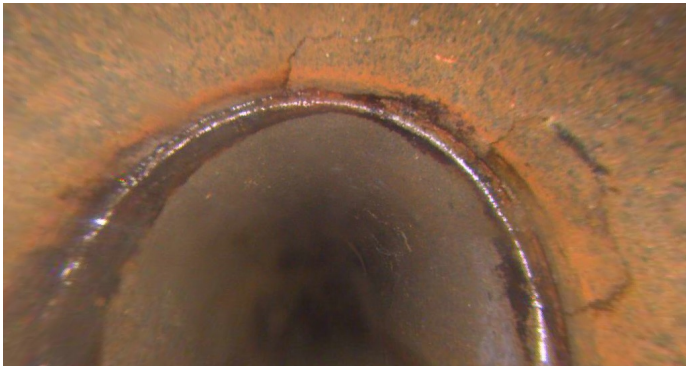
Code: **CM**
Description: **Crack Multiple**

Distance (ft): **73.5**
Structural Grade: **3**
O&M Grade: **0**
Clock Start/From: **1**
Clock To: **4**
1st Value:
2nd Value:
Value Percent:
Continuous Index:
Within 8" of Joint: **YES**
Remarks:

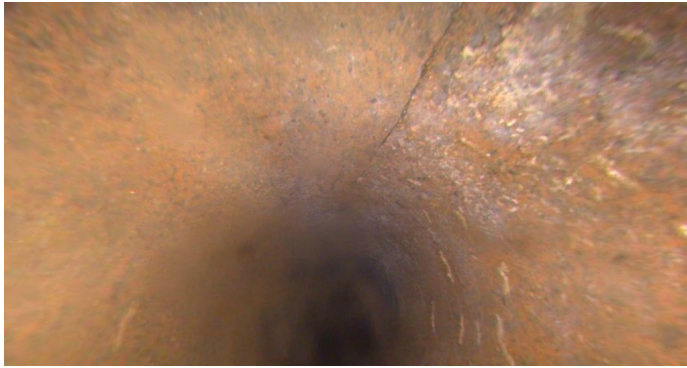
Code: **CL**
Description: **Crack Longitudinal**

Distance (ft): **78.0**
Structural Grade: **2**
O&M Grade: **0**
Clock Start/From: **1**
Clock To:
1st Value:
2nd Value:
Value Percent:
Continuous Index:
Within 8" of Joint: **YES**
Remarks:

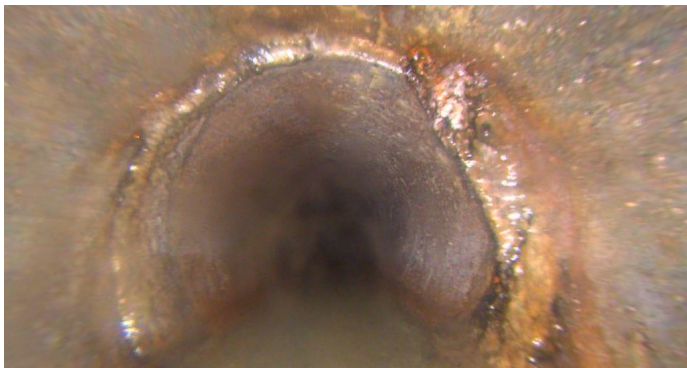
Code: **DAZ**
Description: **Deposits Attached Other**

Distance (ft): **81.6**
Structural Grade: **0**
O&M Grade: **2**
Clock Start/From: **7**
Clock To: **5**
1st Value:
2nd Value:
Value Percent: **5.000**
Continuous Index:
Within 8" of Joint: **YES**
Remarks:

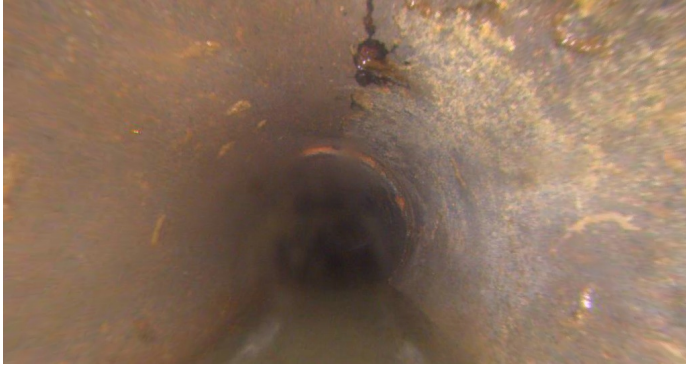
Code: **CL**
Description: **Crack Longitudinal**

Distance (ft): **86.8**
Structural Grade: **2**
O&M Grade: **0**
Clock Start/From: **1**
Clock To:
1st Value:
2nd Value:
Value Percent:
Continuous Index:
Within 8" of Joint:
Remarks:

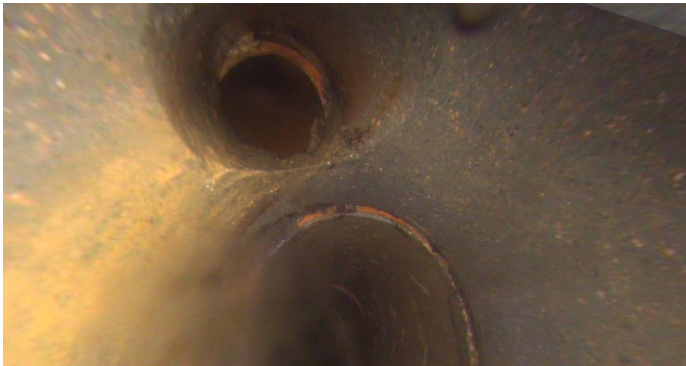
Code: **TF**
Description: **Tap Factory**

Distance (ft): **97.4**
Structural Grade: **0**
O&M Grade: **0**
Clock Start/From: **11**
Clock To:
1st Value: **4.000**
2nd Value:
Value Percent:
Continuous Index:
Within 8" of Joint:
Remarks:

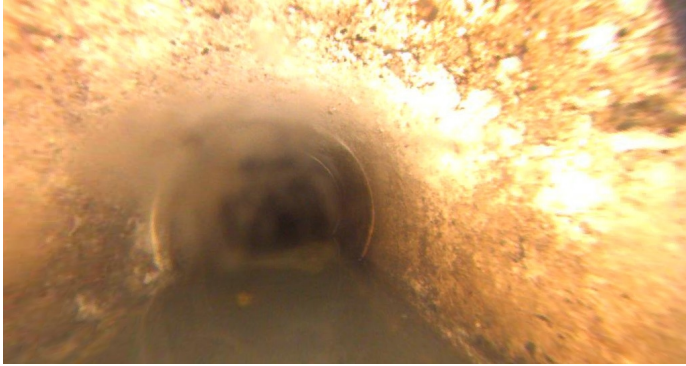
Code: **MMC**
Description: **Material Change**

Distance (ft): **102.4**
Structural Grade: **0**
O&M Grade: **0**
Clock Start/From:
Clock To:
1st Value:
2nd Value:
Value Percent:
Continuous Index:
Within 8" of Joint: **NO**
Remarks: **PVC**

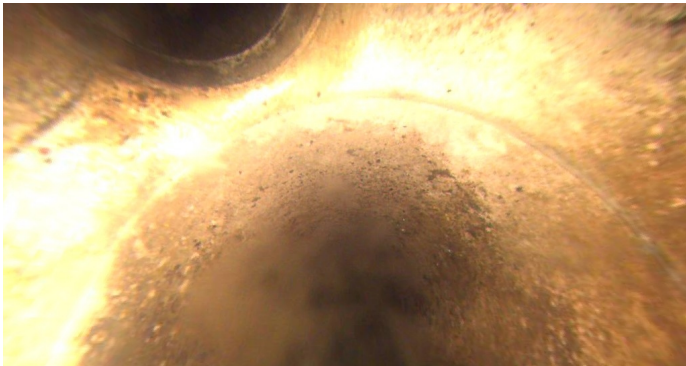
Code: **TF**
Description: **Tap Factory**

Distance (ft): **103.7**
Structural Grade: **0**
O&M Grade: **0**
Clock Start/From: **11**
Clock To:
1st Value: **4.000**
2nd Value:
Value Percent:
Continuous Index:
Within 8" of Joint:
Remarks:

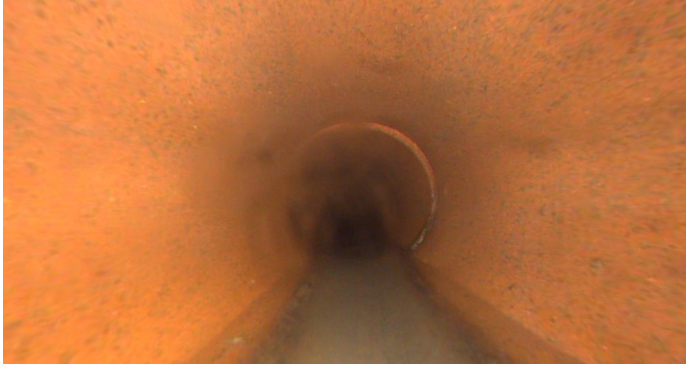
Code: **MMC**
Description: **Material Change**

Distance (ft): **107.4**
Structural Grade: **0**
O&M Grade: **0**
Clock Start/From:
Clock To:
1st Value:
2nd Value:
Value Percent:
Continuous Index:
Within 8" of Joint: **NO**
Remarks: **VCP**

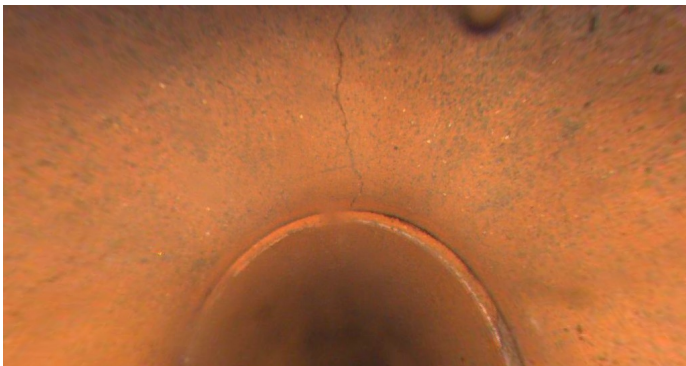
Code: **CL**
Description: **Crack Longitudinal**

Distance (ft): **107.9**
Structural Grade: **2**
O&M Grade: **0**
Clock Start/From: **12**
Clock To:
1st Value:
2nd Value:
Value Percent:
Continuous Index:
Within 8" of Joint: **YES**
Remarks:

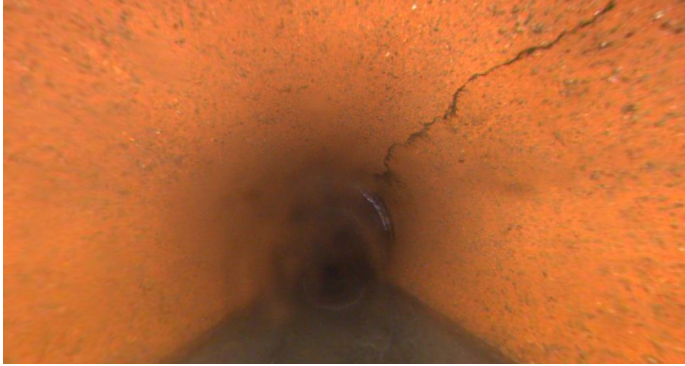
Code: **CL**
Description: **Crack Longitudinal**

Distance (ft): **127.4**
Structural Grade: **2**
O&M Grade: **0**
Clock Start/From: **2**
Clock To:
1st Value:
2nd Value:
Value Percent:
Continuous Index:
Within 8" of Joint:
Remarks:

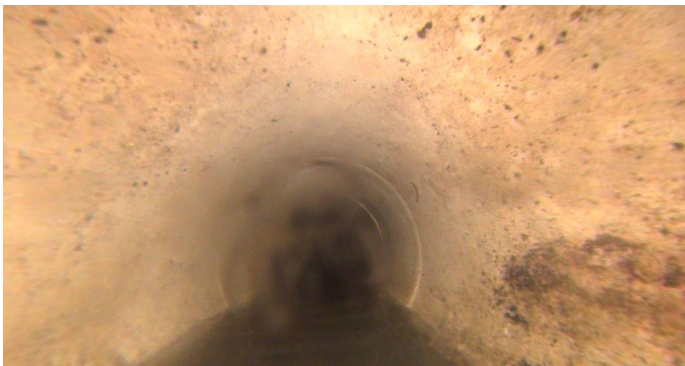
Code: **MMC**
Description: **Material Change**

Distance (ft): **131.5**
Structural Grade: **0**
O&M Grade: **0**
Clock Start/From:
Clock To:
1st Value:
2nd Value:
Value Percent:
Continuous Index:
Within 8" of Joint: **NO**
Remarks: **PVC**

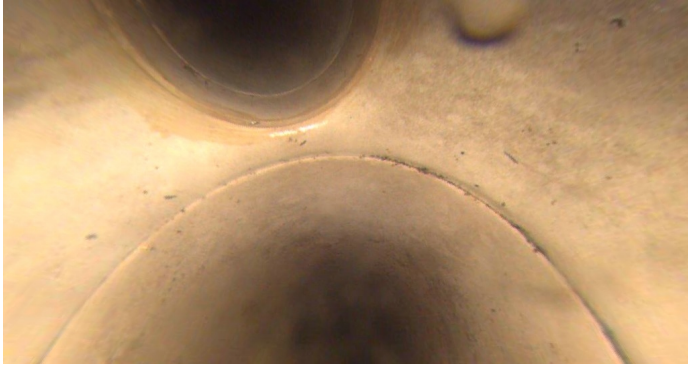
Code: **TF**
Description: **Tap Factory**

Distance (ft): **132.8**
Structural Grade: **0**
O&M Grade: **0**
Clock Start/From: **11**
Clock To:
1st Value: **4.000**
2nd Value:
Value Percent:
Continuous Index:
Within 8" of Joint:
Remarks:

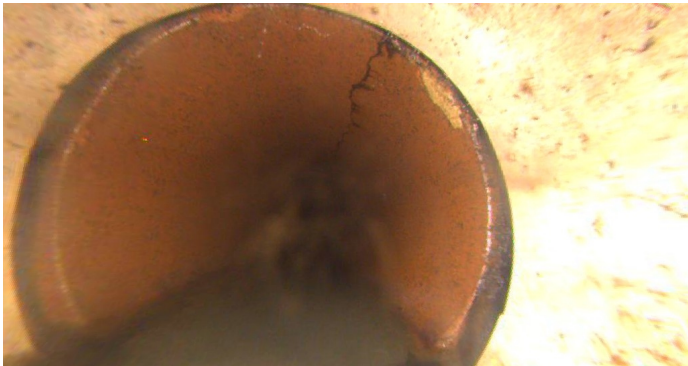
Code: **MMC**
Description: **Material Change**

Distance (ft): **145.9**
Structural Grade: **0**
O&M Grade: **0**
Clock Start/From:
Clock To:
1st Value:
2nd Value:
Value Percent:
Continuous Index:
Within 8" of Joint: **NO**
Remarks: **VCP**

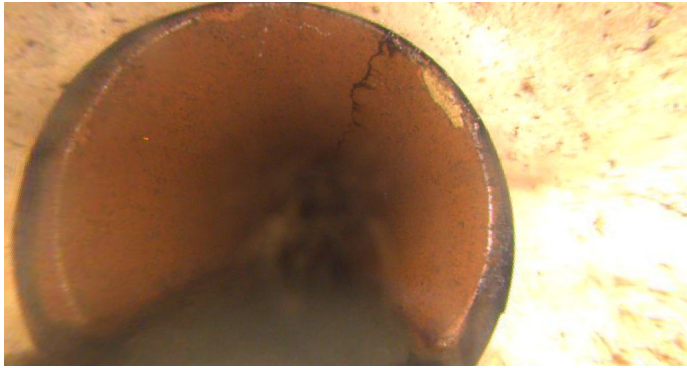
Code: **CL**
Description: **Crack Longitudinal**

Distance (ft): **145.9**
Structural Grade: **2**
O&M Grade: **0**
Clock Start/From: **2**
Clock To:
1st Value:
2nd Value:
Value Percent:
Continuous Index:
Within 8" of Joint:
Remarks:

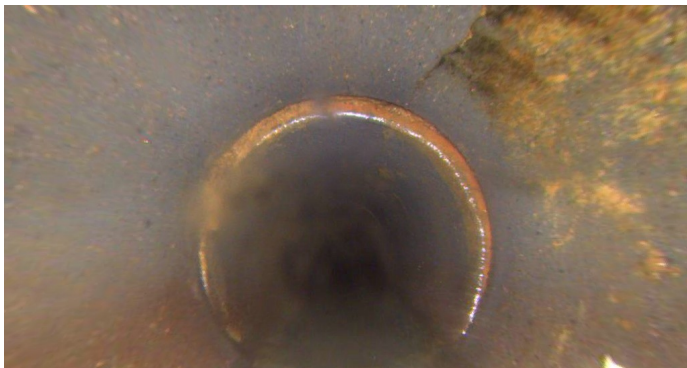
Code: **CL**
Description: **Crack Longitudinal**

Distance (ft): **157.4**
Structural Grade: **2**
O&M Grade: **0**
Clock Start/From: **2**
Clock To:
1st Value:
2nd Value:
Value Percent:
Continuous Index:
Within 8" of Joint: **YES**
Remarks:

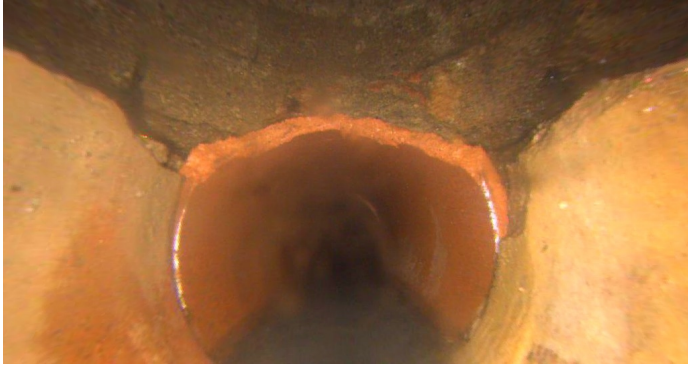
Code:	AMH
Description:	Manhole
Distance (ft):	167.6
Structural Grade:	0
O&M Grade:	0
Clock Start/From:	
Clock To:	
1st Value:	
2nd Value:	
Value Percent:	
Continuous Index:	
Within 8" of Joint:	NO
Remarks:	M-604-094
