Profile/Photo Observation Report

Date:	04/22/2018	Weather:		Coding:	PACP 6.0
Pipe Length (ft):	205.8	Owner:	NA	Pre Clean:	Not Known
P.O.#:		Surveyor:	Mark Ruby	PSR:	P-604-088-089
Customer:		Clean Date:	01/01/1900	Shape:	C

Street:	N PENNSYLVANIA ST	Flow Control:	Not Controlled
City:	Hobart, IN	Year Renewed:	
Location:	Light Highway	Tape/Media #:	
Purpose:	Not Known	Dia/Height:	12"
Use:	Sanitary	Material:	VCP
Drain Area:	NA	Lining:	
Category:	NA		
Comment:

Location Details:		Direction of Survey:	Upstream
US MH:	M-604-089	DS MH:	M-604-088
		Total Length Surveyed (ft):	68.2

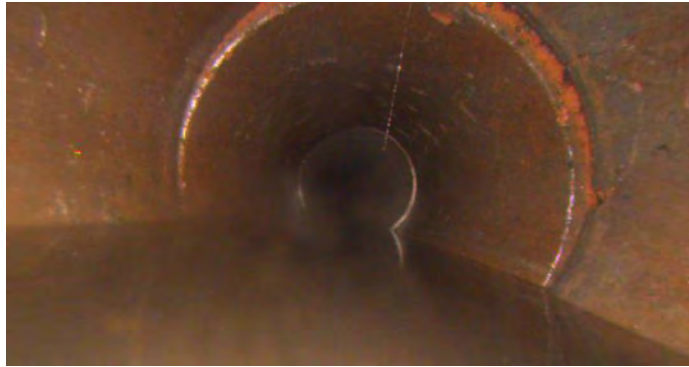
Code: **MWL**
Description: **Water Level**

Distance (ft): **.0**
Structural Grade: **0**
O&M Grade: **0**
Clock Start/From:
Clock To:
1st Value:
2nd Value:
Value Percent: **10.000**
Continuous Index:
Within 8" of Joint: **NO**
Remarks:

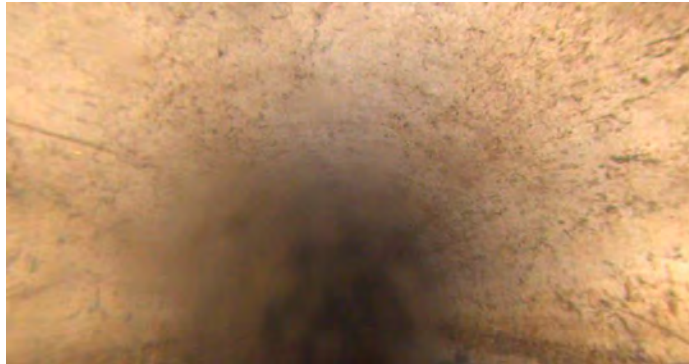
Code: **MMC**
Description: **Material Change**

Distance (ft): **4.1**
Structural Grade: **0**
O&M Grade: **0**
Clock Start/From:
Clock To:
1st Value:
2nd Value:
Value Percent:
Continuous Index:
Within 8" of Joint: **NO**
Remarks: **PVC**

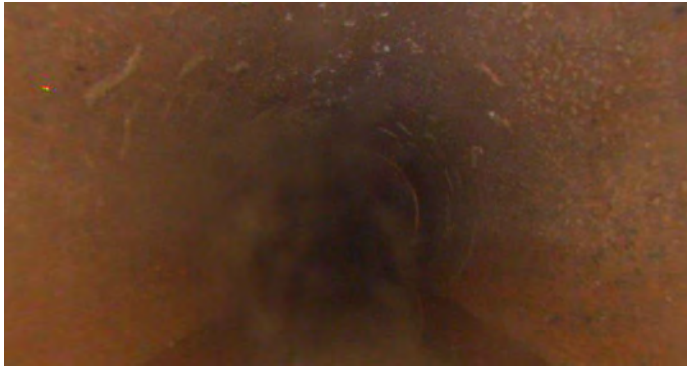
Code: **MMC**
Description: **Material Change**

Distance (ft): **12.0**
Structural Grade: **0**
O&M Grade: **0**
Clock Start/From:
Clock To:
1st Value:
2nd Value:
Value Percent:
Continuous Index:
Within 8" of Joint: **NO**
Remarks: **VCP**

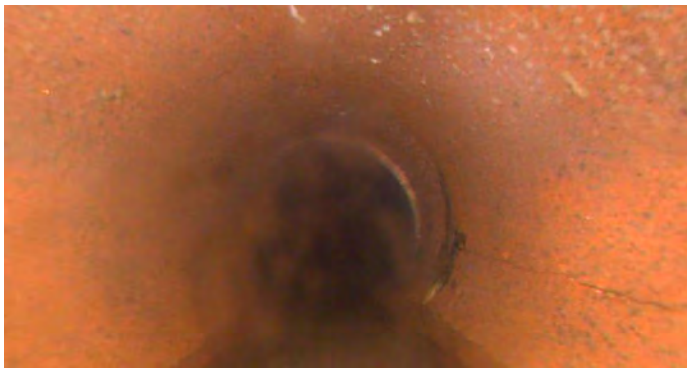
Code: **CM**
Description: **Crack Multiple**

Distance (ft): **14.6**
Structural Grade: **3**
O&M Grade: **0**
Clock Start/From: **11**
Clock To: **5**
1st Value:
2nd Value:
Value Percent:
Continuous Index:
Within 8" of Joint:
Remarks:

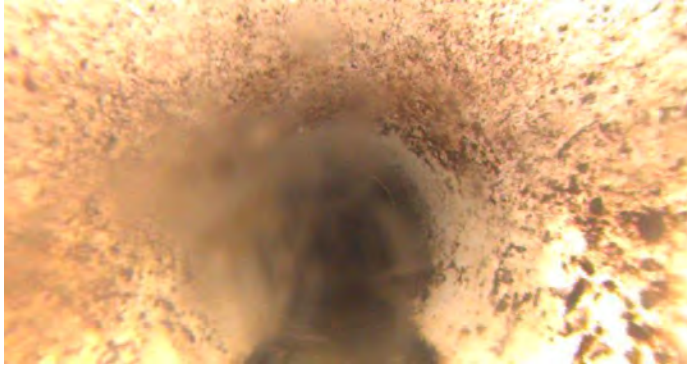
Code: **MMC**
Description: **Material Change**

Distance (ft): **38.6**
Structural Grade: **0**
O&M Grade: **0**
Clock Start/From:
Clock To:
1st Value:
2nd Value:
Value Percent:
Continuous Index:
Within 8" of Joint: **NO**
Remarks: **PVC**

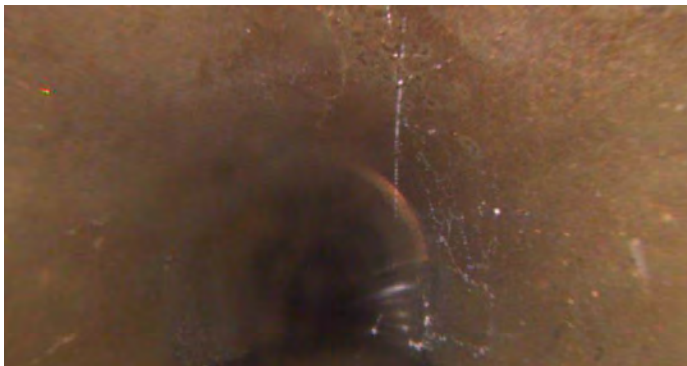
Code: **MMC**
Description: **Material Change**

Distance (ft): **60.2**
Structural Grade: **0**
O&M Grade: **0**
Clock Start/From:
Clock To:
1st Value:
2nd Value:
Value Percent:
Continuous Index:
Within 8" of Joint: **NO**
Remarks: **VCP**

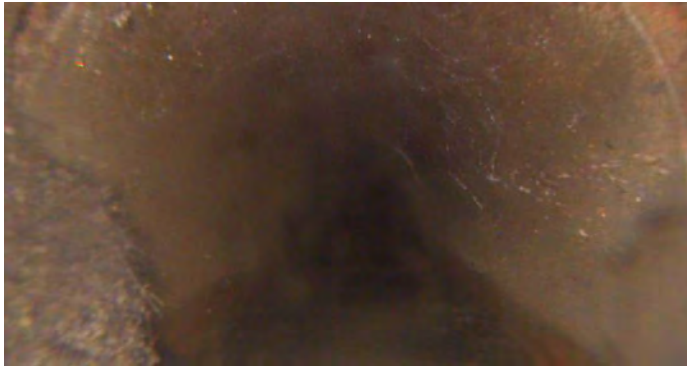
Code: **RFJ**
Description: **Roots Fine Joint**

Distance (ft): **61.2**
Structural Grade: **0**
O&M Grade: **1**
Clock Start/From: **7**
Clock To: **5**
1st Value:
2nd Value:
Value Percent:
Continuous Index:
Within 8" of Joint: **YES**
Remarks:

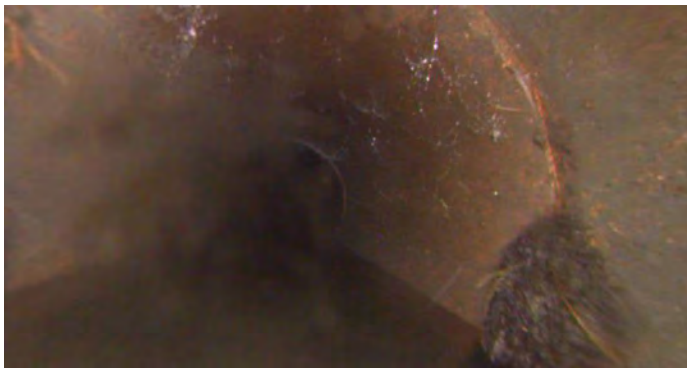
Code: **RFJ**
Description: **Roots Fine Joint**

Distance (ft): **63.1**
Structural Grade: **0**
O&M Grade: **1**
Clock Start/From: **7**
Clock To: **5**
1st Value:
2nd Value:
Value Percent:
Continuous Index:
Within 8" of Joint: **YES**
Remarks:

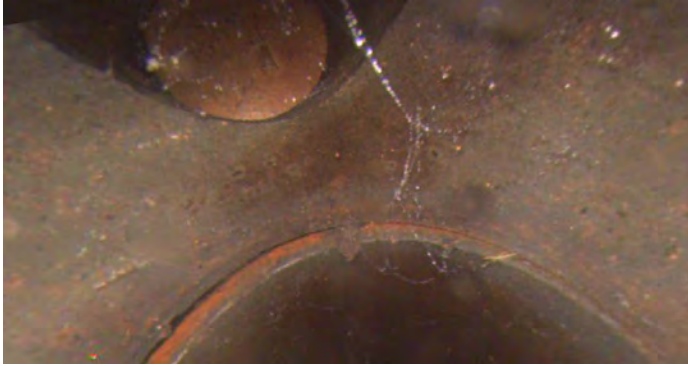
Code: **TFC**
Description: **Tap Factory Capped**

Distance (ft): **65.1**
Structural Grade: **0**
O&M Grade: **0**
Clock Start/From: **10**
Clock To:
1st Value: **4.000**
2nd Value:
Value Percent:
Continuous Index:
Within 8" of Joint:
Remarks:

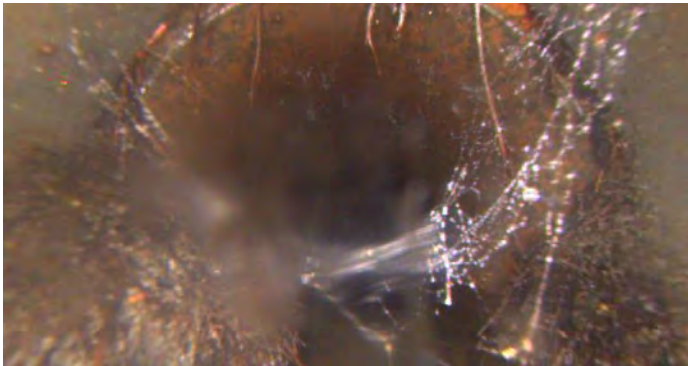
Code: **RFJ**
Description: **Roots Fine Joint**

Distance (ft): **67.2**
Structural Grade: **0**
O&M Grade: **1**
Clock Start/From: **7**
Clock To: **5**
1st Value:
2nd Value:
Value Percent:
Continuous Index:
Within 8" of Joint: **YES**
Remarks:

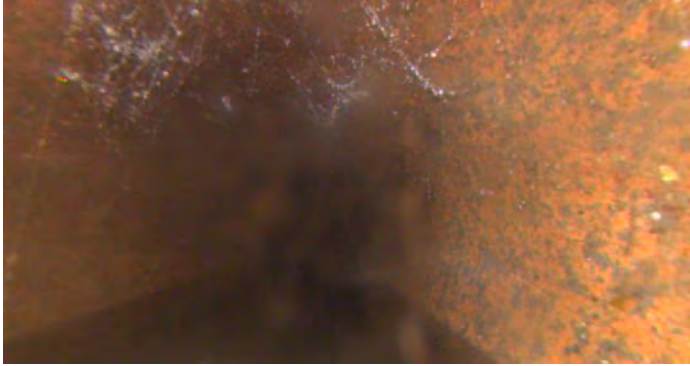
Code:	MSA
Description:	Abandoned Survey
Distance (ft):	68.2
Structural Grade:	0
O&M Grade:	0
Clock Start/From:	
Clock To:	
1st Value:	
2nd Value:	
Value Percent:	
Continuous Index:	
Within 8" of Joint:	NO
Remarks:	Roots
