Profile/Photo Observation Report

Date:	04/22/2018	Weather:		Coding:	PACP 6.0
Pipe Length (ft):	205.8	Owner:	NA	Pre Clean:	Not Known
P.O.#:		Surveyor:	Mark Ruby	PSR:	P-604-088-089
Customer:		Clean Date:	01/01/1900	Shape:	C

Location Details:		Direction of Survey:	Upstream
US MH:	M-604-089	DS MH:	M-604-088
		Total Length Surveyed (ft):	68.2

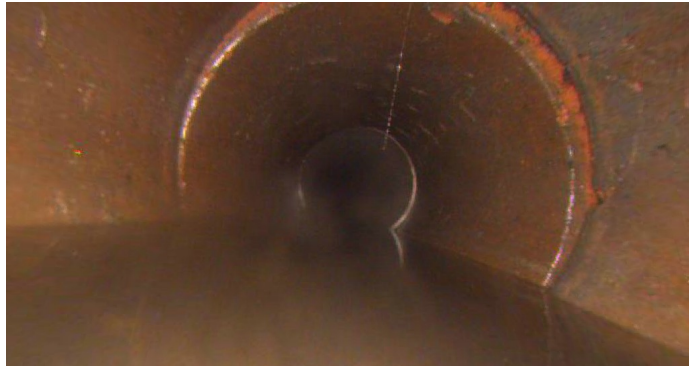
Code: **MWL**
Description: **Water Level**

Distance (ft): **.0**
Structural Grade: **0**
O&M Grade: **0**
Clock Start/From:
Clock To:
1st Value:
2nd Value:
Value Percent: **10.000**
Continuous Index:
Within 8" of Joint: **NO**
Remarks:

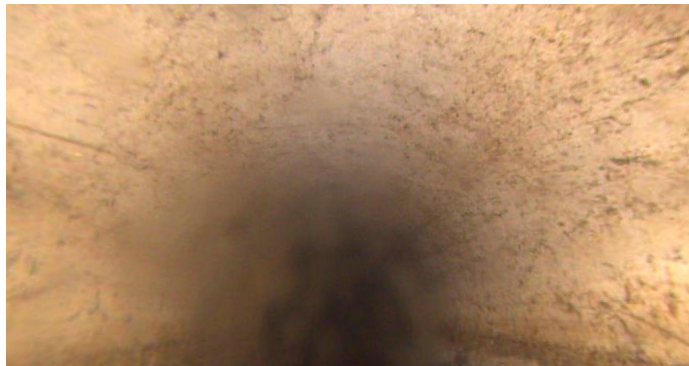
Code: **MMC**
Description: **Material Change**

Distance (ft): **4.1**
Structural Grade: **0**
O&M Grade: **0**
Clock Start/From:
Clock To:
1st Value:
2nd Value:
Value Percent:
Continuous Index:
Within 8" of Joint: **NO**
Remarks: **PVC**

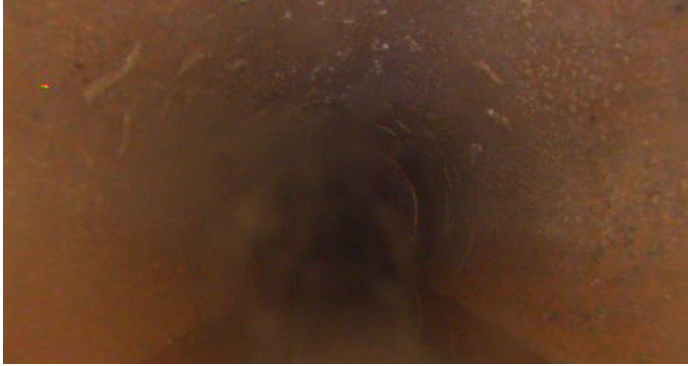
Code: **MMC**
Description: **Material Change**

Distance (ft): **12.0**
Structural Grade: **0**
O&M Grade: **0**
Clock Start/From:
Clock To:
1st Value:
2nd Value:
Value Percent:
Continuous Index:
Within 8" of Joint: **NO**
Remarks: **VCP**

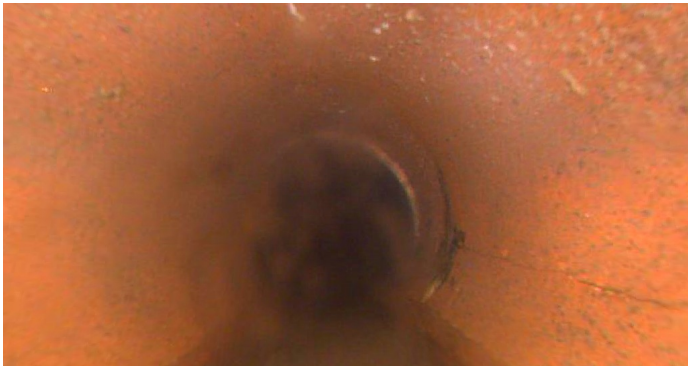
Code: **CM**
Description: **Crack Multiple**

Distance (ft): **14.6**
Structural Grade: **3**
O&M Grade: **0**
Clock Start/From: **11**
Clock To: **5**
1st Value:
2nd Value:
Value Percent:
Continuous Index:
Within 8" of Joint:
Remarks:

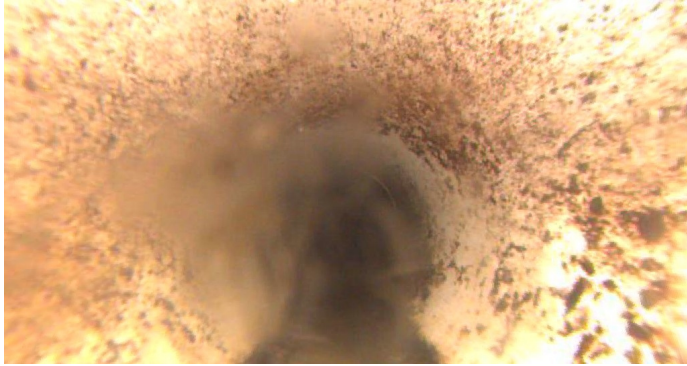
Code: **MMC**
Description: **Material Change**

Distance (ft): **38.6**
Structural Grade: **0**
O&M Grade: **0**
Clock Start/From:
Clock To:
1st Value:
2nd Value:
Value Percent:
Continuous Index:
Within 8" of Joint: **NO**
Remarks: **PVC**

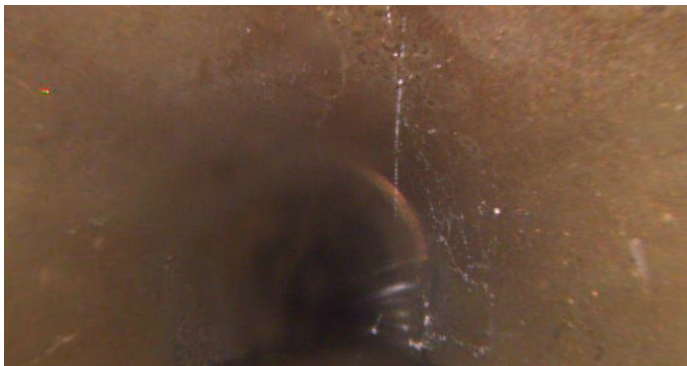
Code: **MMC**
Description: **Material Change**

Distance (ft): **60.2**
Structural Grade: **0**
O&M Grade: **0**
Clock Start/From:
Clock To:
1st Value:
2nd Value:
Value Percent:
Continuous Index:
Within 8" of Joint: **NO**
Remarks: **VCP**

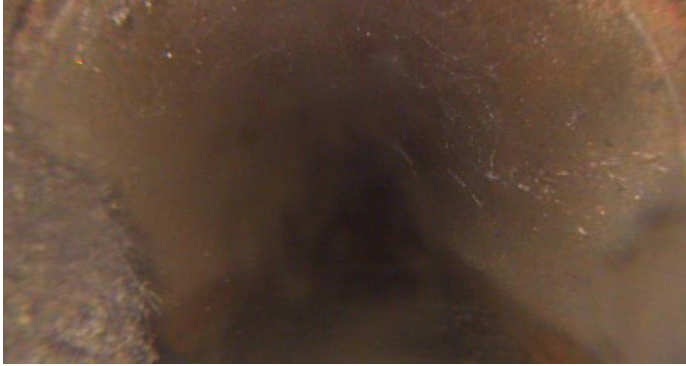
Code: **RFJ**
Description: **Roots Fine Joint**

Distance (ft): **61.2**
Structural Grade: **0**
O&M Grade: **1**
Clock Start/From: **7**
Clock To: **5**
1st Value:
2nd Value:
Value Percent:
Continuous Index:
Within 8" of Joint: **YES**
Remarks:

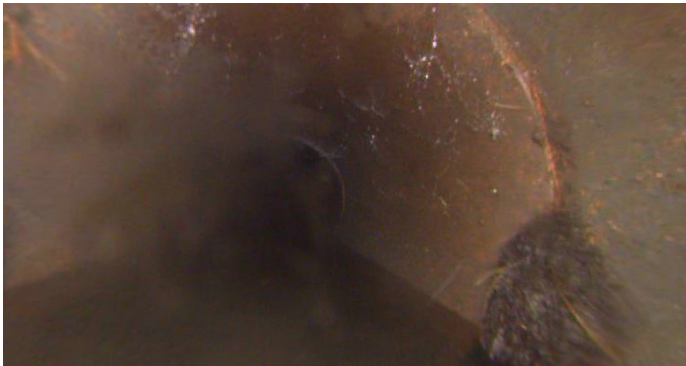
Code: **RFJ**
Description: **Roots Fine Joint**

Distance (ft): **63.1**
Structural Grade: **0**
O&M Grade: **1**
Clock Start/From: **7**
Clock To: **5**
1st Value:
2nd Value:
Value Percent:
Continuous Index:
Within 8" of Joint: **YES**
Remarks:

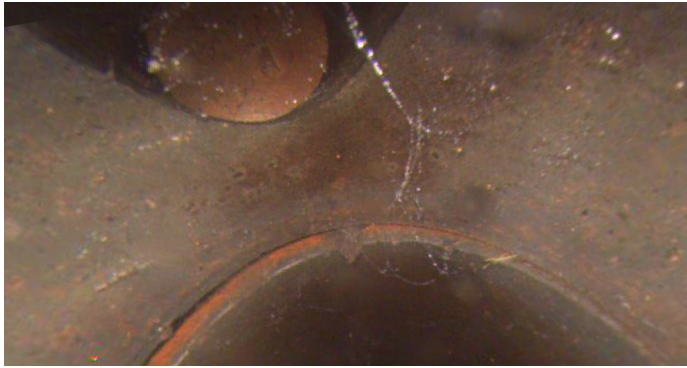
Code: **TFC**
Description: **Tap Factory Capped**

Distance (ft): **65.1**
Structural Grade: **0**
O&M Grade: **0**
Clock Start/From: **10**
Clock To:
1st Value: **4.000**
2nd Value:
Value Percent:
Continuous Index:
Within 8" of Joint:
Remarks:

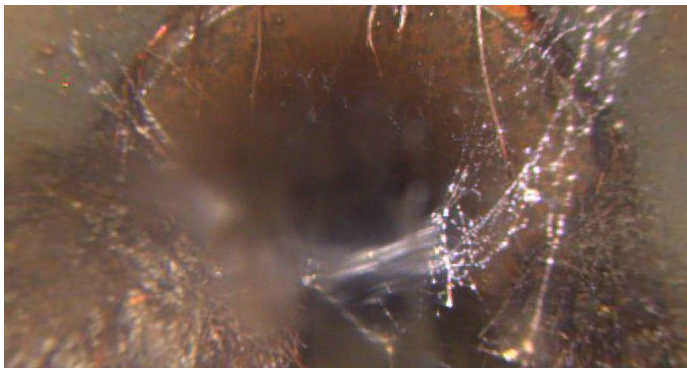
Code: **RFJ**
Description: **Roots Fine Joint**

Distance (ft): **67.2**
Structural Grade: **0**
O&M Grade: **1**
Clock Start/From: **7**
Clock To: **5**
1st Value:
2nd Value:
Value Percent:
Continuous Index:
Within 8" of Joint: **YES**
Remarks:

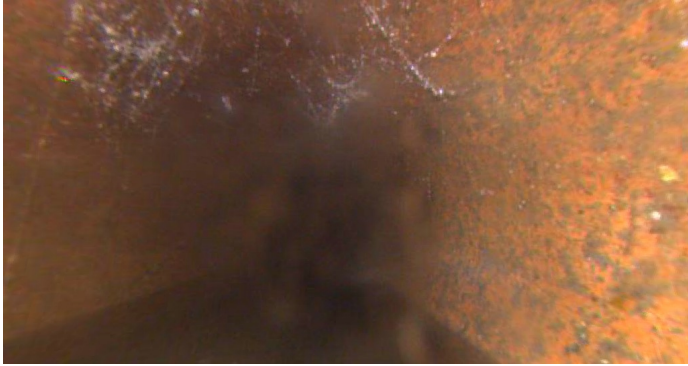
Code:	MSA
Description:	Abandoned Survey
Distance (ft):	68.2
Structural Grade:	0
O&M Grade:	0
Clock Start/From:	
Clock To:	
1st Value:	
2nd Value:	
Value Percent:	
Continuous Index:	
Within 8" of Joint:	NO
Remarks:	Roots
