Profile/Photo Observation Report

Date:	04/23/2018	Weather:		Coding:	PACP 6.0
Pipe Length (ft):	177.3	Owner:	NA	Pre Clean:	Not Known
P.O.#:		Surveyor:	Jen Costello	PSR:	P-604-090-089
Customer:		Clean Date:	01/01/1900	Shape:	C

Street:	ALLEY BETWEEN N PENNSYLVANIA S	Flow Control:	Not Controlled
City:	Hobart, IN	Year Renewed:	
Location:	Light Highway	Tape/Media #:	
Purpose:	Not Known	Dia/Height:	12"
Use:	Sanitary	Material:	VCP
Drain Area:	NA	Lining:	
Category:	NA		
Comment:

Location Details:		Direction of Survey:	Downstream
US MH:	M-604-089	DS MH:	M-604-090
		Total Length Surveyed (ft):	86.8

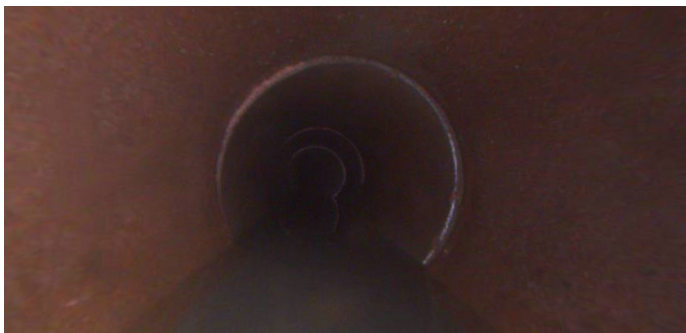
Code: **AMH**
Description: **Manhole**

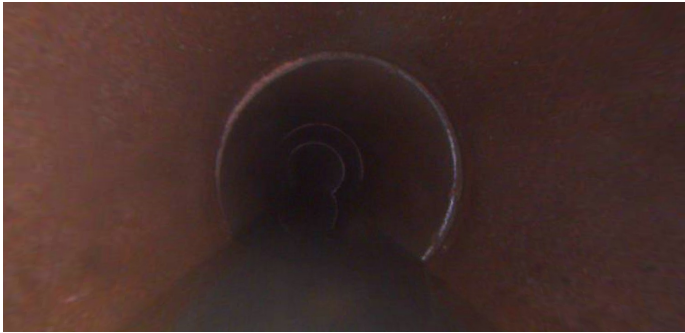
Code:	MWL
Description:	Water Level

Distance (ft):	.0
Structural Grade:	0
O&M Grade:	0
Clock Start/From:	
Clock To:	
1st Value:	
2nd Value:	
Value Percent:	10.000
Continuous Index:	
Within 8" of Joint:	NO
Remarks:

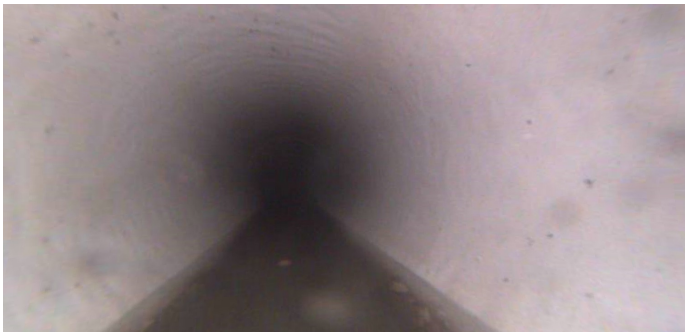
Code:	MMC
Description:	Material Change

Distance (ft):	6.3
Structural Grade:	0
O&M Grade:	0
Clock Start/From:	
Clock To:	
1st Value:	
2nd Value:	
Value Percent:	
Continuous Index:	
Within 8" of Joint:	NO
Remarks:	PVC

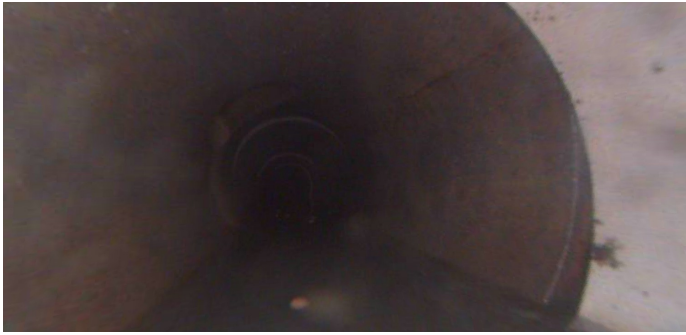
Code: **MMC**
Description: **Material Change**

Distance (ft): **22.4**
Structural Grade: **0**
O&M Grade: **0**
Clock Start/From:
Clock To:
1st Value:
2nd Value:
Value Percent:
Continuous Index:
Within 8" of Joint: **NO**
Remarks: **vcp**

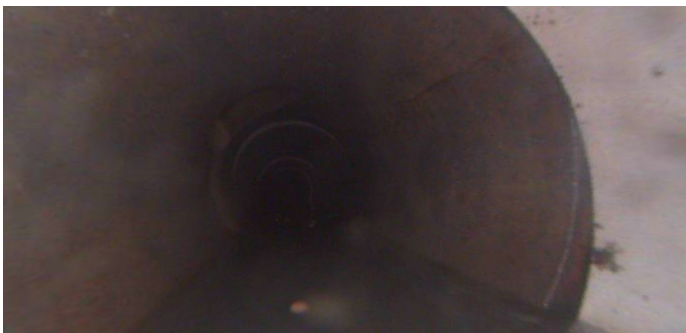
Code: **FL**
Description: **Fracture Longitudinal**

Distance (ft): **22.4**
Structural Grade: **3**
O&M Grade: **0**
Clock Start/From: **2**
Clock To:
1st Value:
2nd Value:
Value Percent:
Continuous Index:
Within 8" of Joint: **YES**
Remarks:

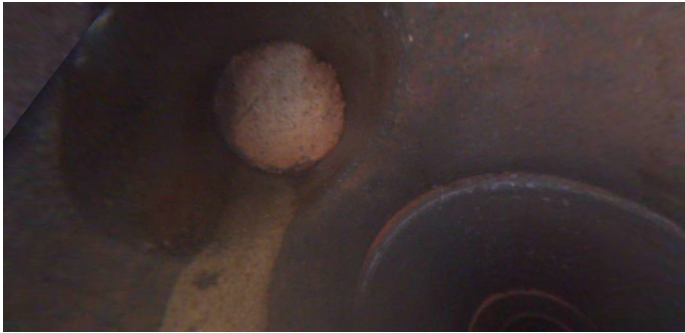
Code: **TFC**
Description: **Tap Factory Capped**

Distance (ft): **23.9**
Structural Grade: **0**
O&M Grade: **0**
Clock Start/From: **10**
Clock To:
1st Value: **4.000**
2nd Value:
Value Percent:
Continuous Index:
Within 8" of Joint:
Remarks:

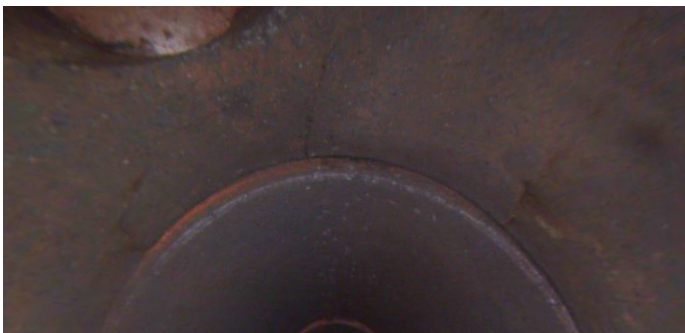
Code: **FM**
Description: **Fracture Multiple**

Distance (ft): **24.2**
Structural Grade: **4**
O&M Grade: **0**
Clock Start/From: **10**
Clock To: **2**
1st Value:
2nd Value:
Value Percent:
Continuous Index:
Within 8" of Joint: **YES**
Remarks:

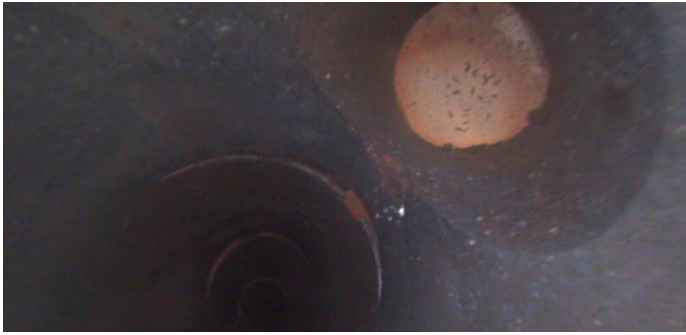
Code: **TFC**
Description: **Tap Factory Capped**

Distance (ft): **71.3**
Structural Grade: **0**
O&M Grade: **0**
Clock Start/From: **2**
Clock To:
1st Value: **4.000**
2nd Value:
Value Percent:
Continuous Index:
Within 8" of Joint:
Remarks:

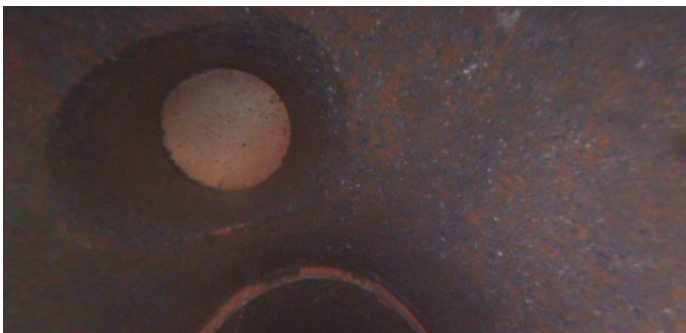
Code: **TFC**
Description: **Tap Factory Capped**

Distance (ft): **73.2**
Structural Grade: **0**
O&M Grade: **0**
Clock Start/From: **11**
Clock To:
1st Value: **4.000**
2nd Value:
Value Percent:
Continuous Index:
Within 8" of Joint:
Remarks:

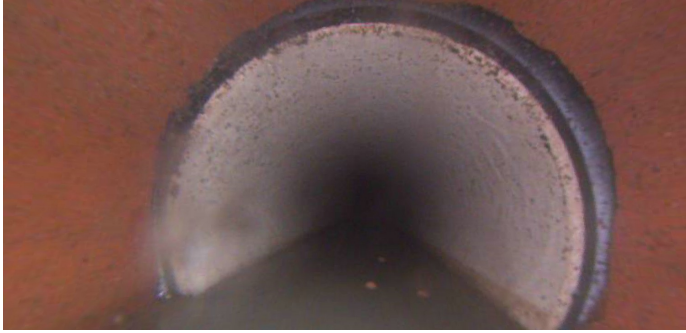
Code: **MMC**
Description: **Material Change**

Distance (ft): **77.7**
Structural Grade: **0**
O&M Grade: **0**
Clock Start/From:
Clock To:
1st Value:
2nd Value:
Value Percent:
Continuous Index:
Within 8" of Joint: **NO**
Remarks: **PVC**

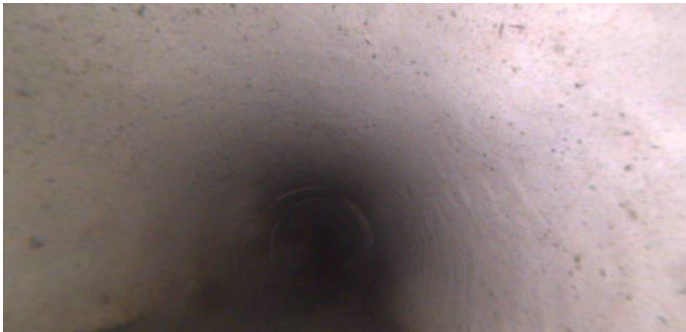
Code: **MSA**
Description: **Abandoned Survey**

Distance (ft): **86.8**
Structural Grade: **0**
O&M Grade: **0**
Clock Start/From:
Clock To:
1st Value:
2nd Value:
Value Percent:
Continuous Index:
Within 8" of Joint: **NO**
Remarks: **DEBRIS UNDER WATER**
