Profile/Photo Observation Report

Date:	04/23/2018	Weather:		Coding:	PACP 6.0
Pipe Length (ft):	177.3	Owner:	NA	Pre Clean:	Not Known
P.O.#:		Surveyor:	Jen Costello	PSR:	P-604-090-089
Customer:		Clean Date:	01/01/1900	Shape:	C

Street:	Summerlin	Flow Control:	Not Controlled
City:	Hobart, IN	Year Renewed:	
Location:	Light Highway	Tape/Media #:	
Purpose:	Not Known	Dia/Height:	12"
Use:	Sanitary	Material:	VCP
Drain Area:	NA	Lining:	
Category:	NA		
Comment:

Location Details:		Direction of Survey:	Downstream
US MH:	M-604-089	DS MH:	M-604-090
		Total Length Surveyed (ft):	86.8

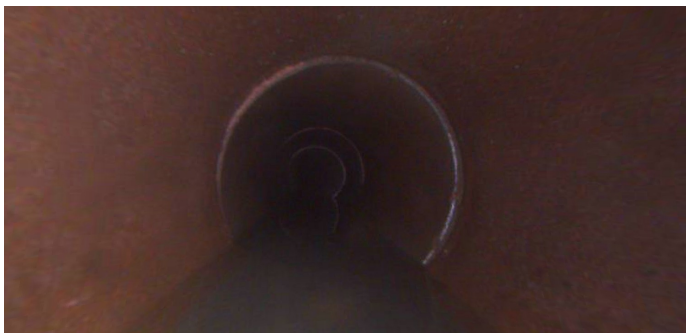
Code: **AMH**
Description: **Manhole**

Distance (ft): **.0**
Structural Grade: **0**
O&M Grade: **0**
Clock Start/From:
Clock To:
1st Value:
2nd Value:
Value Percent:
Continuous Index:
Within 8" of Joint: **NO**
Remarks: **M-604-089**

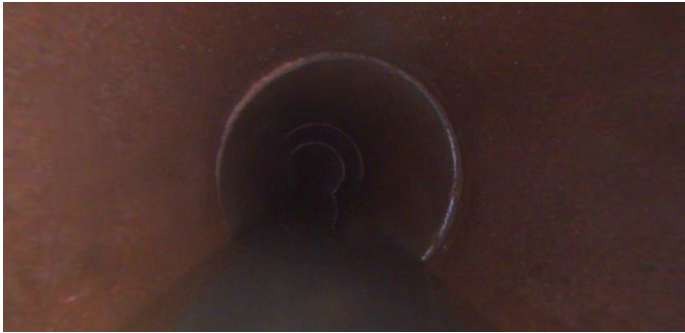
Code:	MWL
Description:	Water Level

Distance (ft):	.0
Structural Grade:	0
O&M Grade:	0
Clock Start/From:	
Clock To:	
1st Value:	
2nd Value:	
Value Percent:	10.000
Continuous Index:	
Within 8" of Joint:	NO
Remarks:

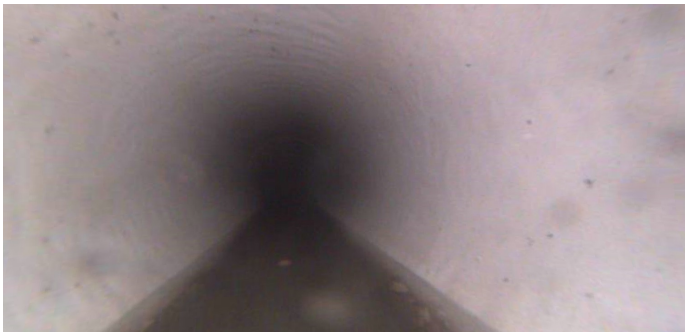
Code:	MMC
Description:	Material Change

Distance (ft):	6.3
Structural Grade:	0
O&M Grade:	0
Clock Start/From:	
Clock To:	
1st Value:	
2nd Value:	
Value Percent:	
Continuous Index:	
Within 8" of Joint:	NO
Remarks:	PVC

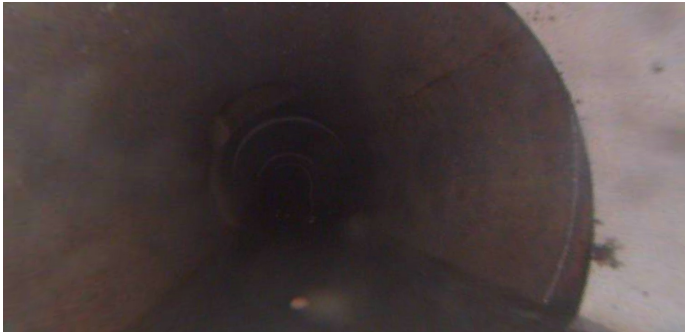
Code: **MMC**
Description: **Material Change**

Distance (ft): **22.4**
Structural Grade: **0**
O&M Grade: **0**
Clock Start/From:
Clock To:
1st Value:
2nd Value:
Value Percent:
Continuous Index:
Within 8" of Joint: **NO**
Remarks: **vcp**

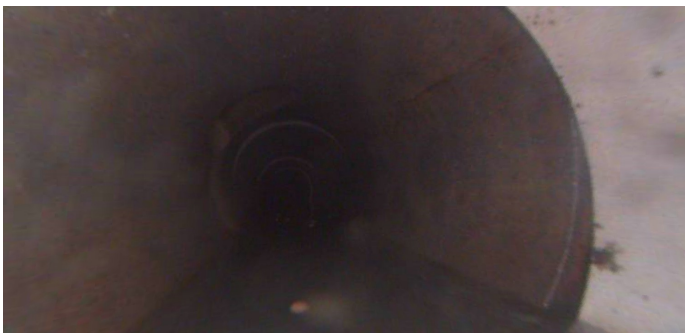
Code: **FL**
Description: **Fracture Longitudinal**

Distance (ft): **22.4**
Structural Grade: **3**
O&M Grade: **0**
Clock Start/From: **2**
Clock To:
1st Value:
2nd Value:
Value Percent:
Continuous Index:
Within 8" of Joint: **YES**
Remarks:

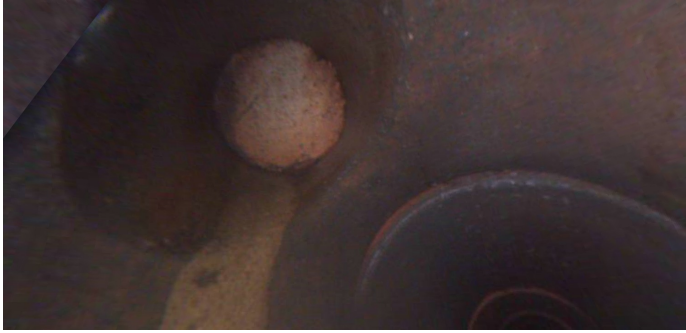
Code: **TFC**
Description: **Tap Factory Capped**

Distance (ft): **23.9**
Structural Grade: **0**
O&M Grade: **0**
Clock Start/From: **10**
Clock To:
1st Value: **4.000**
2nd Value:
Value Percent:
Continuous Index:
Within 8" of Joint:
Remarks:

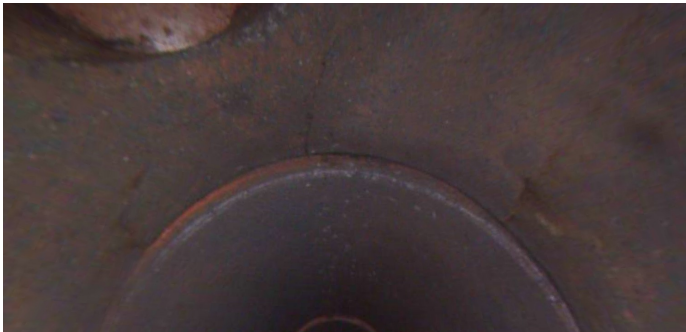
Code: **FM**
Description: **Fracture Multiple**

Distance (ft): **24.2**
Structural Grade: **4**
O&M Grade: **0**
Clock Start/From: **10**
Clock To: **2**
1st Value:
2nd Value:
Value Percent:
Continuous Index:
Within 8" of Joint: **YES**
Remarks:

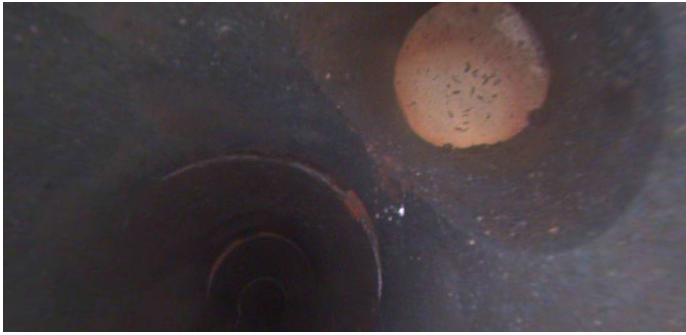
Code: **TFC**
Description: **Tap Factory Capped**

Distance (ft): **71.3**
Structural Grade: **0**
O&M Grade: **0**
Clock Start/From: **2**
Clock To:
1st Value: **4.000**
2nd Value:
Value Percent:
Continuous Index:
Within 8" of Joint:
Remarks:

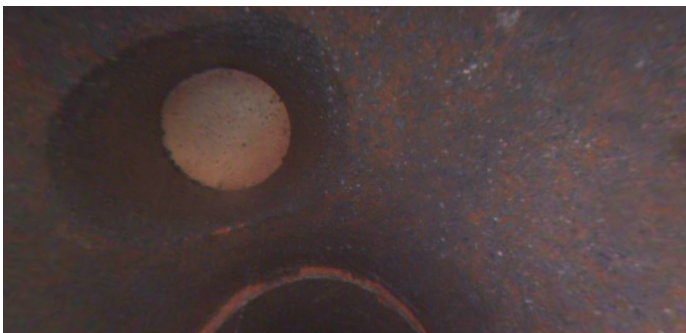
Code: **TFC**
Description: **Tap Factory Capped**

Distance (ft): **73.2**
Structural Grade: **0**
O&M Grade: **0**
Clock Start/From: **11**
Clock To:
1st Value: **4.000**
2nd Value:
Value Percent:
Continuous Index:
Within 8" of Joint:
Remarks:

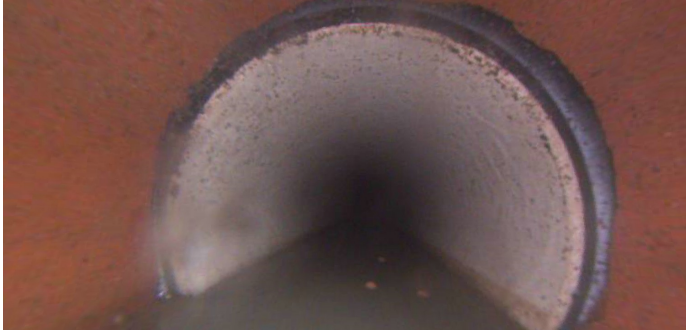
Code: **MMC**
Description: **Material Change**

Distance (ft): **77.7**
Structural Grade: **0**
O&M Grade: **0**
Clock Start/From:
Clock To:
1st Value:
2nd Value:
Value Percent:
Continuous Index:
Within 8" of Joint: **NO**
Remarks: **PVC**

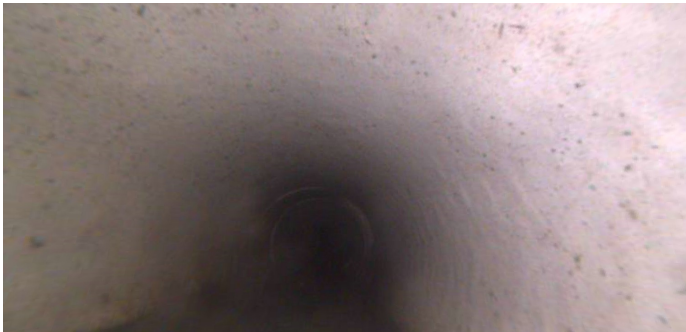
Code: **MSA**
Description: **Abandoned Survey**

Distance (ft): **86.8**
Structural Grade: **0**
O&M Grade: **0**
Clock Start/From:
Clock To:
1st Value:
2nd Value:
Value Percent:
Continuous Index:
Within 8" of Joint: **NO**
Remarks: **DEBRIS UNDER WATER**
