Profile/Photo Observation Report

Street:	ALLEY BETWEEN N PENNSYLVANIA S	Flow Control:	Not Controlled
City:	Hobart, IN	Year Renewed:	
Location:	Light Highway	Tape/Media #:	
Purpose:	Not Known	Dia/Height:	12"
Use:	Sanitary	Material:	VCP
Drain Area:	NA	Lining:	
Category:	NA		
Comment:

Location Details:		Direction of Survey:	Downstream
US MH:	M-604-091	DS MH:	M-604-092
		Total Length Surveyed (ft):	43.7

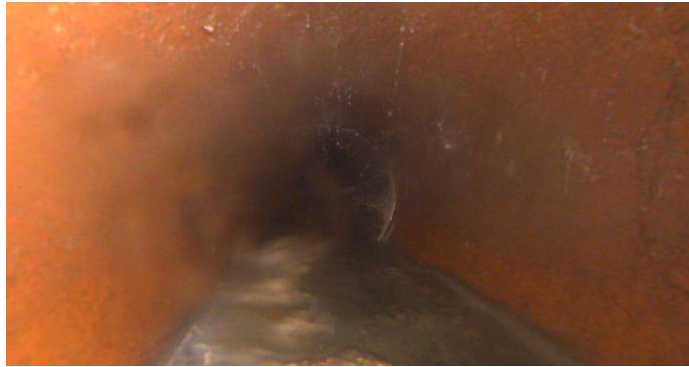
Code: **MWL**
Description: **Water Level**

Distance (ft): **.0**
Structural Grade: **0**
O&M Grade: **0**
Clock Start/From:
Clock To:
1st Value:
2nd Value:
Value Percent: **10.000**
Continuous Index:
Within 8" of Joint: **NO**
Remarks:

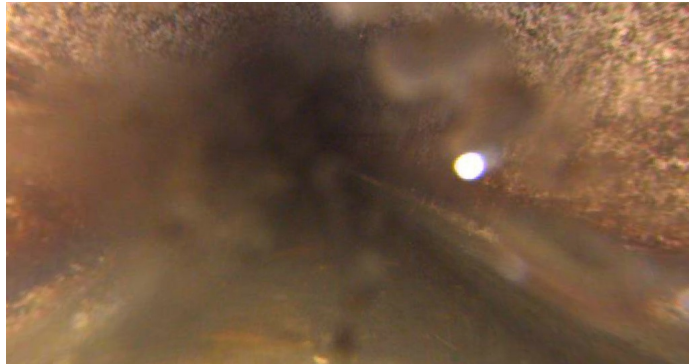
Code: **MMC**
Description: **Material Change**

Distance (ft): **5.1**
Structural Grade: **0**
O&M Grade: **0**
Clock Start/From:
Clock To:
1st Value:
2nd Value:
Value Percent:
Continuous Index:
Within 8" of Joint: **NO**
Remarks: **PVC**

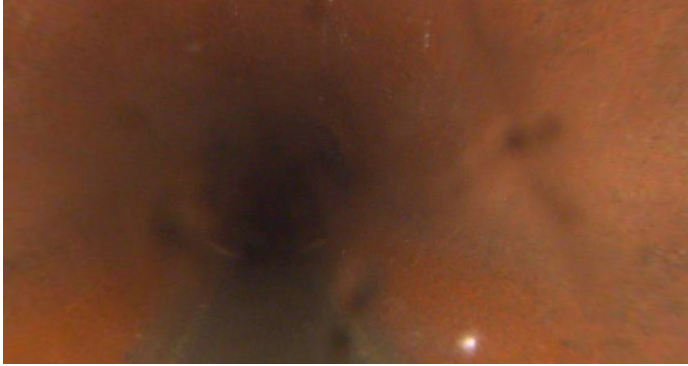
Code: **MMC**
Description: **Material Change**

Distance (ft): **12.5**
Structural Grade: **0**
O&M Grade: **0**
Clock Start/From:
Clock To:
1st Value:
2nd Value:
Value Percent:
Continuous Index:
Within 8" of Joint: **NO**
Remarks: **VCP**

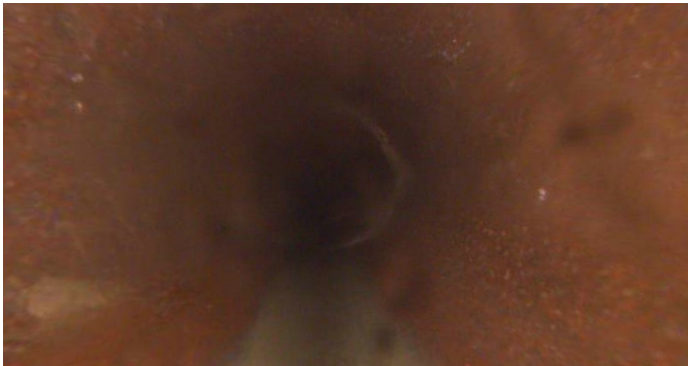
Code: **RFJ**
Description: **Roots Fine Joint**

Distance (ft): **14.3**
Structural Grade: **0**
O&M Grade: **1**
Clock Start/From: **7**
Clock To: **5**
1st Value:
2nd Value:
Value Percent:
Continuous Index: **S01**
Within 8" of Joint: **YES**
Remarks:

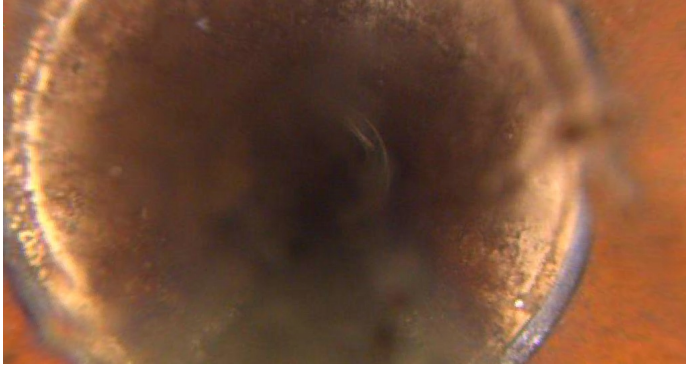
Code: **RFJ**
Description: **Roots Fine Joint**

Distance (ft): **22.1**
Structural Grade: **0**
O&M Grade: **1**
Clock Start/From: **7**
Clock To: **5**
1st Value:
2nd Value:
Value Percent:
Continuous Index: **F01**
Within 8" of Joint: **YES**
Remarks:

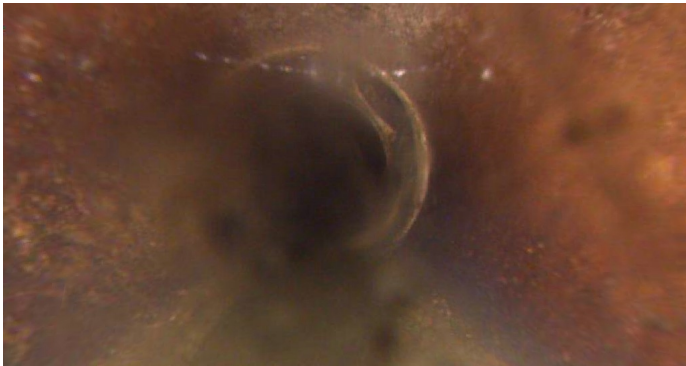
Code: **MMC**
Description: **Material Change**

Distance (ft): **23.0**
Structural Grade: **0**
O&M Grade: **0**
Clock Start/From:
Clock To:
1st Value:
2nd Value:
Value Percent:
Continuous Index:
Within 8" of Joint: **NO**
Remarks: **PVC**

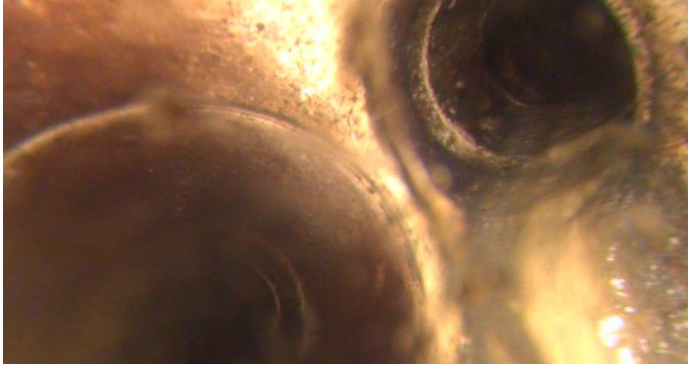
Code: **TF**
Description: **Tap Factory**

Distance (ft): **24.3**
Structural Grade: **0**
O&M Grade: **0**
Clock Start/From: **2**
Clock To:
1st Value: **4.000**
2nd Value:
Value Percent:
Continuous Index:
Within 8" of Joint:
Remarks:

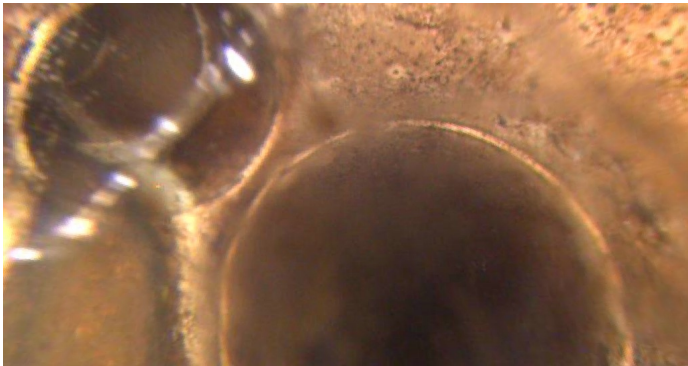
Code: **TF**
Description: **Tap Factory**

Distance (ft): **26.1**
Structural Grade: **0**
O&M Grade: **0**
Clock Start/From: **10**
Clock To:
1st Value: **4.000**
2nd Value:
Value Percent:
Continuous Index:
Within 8" of Joint:
Remarks:

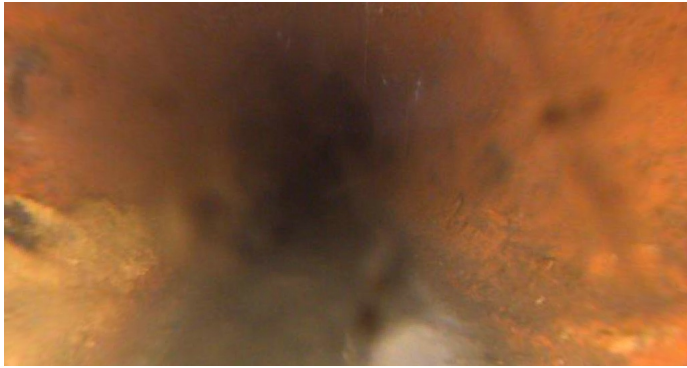
Code: **MMC**
Description: **Material Change**

Distance (ft): **30.5**
Structural Grade: **0**
O&M Grade: **0**
Clock Start/From:
Clock To:
1st Value:
2nd Value:
Value Percent:
Continuous Index:
Within 8" of Joint: **NO**
Remarks: **VCP**

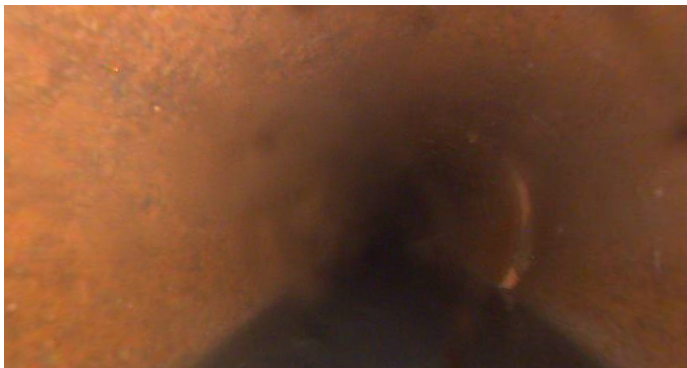
Code: **MSA**
Description: **Abandoned Survey**

Distance (ft): **43.7**
Structural Grade: **0**
O&M Grade: **0**
Clock Start/From:
Clock To:
1st Value:
2nd Value:
Value Percent:
Continuous Index:
Within 8" of Joint: **NO**
Remarks: **No blockage**
