## Profile/Photo Observation Report

Street:	<b>ALLEY BETWEEN N PENNSYLVANIA S</b>	Flow Control:	<b>Not Controlled</b>
City:	<b>Hobart, IN</b>	Year Renewed:	
Location:	<b>Light Highway</b>	Tape/Media #:	
Purpose:	<b>Not Known</b>	Dia/Height:	<b>12"</b>
Use:	<b>Sanitary</b>	Material:	<b>PVC</b>
Drain Area:	<b>NA</b>	Lining:	
Category:	<b>NA</b>		
Comment:

Location Details:		Direction of Survey:	<b>Upstream</b>
US MH:	<b>M-604-091</b>	DS MH:	<b>M-604-092</b>
		Total Length Surveyed (ft):	<b>5.4</b>

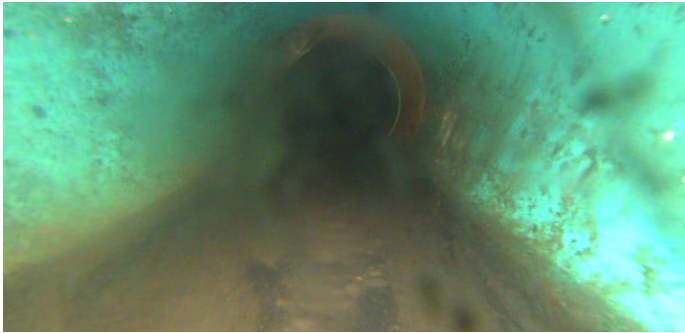
Code:	<b>MWL</b>
Description:	<b>Water Level</b>

Distance (ft):	<b>.0</b>
Structural Grade:	<b>0</b>
O&M Grade:	<b>0</b>
Clock Start/From:	
Clock To:	
1st Value:	
2nd Value:	
Value Percent:	<b>10.000</b>
Continuous Index:	
Within 8" of Joint:	<b>NO</b>
Remarks:

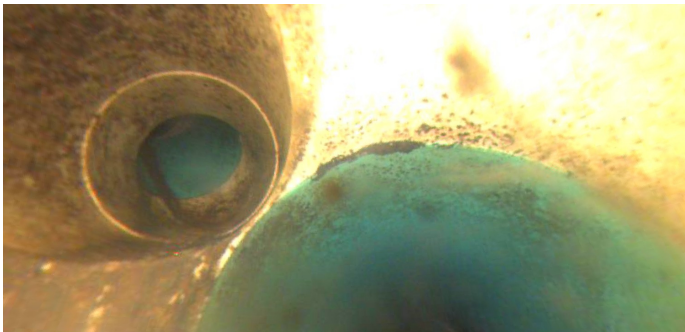
Code:	<b>TF</b>
Description:	<b>Tap Factory</b>

Distance (ft):	<b>2.9</b>
Structural Grade:	<b>0</b>
O&M Grade:	<b>0</b>
Clock Start/From:	<b>11</b>
Clock To:	
1st Value:	<b>4.000</b>
2nd Value:	
Value Percent:	
Continuous Index:	
Within 8" of Joint:	
Remarks:

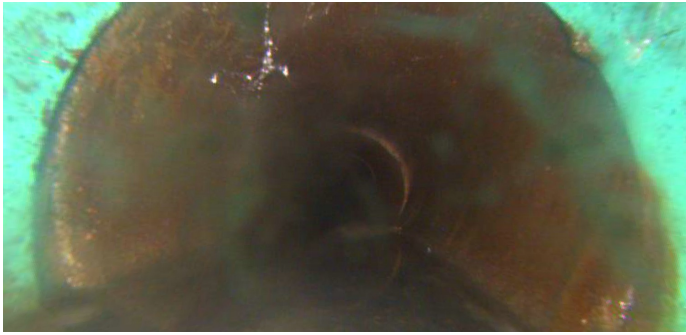
Code: **MMC**  
Description: **Material Change**

Distance (ft): **5.4**  
Structural Grade: **0**  
O&M Grade: **0**  
Clock Start/From:  
Clock To:  
1st Value:  
2nd Value:  
Value Percent:  
Continuous Index:  
Within 8" of Joint: **NO**  
Remarks: **vcp**

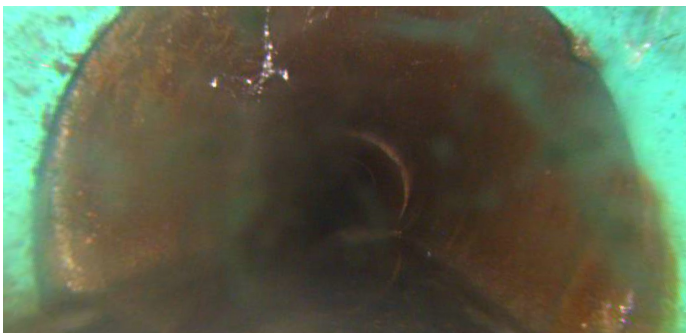
Code: **IW**  
Description: **Infil Weeper**

Distance (ft): **5.4**  
Structural Grade: **0**  
O&M Grade: **2**  
Clock Start/From: **3**  
Clock To: **4**  
1st Value:  
2nd Value:  
Value Percent:  
Continuous Index:  
Within 8" of Joint: **YES**  
Remarks:

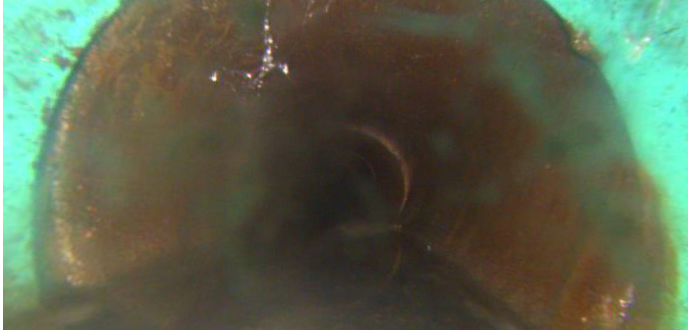
Code:	<b>MSA</b>
Description:	<b>Abandoned Survey</b>
Distance (ft):	<b>5.4</b>
Structural Grade:	<b>0</b>
O&M Grade:	<b>0</b>
Clock Start/From:	
Clock To:	
1st Value:	
2nd Value:	
Value Percent:	
Continuous Index:	
Within 8" of Joint:	<b>NO</b>
Remarks:	<b>unknown</b>
