## Profile/Photo Observation Report

Street:	<b>ALLEY BETWEEN N PENNSYLVANIA S</b>	Flow Control:	<b>Not Controlled</b>
City:	<b>Hobart, IN</b>	Year Renewed:	
Location:	<b>Light Highway</b>	Tape/Media #:	
Purpose:	<b>Not Known</b>	Dia/Height:	<b>12"</b>
Use:	<b>Sanitary</b>	Material:	<b>VCP</b>
Drain Area:	<b>NA</b>	Lining:	
Category:	<b>NA</b>		
Comment:

Location Details:		Direction of Survey:	<b>Upstream</b>
US MH:	<b>M-604-092</b>	DS MH:	<b>M-604-093</b>
		Total Length Surveyed (ft):	<b>34.7</b>

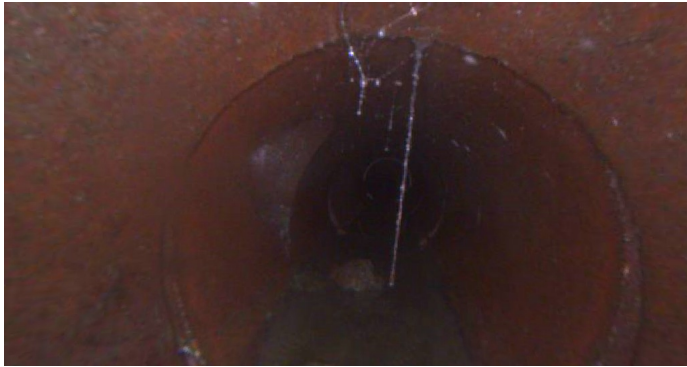
Code: **MWL**  
Description: **Water Level**

Distance (ft): **.0**  
Structural Grade: **0**  
O&M Grade: **0**  
Clock Start/From:  
Clock To:  
1st Value:  
2nd Value:  
Value Percent: **10.000**  
Continuous Index:  
Within 8" of Joint: **NO**  
Remarks:

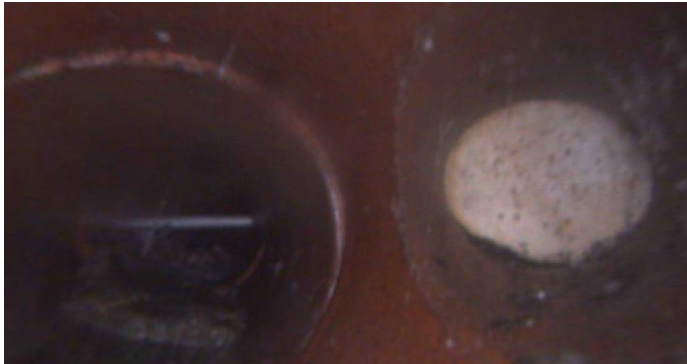
Code: **TFC**  
Description: **Tap Factory Capped**

Distance (ft): **2.6**  
Structural Grade: **0**  
O&M Grade: **0**  
Clock Start/From: **8**  
Clock To:  
1st Value: **4.000**  
2nd Value:  
Value Percent:  
Continuous Index:  
Within 8" of Joint:  
Remarks:

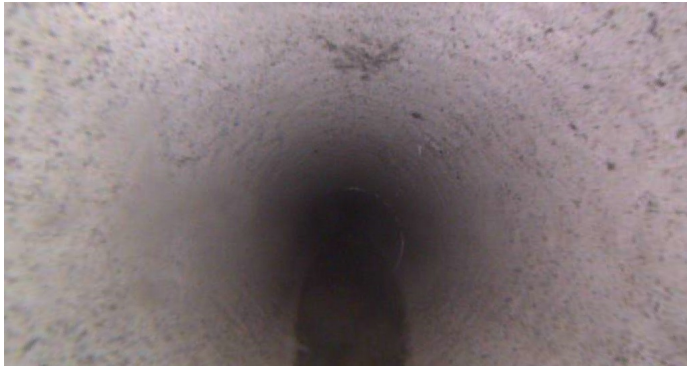
Code:	<b>MMC</b>
Description:	<b>Material Change</b>
Distance (ft):	<b>7.8</b>
Structural Grade:	<b>0</b>
O&M Grade:	<b>0</b>
Clock Start/From:	
Clock To:	
1st Value:	
2nd Value:	
Value Percent:	
Continuous Index:	
Within 8" of Joint:	<b>NO</b>
Remarks:	<b>PVC</b>

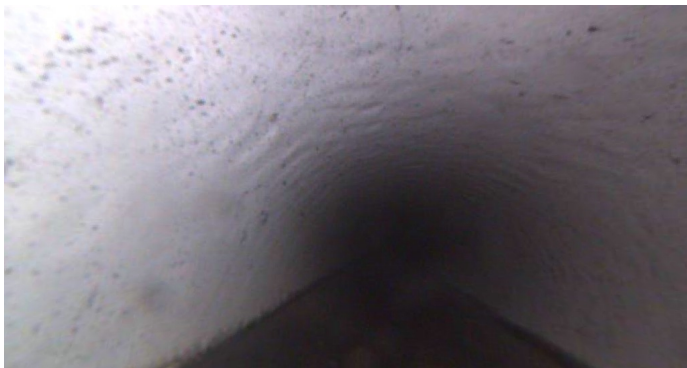
Code:	<b>MSA</b>
Description:	<b>Abandoned Survey</b>
Distance (ft):	<b>34.7</b>
Structural Grade:	<b>0</b>
O&M Grade:	<b>0</b>
Clock Start/From:	
Clock To:	
1st Value:	
2nd Value:	
Value Percent:	
Continuous Index:	
Within 8" of Joint:	<b>NO</b>
Remarks:	<b>No blockage</b>
