Profile/Photo Observation Report

Street:	Summerlin	Flow Control:	Not Controlled
City:	Hobart, IN	Year Renewed:	
Location:	Light Highway	Tape/Media #:	
Purpose:	Not Known	Dia/Height:	12"
Use:	Sanitary	Material:	VCP
Drain Area:	NA	Lining:	
Category:	NA		
Comment:

Location Details:		Direction of Survey:	Upstream
US MH:	M-604-092	DS MH:	M-604-093
		Total Length Surveyed (ft):	34.7

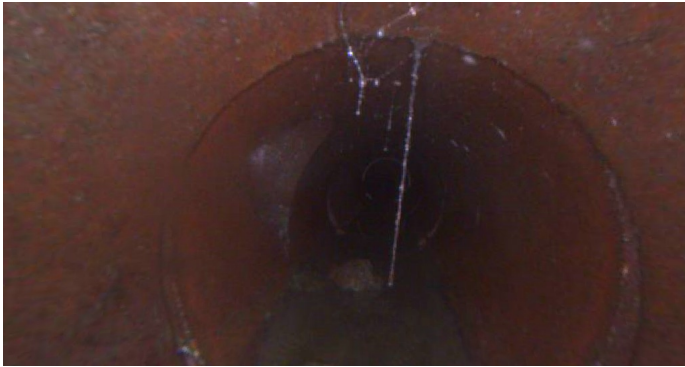
Code: **MWL**
Description: **Water Level**

Distance (ft): **.0**
Structural Grade: **0**
O&M Grade: **0**
Clock Start/From:
Clock To:
1st Value:
2nd Value:
Value Percent: **10.000**
Continuous Index:
Within 8" of Joint: **NO**
Remarks:

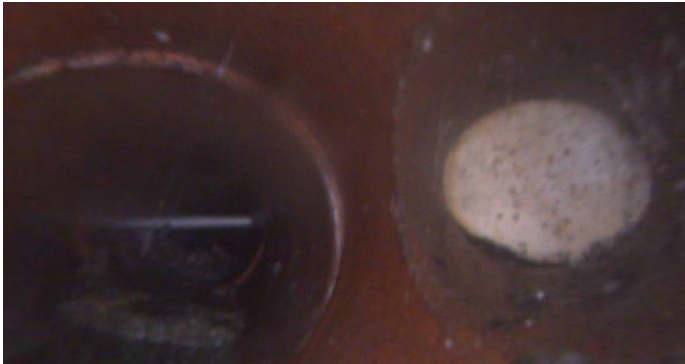
Code: **TFC**
Description: **Tap Factory Capped**

Distance (ft): **2.6**
Structural Grade: **0**
O&M Grade: **0**
Clock Start/From: **8**
Clock To:
1st Value: **4.000**
2nd Value:
Value Percent:
Continuous Index:
Within 8" of Joint:
Remarks:

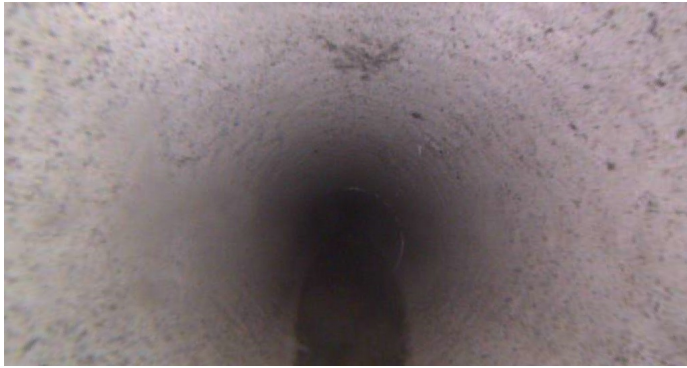
Code: **MMC**
Description: **Material Change**

Distance (ft): **7.8**
Structural Grade: **0**
O&M Grade: **0**
Clock Start/From:
Clock To:
1st Value:
2nd Value:
Value Percent:
Continuous Index:
Within 8" of Joint: **NO**
Remarks: **PVC**

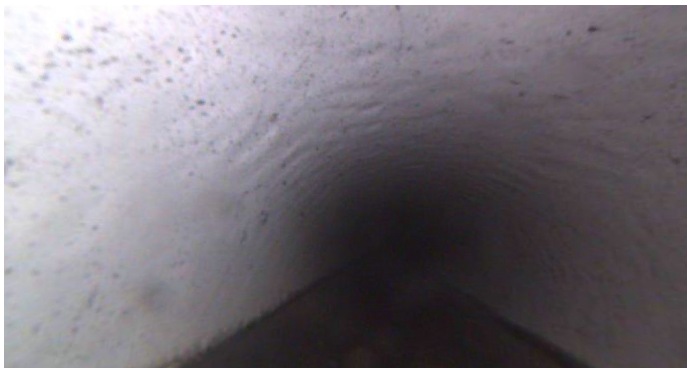
Code: **MSA**
Description: **Abandoned Survey**

Distance (ft): **34.7**
Structural Grade: **0**
O&M Grade: **0**
Clock Start/From:
Clock To:
1st Value:
2nd Value:
Value Percent:
Continuous Index:
Within 8" of Joint: **NO**
Remarks: **No blockage**
