Profile/Photo Observation Report

Date:	04/22/2018	Weather:		Coding:	PACP 6.0
Pipe Length (ft):	166.8	Owner:	NA	Pre Clean:	Not Known
P.O.#:		Surveyor:	Brandon Helbling	PSR:	P-604-095-094
Customer:		Clean Date:	01/01/1900	Shape:	C

Street:	N PENNSYLVANIA ST	Flow Control:	Not Controlled
City:	Hobart, IN	Year Renewed:	
Location:	Light Highway	Tape/Media #:	
Purpose:	Not Known	Dia/Height:	12"
Use:	Sanitary	Material:	VCP
Drain Area:	NA	Lining:	
Category:	NA		
Comment:

Location Details:		Direction of Survey:	Downstream
US MH:	M-604-094	DS MH:	M-604-095
		Total Length Surveyed (ft):	30.3

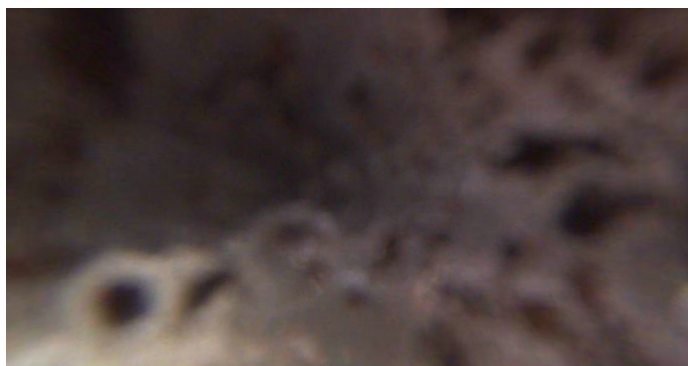
Code: **AMH**
 Description: **Manhole**

Distance (ft): **.0**
 Structural Grade: **0**
 O&M Grade: **0**
 Clock Start/From:
 Clock To:
 1st Value:
 2nd Value:
 Value Percent:
 Continuous Index:
 Within 8" of Joint: **NO**
 Remarks: **M-604-094**

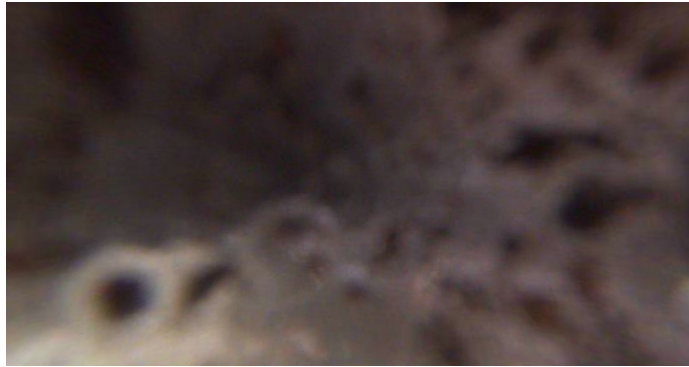
Code: **MWL**
Description: **Water Level**

Distance (ft): **.0**
Structural Grade: **0**
O&M Grade: **0**
Clock Start/From:
Clock To:
1st Value:
2nd Value:
Value Percent: **10.000**
Continuous Index:
Within 8" of Joint: **NO**
Remarks:

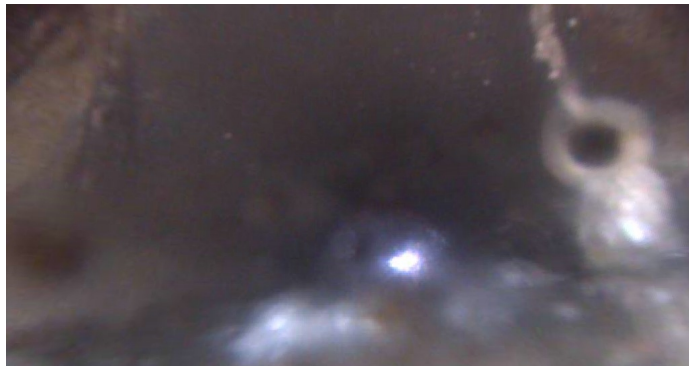
Code: **RFJ**
Description: **Roots Fine Joint**

Distance (ft): **7.6**
Structural Grade: **0**
O&M Grade: **1**
Clock Start/From: **5**
Clock To: **7**
1st Value:
2nd Value:
Value Percent:
Continuous Index: **S01**
Within 8" of Joint: **YES**
Remarks:

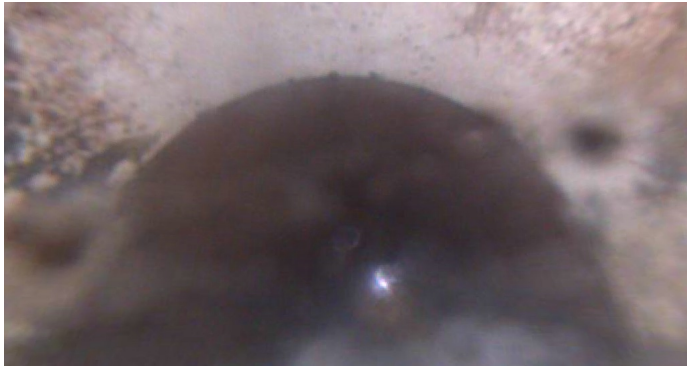
Code: **RFJ**
Description: **Roots Fine Joint**

Distance (ft): **18.2**
Structural Grade: **0**
O&M Grade: **1**
Clock Start/From: **5**
Clock To: **7**
1st Value:
2nd Value:
Value Percent:
Continuous Index: **F01**
Within 8" of Joint: **YES**
Remarks:

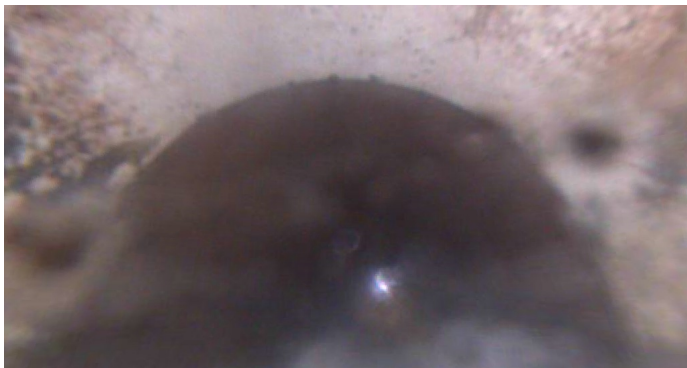
Code: **MMC**
Description: **Material Change**

Distance (ft): **18.2**
Structural Grade: **0**
O&M Grade: **0**
Clock Start/From:
Clock To:
1st Value:
2nd Value:
Value Percent:
Continuous Index:
Within 8" of Joint: **NO**
Remarks: **PVC**
