Profile/Photo Observation Report

Street:	Summerlin	Flow Control:	Not Controlled
City:	Hobart, IN	Year Renewed:	
Location:	Light Highway	Tape/Media #:	
Purpose:	Not Known	Dia/Height:	12"
Use:	Sanitary	Material:	VCP
Drain Area:	NA	Lining:	
Category:	NA		
Comment:

Location Details:		Direction of Survey:	Downstream
US MH:	M-604-094	DS MH:	M-604-095
		Total Length Surveyed (ft):	30.3

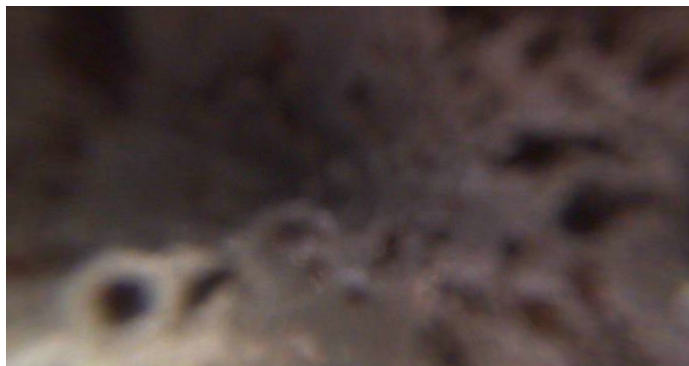
Code: **AMH**
 Description: **Manhole**

Distance (ft): **.0**
 Structural Grade: **0**
 O&M Grade: **0**
 Clock Start/From:
 Clock To:
 1st Value:
 2nd Value:
 Value Percent:
 Continuous Index:
 Within 8" of Joint: **NO**
 Remarks: **M-604-094**

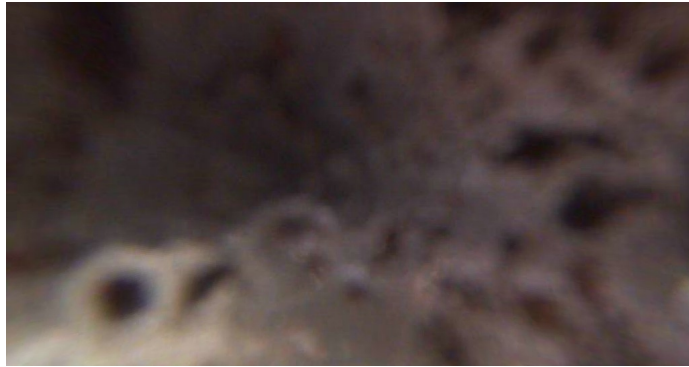
Code: **MWL**
Description: **Water Level**

Distance (ft): **.0**
Structural Grade: **0**
O&M Grade: **0**
Clock Start/From:
Clock To:
1st Value:
2nd Value:
Value Percent: **10.000**
Continuous Index:
Within 8" of Joint: **NO**
Remarks:

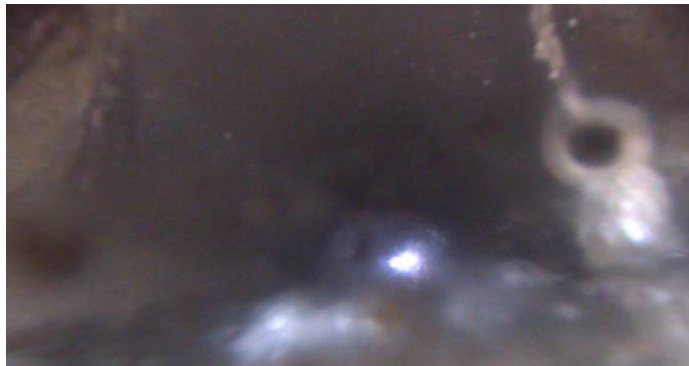
Code: **RFJ**
Description: **Roots Fine Joint**

Distance (ft): **7.6**
Structural Grade: **0**
O&M Grade: **1**
Clock Start/From: **5**
Clock To: **7**
1st Value:
2nd Value:
Value Percent:
Continuous Index: **S01**
Within 8" of Joint: **YES**
Remarks:

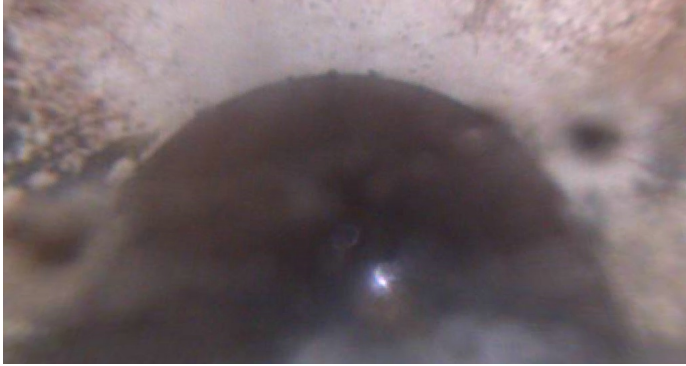
Code: **RFJ**
Description: **Roots Fine Joint**

Distance (ft): **18.2**
Structural Grade: **0**
O&M Grade: **1**
Clock Start/From: **5**
Clock To: **7**
1st Value:
2nd Value:
Value Percent:
Continuous Index: **F01**
Within 8" of Joint: **YES**
Remarks:

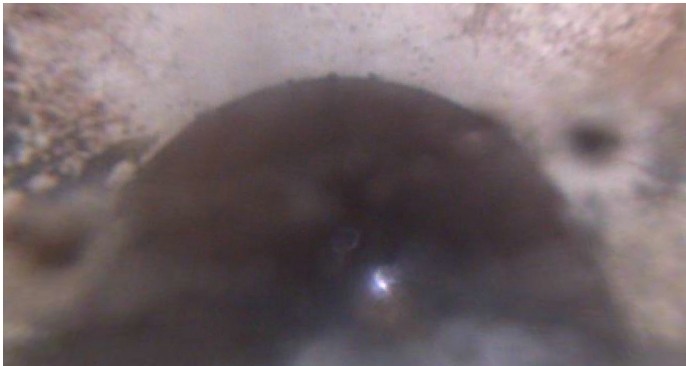
Code: **MMC**
Description: **Material Change**

Distance (ft): **18.2**
Structural Grade: **0**
O&M Grade: **0**
Clock Start/From:
Clock To:
1st Value:
2nd Value:
Value Percent:
Continuous Index:
Within 8" of Joint: **NO**
Remarks: **PVC**
