# Profile/Photo Observation Report

Date:	<b>11/20/2021</b>	Weather:		Coding:	<b>PACP 7.0</b>
Pipe Length (ft):	<b>170.0</b>	Owner:	<b>City of Hobart</b>	Pre Clean:	<b>Heavy Cleaning</b>
P.O.#:	<b>YES502259</b>	Surveyor:	<b>S. Bucklin</b>	PSR:	<b>P-604-095-094</b>
Customer:	<b>City of Hobart</b>	Clean Date:	<b>11/20/2021</b>	Shape:	<b>C</b>

Street:	<b>North Pennsylvania Street</b>	Flow Control:	<b>Not Controlled</b>
City:	<b>Hobart, IN</b>	Year Renewed:	
Location:	<b>Local rural streets with light traffic, t</b>	Tape/Media #:	
Purpose:	<b>Routine Assessment</b>	Dia/Height:	<b>12"</b>
Use:	<b>Sanitary Sewage Pipe</b>	Material:	<b>VCP</b>
Drain Area:		Lining:	<b>None</b>
Category:	<b>NA</b>		
Comment:			
Location Details:		Direction of Survey:	<b>Downstream</b>
US MH:	<b>M-604-094</b>	DS MH:	<b>M-604-095</b>
		Total Length Surveyed (ft):	<b>170.0</b>

O&M Index:	<b>1.86</b>	O&M Quick:	<b>352D</b>	O&M Rating:	<b>78.00</b>
Structural Index:	<b>2.92</b>	Structural Quick:	<b>4B34</b>	Structural Rating:	<b>108.00</b>
Overall Index:	<b>2.35</b>	Overall Quick:	<b>4B39</b>	Overall Rating:	<b>186.00</b>

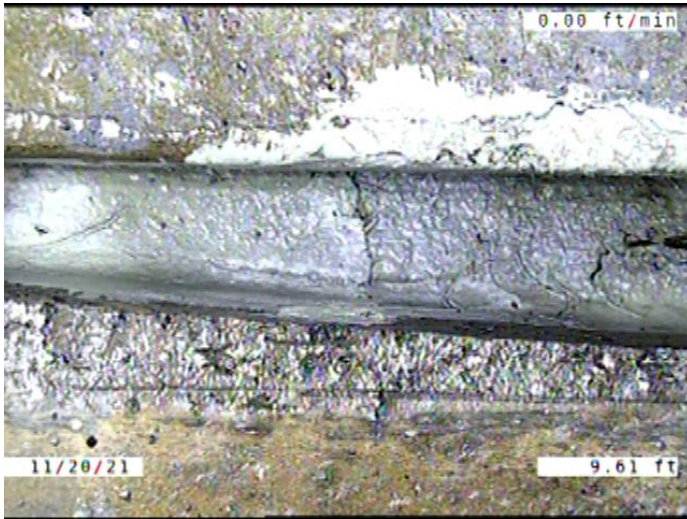
Code: **DAE**  
Description: **Deposits Attached Encrustation**

Distance (ft): **9.6**  
Structural Grade: **0**  
O&M Grade: **2**  
Clock Start/From: **9**  
Clock To: **11**  
1st Value:  
2nd Value:  
Value Percent: **5.000**  
Continuous Index:  
Within 8" of Joint: **YES**  
Remarks:

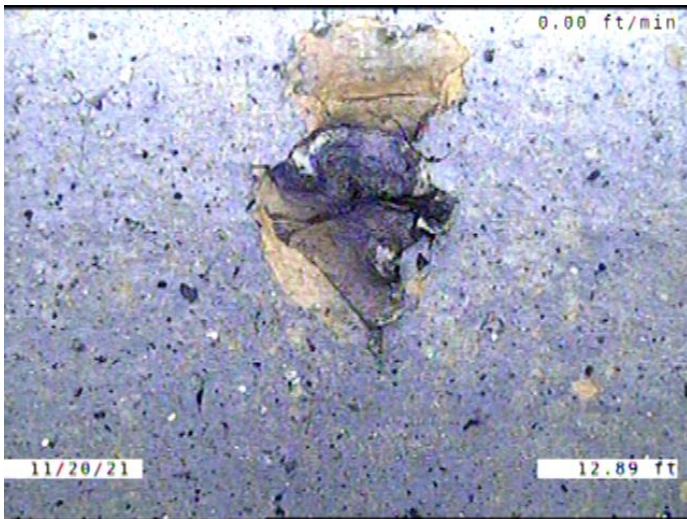
Code: **SSS**  
Description: **Surface Damage Surface Spalling**

Distance (ft): **12.9**  
Structural Grade: **2**  
O&M Grade: **0**  
Clock Start/From: **1**  
Clock To:  
1st Value:  
2nd Value:  
Value Percent:  
Continuous Index:  
Within 8" of Joint: **NO**  
Remarks:

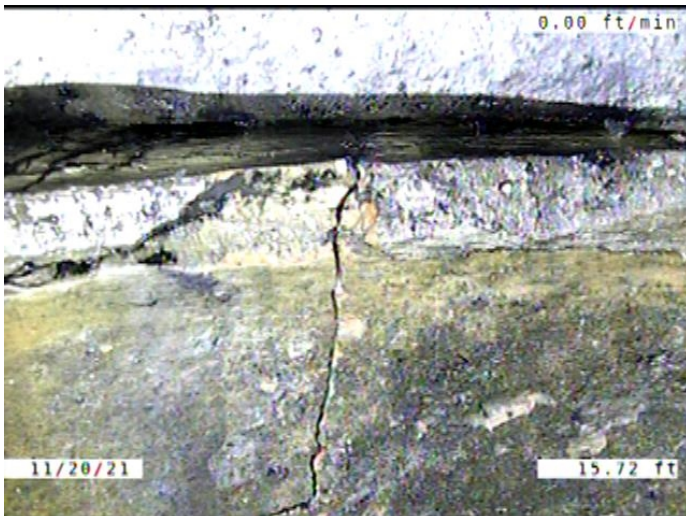
Code: **FM**  
 Description: **Fracture Multiple**

Distance (ft): **15.7**  
 Structural Grade: **4**  
 O&M Grade: **0**  
 Clock Start/From: **7**  
 Clock To: **9**  
 1st Value:  
 2nd Value:  
 Value Percent:  
 Continuous Index:  
 Within 8" of Joint: **YES**  
 Remarks:

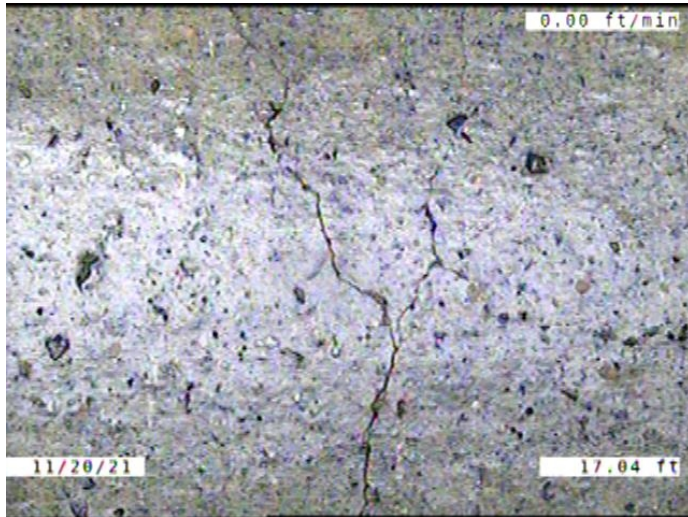
Code: **CM**  
Description: **Crack Multiple**

Distance (ft): **17.0**  
Structural Grade: **3**  
O&M Grade: **0**  
Clock Start/From: **11**  
Clock To: **1**  
1st Value:  
2nd Value:  
Value Percent:  
Continuous Index: **S02**  
Within 8" of Joint: **YES**  
Remarks:

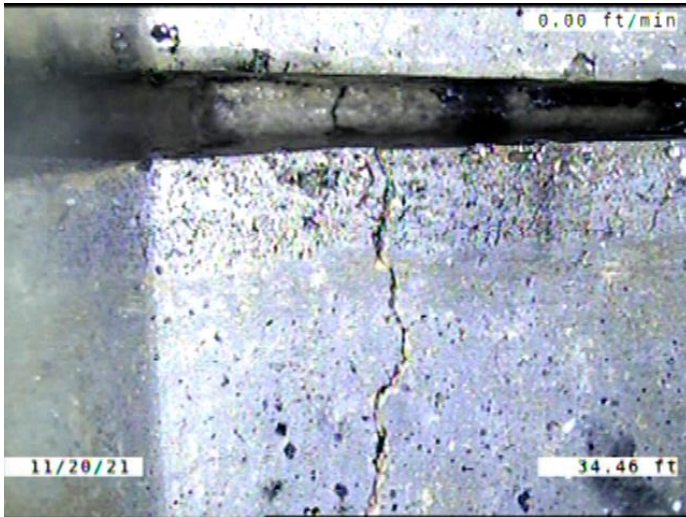
Code: **FM**  
 Description: **Fracture Multiple**

Distance (ft): **34.5**  
 Structural Grade: **4**  
 O&M Grade: **0**  
 Clock Start/From: **8**  
 Clock To: **9**  
 1st Value:  
 2nd Value:  
 Value Percent:  
 Continuous Index:  
 Within 8" of Joint: **YES**  
 Remarks:

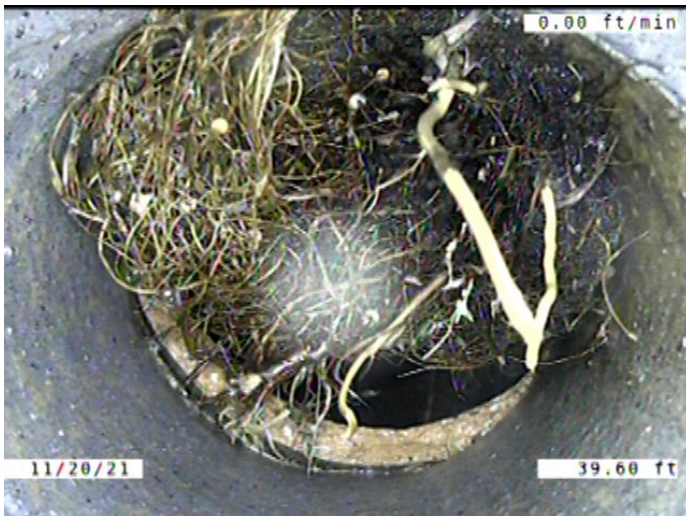
Code: **TFD**  
 Description: **Tap Factory Defective**

Distance (ft): **39.6**  
 Structural Grade: **0**  
 O&M Grade: **3**  
 Clock Start/From: **1**  
 Clock To:  
 1st Value: **4.000**  
 2nd Value:  
 Value Percent:  
 Continuous Index:  
 Within 8" of Joint: **YES**  
 Remarks: **OFFSET. ROOTS GROWING OUT OF THE TAP AND THE JOINT INTO THE**

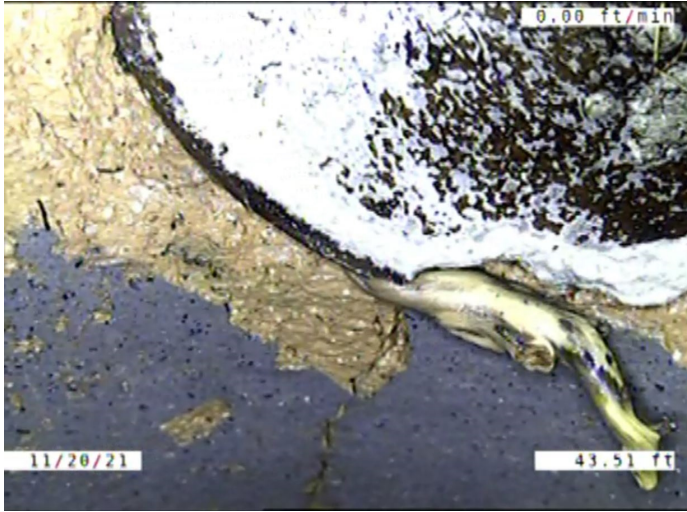
Code: **SSS**  
Description: **Surface Damage Surface Spalling**

Distance (ft): **43.5**  
Structural Grade: **2**  
O&M Grade: **0**  
Clock Start/From: **12**  
Clock To: **2**  
1st Value:  
2nd Value:  
Value Percent:  
Continuous Index:  
Within 8" of Joint: **NO**  
Remarks:

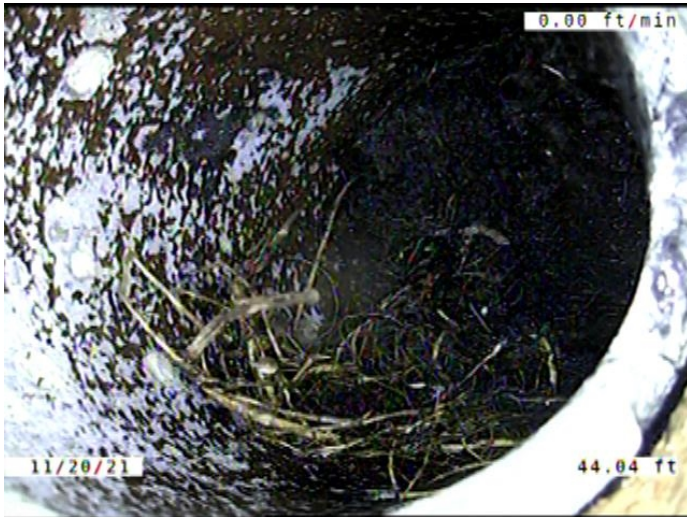
Code: **TBD**  
Description: **Tap Break-in/Hammer Defective**

Distance (ft): **44.0**  
Structural Grade: **0**  
O&M Grade: **3**  
Clock Start/From: **1**  
Clock To:  
1st Value: **4.000**  
2nd Value:  
Value Percent:  
Continuous Index:  
Within 8" of Joint: **YES**  
Remarks: **LOOKS TO BE 100% PLUGGED WITH ROOTS**

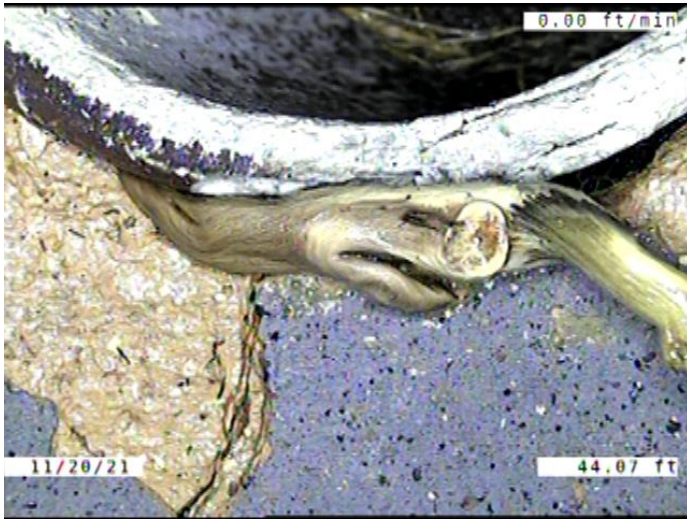
Code: **RTB**  
 Description: **Roots Tap Barrel**

Distance (ft): **44.1**  
 Structural Grade: **0**  
 O&M Grade: **3**  
 Clock Start/From: **1**  
 Clock To:  
 1st Value:  
 2nd Value:  
 Value Percent: **5.000**  
 Continuous Index:  
 Within 8" of Joint: **NO**  
 Remarks:

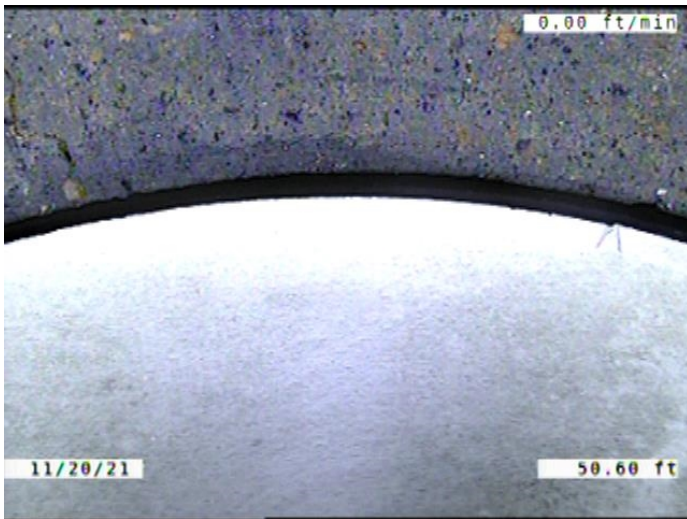
Code: **JOM**  
 Description: **Joint Offset Medium**

Distance (ft): **50.6**  
 Structural Grade: **3**  
 O&M Grade: **0**  
 Clock Start/From:  
 Clock To:  
 1st Value:  
 2nd Value:  
 Value Percent:  
 Continuous Index:  
 Within 8" of Joint: **NO**  
 Remarks:

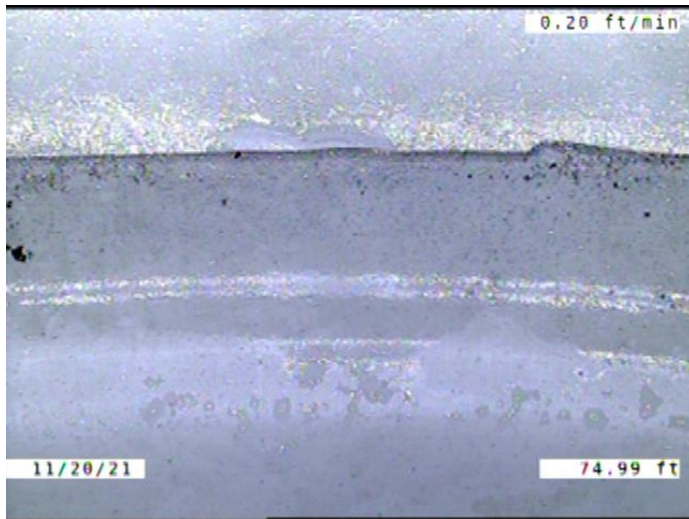
Code: **MGO**  
 Description: **Miscellaneous General Observation**

Distance (ft): **75.0**  
 Structural Grade: **0**  
 O&M Grade: **0**  
 Clock Start/From:  
 Clock To:  
 1st Value:  
 2nd Value:  
 Value Percent:  
 Continuous Index:  
 Within 8" of Joint: **NO**  
 Remarks: **JOINT/ PIPES NOT PUSHED ALL THE WAY TOGETHER WHEN INSTALLED**

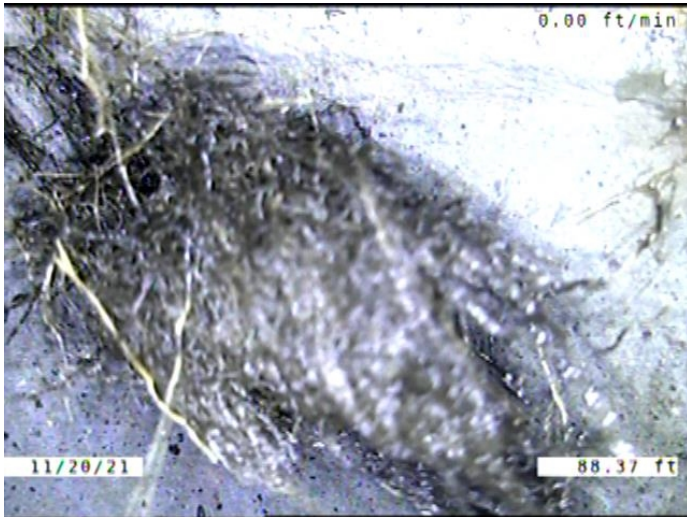
Code: **RMJ**  
 Description: **Roots Medium Joint**

Distance (ft): **88.4**  
 Structural Grade: **0**  
 O&M Grade: **3**  
 Clock Start/From: **9**  
 Clock To: **3**  
 1st Value:  
 2nd Value:  
 Value Percent: **5.000**  
 Continuous Index:  
 Within 8" of Joint: **YES**  
 Remarks:

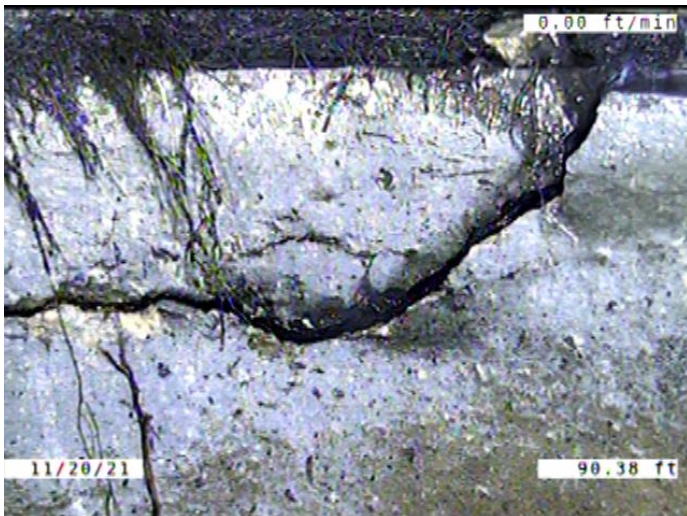
Code: **B**  
 Description: **Broken**

Distance (ft): **90.4**  
 Structural Grade: **4**  
 O&M Grade: **0**  
 Clock Start/From: **1**  
 Clock To: **3**  
 1st Value:  
 2nd Value:  
 Value Percent:  
 Continuous Index:  
 Within 8" of Joint: **YES**  
 Remarks:

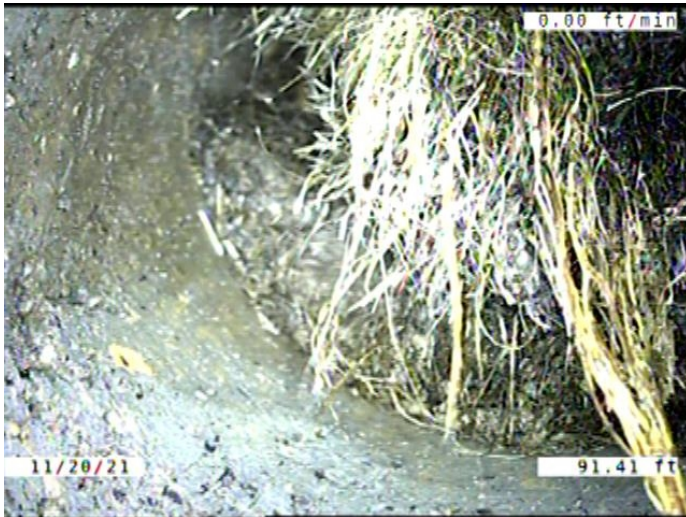
Code: **TFD**  
 Description: **Tap Factory Defective**

Distance (ft): **91.4**  
 Structural Grade: **0**  
 O&M Grade: **3**  
 Clock Start/From: **1**  
 Clock To:  
 1st Value: **4.000**  
 2nd Value:  
 Value Percent:  
 Continuous Index:  
 Within 8" of Joint: **YES**  
 Remarks: **BROKEN. LOOKS TO BE 100% PLUGGED WITH ROOTS**

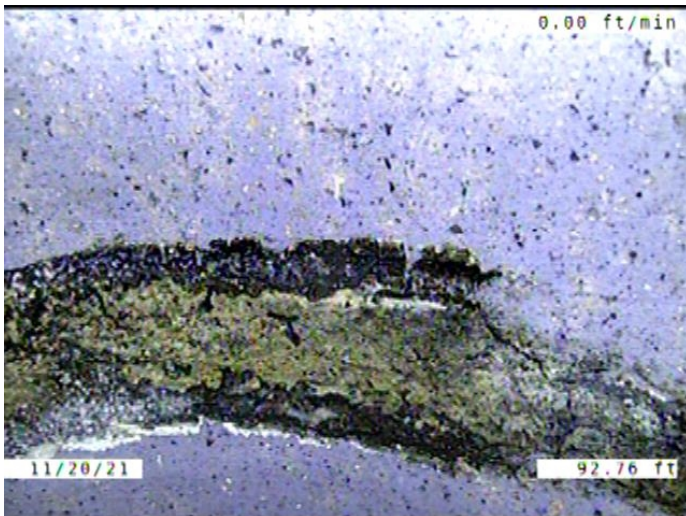
Code: **DAE**  
 Description: **Deposits Attached Encrustation**

Distance (ft): **92.8**  
 Structural Grade: **0**  
 O&M Grade: **2**  
 Clock Start/From: **9**  
 Clock To: **4**  
 1st Value:  
 2nd Value:  
 Value Percent: **5.000**  
 Continuous Index:  
 Within 8" of Joint: **NO**  
 Remarks:

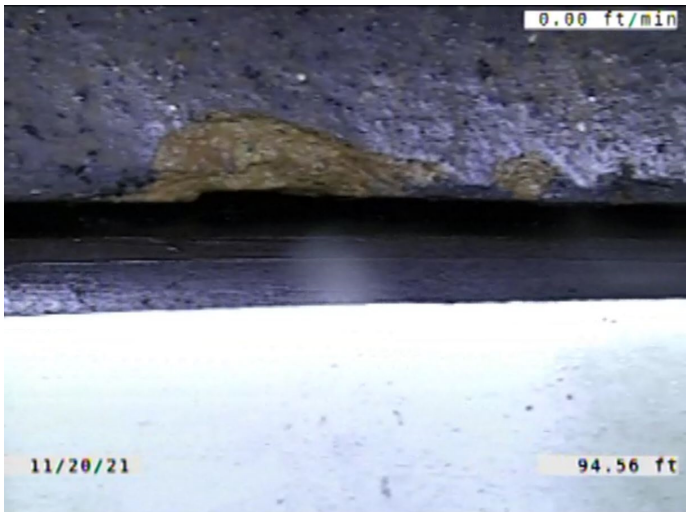
Code: **SSS**  
 Description: **Surface Damage Surface Spalling**

Distance (ft): **94.5**  
 Structural Grade: **2**  
 O&M Grade: **0**  
 Clock Start/From: **11**  
 Clock To:  
 1st Value:  
 2nd Value:  
 Value Percent:  
 Continuous Index:  
 Within 8" of Joint: **YES**  
 Remarks:

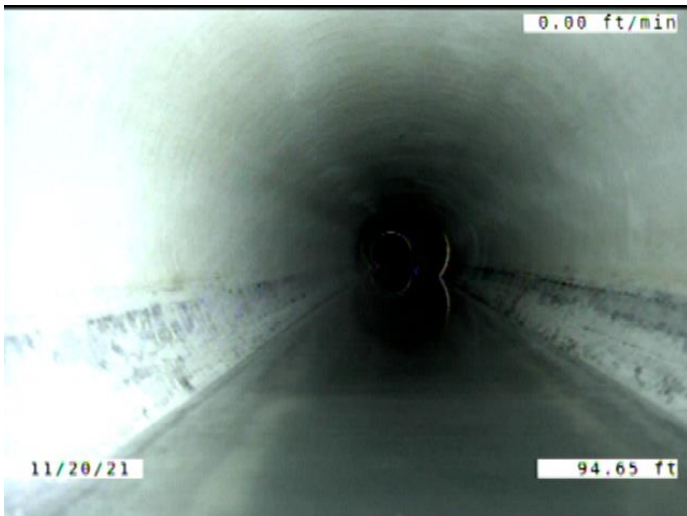
Code: **FM**  
 Description: **Fracture Multiple**

Distance (ft): **94.7**  
 Structural Grade: **4**  
 O&M Grade: **0**  
 Clock Start/From: **12**  
 Clock To: **12**  
 1st Value:  
 2nd Value:  
 Value Percent:  
 Continuous Index: **F09**  
 Within 8" of Joint: **YES**  
 Remarks:

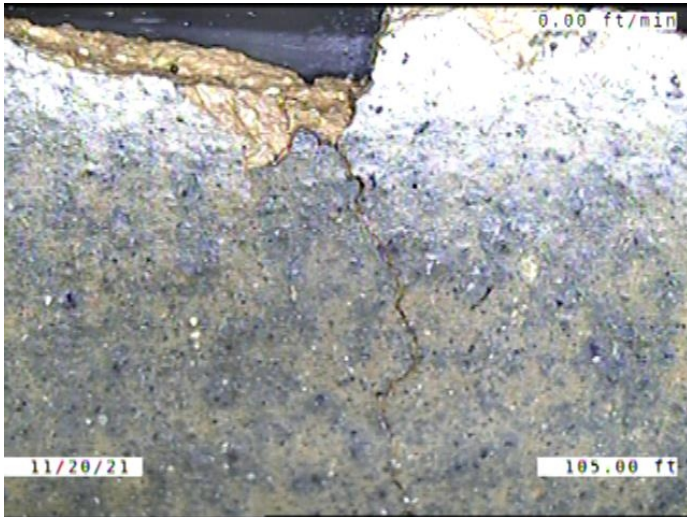
Code: **FM**  
 Description: **Fracture Multiple**

Distance (ft): **105.0**  
 Structural Grade: **4**  
 O&M Grade: **0**  
 Clock Start/From: **8**  
 Clock To: **4**  
 1st Value:  
 2nd Value:  
 Value Percent:  
 Continuous Index: **S11**  
 Within 8" of Joint: **YES**  
 Remarks:

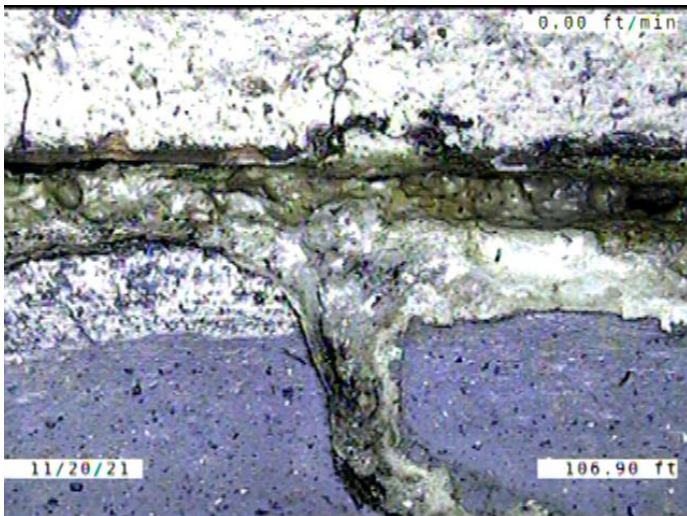
Code: **DAE**  
 Description: **Deposits Attached Encrustation**

Distance (ft): **106.9**  
 Structural Grade: **0**  
 O&M Grade: **2**  
 Clock Start/From: **8**  
 Clock To: **4**  
 1st Value:  
 2nd Value:  
 Value Percent: **5.000**  
 Continuous Index: **S12**  
 Within 8" of Joint: **YES**  
 Remarks:

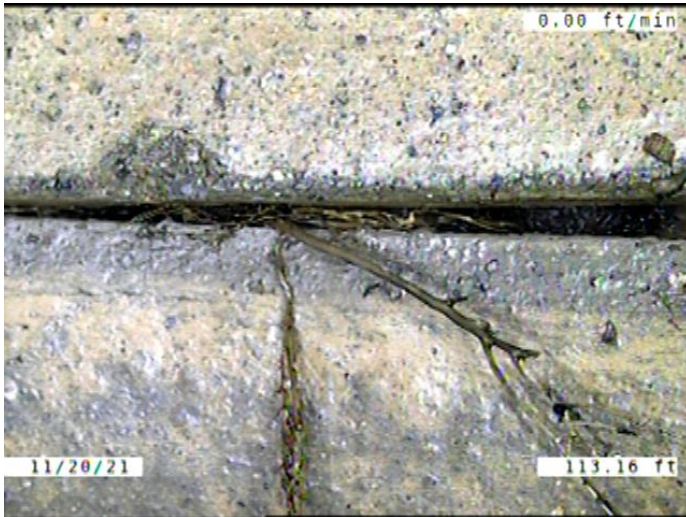
Code: **RFJ**  
Description: **Roots Fine Joint**

Distance (ft): **113.2**  
Structural Grade: **0**  
O&M Grade: **1**  
Clock Start/From: **9**  
Clock To: **4**  
1st Value:  
2nd Value:  
Value Percent:  
Continuous Index: **S13**  
Within 8" of Joint: **YES**  
Remarks:

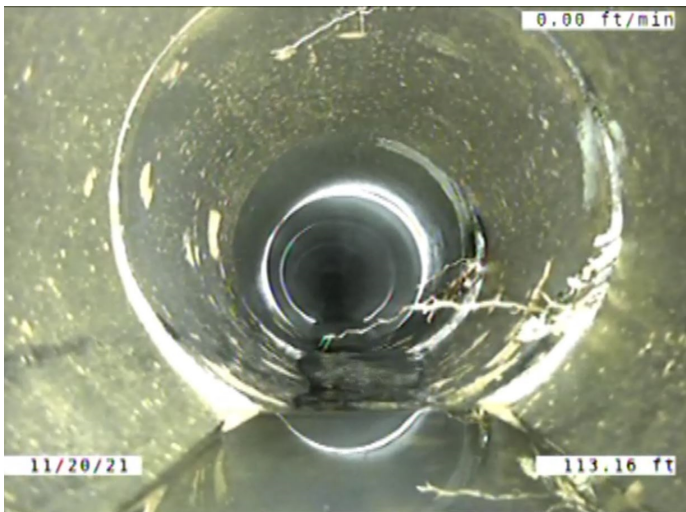
Code: **SSS**  
Description: **Surface Damage Surface Spalling**

Distance (ft): **113.2**  
Structural Grade: **2**  
O&M Grade: **0**  
Clock Start/From: **12**  
Clock To: **12**  
1st Value:  
2nd Value:  
Value Percent:  
Continuous Index:  
Within 8" of Joint: **NO**  
Remarks: **Wandering**

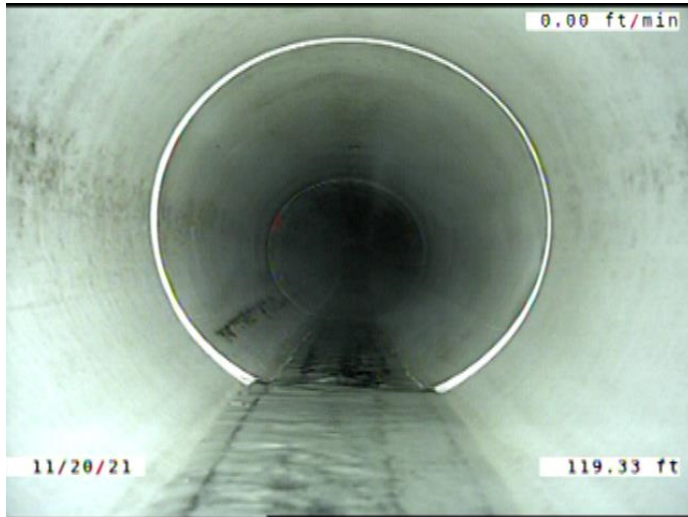
Code: **RFJ**  
Description: **Roots Fine Joint**

Distance (ft): **119.3**  
Structural Grade: **0**  
O&M Grade: **1**  
Clock Start/From: **9**  
Clock To: **4**  
1st Value:  
2nd Value:  
Value Percent:  
Continuous Index: **F13**  
Within 8" of Joint: **YES**  
Remarks:

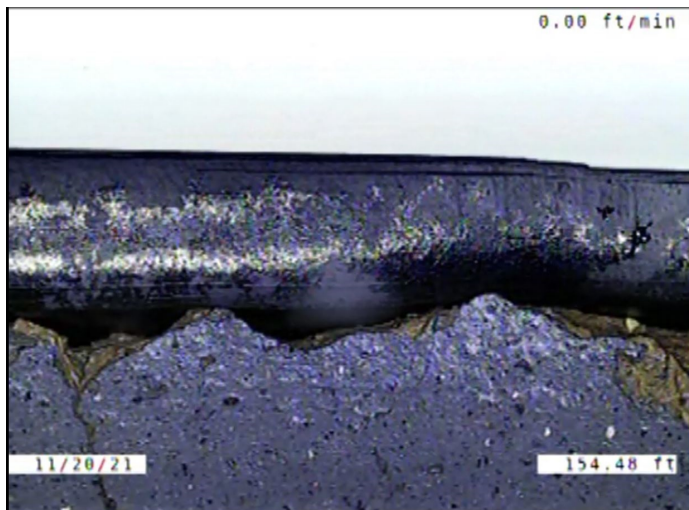
Code: **FM**  
 Description: **Fracture Multiple**

Distance (ft): **154.5**  
 Structural Grade: **4**  
 O&M Grade: **0**  
 Clock Start/From: **10**  
 Clock To: **2**  
 1st Value:  
 2nd Value:  
 Value Percent:  
 Continuous Index:  
 Within 8" of Joint: **YES**  
 Remarks:

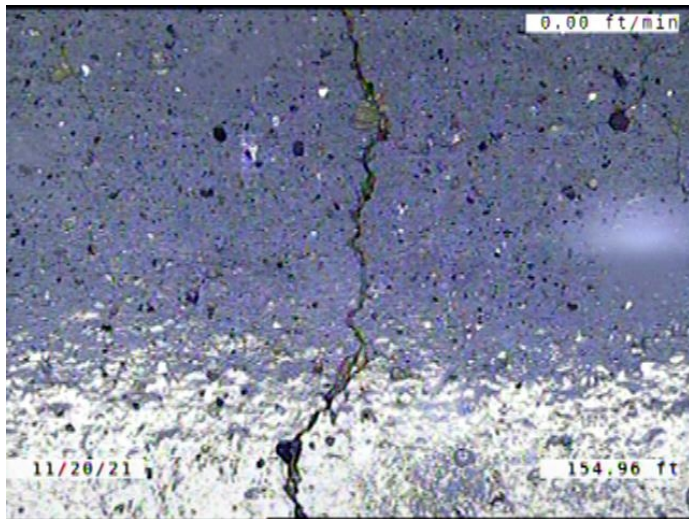
Code: **CM**  
Description: **Crack Multiple**

Distance (ft): **155.0**  
Structural Grade: **3**  
O&M Grade: **0**  
Clock Start/From: **11**  
Clock To: **1**  
1st Value:  
2nd Value:  
Value Percent:  
Continuous Index:  
Within 8" of Joint: **YES**  
Remarks:

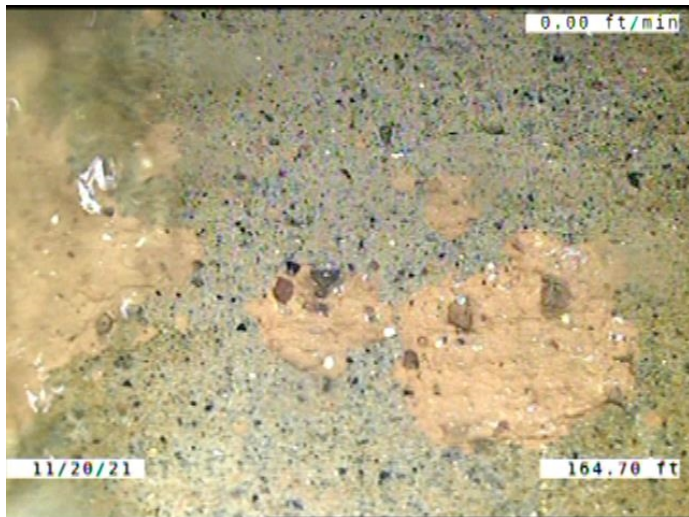
Code: **SSS**  
 Description: **Surface Damage Surface Spalling**

Distance (ft): **164.7**  
 Structural Grade: **2**  
 O&M Grade: **0**  
 Clock Start/From: **4**  
 Clock To: **7**  
 1st Value:  
 2nd Value:  
 Value Percent:  
 Continuous Index:  
 Within 8" of Joint: **YES**  
 Remarks:

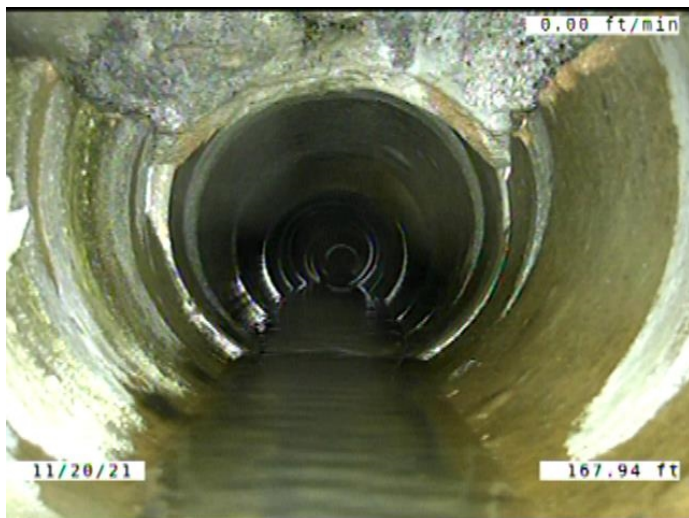
Code: **DSF**  
 Description: **Deposits Settled Fine**

Distance (ft): **167.9**  
 Structural Grade: **0**  
 O&M Grade: **2**  
 Clock Start/From: **5**  
 Clock To: **7**  
 1st Value:  
 2nd Value:  
 Value Percent: **5.000**  
 Continuous Index: **F08**  
 Within 8" of Joint: **YES**  
 Remarks:
