Profile/Photo Observation Report

Date:	11/20/2021	Weather:		Coding:	PACP 7.0
Pipe Length (ft):	170.0	Owner:	City of Hobart	Pre Clean:	Heavy Cleaning
P.O.#:	YES502259	Surveyor:	S. Bucklin	PSR:	P-604-095-094
Customer:	City of Hobart	Clean Date:	11/20/2021	Shape:	C

Street:	North Pennsylvania Street	Flow Control:	Not Controlled
City:	Hobart, IN	Year Renewed:	
Location:	Local rural streets with light traffic, t	Tape/Media #:	
Purpose:	Routine Assessment	Dia/Height:	12"
Use:	Sanitary Sewage Pipe	Material:	VCP
Drain Area:		Lining:	None
Category:	NA		
Comment:			
Location Details:		Direction of Survey:	Downstream
US MH:	M-604-094	DS MH:	M-604-095
		Total Length Surveyed (ft):	170.0

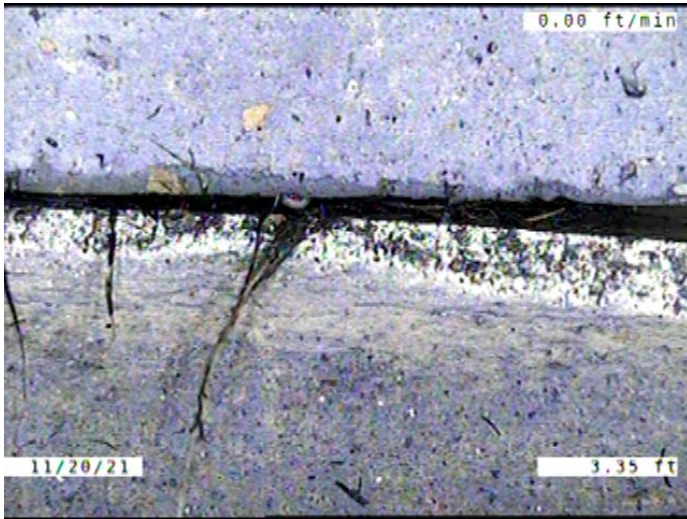
Code: **RFJ**
Description: **Roots Fine Joint**

Distance (ft): **3.3**
Structural Grade: **0**
O&M Grade: **1**
Clock Start/From: **9**
Clock To: **4**
1st Value:
2nd Value:
Value Percent:
Continuous Index: **S01**
Within 8" of Joint: **YES**
Remarks:

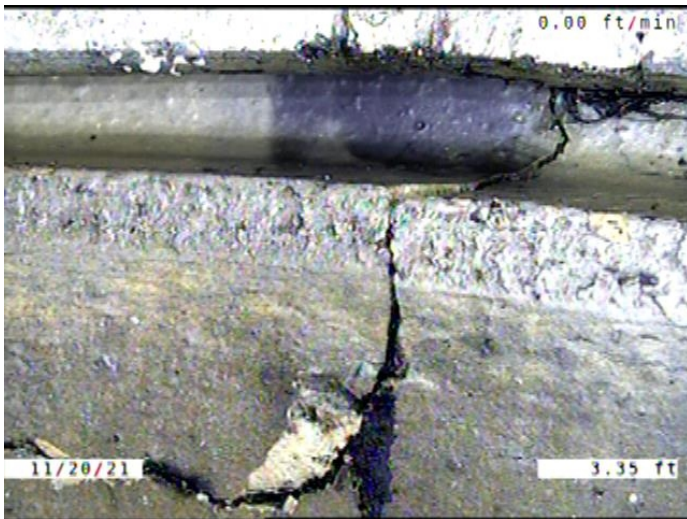
Code: **B**
Description: **Broken**

Distance (ft): **3.3**
Structural Grade: **4**
O&M Grade: **0**
Clock Start/From: **1**
Clock To: **4**
1st Value:
2nd Value:
Value Percent:
Continuous Index:
Within 8" of Joint: **YES**
Remarks:

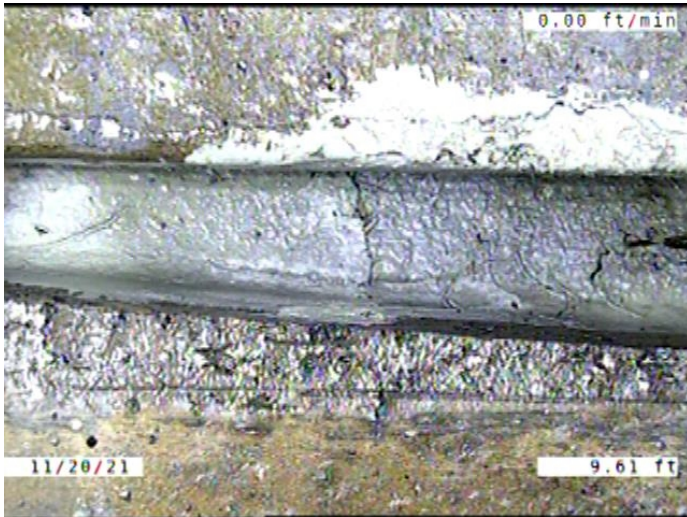
Code: **DAE**
 Description: **Deposits Attached Encrustation**

Distance (ft): **9.6**
 Structural Grade: **0**
 O&M Grade: **2**
 Clock Start/From: **9**
 Clock To: **11**
 1st Value:
 2nd Value:
 Value Percent: **5.000**
 Continuous Index:
 Within 8" of Joint: **YES**
 Remarks:

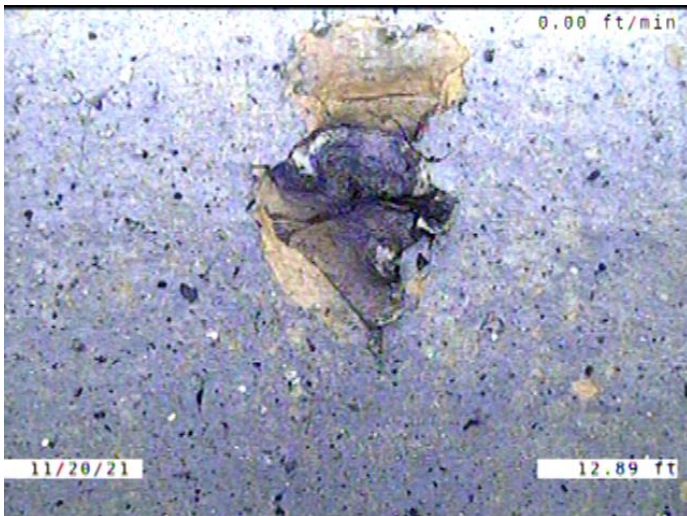
Code: **SSS**
 Description: **Surface Damage Surface Spalling**

Distance (ft): **12.9**
 Structural Grade: **2**
 O&M Grade: **0**
 Clock Start/From: **1**
 Clock To:
 1st Value:
 2nd Value:
 Value Percent:
 Continuous Index:
 Within 8" of Joint: **NO**
 Remarks:

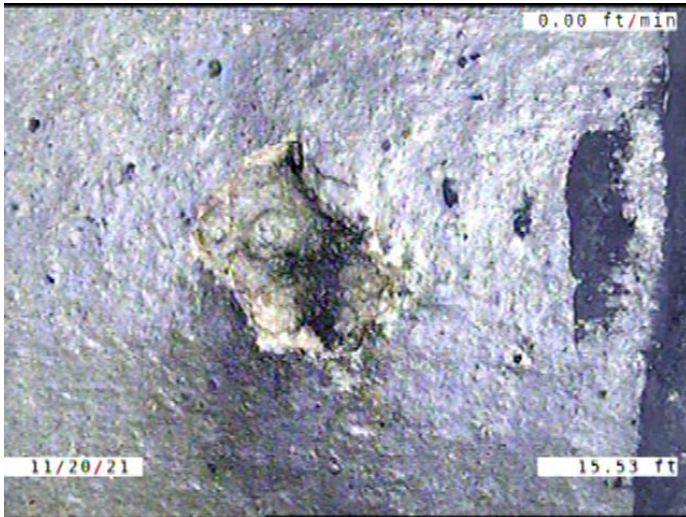
Code: **SSS**
 Description: **Surface Damage Surface Spalling**

Distance (ft): **15.5**
 Structural Grade: **2**
 O&M Grade: **0**
 Clock Start/From: **3**
 Clock To:
 1st Value:
 2nd Value:
 Value Percent:
 Continuous Index:
 Within 8" of Joint: **YES**
 Remarks:

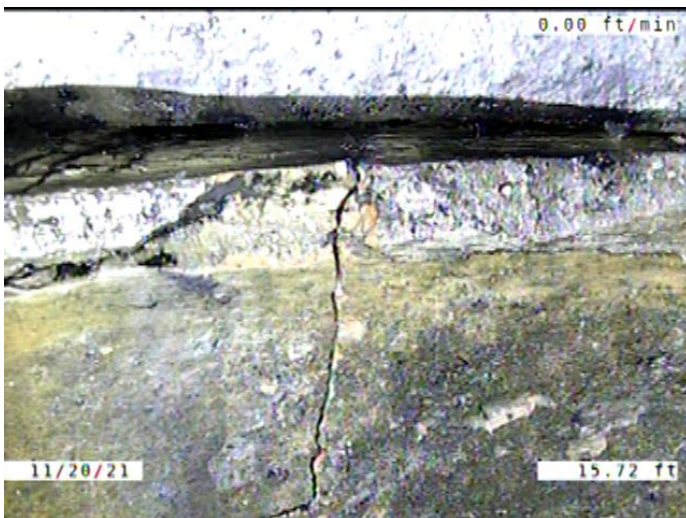
Code: **FM**
 Description: **Fracture Multiple**

Distance (ft): **15.7**
 Structural Grade: **4**
 O&M Grade: **0**
 Clock Start/From: **7**
 Clock To: **9**
 1st Value:
 2nd Value:
 Value Percent:
 Continuous Index:
 Within 8" of Joint: **YES**
 Remarks:

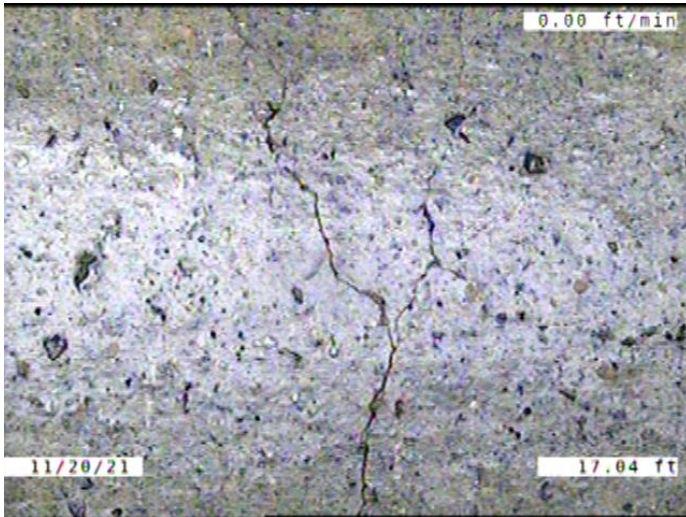
Code: **CM**
 Description: **Crack Multiple**

Distance (ft): **17.0**
 Structural Grade: **3**
 O&M Grade: **0**
 Clock Start/From: **11**
 Clock To: **1**
 1st Value:
 2nd Value:
 Value Percent:
 Continuous Index: **S02**
 Within 8" of Joint: **YES**
 Remarks:

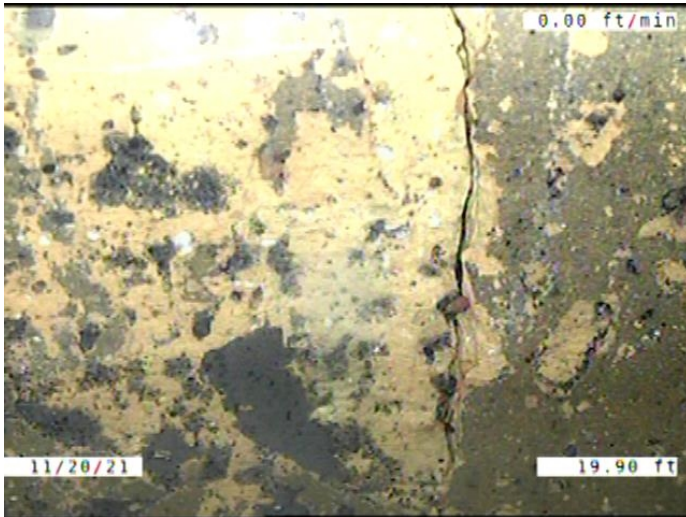
Code: **FM**
 Description: **Fracture Multiple**

Distance (ft): **19.9**
 Structural Grade: **4**
 O&M Grade: **0**
 Clock Start/From: **5**
 Clock To: **6**
 1st Value:
 2nd Value:
 Value Percent:
 Continuous Index:
 Within 8" of Joint: **YES**
 Remarks:

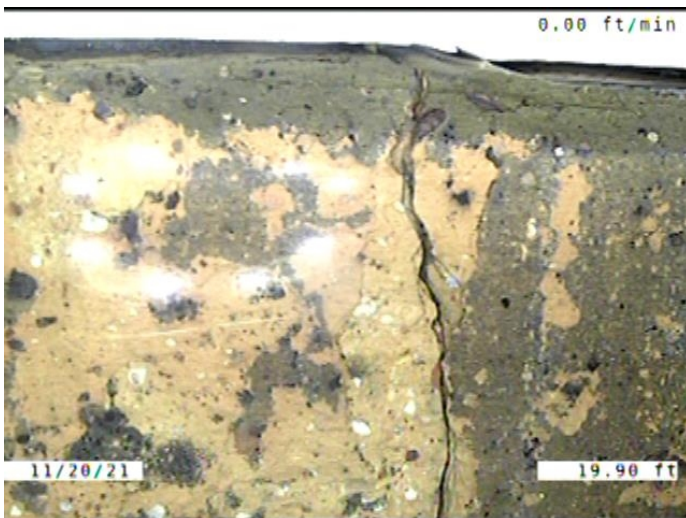
Code: **SSS**
 Description: **Surface Damage Surface Spalling**

Distance (ft): **19.9**
 Structural Grade: **2**
 O&M Grade: **0**
 Clock Start/From: **4**
 Clock To: **7**
 1st Value:
 2nd Value:
 Value Percent:
 Continuous Index:
 Within 8" of Joint: **YES**
 Remarks:

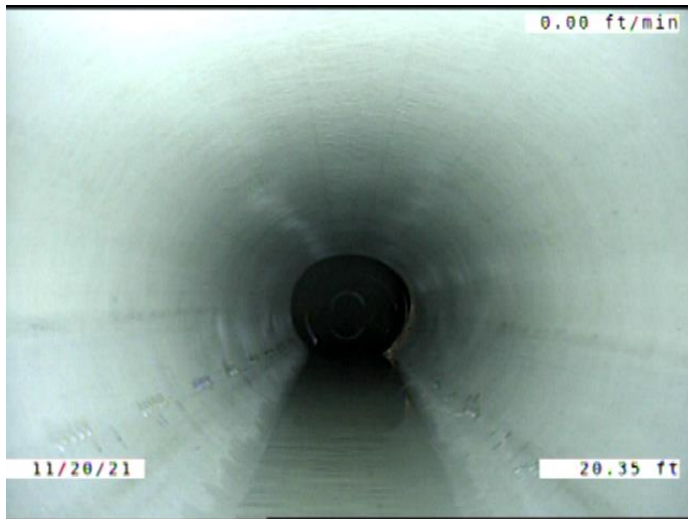
Code: **RFJ**
Description: **Roots Fine Joint**

Distance (ft): **20.3**
Structural Grade: **0**
O&M Grade: **1**
Clock Start/From: **9**
Clock To: **4**
1st Value:
2nd Value:
Value Percent:
Continuous Index: **F01**
Within 8" of Joint: **YES**
Remarks:

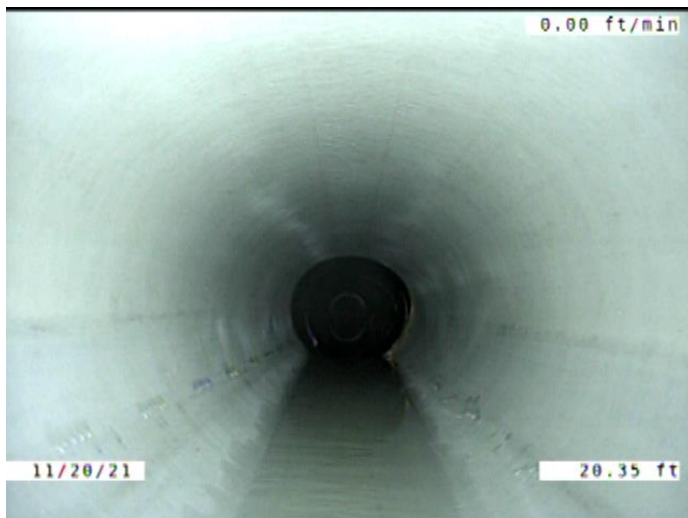
Code: **CM**
Description: **Crack Multiple**

Distance (ft): **20.4**
Structural Grade: **3**
O&M Grade: **0**
Clock Start/From: **11**
Clock To: **1**
1st Value:
2nd Value:
Value Percent:
Continuous Index: **F02**
Within 8" of Joint: **YES**
Remarks:

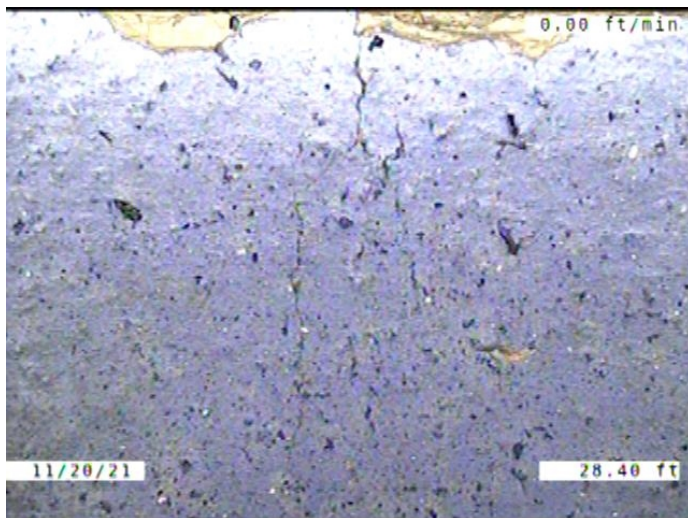
Code: **CM**
 Description: **Crack Multiple**

Distance (ft): **28.4**
 Structural Grade: **3**
 O&M Grade: **0**
 Clock Start/From: **11**
 Clock To: **12**
 1st Value:
 2nd Value:
 Value Percent:
 Continuous Index:
 Within 8" of Joint: **YES**
 Remarks:

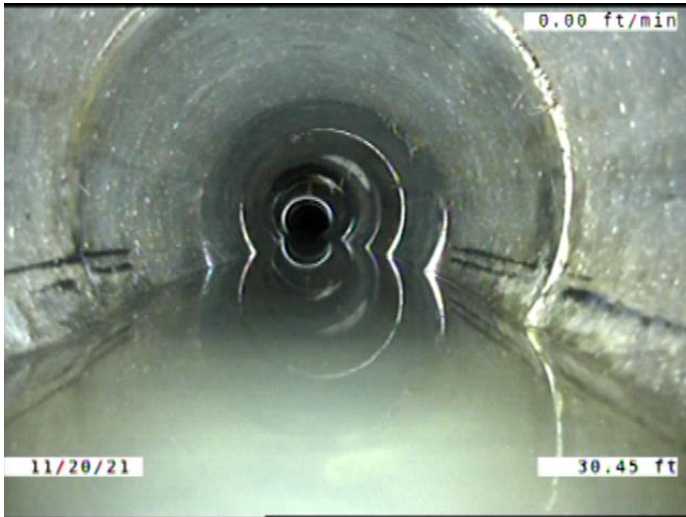
Code: **MWLS**
 Description: **Miscellaneous Water Level Sag**

Distance (ft): **30.4**
 Structural Grade: **2**
 O&M Grade: **0**
 Clock Start/From:
 Clock To:
 1st Value:
 2nd Value:
 Value Percent: **10.000**
 Continuous Index: **S03**
 Within 8" of Joint: **NO**
 Remarks:

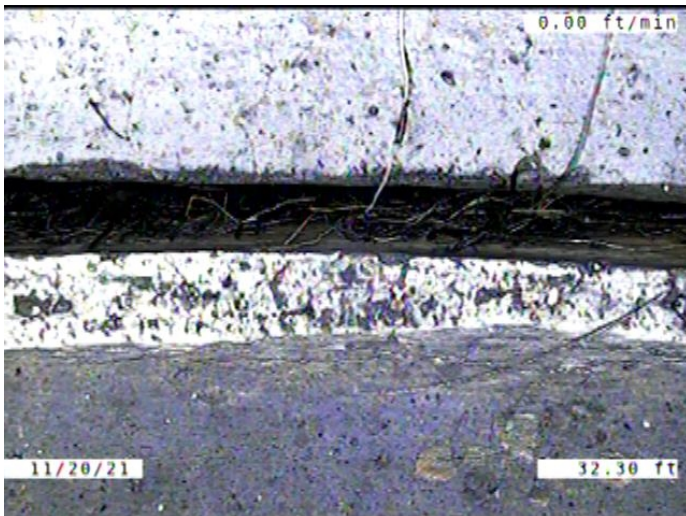
Code: **RFJ**
 Description: **Roots Fine Joint**

Distance (ft): **32.3**
 Structural Grade: **0**
 O&M Grade: **1**
 Clock Start/From: **8**
 Clock To: **3**
 1st Value:
 2nd Value:
 Value Percent:
 Continuous Index: **S04**
 Within 8" of Joint: **YES**
 Remarks:

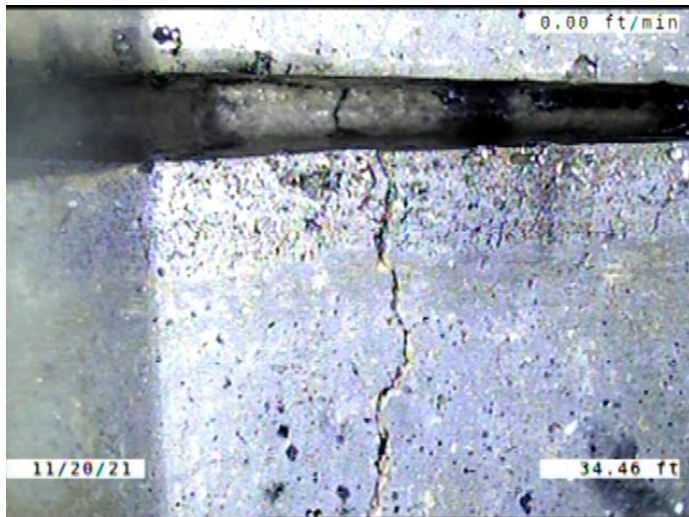
Code: **FM**
 Description: **Fracture Multiple**

Distance (ft): **34.5**
 Structural Grade: **4**
 O&M Grade: **0**
 Clock Start/From: **8**
 Clock To: **9**
 1st Value:
 2nd Value:
 Value Percent:
 Continuous Index:
 Within 8" of Joint: **YES**
 Remarks:

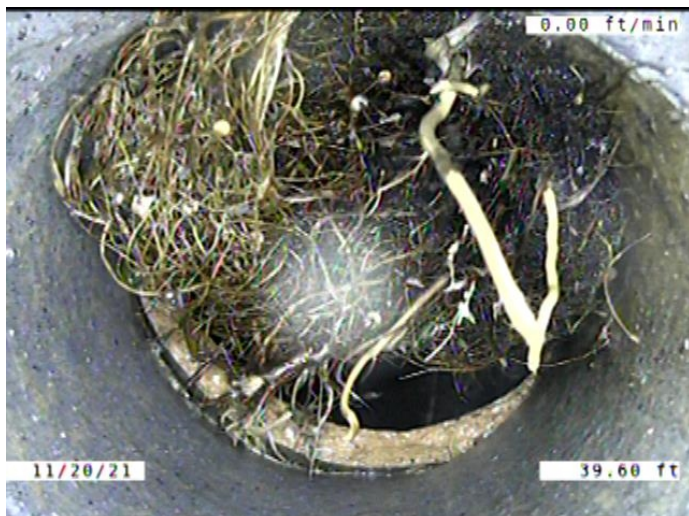
Code: **TFD**
 Description: **Tap Factory Defective**

Distance (ft): **39.6**
 Structural Grade: **0**
 O&M Grade: **3**
 Clock Start/From: **1**
 Clock To:
 1st Value: **4.000**
 2nd Value:
 Value Percent:
 Continuous Index:
 Within 8" of Joint: **YES**
 Remarks: **OFFSET. ROOTS GROWING OUT OF THE TAP AND THE JOINT INTO THE**

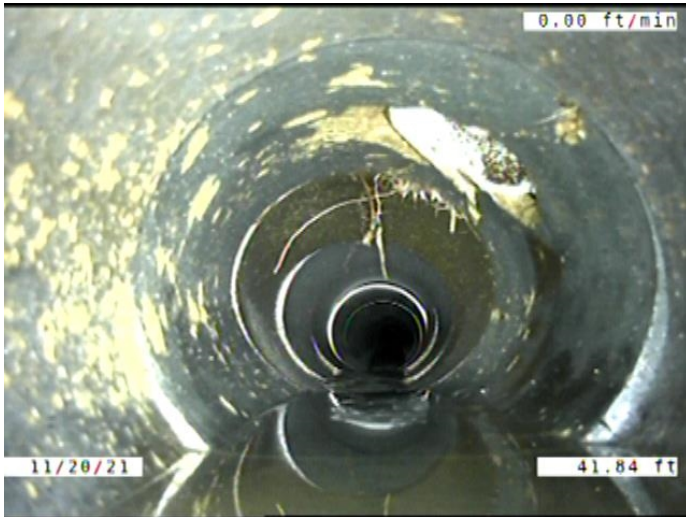
Code:	SSS
Description:	Surface Damage Surface Spalling
Distance (ft):	41.8
Structural Grade:	2
O&M Grade:	0
Clock Start/From:	12
Clock To:	12
1st Value:	
2nd Value:	
Value Percent:	
Continuous Index:	S06
Within 8" of Joint:	YES
Remarks:

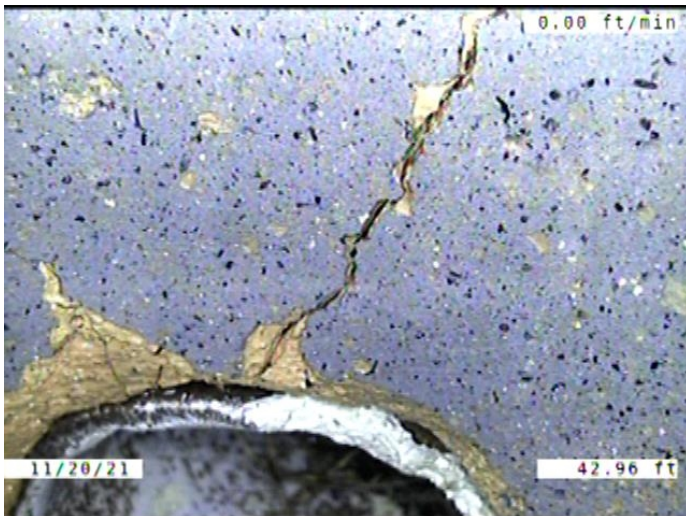
Code:	FM
Description:	Fracture Multiple
Distance (ft):	43.0
Structural Grade:	4
O&M Grade:	0
Clock Start/From:	12
Clock To:	12
1st Value:	
2nd Value:	
Value Percent:	
Continuous Index:	S05
Within 8" of Joint:	YES
Remarks:

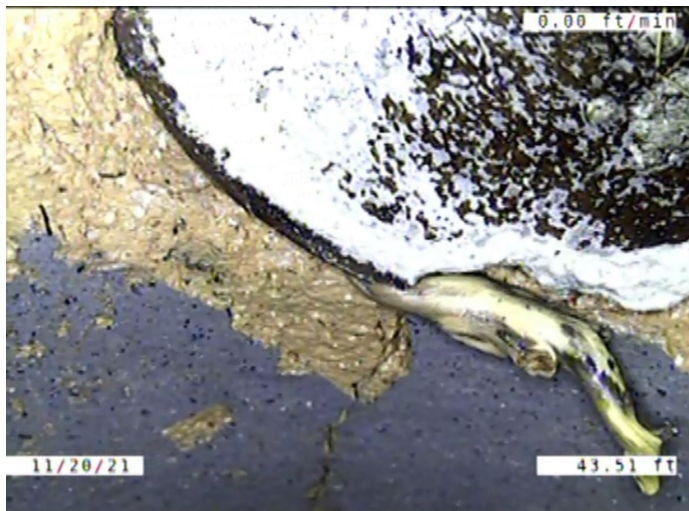
Code: **SSS**
 Description: **Surface Damage Surface Spalling**

Distance (ft): **43.5**
 Structural Grade: **2**
 O&M Grade: **0**
 Clock Start/From: **12**
 Clock To: **2**
 1st Value:
 2nd Value:
 Value Percent:
 Continuous Index:
 Within 8" of Joint: **NO**
 Remarks:

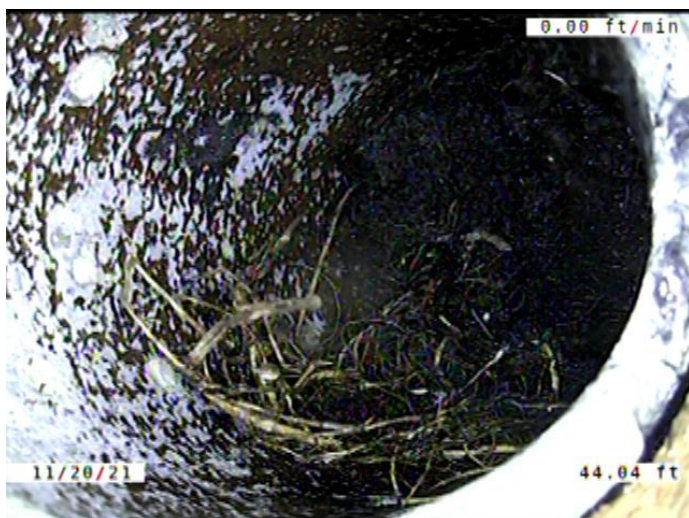
Code: **TBD**
 Description: **Tap Break-in/Hammer Defective**

Distance (ft): **44.0**
 Structural Grade: **0**
 O&M Grade: **3**
 Clock Start/From: **1**
 Clock To:
 1st Value: **4.000**
 2nd Value:
 Value Percent:
 Continuous Index:
 Within 8" of Joint: **YES**
 Remarks: **LOOKS TO BE 100% PLUGGED WITH ROOTS**

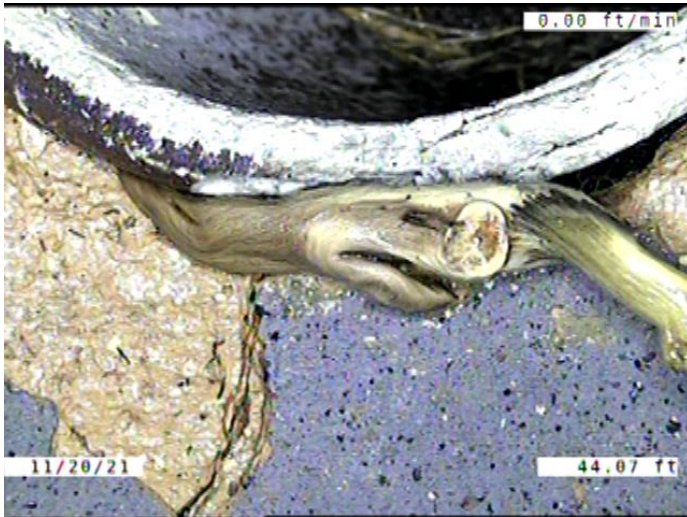
Code: **RTB**
 Description: **Roots Tap Barrel**

Distance (ft): **44.1**
 Structural Grade: **0**
 O&M Grade: **3**
 Clock Start/From: **1**
 Clock To:
 1st Value:
 2nd Value:
 Value Percent: **5.000**
 Continuous Index:
 Within 8" of Joint: **NO**
 Remarks:

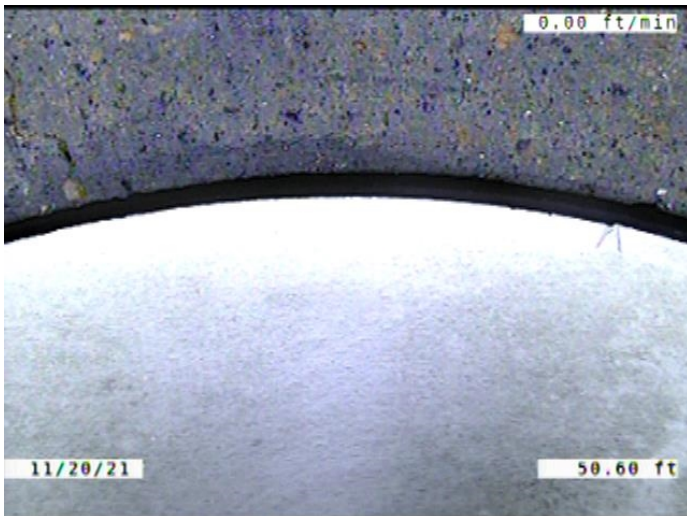
Code: **JOM**
 Description: **Joint Offset Medium**

Distance (ft): **50.6**
 Structural Grade: **3**
 O&M Grade: **0**
 Clock Start/From:
 Clock To:
 1st Value:
 2nd Value:
 Value Percent:
 Continuous Index:
 Within 8" of Joint: **NO**
 Remarks:

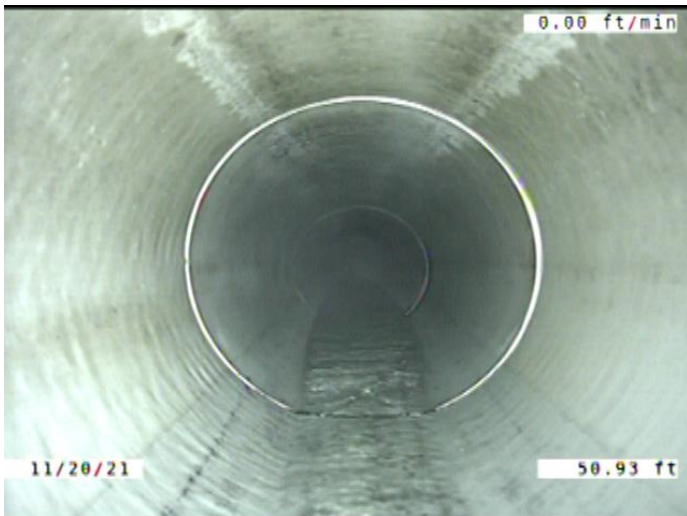
Code: **MWLS**
 Description: **Miscellaneous Water Level Sag**

Distance (ft): **50.9**
 Structural Grade: **2**
 O&M Grade: **0**
 Clock Start/From:
 Clock To:
 1st Value:
 2nd Value:
 Value Percent: **10.000**
 Continuous Index: **F03**
 Within 8" of Joint: **NO**
 Remarks:

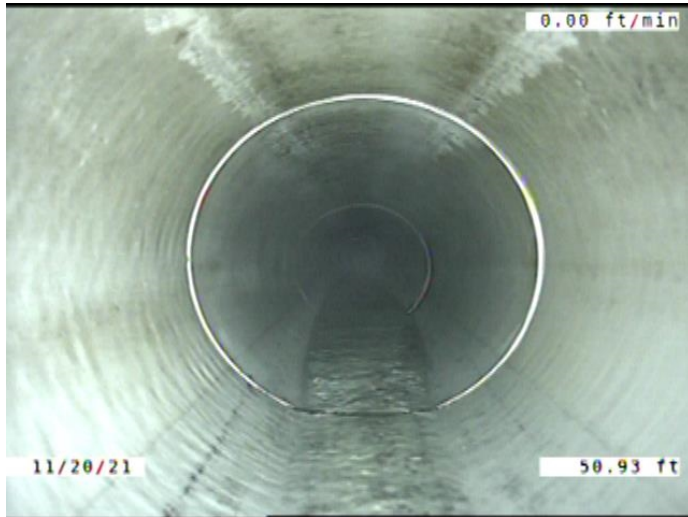
Code: **RFJ**
 Description: **Roots Fine Joint**

Distance (ft): **50.9**
 Structural Grade: **0**
 O&M Grade: **1**
 Clock Start/From: **8**
 Clock To: **3**
 1st Value:
 2nd Value:
 Value Percent:
 Continuous Index: **F04**
 Within 8" of Joint: **YES**
 Remarks:

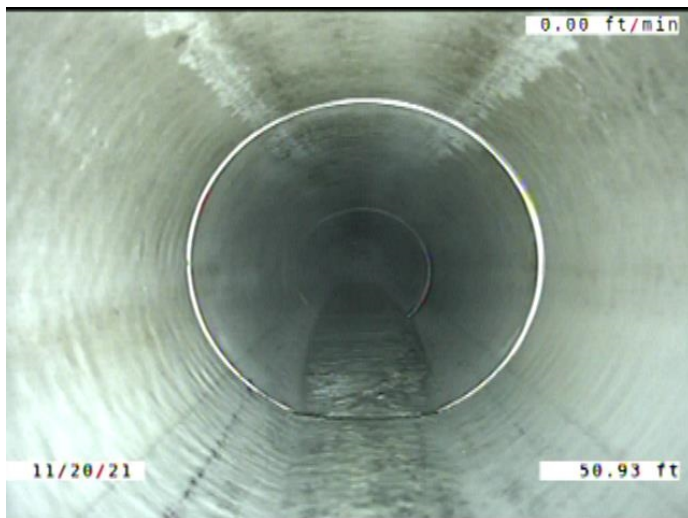
Code: **SSS**
 Description: **Surface Damage Surface Spalling**

Distance (ft): **50.9**
 Structural Grade: **2**
 O&M Grade: **0**
 Clock Start/From: **12**
 Clock To: **12**
 1st Value:
 2nd Value:
 Value Percent:
 Continuous Index: **F06**
 Within 8" of Joint: **YES**
 Remarks:

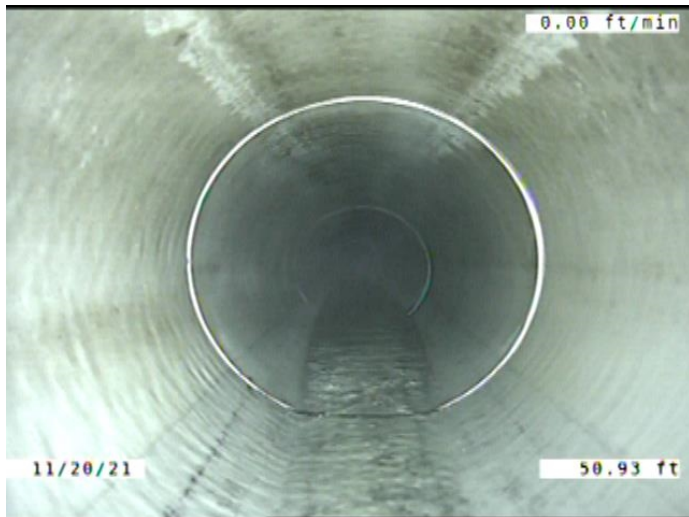
Code: **FM**
 Description: **Fracture Multiple**

Distance (ft): **50.9**
 Structural Grade: **4**
 O&M Grade: **0**
 Clock Start/From: **12**
 Clock To: **12**
 1st Value:
 2nd Value:
 Value Percent:
 Continuous Index: **F05**
 Within 8" of Joint: **YES**
 Remarks:

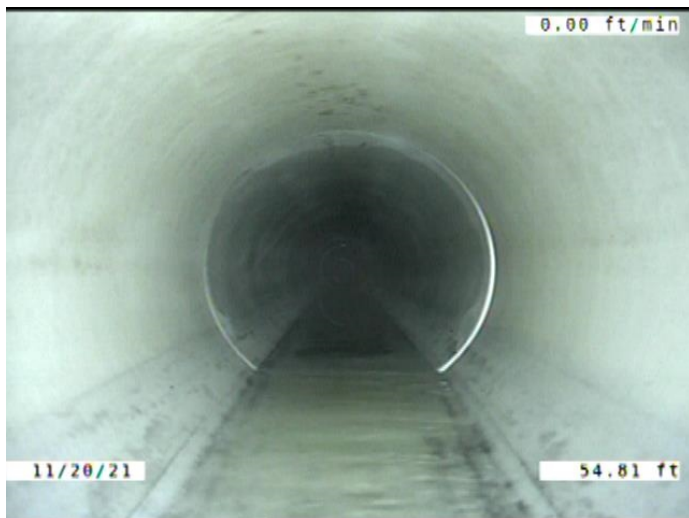
Code: **MWLS**
 Description: **Miscellaneous Water Level Sag**

Distance (ft): **54.8**
 Structural Grade: **2**
 O&M Grade: **0**
 Clock Start/From:
 Clock To:
 1st Value:
 2nd Value:
 Value Percent: **5.000**
 Continuous Index: **S07**
 Within 8" of Joint: **NO**
 Remarks:

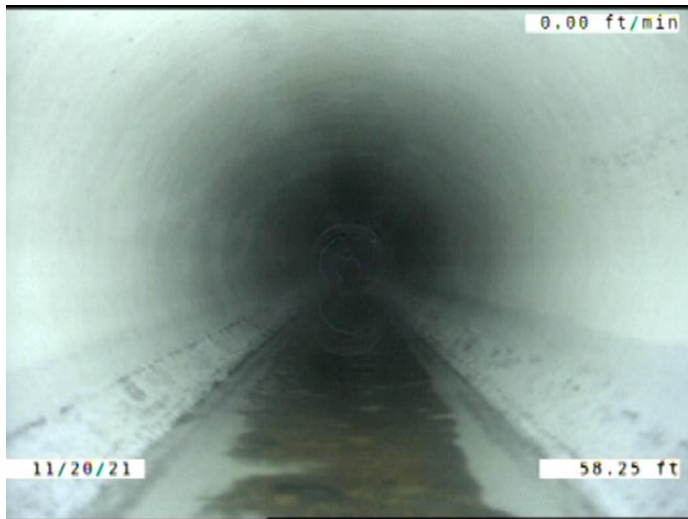
Code: **DSF**
 Description: **Deposits Settled Fine**

Distance (ft): **58.3**
 Structural Grade: **0**
 O&M Grade: **2**
 Clock Start/From: **5**
 Clock To: **7**
 1st Value:
 2nd Value:
 Value Percent: **5.000**
 Continuous Index: **S08**
 Within 8" of Joint: **YES**
 Remarks:

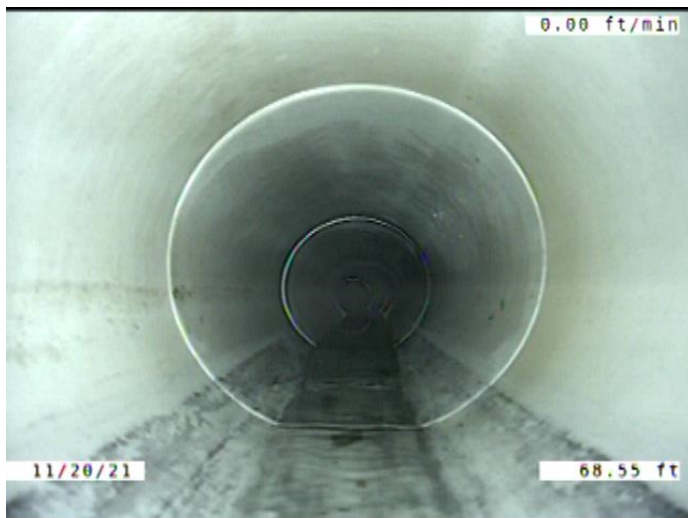
Code: **MWLS**
 Description: **Miscellaneous Water Level Sag**

Distance (ft): **68.5**
 Structural Grade: **2**
 O&M Grade: **0**
 Clock Start/From:
 Clock To:
 1st Value:
 2nd Value:
 Value Percent: **5.000**
 Continuous Index: **F07**
 Within 8" of Joint: **NO**
 Remarks:

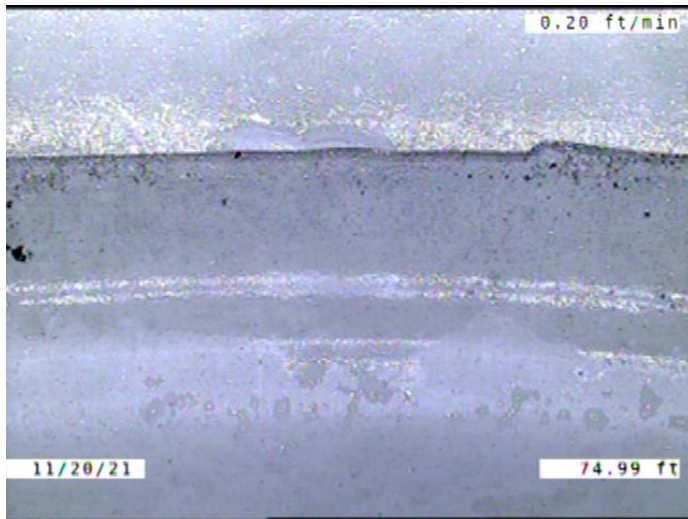
Code:	MGO
Description:	Miscellaneous General Observation
Distance (ft):	75.0
Structural Grade:	0
O&M Grade:	0
Clock Start/From:	
Clock To:	
1st Value:	
2nd Value:	
Value Percent:	
Continuous Index:	
Within 8" of Joint:	NO
Remarks:	JOINT/ PIPES NOT PUSHED ALL THE WAY TOGETHER WHEN INSTALLED

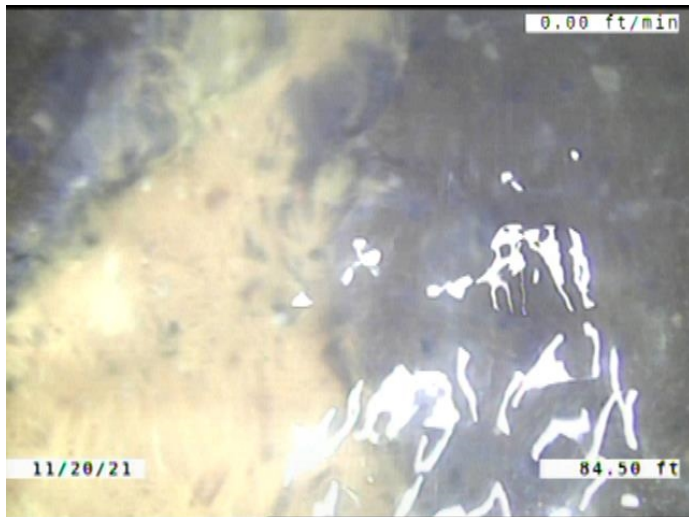
Code: **FM**
 Description: **Fracture Multiple**

Distance (ft): **84.5**
 Structural Grade: **4**
 O&M Grade: **0**
 Clock Start/From: **12**
 Clock To: **12**
 1st Value:
 2nd Value:
 Value Percent:
 Continuous Index: **S09**
 Within 8" of Joint: **YES**
 Remarks:

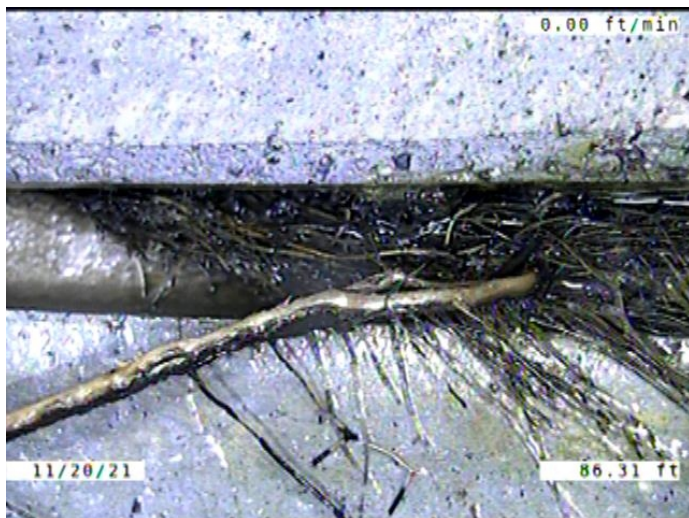
Code: **RFJ**
 Description: **Roots Fine Joint**

Distance (ft): **86.3**
 Structural Grade: **0**
 O&M Grade: **1**
 Clock Start/From: **9**
 Clock To: **4**
 1st Value:
 2nd Value:
 Value Percent:
 Continuous Index: **S10**
 Within 8" of Joint: **YES**
 Remarks:

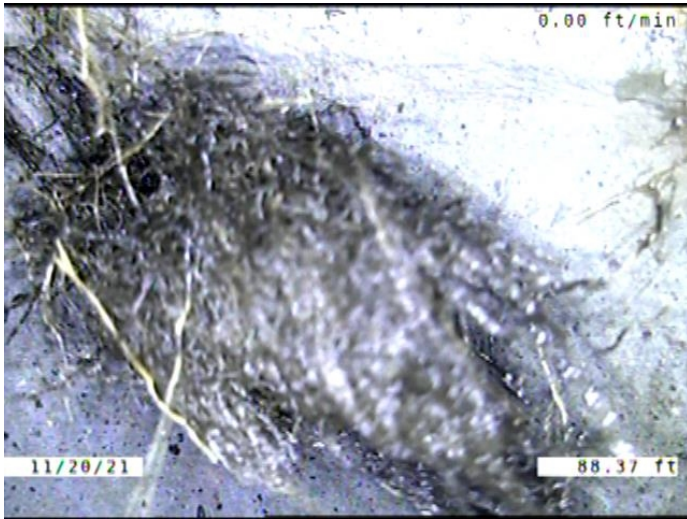
Code: **RMJ**
 Description: **Roots Medium Joint**

Distance (ft): **88.4**
 Structural Grade: **0**
 O&M Grade: **3**
 Clock Start/From: **9**
 Clock To: **3**
 1st Value:
 2nd Value:
 Value Percent: **5.000**
 Continuous Index:
 Within 8" of Joint: **YES**
 Remarks:

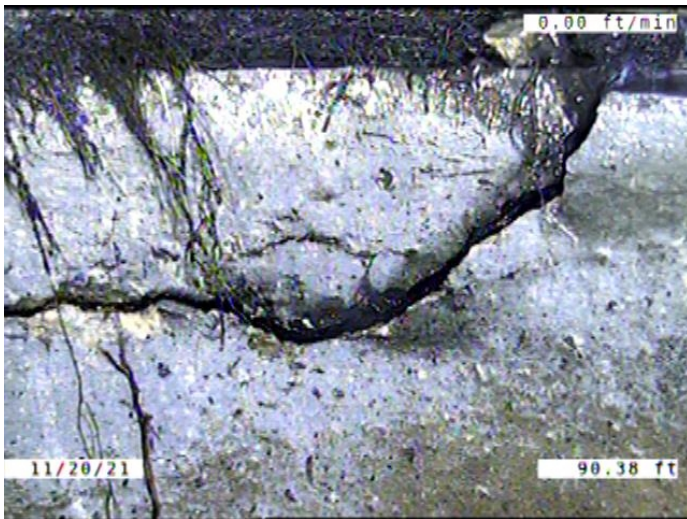
Code: **B**
 Description: **Broken**

Distance (ft): **90.4**
 Structural Grade: **4**
 O&M Grade: **0**
 Clock Start/From: **1**
 Clock To: **3**
 1st Value:
 2nd Value:
 Value Percent:
 Continuous Index:
 Within 8" of Joint: **YES**
 Remarks:

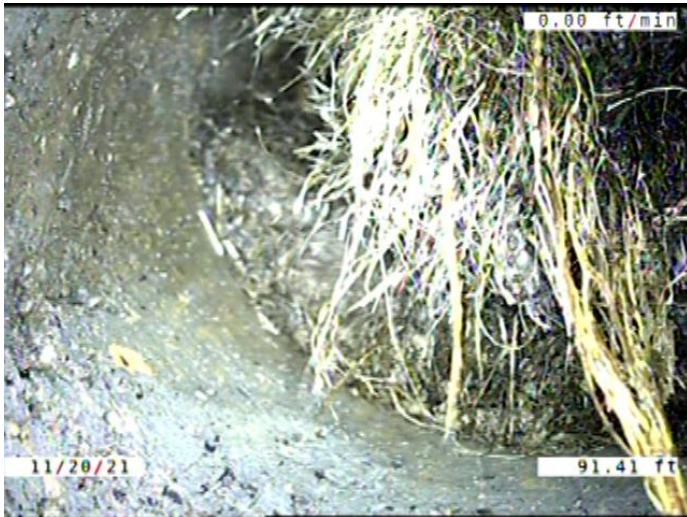
Code:	TFD
Description:	Tap Factory Defective
Distance (ft):	91.4
Structural Grade:	0
O&M Grade:	3
Clock Start/From:	1
Clock To:	
1st Value:	4.000
2nd Value:	
Value Percent:	
Continuous Index:	
Within 8" of Joint:	YES
Remarks:	BROKEN. LOOKS TO BE 100% PLUGGED WITH ROOTS

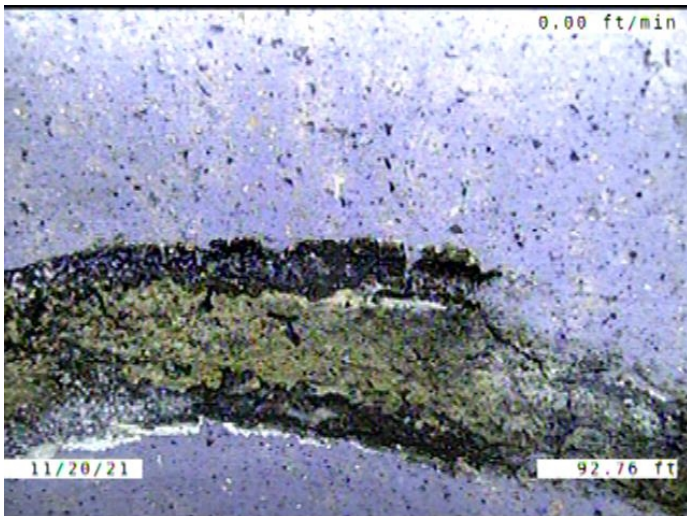
Code:	DAE
Description:	Deposits Attached Encrustation
Distance (ft):	92.8
Structural Grade:	0
O&M Grade:	2
Clock Start/From:	9
Clock To:	4
1st Value:	
2nd Value:	
Value Percent:	5.000
Continuous Index:	
Within 8" of Joint:	NO
Remarks:

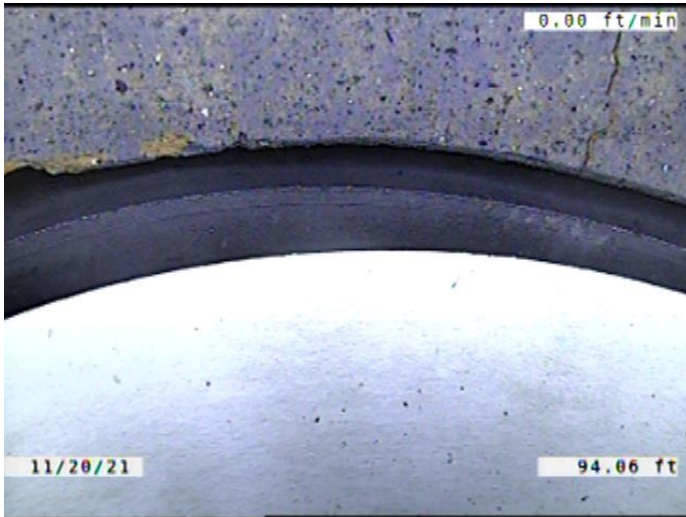
Code: **JOL**
 Description: **Joint Offset Large**

Distance (ft): **94.1**
 Structural Grade: **4**
 O&M Grade: **0**
 Clock Start/From:
 Clock To:
 1st Value: **1.000**
 2nd Value:
 Value Percent:
 Continuous Index:
 Within 8" of Joint: **NO**
 Remarks:

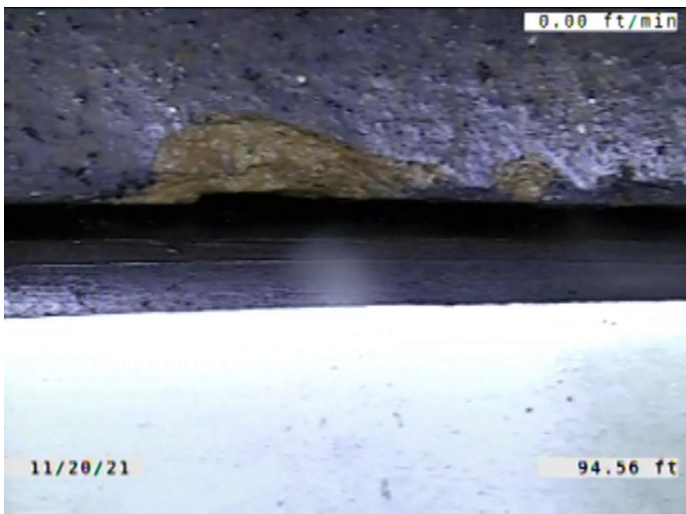
Code: **SSS**
 Description: **Surface Damage Surface Spalling**

Distance (ft): **94.5**
 Structural Grade: **2**
 O&M Grade: **0**
 Clock Start/From: **11**
 Clock To:
 1st Value:
 2nd Value:
 Value Percent:
 Continuous Index:
 Within 8" of Joint: **YES**
 Remarks:

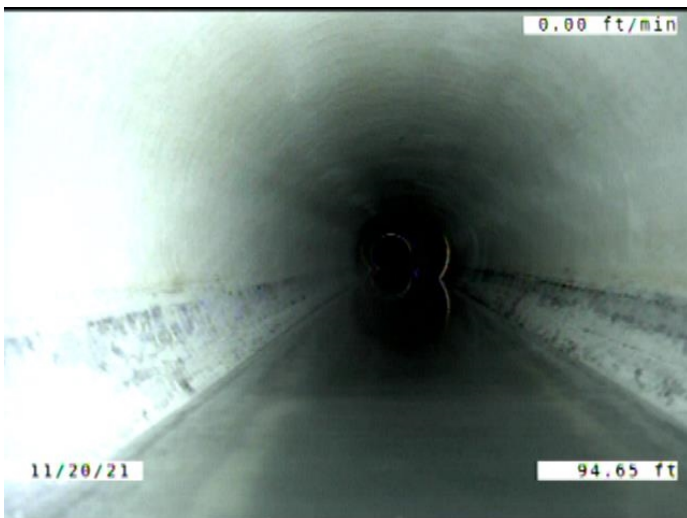
Code: **FM**
Description: **Fracture Multiple**

Distance (ft): **94.7**
Structural Grade: **4**
O&M Grade: **0**
Clock Start/From: **12**
Clock To: **12**
1st Value:
2nd Value:
Value Percent:
Continuous Index: **F09**
Within 8" of Joint: **YES**
Remarks:

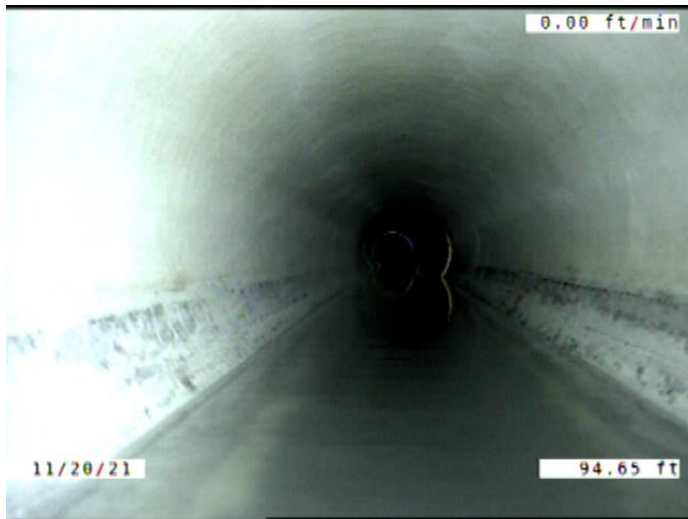
Code: **RFJ**
Description: **Roots Fine Joint**

Distance (ft): **94.7**
Structural Grade: **0**
O&M Grade: **1**
Clock Start/From: **9**
Clock To: **4**
1st Value:
2nd Value:
Value Percent:
Continuous Index: **F10**
Within 8" of Joint: **YES**
Remarks:

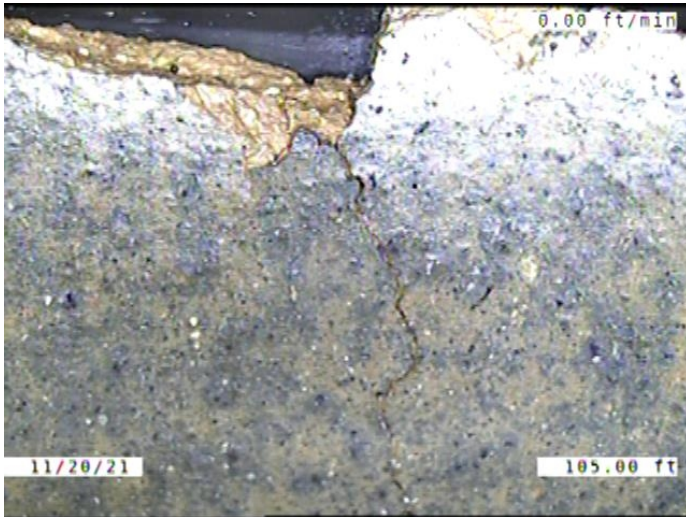
Code: **FM**
 Description: **Fracture Multiple**

Distance (ft): **105.0**
 Structural Grade: **4**
 O&M Grade: **0**
 Clock Start/From: **8**
 Clock To: **4**
 1st Value:
 2nd Value:
 Value Percent:
 Continuous Index: **S11**
 Within 8" of Joint: **YES**
 Remarks:

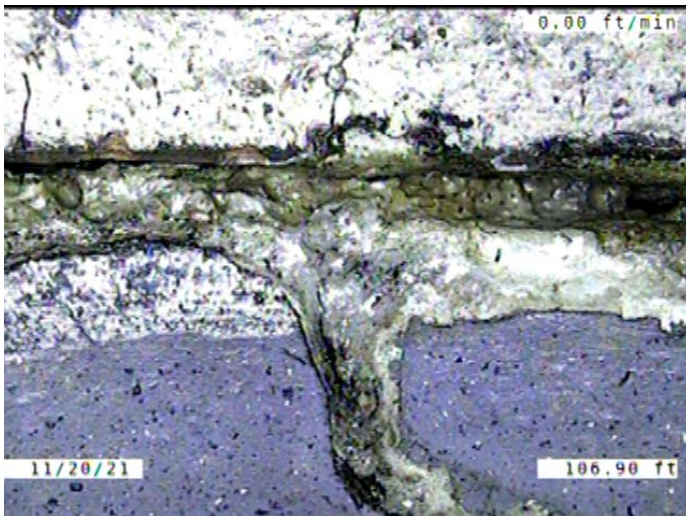
Code: **DAE**
 Description: **Deposits Attached Encrustation**

Distance (ft): **106.9**
 Structural Grade: **0**
 O&M Grade: **2**
 Clock Start/From: **8**
 Clock To: **4**
 1st Value:
 2nd Value:
 Value Percent: **5.000**
 Continuous Index: **S12**
 Within 8" of Joint: **YES**
 Remarks:

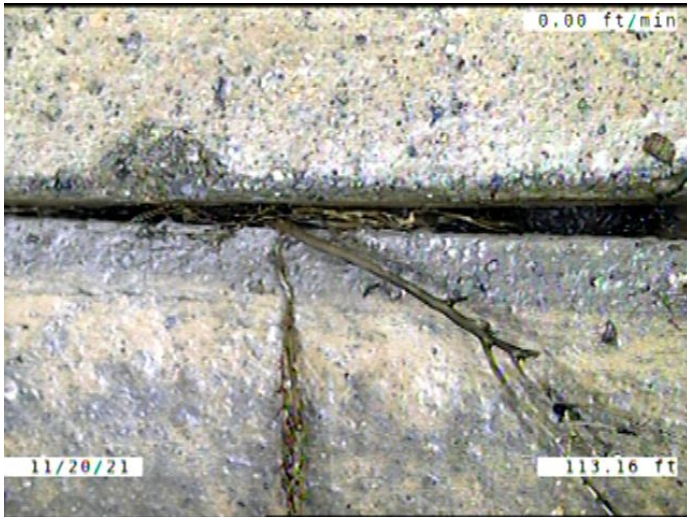
Code: **RFJ**
 Description: **Roots Fine Joint**

Distance (ft): **113.2**
 Structural Grade: **0**
 O&M Grade: **1**
 Clock Start/From: **9**
 Clock To: **4**
 1st Value:
 2nd Value:
 Value Percent:
 Continuous Index: **S13**
 Within 8" of Joint: **YES**
 Remarks:

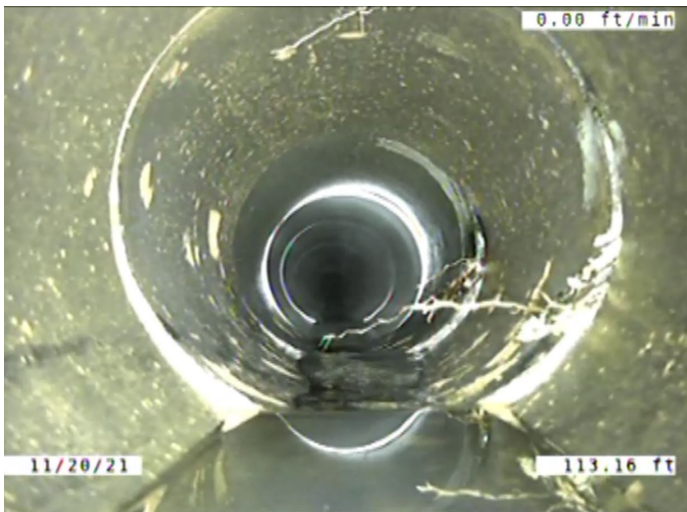
Code: **SSS**
 Description: **Surface Damage Surface Spalling**

Distance (ft): **113.2**
 Structural Grade: **2**
 O&M Grade: **0**
 Clock Start/From: **12**
 Clock To: **12**
 1st Value:
 2nd Value:
 Value Percent:
 Continuous Index:
 Within 8" of Joint: **NO**
 Remarks: **Wandering**

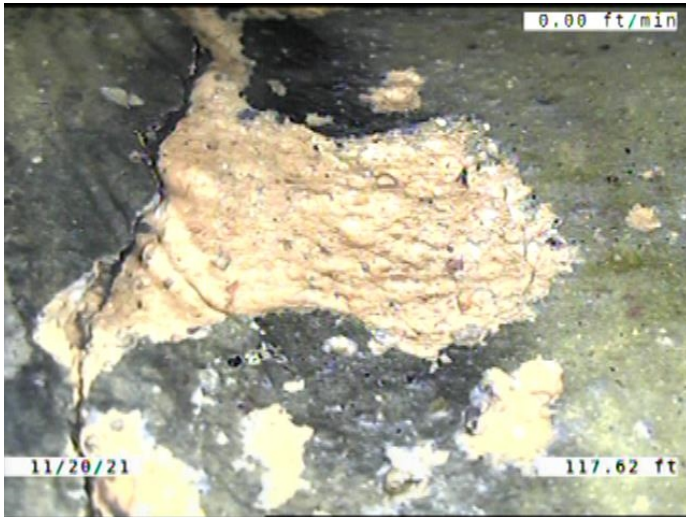
Code: **SSS**
 Description: **Surface Damage Surface Spalling**

Distance (ft): **117.6**
 Structural Grade: **2**
 O&M Grade: **0**
 Clock Start/From: **4**
 Clock To: **8**
 1st Value:
 2nd Value:
 Value Percent:
 Continuous Index:
 Within 8" of Joint: **YES**
 Remarks:

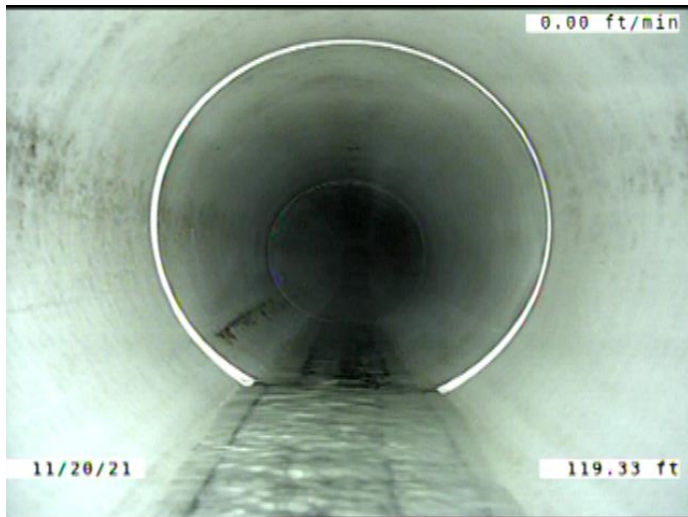
Code: **FM**
Description: **Fracture Multiple**

Distance (ft): **119.3**
Structural Grade: **4**
O&M Grade: **0**
Clock Start/From: **8**
Clock To: **4**
1st Value:
2nd Value:
Value Percent:
Continuous Index: **F11**
Within 8" of Joint: **YES**
Remarks:

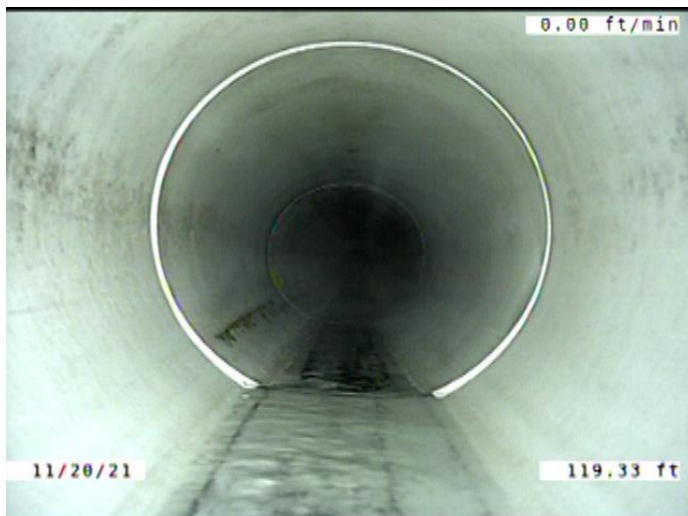
Code: **DAE**
Description: **Deposits Attached Encrustation**

Distance (ft): **119.3**
Structural Grade: **0**
O&M Grade: **2**
Clock Start/From: **8**
Clock To: **4**
1st Value:
2nd Value:
Value Percent: **5.000**
Continuous Index: **F12**
Within 8" of Joint: **YES**
Remarks:

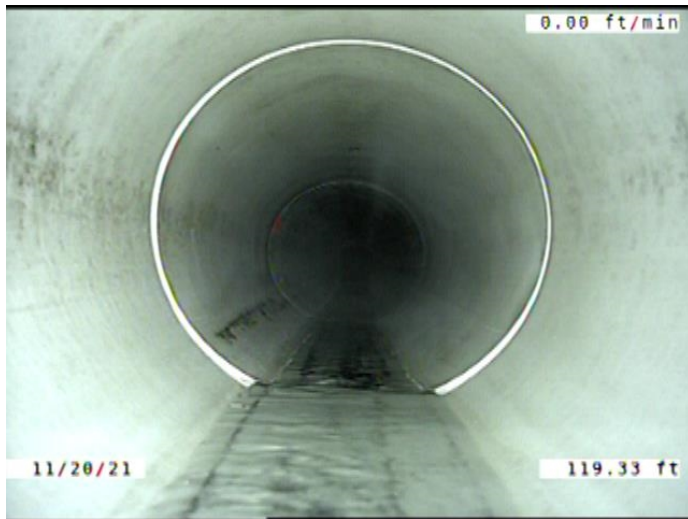
Code: **RFJ**
Description: **Roots Fine Joint**

Distance (ft): **119.3**
Structural Grade: **0**
O&M Grade: **1**
Clock Start/From: **9**
Clock To: **4**
1st Value:
2nd Value:
Value Percent:
Continuous Index: **F13**
Within 8" of Joint: **YES**
Remarks:

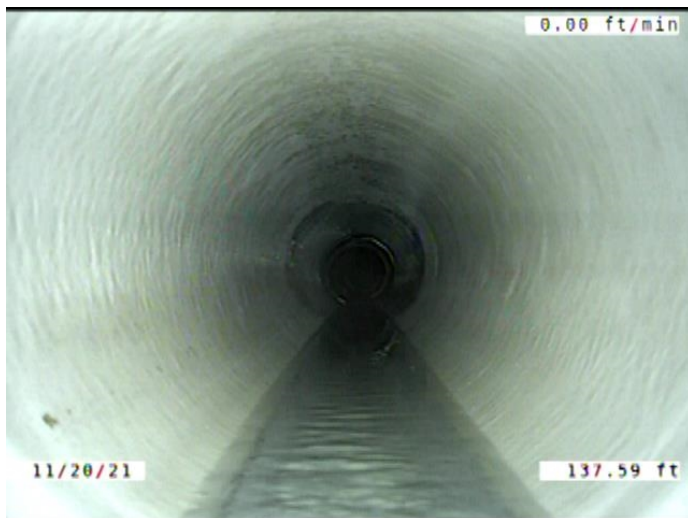
Code: **MWLS**
Description: **Miscellaneous Water Level Sag**

Distance (ft): **137.6**
Structural Grade: **2**
O&M Grade: **0**
Clock Start/From:
Clock To:
1st Value:
2nd Value:
Value Percent: **5.000**
Continuous Index:
Within 8" of Joint: **NO**
Remarks:

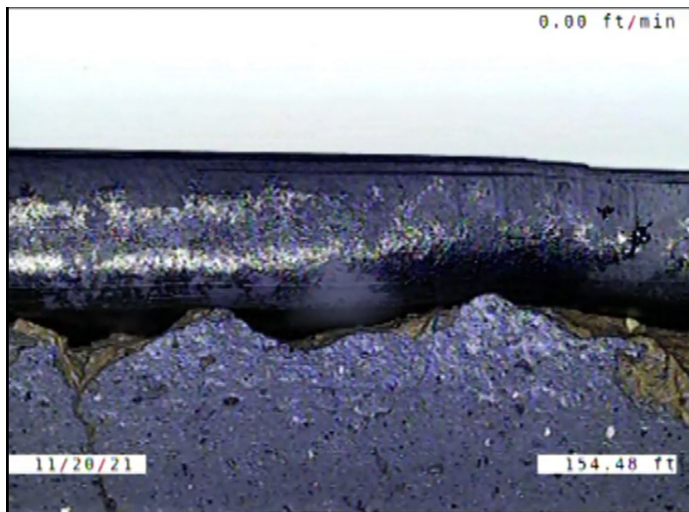
Code:	FM
Description:	Fracture Multiple
Distance (ft):	154.5
Structural Grade:	4
O&M Grade:	0
Clock Start/From:	10
Clock To:	2
1st Value:	
2nd Value:	
Value Percent:	
Continuous Index:	
Within 8" of Joint:	YES
Remarks:

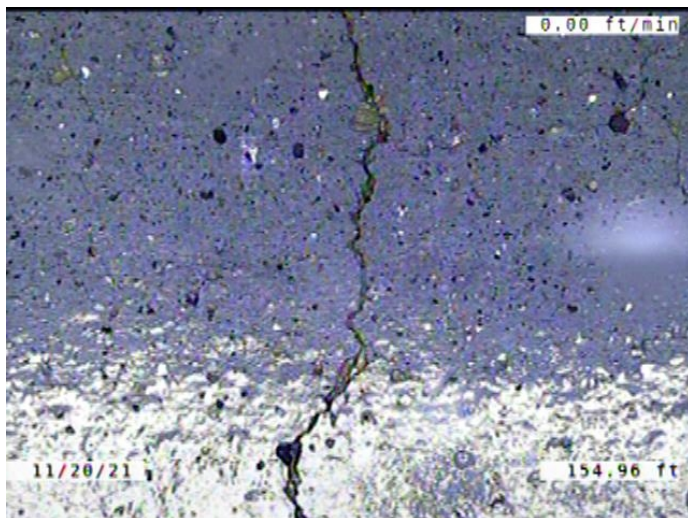
Code: **CM**
 Description: **Crack Multiple**

Distance (ft): **155.0**
 Structural Grade: **3**
 O&M Grade: **0**
 Clock Start/From: **11**
 Clock To: **1**
 1st Value:
 2nd Value:
 Value Percent:
 Continuous Index:
 Within 8" of Joint: **YES**
 Remarks:

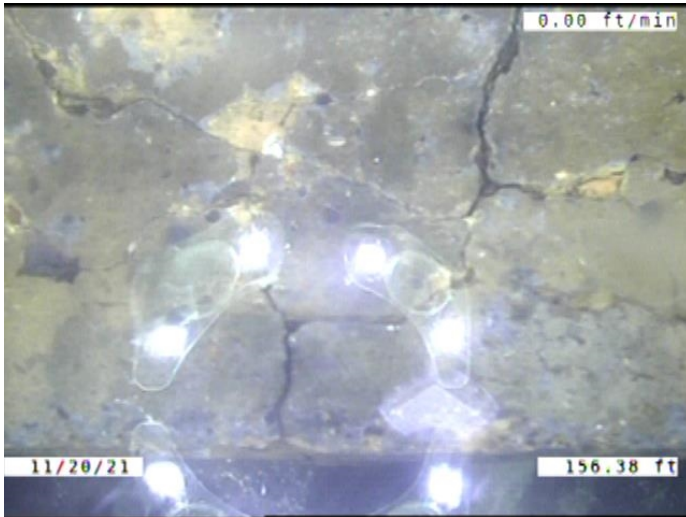
Code: **B**
 Description: **Broken**

Distance (ft): **156.4**
 Structural Grade: **4**
 O&M Grade: **0**
 Clock Start/From: **4**
 Clock To: **8**
 1st Value:
 2nd Value:
 Value Percent:
 Continuous Index:
 Within 8" of Joint: **YES**
 Remarks:

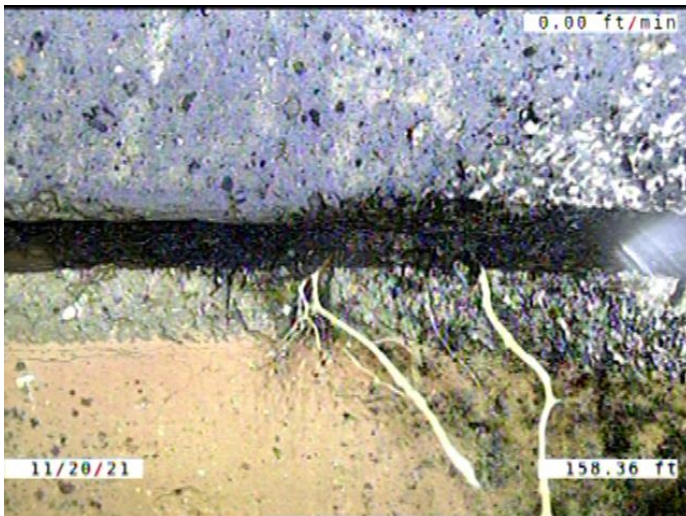
Code: **RFJ**
 Description: **Roots Fine Joint**

Distance (ft): **158.4**
 Structural Grade: **0**
 O&M Grade: **1**
 Clock Start/From: **2**
 Clock To: **4**
 1st Value:
 2nd Value:
 Value Percent:
 Continuous Index:
 Within 8" of Joint: **YES**
 Remarks:
