Profile/Photo Observation Report

Date:	11/20/2021	Weather:		Coding:	PACP 7.0
Pipe Length (ft):	170.0	Owner:	City of Hobart	Pre Clean:	Heavy Cleaning
P.O.#:	YES502259	Surveyor:	S. Bucklin	PSR:	P-604-095-094
Customer:	City of Hobart	Clean Date:	11/20/2021	Shape:	C

Street:	North Pennsylvania Street	Flow Control:	Not Controlled
City:	Hobart, IN	Year Renewed:	
Location:	Local rural streets with light traffic, t	Tape/Media #:	
Purpose:	Routine Assessment	Dia/Height:	12"
Use:	Sanitary Sewage Pipe	Material:	VCP
Drain Area:		Lining:	None
Category:	NA		
Comment:			
Location Details:		Direction of Survey:	Downstream
US MH:	M-604-094	DS MH:	M-604-095
		Total Length Surveyed (ft):	170.0

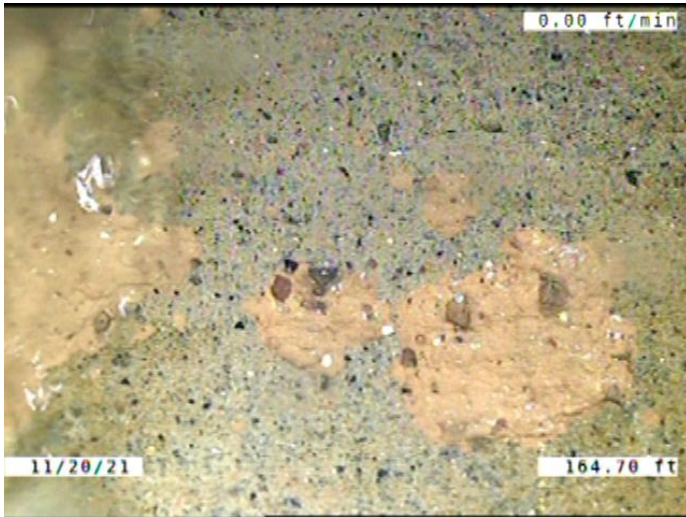
Code: **SSS**
 Description: **Surface Damage Surface Spalling**

Distance (ft): **164.7**
 Structural Grade: **2**
 O&M Grade: **0**
 Clock Start/From: **4**
 Clock To: **7**
 1st Value:
 2nd Value:
 Value Percent:
 Continuous Index:
 Within 8" of Joint: **YES**
 Remarks:

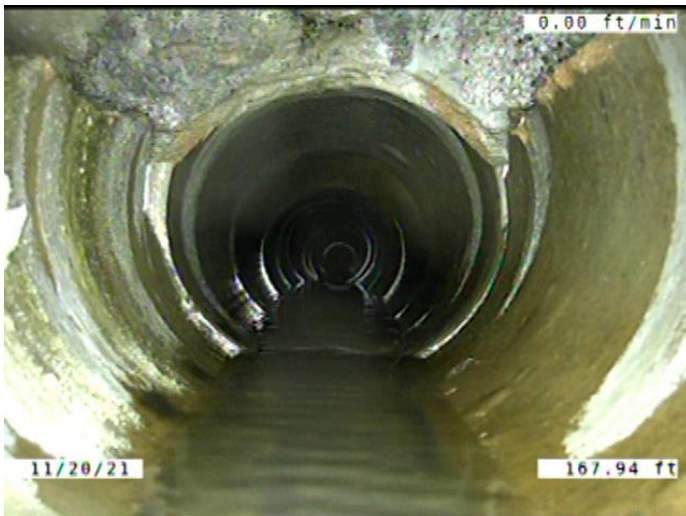
Code: **DSF**
 Description: **Deposits Settled Fine**

Distance (ft): **167.9**
 Structural Grade: **0**
 O&M Grade: **2**
 Clock Start/From: **5**
 Clock To: **7**
 1st Value:
 2nd Value:
 Value Percent: **5.000**
 Continuous Index: **F08**
 Within 8" of Joint: **YES**
 Remarks:
