## Profile/Photo Observation Report

Street:	<b>N PENNSYLVANIA ST</b>	Flow Control:	<b>Not Controlled</b>
City:	<b>Hobart, IN</b>	Year Renewed:	
Location:	<b>Light Highway</b>	Tape/Media #:	
Purpose:	<b>Not Known</b>	Dia/Height:	<b>12"</b>
Use:	<b>Sanitary</b>	Material:	<b>VCP</b>
Drain Area:	<b>NA</b>	Lining:	
Category:	<b>NA</b>		
Comment:			
Location Details:		Direction of Survey:	<b>Downstream</b>
US MH:	<b>M-604-095</b>	DS MH:	<b>M-604-096</b>
		Total Length Surveyed (ft):	<b>6.5</b>

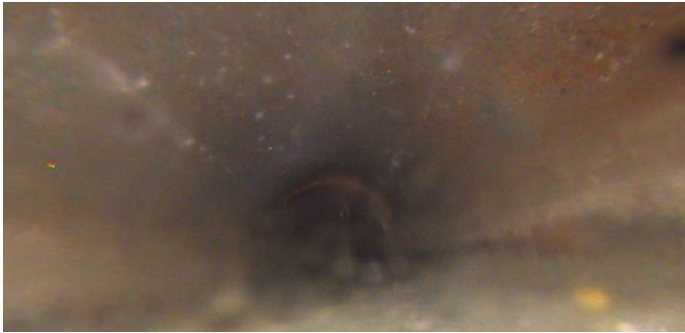
Code:	<b>MWL</b>
Description:	<b>Water Level</b>

Distance (ft):	<b>.0</b>
Structural Grade:	<b>0</b>
O&M Grade:	<b>0</b>
Clock Start/From:	
Clock To:	
1st Value:	
2nd Value:	
Value Percent:	<b>40.000</b>
Continuous Index:	
Within 8" of Joint:	<b>NO</b>
Remarks:

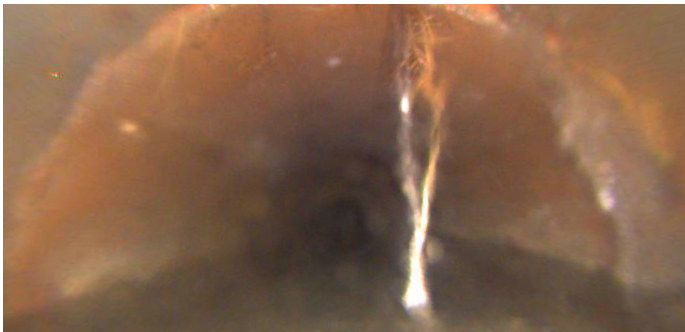
Code:	<b>RFJ</b>
Description:	<b>Roots Fine Joint</b>

Distance (ft):	<b>2.8</b>
Structural Grade:	<b>0</b>
O&M Grade:	<b>1</b>
Clock Start/From:	<b>11</b>
Clock To:	<b>1</b>
1st Value:	
2nd Value:	
Value Percent:	
Continuous Index:	
Within 8" of Joint:	<b>YES</b>
Remarks:

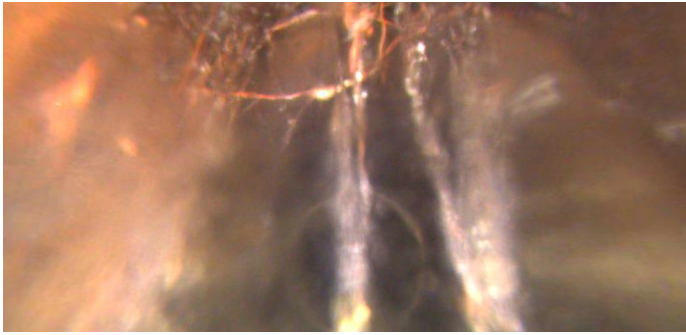
Code: **RMJ**  
Description: **Roots Medium Joint**

Distance (ft): **4.9**  
Structural Grade: **0**  
O&M Grade: **3**  
Clock Start/From: **8**  
Clock To: **4**  
1st Value:  
2nd Value:  
Value Percent: **20.000**  
Continuous Index:  
Within 8" of Joint: **YES**  
Remarks:

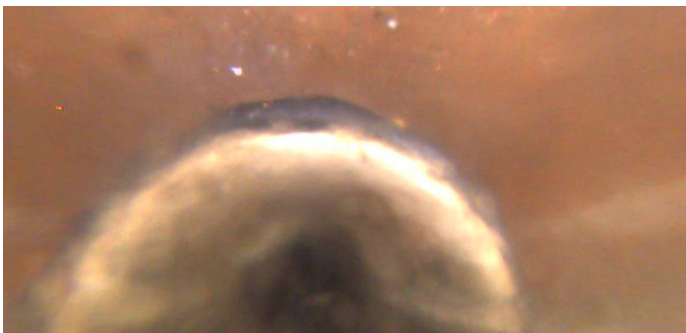
Code: **MSA**  
Description: **Abandoned Survey**

Distance (ft): **6.5**  
Structural Grade: **0**  
O&M Grade: **0**  
Clock Start/From:  
Clock To:  
1st Value:  
2nd Value:  
Value Percent:  
Continuous Index:  
Within 8" of Joint: **NO**  
Remarks: **roots**
