Profile/Photo Observation Report

Date:	04/22/2018	Weather:		Coding:	PACP 6.0
Pipe Length (ft):	170.0	Owner:	NA	Pre Clean:	Not Known
P.O.#:		Surveyor:	Jen Costello	PSR:	P-604-096-095
Customer:		Clean Date:	01/01/1900	Shape:	C

Street:	Summerlin	Flow Control:	Not Controlled
City:	Hobart, IN	Year Renewed:	
Location:	Light Highway	Tape/Media #:	
Purpose:	Not Known	Dia/Height:	12"
Use:	Sanitary	Material:	VCP
Drain Area:	NA	Lining:	
Category:	NA		
Comment:

Location Details:		Direction of Survey:	Upstream
US MH:	M-604-095	DS MH:	M-604-096
		Total Length Surveyed (ft):	8.3

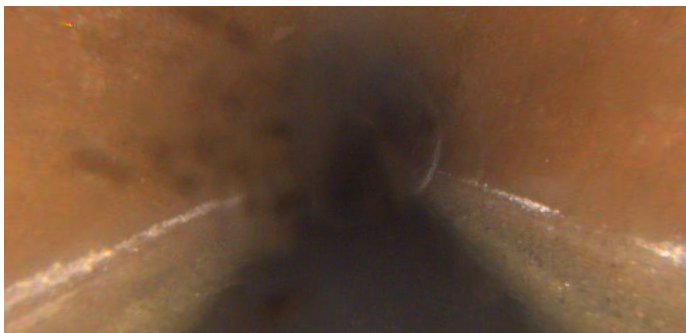
Code: **AMH**
Description: **Manhole**

Distance (ft): **.0**
Structural Grade: **0**
O&M Grade: **0**
Clock Start/From:
Clock To:
1st Value:
2nd Value:
Value Percent:
Continuous Index:
Within 8" of Joint: **NO**
Remarks: **M-604-095**

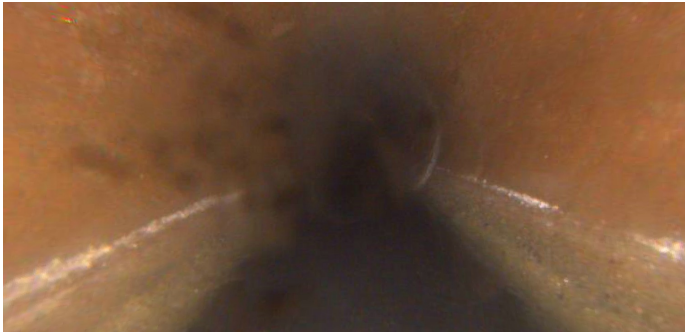
Code:	MWL
Description:	Water Level

Distance (ft):	.0
Structural Grade:	0
O&M Grade:	0
Clock Start/From:	
Clock To:	
1st Value:	
2nd Value:	
Value Percent:	10.000
Continuous Index:	
Within 8" of Joint:	NO
Remarks:

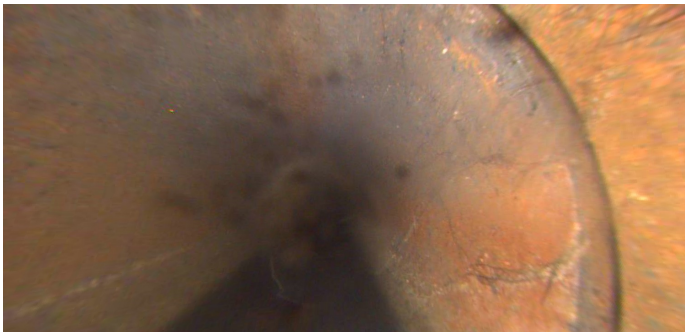
Code:	RFJ
Description:	Roots Fine Joint

Distance (ft):	2.7
Structural Grade:	0
O&M Grade:	1
Clock Start/From:	8
Clock To:	4
1st Value:	
2nd Value:	
Value Percent:	
Continuous Index:	
Within 8" of Joint:	YES
Remarks:

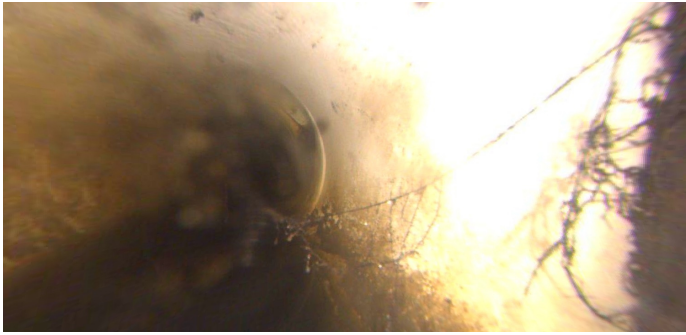
Code: **RFJ**
Description: **Roots Fine Joint**

Distance (ft): **4.9**
Structural Grade: **0**
O&M Grade: **1**
Clock Start/From: **2**
Clock To: **4**
1st Value:
2nd Value:
Value Percent:
Continuous Index:
Within 8" of Joint: **YES**
Remarks:

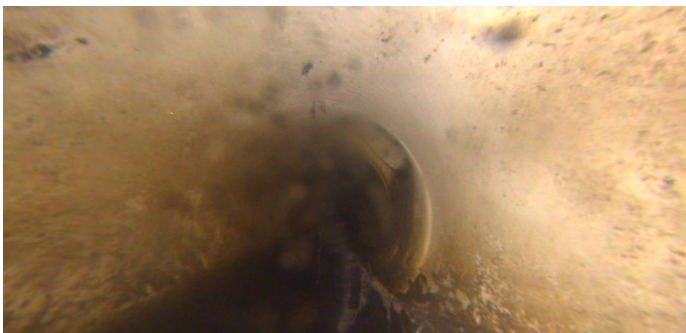
Code: **MMC**
Description: **Material Change**

Distance (ft): **5.0**
Structural Grade: **0**
O&M Grade: **0**
Clock Start/From:
Clock To:
1st Value:
2nd Value:
Value Percent:
Continuous Index:
Within 8" of Joint: **NO**
Remarks: **PVC**

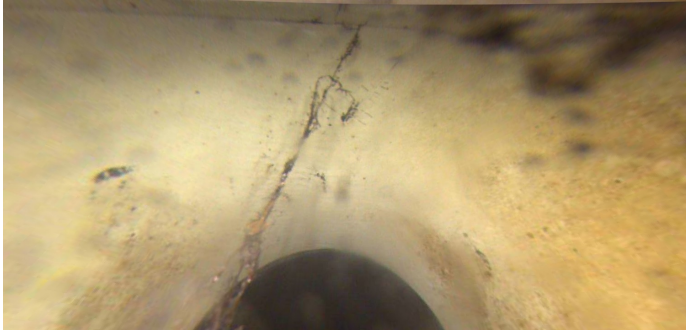
Code: **RFJ**
Description: **Roots Fine Joint**

Distance (ft): **5.9**
Structural Grade: **0**
O&M Grade: **1**
Clock Start/From: **12**
Clock To:
1st Value:
2nd Value:
Value Percent:
Continuous Index:
Within 8" of Joint: **YES**
Remarks:

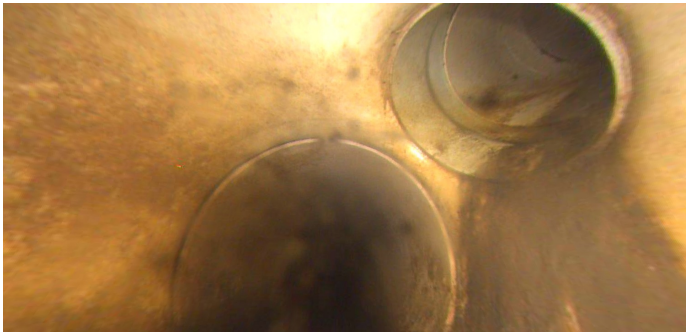
Code: **TF**
Description: **Tap Factory**

Distance (ft): **5.9**
Structural Grade: **0**
O&M Grade: **0**
Clock Start/From: **2**
Clock To:
1st Value: **4.000**
2nd Value:
Value Percent:
Continuous Index:
Within 8" of Joint:
Remarks:

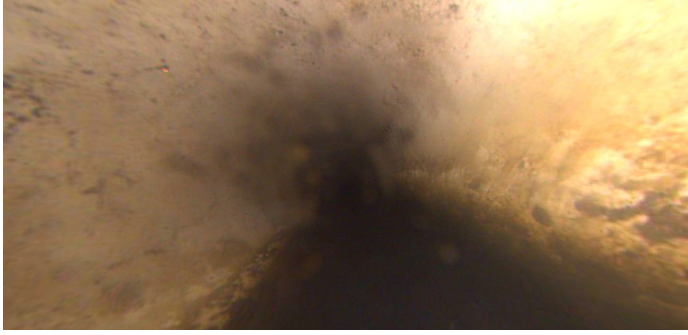
Code:	MSA
Description:	Abandoned Survey
Distance (ft):	8.3
Structural Grade:	0
O&M Grade:	0
Clock Start/From:	
Clock To:	
1st Value:	
2nd Value:	
Value Percent:	
Continuous Index:	
Within 8" of Joint:	NO
Remarks:	debris
