Profile/Photo Observation Report

Date:	11/20/2021	Weather:		Coding:	PACP 7.0
Pipe Length (ft):	166.7	Owner:	City of Hobart	Pre Clean:	Heavy Cleaning
P.O.#:	YES502259	Surveyor:	S. Bucklin	PSR:	P-604-096-095
Customer:	City of Hobart	Clean Date:	11/20/2021	Shape:	C

Street:	North Pennsylvania Street	Flow Control:	Not Controlled
City:	Hobart, IN	Year Renewed:	
Location:	Local rural streets with light traffic, t	Tape/Media #:	
Purpose:	Routine Assessment	Dia/Height:	12"
Use:	Sanitary Sewage Pipe	Material:	VCP
Drain Area:		Lining:	None
Category:	NA		
Comment:			
Location Details:		Direction of Survey:	Downstream
US MH:	M-604-095	DS MH:	M-604-096
		Total Length Surveyed (ft):	166.7

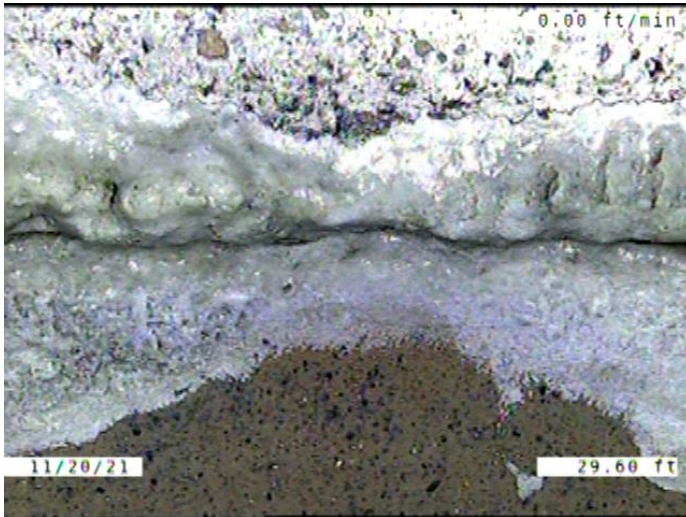
Code: **DAE**
 Description: **Deposits Attached Encrustation**

Distance (ft): **29.6**
 Structural Grade: **0**
 O&M Grade: **2**
 Clock Start/From: **8**
 Clock To: **4**
 1st Value:
 2nd Value:
 Value Percent: **5.000**
 Continuous Index:
 Within 8" of Joint: **YES**
 Remarks:

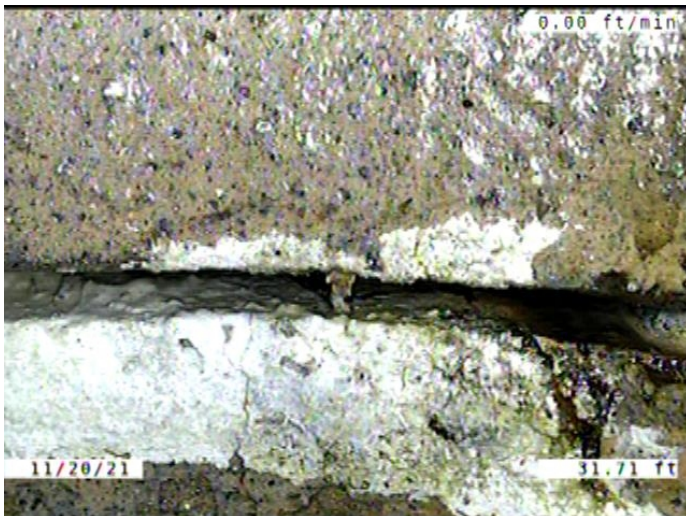
Code: **DAE**
 Description: **Deposits Attached Encrustation**

Distance (ft): **31.7**
 Structural Grade: **0**
 O&M Grade: **2**
 Clock Start/From: **1**
 Clock To: **4**
 1st Value:
 2nd Value:
 Value Percent: **5.000**
 Continuous Index:
 Within 8" of Joint: **YES**
 Remarks:

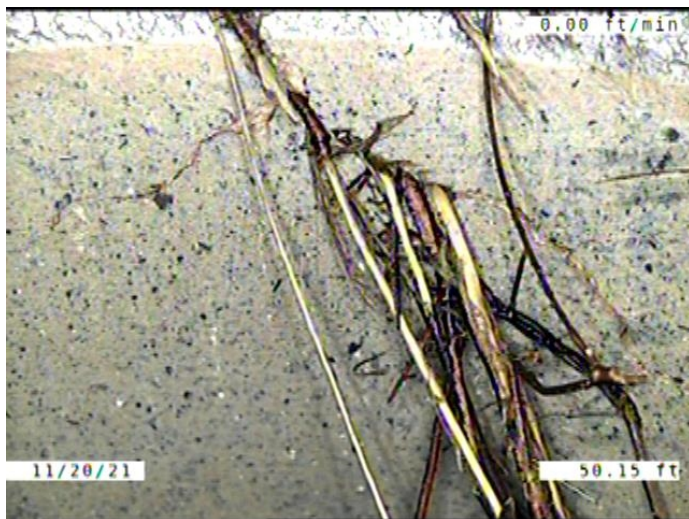
Code: **RMB**
 Description: **Roots Medium Barrel**

Distance (ft): **50.2**
 Structural Grade: **0**
 O&M Grade: **4**
 Clock Start/From: **8**
 Clock To: **4**
 1st Value:
 2nd Value:
 Value Percent: **10.000**
 Continuous Index:
 Within 8" of Joint: **NO**
 Remarks:

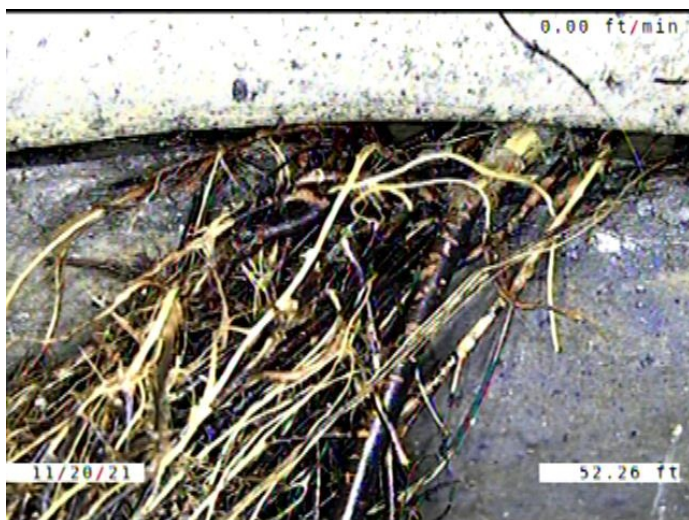
Code: **RMJ**
 Description: **Roots Medium Joint**

Distance (ft): **52.3**
 Structural Grade: **0**
 O&M Grade: **3**
 Clock Start/From: **8**
 Clock To: **4**
 1st Value:
 2nd Value:
 Value Percent: **10.000**
 Continuous Index:
 Within 8" of Joint: **YES**
 Remarks:

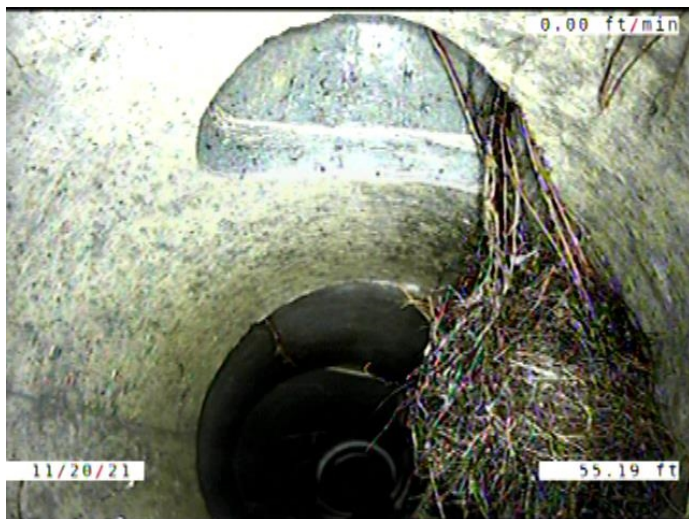
Code: **RML**
 Description: **Roots Medium Lateral**

Distance (ft): **55.2**
 Structural Grade: **0**
 O&M Grade: **3**
 Clock Start/From: **1**
 Clock To: **2**
 1st Value:
 2nd Value:
 Value Percent: **15.000**
 Continuous Index:
 Within 8" of Joint: **NO**
 Remarks:

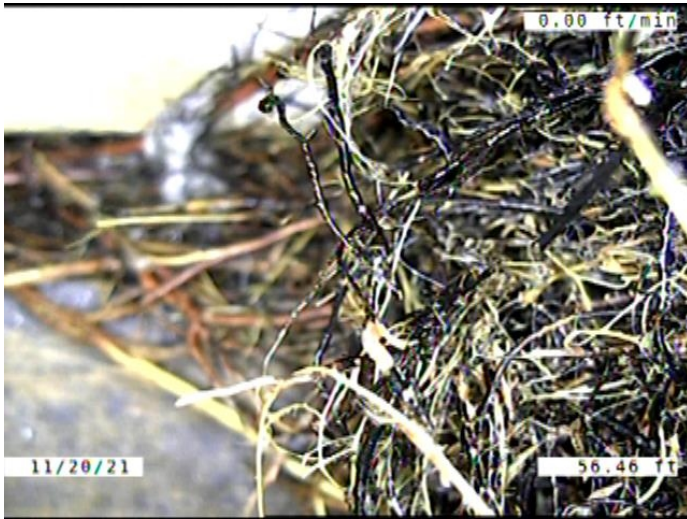
Code: **RMJ**
 Description: **Roots Medium Joint**

Distance (ft): **56.5**
 Structural Grade: **0**
 O&M Grade: **3**
 Clock Start/From: **8**
 Clock To: **4**
 1st Value:
 2nd Value:
 Value Percent: **5.000**
 Continuous Index:
 Within 8" of Joint: **YES**
 Remarks:

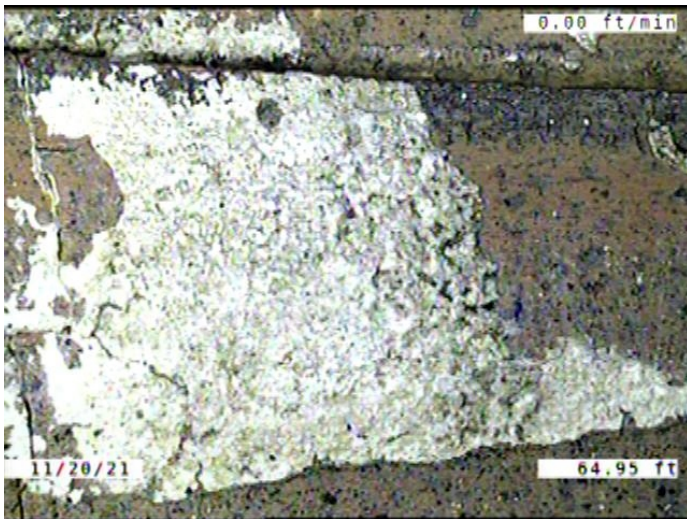
Code: **DAE**
 Description: **Deposits Attached Encrustation**

Distance (ft): **65.0**
 Structural Grade: **0**
 O&M Grade: **2**
 Clock Start/From: **8**
 Clock To: **4**
 1st Value:
 2nd Value:
 Value Percent: **5.000**
 Continuous Index:
 Within 8" of Joint: **YES**
 Remarks:

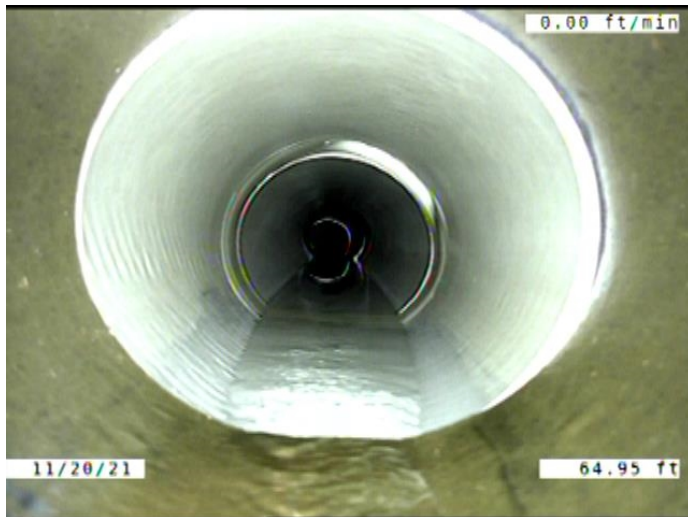
Code: **RFJ**
 Description: **Roots Fine Joint**

Distance (ft): **65.0**
 Structural Grade: **0**
 O&M Grade: **1**
 Clock Start/From: **9**
 Clock To: **3**
 1st Value:
 2nd Value:
 Value Percent:
 Continuous Index: **F03**
 Within 8" of Joint: **YES**
 Remarks:

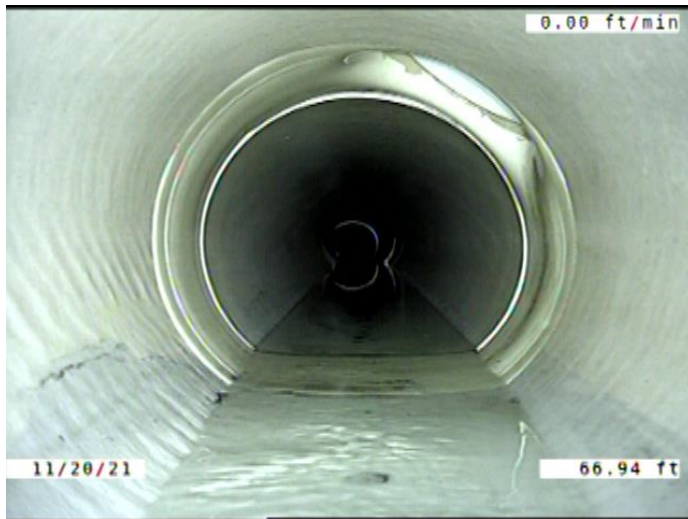
Code: **FM**
 Description: **Fracture Multiple**

Distance (ft): **66.9**
 Structural Grade: **4**
 O&M Grade: **0**
 Clock Start/From: **12**
 Clock To: **12**
 1st Value:
 2nd Value:
 Value Percent:
 Continuous Index: **F02**
 Within 8" of Joint: **YES**
 Remarks:

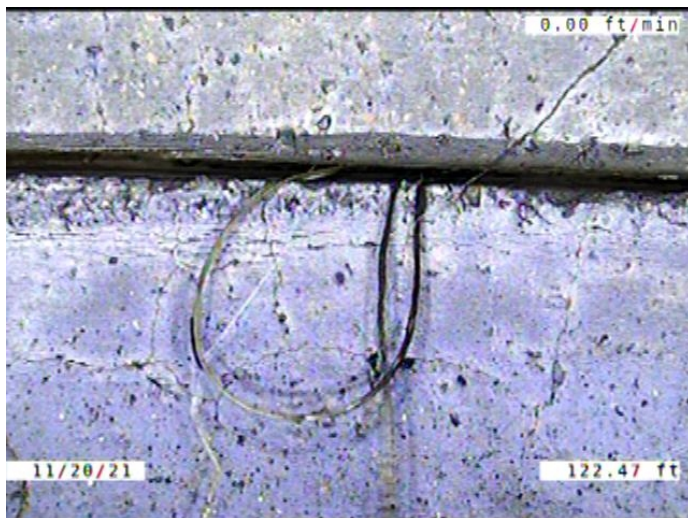
Code: **RFJ**
 Description: **Roots Fine Joint**

Distance (ft): **122.5**
 Structural Grade: **0**
 O&M Grade: **1**
 Clock Start/From: **12**
 Clock To: **1**
 1st Value:
 2nd Value:
 Value Percent:
 Continuous Index:
 Within 8" of Joint: **YES**
 Remarks:

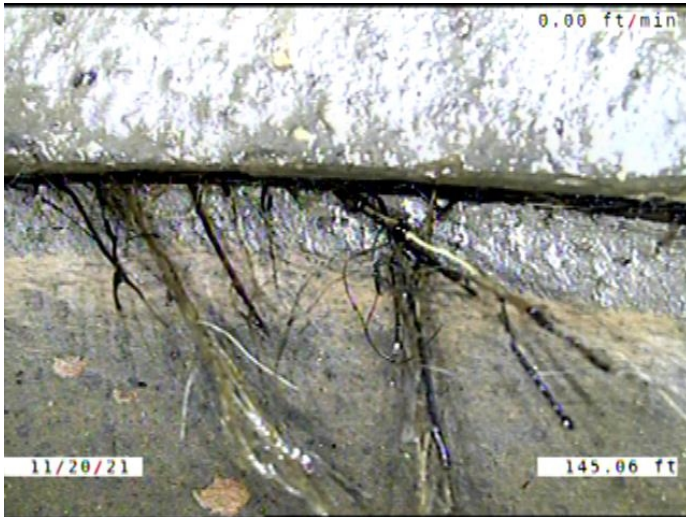
Code: **RFJ**
Description: **Roots Fine Joint**

Distance (ft): **145.1**
Structural Grade: **0**
O&M Grade: **1**
Clock Start/From: **9**
Clock To: **3**
1st Value:
2nd Value:
Value Percent:
Continuous Index:
Within 8" of Joint: **YES**
Remarks:

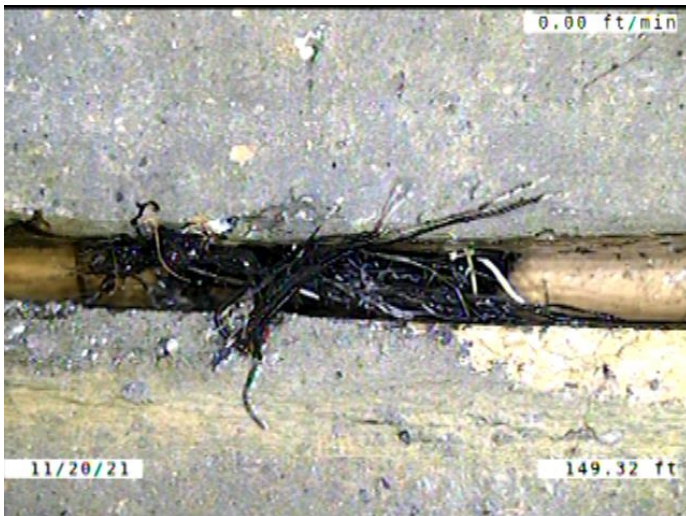
Code: **RFJ**
Description: **Roots Fine Joint**

Distance (ft): **149.3**
Structural Grade: **0**
O&M Grade: **1**
Clock Start/From: **9**
Clock To: **3**
1st Value:
2nd Value:
Value Percent:
Continuous Index:
Within 8" of Joint: **YES**
Remarks:

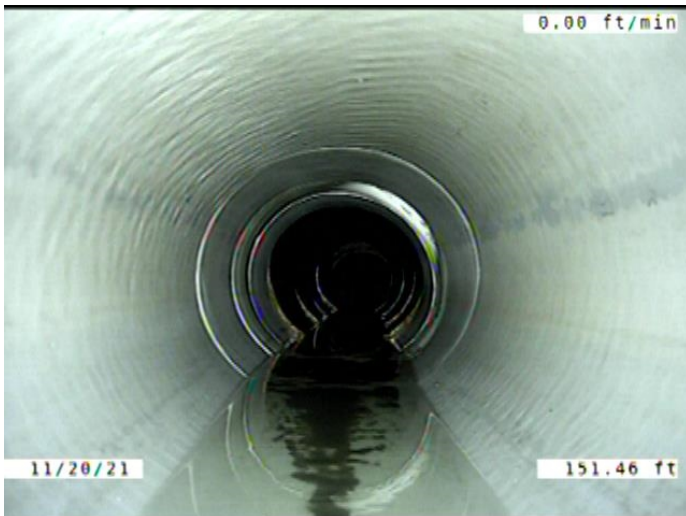
Code:	FM
Description:	Fracture Multiple
Distance (ft):	151.5
Structural Grade:	4
O&M Grade:	0
Clock Start/From:	12
Clock To:	12
1st Value:	
2nd Value:	
Value Percent:	
Continuous Index:	F06
Within 8" of Joint:	YES
Remarks:

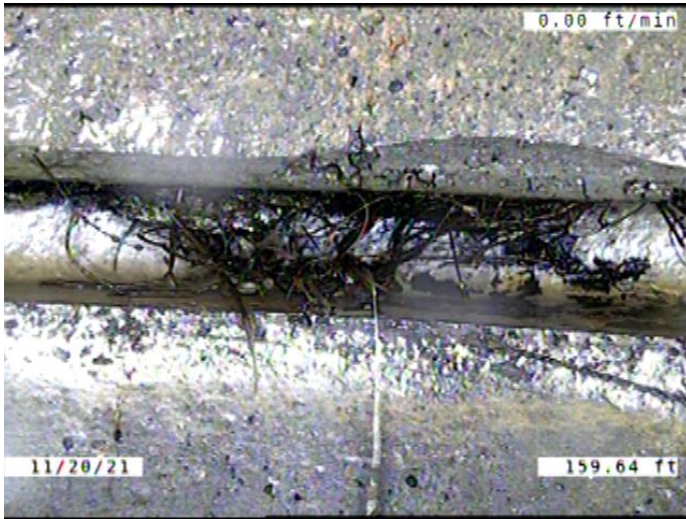
Code: **RFJ**
 Description: **Roots Fine Joint**

Distance (ft): **159.6**
 Structural Grade: **0**
 O&M Grade: **1**
 Clock Start/From: **9**
 Clock To: **3**
 1st Value:
 2nd Value:
 Value Percent:
 Continuous Index:
 Within 8" of Joint: **YES**
 Remarks:

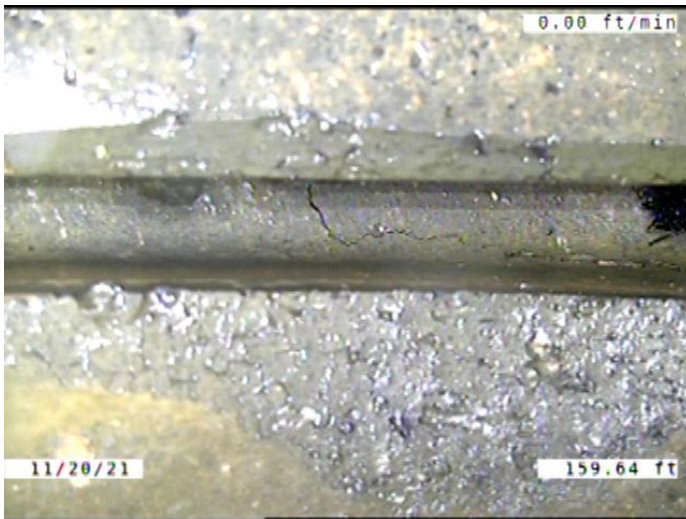
Code: **CM**
 Description: **Crack Multiple**

Distance (ft): **159.6**
 Structural Grade: **3**
 O&M Grade: **0**
 Clock Start/From: **9**
 Clock To: **3**
 1st Value:
 2nd Value:
 Value Percent:
 Continuous Index:
 Within 8" of Joint: **YES**
 Remarks:

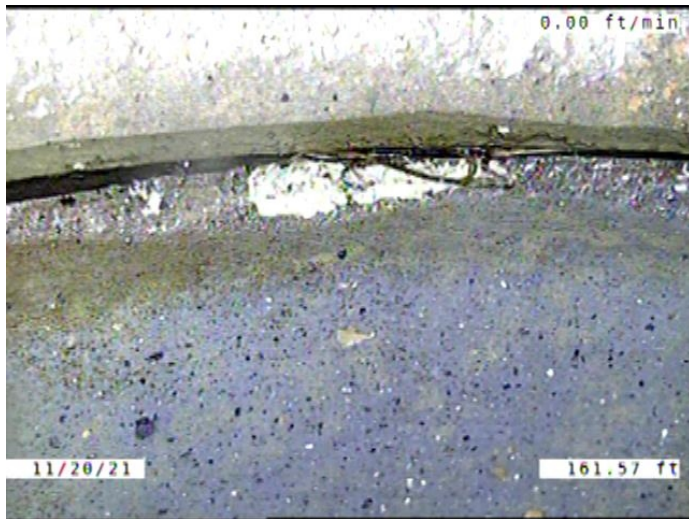
Code: **RFJ**
 Description: **Roots Fine Joint**

Distance (ft): **161.6**
 Structural Grade: **0**
 O&M Grade: **1**
 Clock Start/From: **10**
 Clock To:
 1st Value:
 2nd Value:
 Value Percent:
 Continuous Index:
 Within 8" of Joint: **YES**
 Remarks:

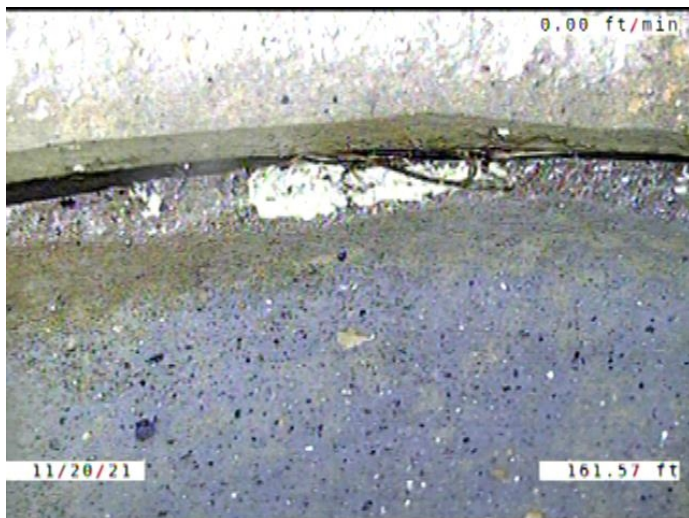
Code: **DAE**
 Description: **Deposits Attached Encrustation**

Distance (ft): **161.6**
 Structural Grade: **0**
 O&M Grade: **2**
 Clock Start/From: **10**
 Clock To:
 1st Value:
 2nd Value:
 Value Percent: **5.000**
 Continuous Index:
 Within 8" of Joint: **YES**
 Remarks:

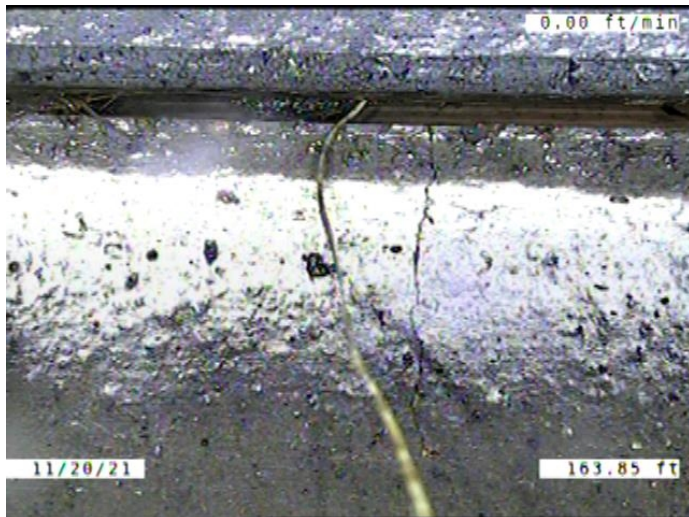
Code: **RFJ**
 Description: **Roots Fine Joint**

Distance (ft): **163.8**
 Structural Grade: **0**
 O&M Grade: **1**
 Clock Start/From: **9**
 Clock To: **3**
 1st Value:
 2nd Value:
 Value Percent:
 Continuous Index:
 Within 8" of Joint: **YES**
 Remarks:

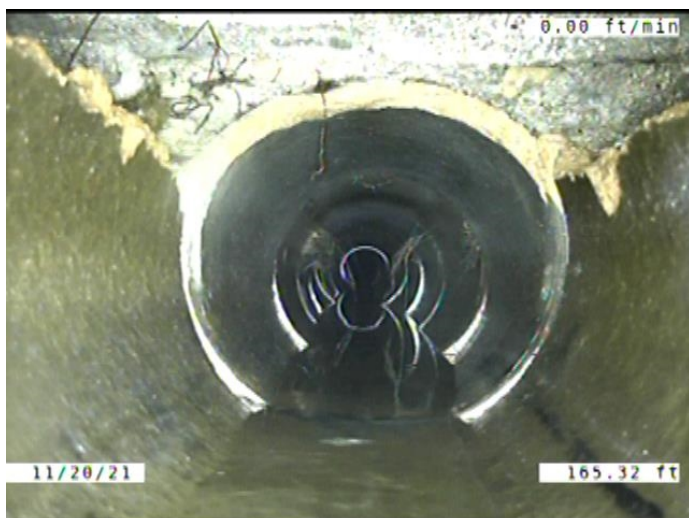
Code: **DSF**
 Description: **Deposits Settled Fine**

Distance (ft): **165.3**
 Structural Grade: **0**
 O&M Grade: **2**
 Clock Start/From: **5**
 Clock To: **7**
 1st Value:
 2nd Value:
 Value Percent: **5.000**
 Continuous Index: **F04**
 Within 8" of Joint: **YES**
 Remarks:
