# Profile/Photo Observation Report

Date:	11/20/2021	Weather:		Coding:	PACP 7.0
Pipe Length (ft):	166.7	Owner:	City of Hobart	Pre Clean:	Heavy Cleaning
P.O.#:	YES502259	Surveyor:	S. Bucklin	PSR:	P-604-096-095
Customer:	City of Hobart	Clean Date:	11/20/2021	Shape:	C

Street:	North Pennsylvania Street	Flow Control:	Not Controlled
City:	Hobart, IN	Year Renewed:	
Location:	Local rural streets with light traffic, t	Tape/Media #:	
Purpose:	Routine Assessment	Dia/Height:	12"
Use:	Sanitary Sewage Pipe	Material:	VCP
Drain Area:		Lining:	None
Category:	NA		
Comment:			
Location Details:		Direction of Survey:	Downstream
US MH:	M-604-095	DS MH:	M-604-096
		Total Length Surveyed (ft):	166.7

O&M Index:	1.83	O&M Quick:	4135	O&M Rating:	84.00
Structural Index:	3.29	Structural Quick:	514B	Structural Rating:	102.00
Overall Index:	2.42	Overall Quick:	514B	Overall Rating:	186.00

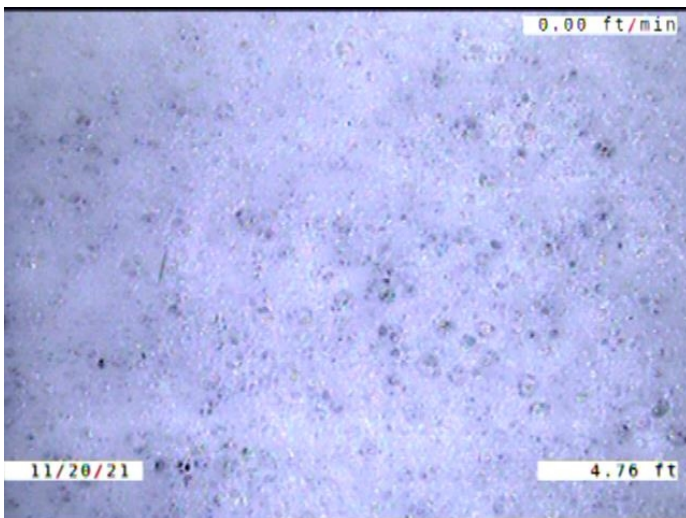
Code: **HSV**  
 Description: **Hole Soil Visible**

Distance (ft): **4.8**  
 Structural Grade: **5**  
 O&M Grade: **0**  
 Clock Start/From: **5**  
 Clock To: **7**  
 1st Value:  
 2nd Value:  
 Value Percent:  
 Continuous Index:  
 Within 8" of Joint: **YES**  
 Remarks: **LOOKS LIKE IT MIGHT STILL HAVE THE FERNCO UNDERNEATH IT.**

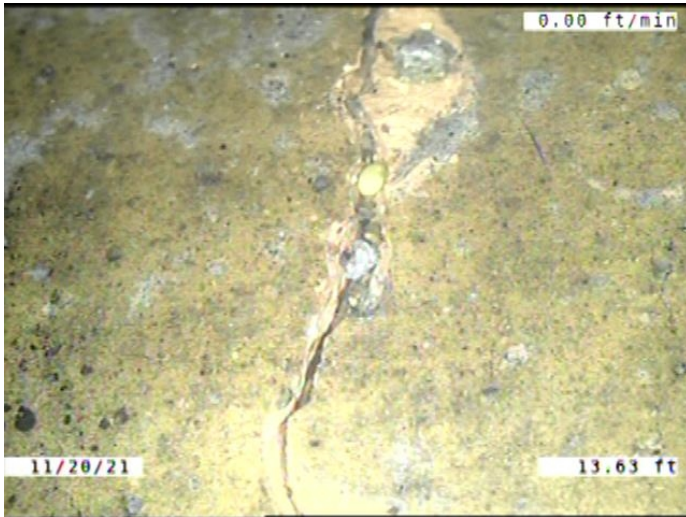
Code: **FM**  
 Description: **Fracture Multiple**

Distance (ft): **13.6**  
 Structural Grade: **4**  
 O&M Grade: **0**  
 Clock Start/From: **12**  
 Clock To: **12**  
 1st Value:  
 2nd Value:  
 Value Percent:  
 Continuous Index: **S02**  
 Within 8" of Joint: **YES**  
 Remarks:

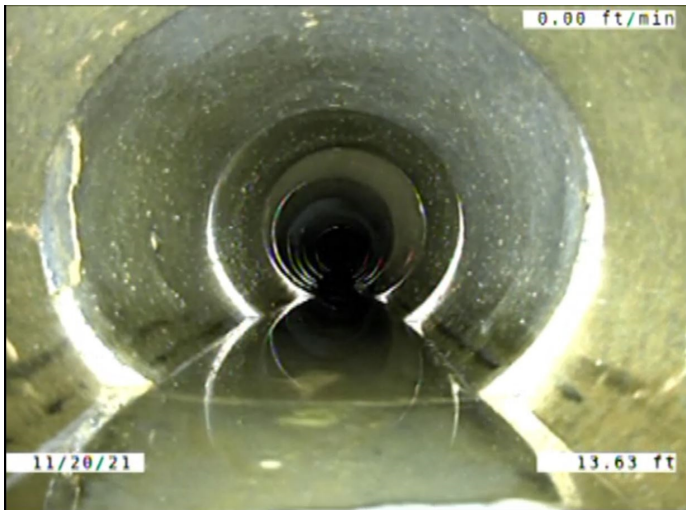
Code: **B**  
 Description: **Broken**

Distance (ft): **13.6**  
 Structural Grade: **4**  
 O&M Grade: **0**  
 Clock Start/From: **9**  
 Clock To:  
 1st Value:  
 2nd Value:  
 Value Percent:  
 Continuous Index:  
 Within 8" of Joint: **YES**  
 Remarks:

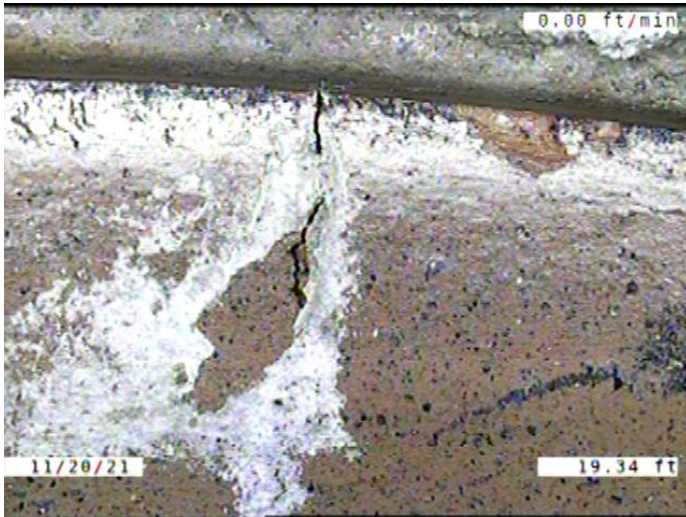
Code: **DAE**  
 Description: **Deposits Attached Encrustation**

Distance (ft): **19.3**  
 Structural Grade: **0**  
 O&M Grade: **2**  
 Clock Start/From: **8**  
 Clock To: **4**  
 1st Value:  
 2nd Value:  
 Value Percent: **5.000**  
 Continuous Index:  
 Within 8" of Joint: **YES**  
 Remarks:

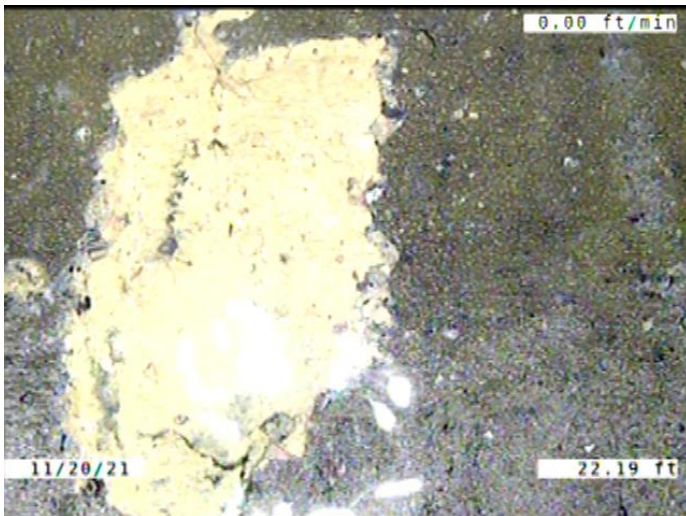
Code: **SSS**  
 Description: **Surface Damage Surface Spalling**

Distance (ft): **22.2**  
 Structural Grade: **2**  
 O&M Grade: **0**  
 Clock Start/From: **6**  
 Clock To:  
 1st Value:  
 2nd Value:  
 Value Percent:  
 Continuous Index:  
 Within 8" of Joint: **YES**  
 Remarks:

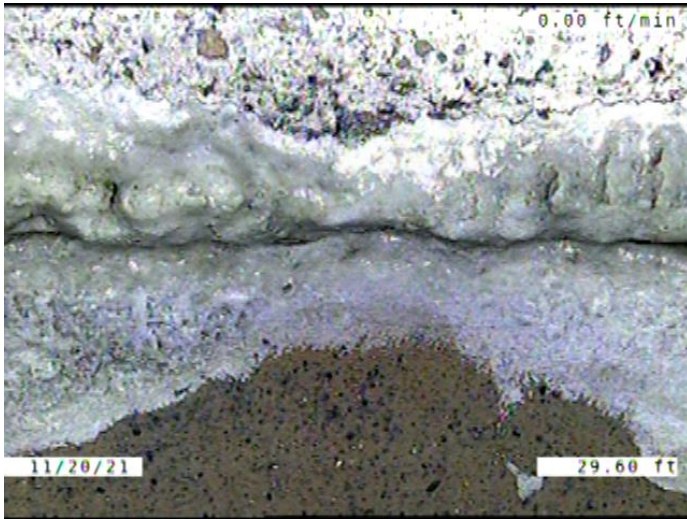
Code: **DAE**  
 Description: **Deposits Attached Encrustation**

Distance (ft): **29.6**  
 Structural Grade: **0**  
 O&M Grade: **2**  
 Clock Start/From: **8**  
 Clock To: **4**  
 1st Value:  
 2nd Value:  
 Value Percent: **5.000**  
 Continuous Index:  
 Within 8" of Joint: **YES**  
 Remarks:

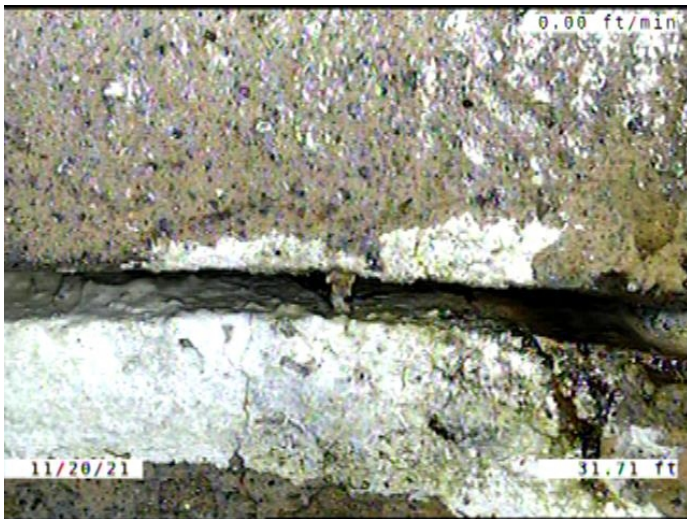
Code: **DAE**  
 Description: **Deposits Attached Encrustation**

Distance (ft): **31.7**  
 Structural Grade: **0**  
 O&M Grade: **2**  
 Clock Start/From: **1**  
 Clock To: **4**  
 1st Value:  
 2nd Value:  
 Value Percent: **5.000**  
 Continuous Index:  
 Within 8" of Joint: **YES**  
 Remarks:

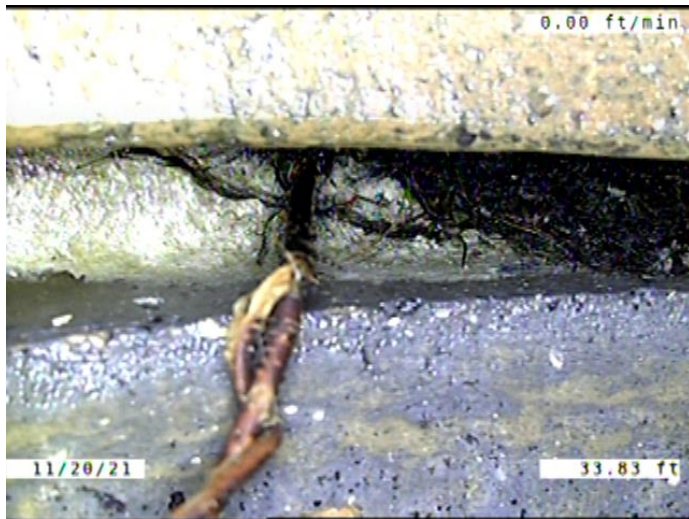
Code: **RFJ**  
 Description: **Roots Fine Joint**

Distance (ft): **33.8**  
 Structural Grade: **0**  
 O&M Grade: **1**  
 Clock Start/From: **9**  
 Clock To: **3**  
 1st Value:  
 2nd Value:  
 Value Percent:  
 Continuous Index: **S03**  
 Within 8" of Joint: **YES**  
 Remarks:

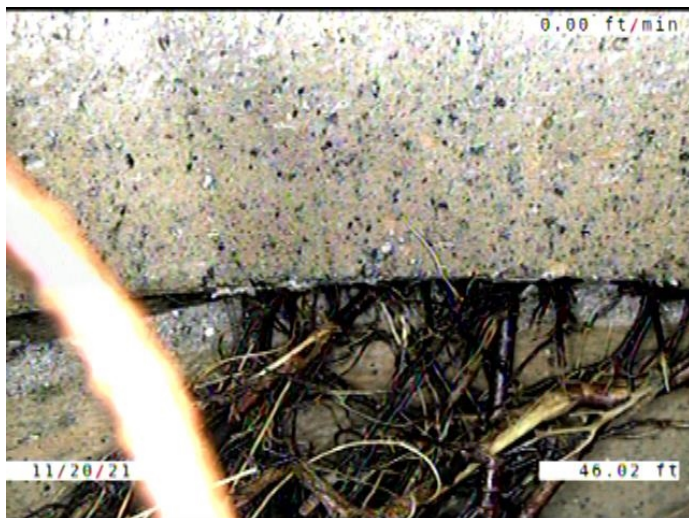
Code: **RMJ**  
 Description: **Roots Medium Joint**

Distance (ft): **46.0**  
 Structural Grade: **0**  
 O&M Grade: **3**  
 Clock Start/From: **10**  
 Clock To: **2**  
 1st Value:  
 2nd Value:  
 Value Percent: **5.000**  
 Continuous Index:  
 Within 8" of Joint: **YES**  
 Remarks:

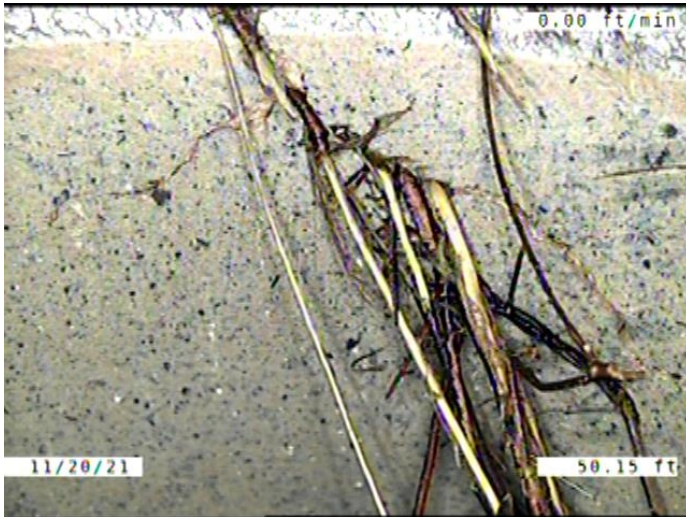
Code: **RMB**  
 Description: **Roots Medium Barrel**

Distance (ft): **50.2**  
 Structural Grade: **0**  
 O&M Grade: **4**  
 Clock Start/From: **8**  
 Clock To: **4**  
 1st Value:  
 2nd Value:  
 Value Percent: **10.000**  
 Continuous Index:  
 Within 8" of Joint: **NO**  
 Remarks:

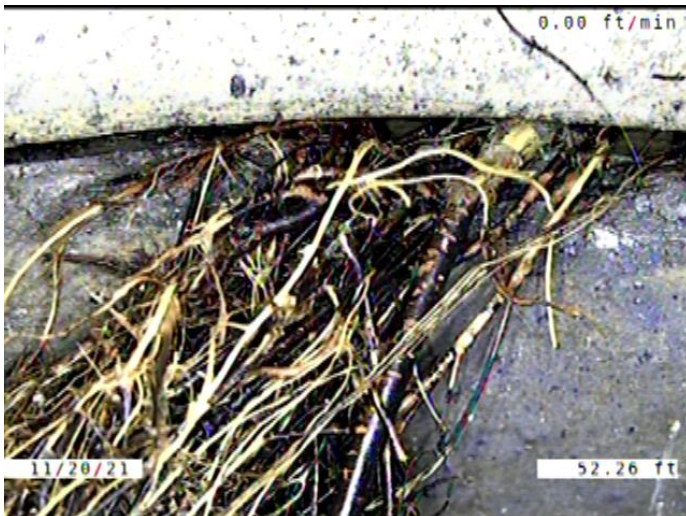
Code: **RMJ**  
 Description: **Roots Medium Joint**

Distance (ft): **52.3**  
 Structural Grade: **0**  
 O&M Grade: **3**  
 Clock Start/From: **8**  
 Clock To: **4**  
 1st Value:  
 2nd Value:  
 Value Percent: **10.000**  
 Continuous Index:  
 Within 8" of Joint: **YES**  
 Remarks:

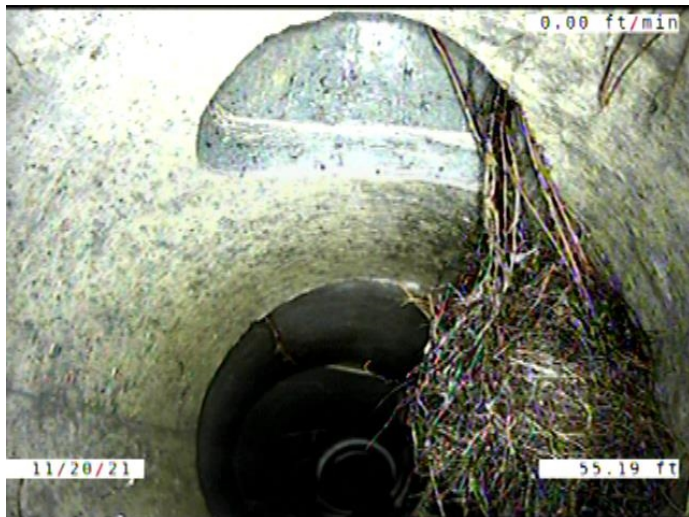
Code: **RML**  
 Description: **Roots Medium Lateral**

Distance (ft): **55.2**  
 Structural Grade: **0**  
 O&M Grade: **3**  
 Clock Start/From: **1**  
 Clock To: **2**  
 1st Value:  
 2nd Value:  
 Value Percent: **15.000**  
 Continuous Index:  
 Within 8" of Joint: **NO**  
 Remarks:

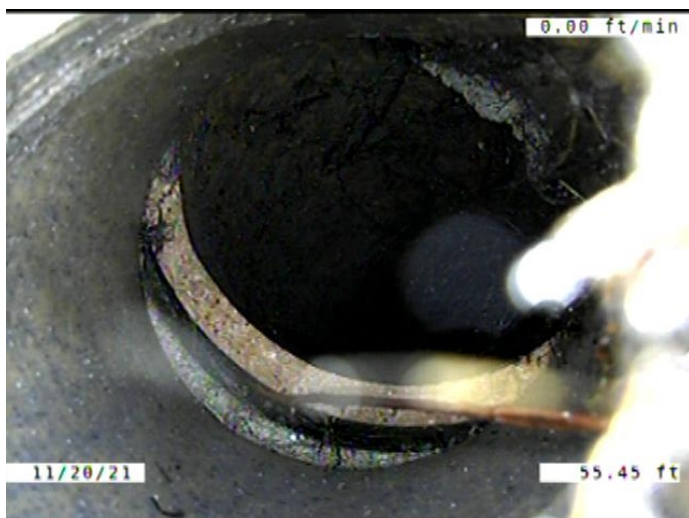
Code: **TFD**  
 Description: **Tap Factory Defective**

Distance (ft): **55.4**  
 Structural Grade: **0**  
 O&M Grade: **3**  
 Clock Start/From: **1**  
 Clock To:  
 1st Value: **4.000**  
 2nd Value:  
 Value Percent:  
 Continuous Index:  
 Within 8" of Joint: **YES**  
 Remarks: **BROKEN. OFFSET. ROOTS GROWING IN THE JOINT AND IN THE TAP INTO**

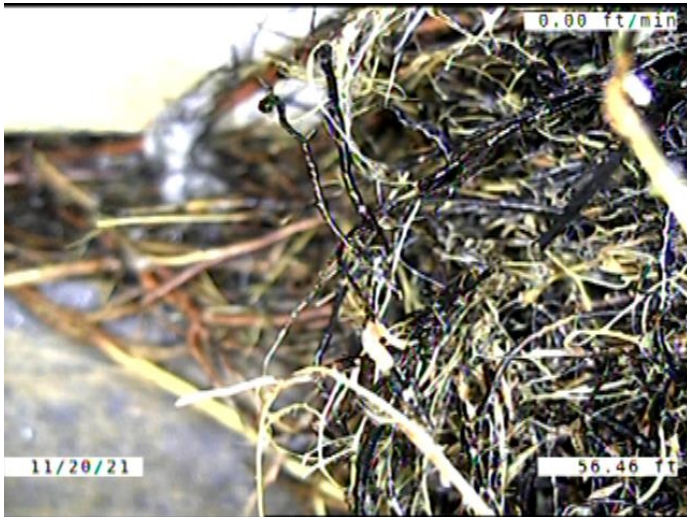
Code: **RMJ**  
 Description: **Roots Medium Joint**

Distance (ft): **56.5**  
 Structural Grade: **0**  
 O&M Grade: **3**  
 Clock Start/From: **8**  
 Clock To: **4**  
 1st Value:  
 2nd Value:  
 Value Percent: **5.000**  
 Continuous Index:  
 Within 8" of Joint: **YES**  
 Remarks:

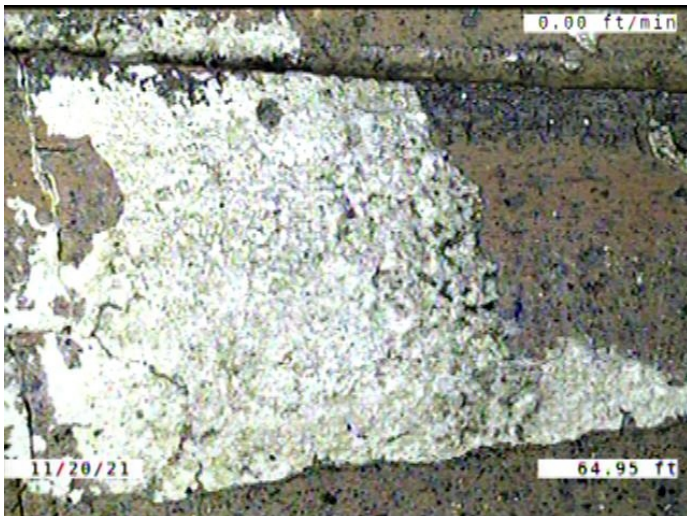
Code: **DAE**  
 Description: **Deposits Attached Encrustation**

Distance (ft): **65.0**  
 Structural Grade: **0**  
 O&M Grade: **2**  
 Clock Start/From: **8**  
 Clock To: **4**  
 1st Value:  
 2nd Value:  
 Value Percent: **5.000**  
 Continuous Index:  
 Within 8" of Joint: **YES**  
 Remarks:

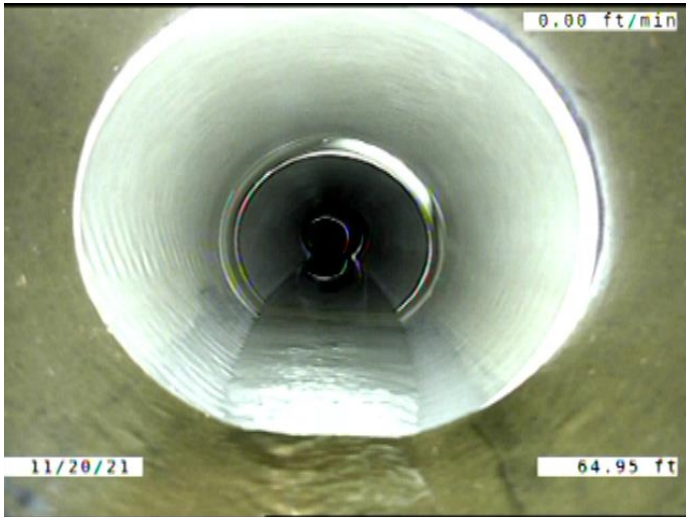
Code: **RFJ**  
Description: **Roots Fine Joint**

Distance (ft): **65.0**  
Structural Grade: **0**  
O&M Grade: **1**  
Clock Start/From: **9**  
Clock To: **3**  
1st Value:  
2nd Value:  
Value Percent:  
Continuous Index: **F03**  
Within 8" of Joint: **YES**  
Remarks:

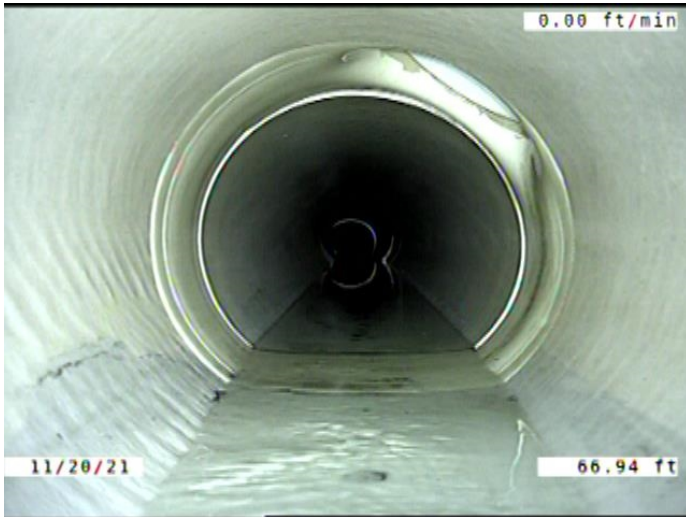
Code: **FM**  
 Description: **Fracture Multiple**

Distance (ft): **66.9**  
 Structural Grade: **4**  
 O&M Grade: **0**  
 Clock Start/From: **12**  
 Clock To: **12**  
 1st Value:  
 2nd Value:  
 Value Percent:  
 Continuous Index: **F02**  
 Within 8" of Joint: **YES**  
 Remarks:

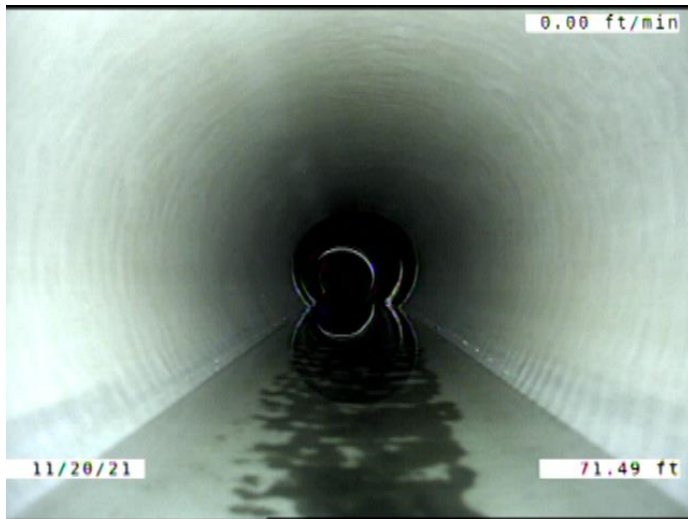
Code: **DSF**  
 Description: **Deposits Settled Fine**

Distance (ft): **71.5**  
 Structural Grade: **0**  
 O&M Grade: **2**  
 Clock Start/From: **5**  
 Clock To: **7**  
 1st Value:  
 2nd Value:  
 Value Percent: **5.000**  
 Continuous Index: **S04**  
 Within 8" of Joint: **YES**  
 Remarks:

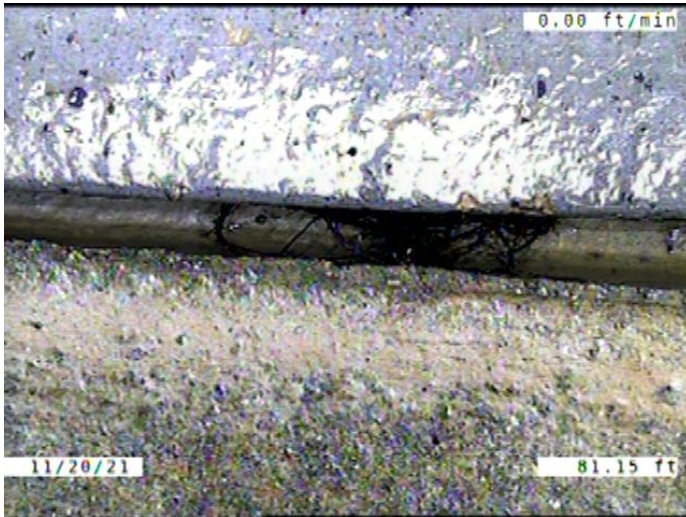
Code: **RFJ**  
 Description: **Roots Fine Joint**

Distance (ft): **81.2**  
 Structural Grade: **0**  
 O&M Grade: **1**  
 Clock Start/From: **10**  
 Clock To: **2**  
 1st Value:  
 2nd Value:  
 Value Percent:  
 Continuous Index:  
 Within 8" of Joint: **YES**  
 Remarks:

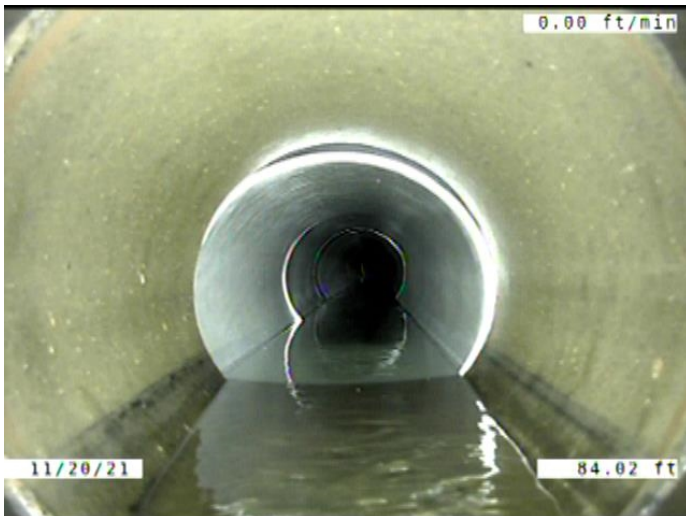
Code: **MWLS**  
 Description: **Miscellaneous Water Level Sag**

Distance (ft): **84.0**  
 Structural Grade: **2**  
 O&M Grade: **0**  
 Clock Start/From:  
 Clock To:  
 1st Value:  
 2nd Value:  
 Value Percent: **5.000**  
 Continuous Index: **S05**  
 Within 8" of Joint: **NO**  
 Remarks:

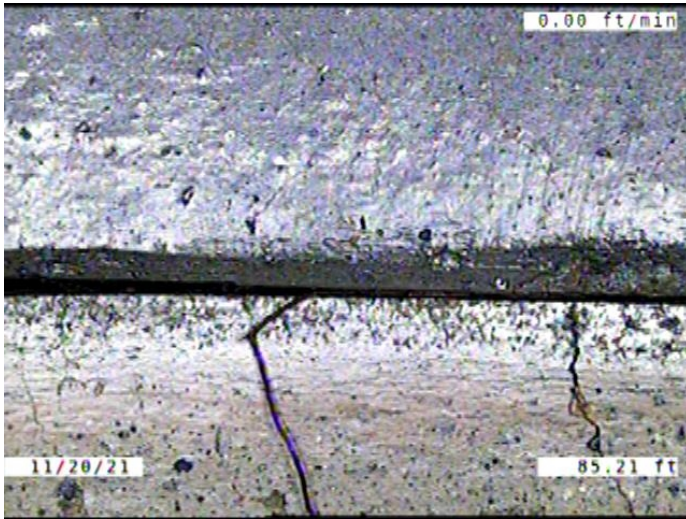
Code: **RFJ**  
 Description: **Roots Fine Joint**

Distance (ft): **85.2**  
 Structural Grade: **0**  
 O&M Grade: **1**  
 Clock Start/From: **12**  
 Clock To:  
 1st Value:  
 2nd Value:  
 Value Percent:  
 Continuous Index:  
 Within 8" of Joint: **YES**  
 Remarks:

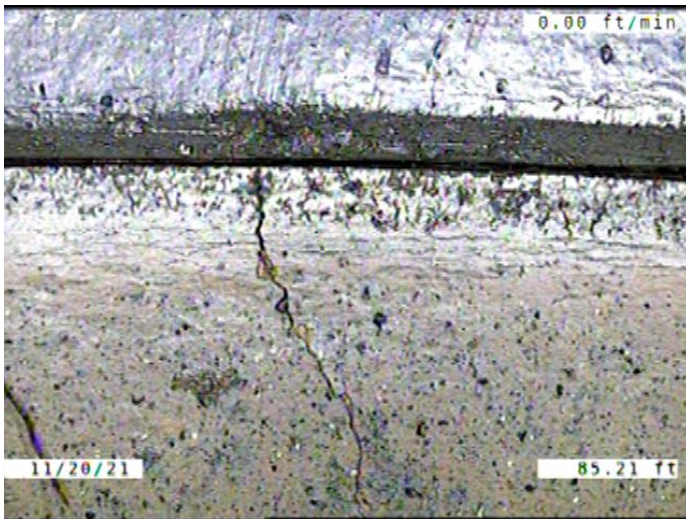
Code: **CS**  
 Description: **Crack Spiral**

Distance (ft): **85.2**  
 Structural Grade: **2**  
 O&M Grade: **0**  
 Clock Start/From: **12**  
 Clock To: **1**  
 1st Value:  
 2nd Value:  
 Value Percent:  
 Continuous Index:  
 Within 8" of Joint: **YES**  
 Remarks:

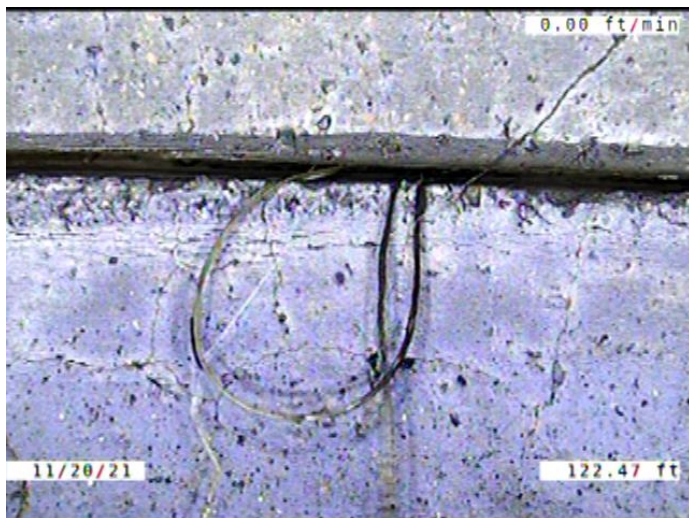
Code: **RFJ**  
 Description: **Roots Fine Joint**

Distance (ft): **122.5**  
 Structural Grade: **0**  
 O&M Grade: **1**  
 Clock Start/From: **12**  
 Clock To: **1**  
 1st Value:  
 2nd Value:  
 Value Percent:  
 Continuous Index:  
 Within 8" of Joint: **YES**  
 Remarks:

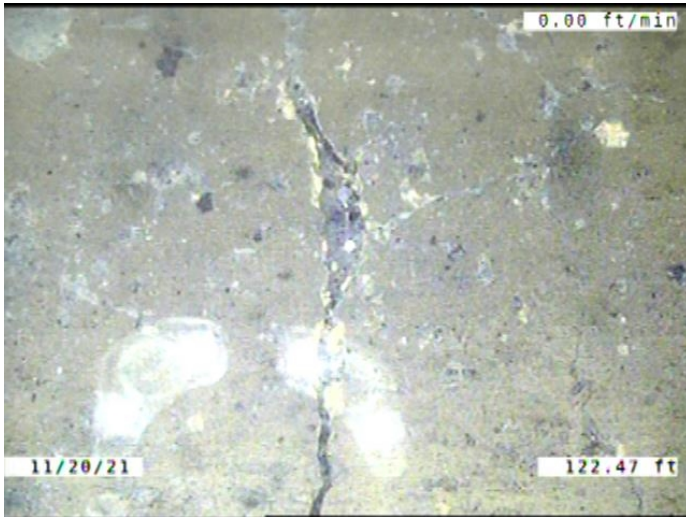
Code: **FM**  
 Description: **Fracture Multiple**

Distance (ft): **122.5**  
 Structural Grade: **4**  
 O&M Grade: **0**  
 Clock Start/From: **12**  
 Clock To: **12**  
 1st Value:  
 2nd Value:  
 Value Percent:  
 Continuous Index: **S06**  
 Within 8" of Joint: **YES**  
 Remarks:

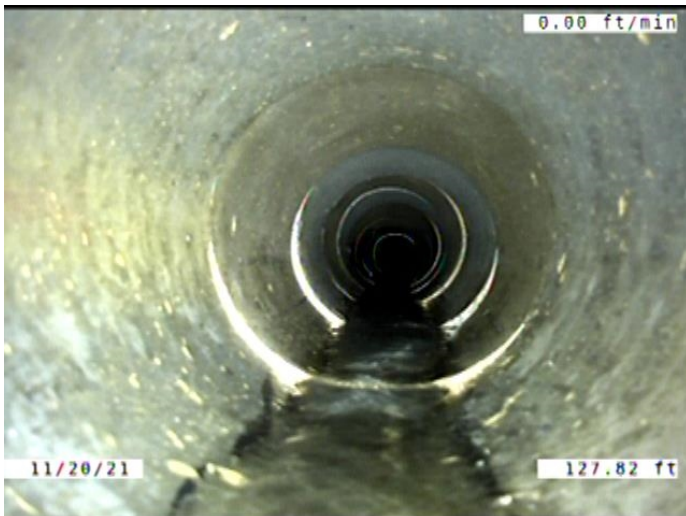
Code: **MWLS**  
 Description: **Miscellaneous Water Level Sag**

Distance (ft): **127.8**  
 Structural Grade: **2**  
 O&M Grade: **0**  
 Clock Start/From:  
 Clock To:  
 1st Value:  
 2nd Value:  
 Value Percent: **5.000**  
 Continuous Index: **F05**  
 Within 8" of Joint: **NO**  
 Remarks:

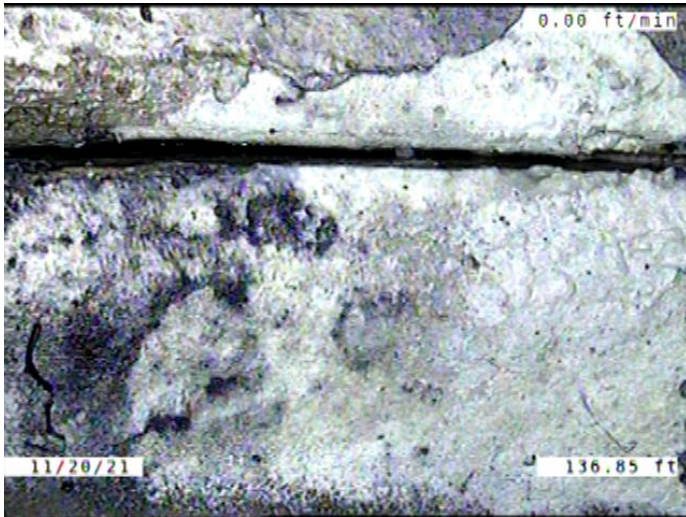
Code: **DAE**  
 Description: **Deposits Attached Encrustation**

Distance (ft): **136.9**  
 Structural Grade: **0**  
 O&M Grade: **2**  
 Clock Start/From: **8**  
 Clock To: **11**  
 1st Value:  
 2nd Value:  
 Value Percent: **5.000**  
 Continuous Index:  
 Within 8" of Joint: **YES**  
 Remarks:

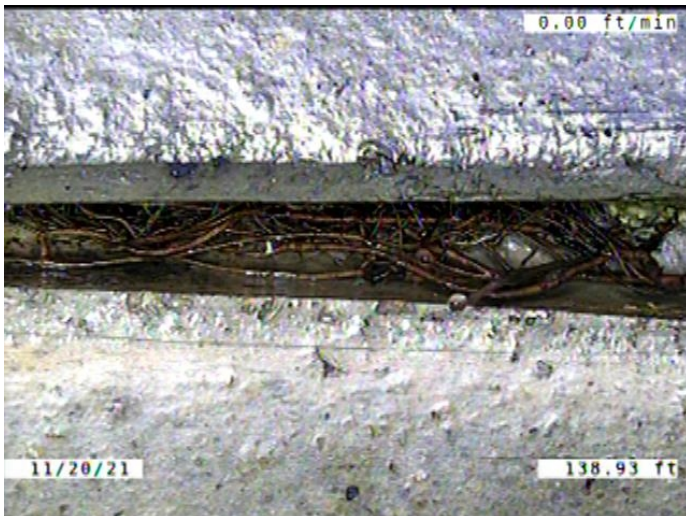
Code: **RFJ**  
 Description: **Roots Fine Joint**

Distance (ft): **138.9**  
 Structural Grade: **0**  
 O&M Grade: **1**  
 Clock Start/From: **9**  
 Clock To: **11**  
 1st Value:  
 2nd Value:  
 Value Percent:  
 Continuous Index:  
 Within 8" of Joint: **YES**  
 Remarks:

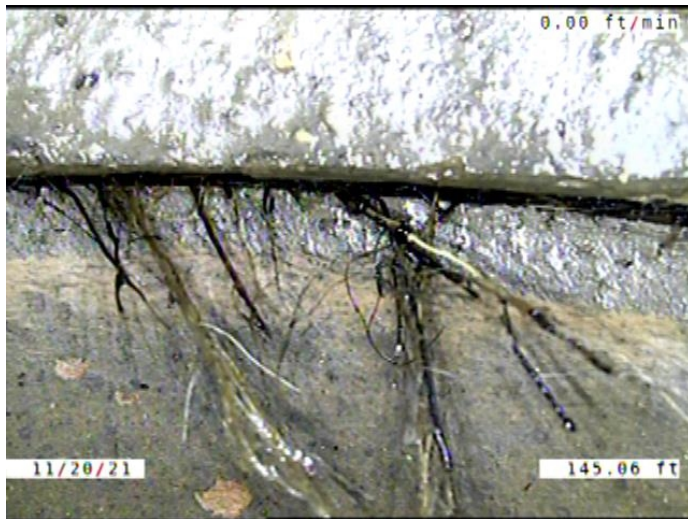
Code: **RFJ**  
 Description: **Roots Fine Joint**

Distance (ft): **145.1**  
 Structural Grade: **0**  
 O&M Grade: **1**  
 Clock Start/From: **9**  
 Clock To: **3**  
 1st Value:  
 2nd Value:  
 Value Percent:  
 Continuous Index:  
 Within 8" of Joint: **YES**  
 Remarks:

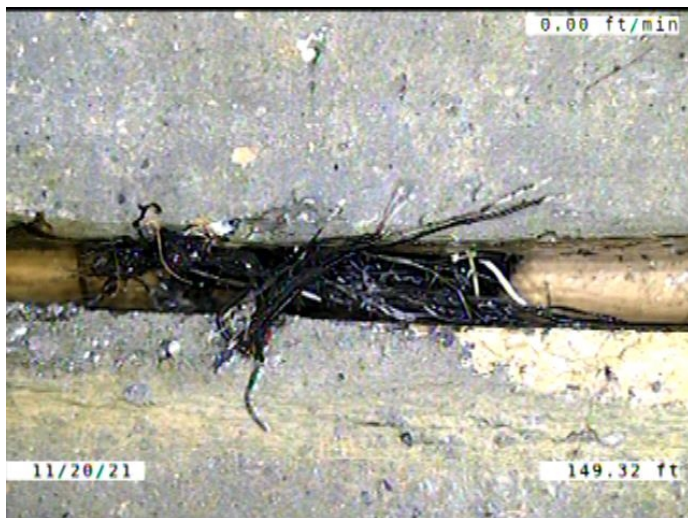
Code: **RFJ**  
 Description: **Roots Fine Joint**

Distance (ft): **149.3**  
 Structural Grade: **0**  
 O&M Grade: **1**  
 Clock Start/From: **9**  
 Clock To: **3**  
 1st Value:  
 2nd Value:  
 Value Percent:  
 Continuous Index:  
 Within 8" of Joint: **YES**  
 Remarks:

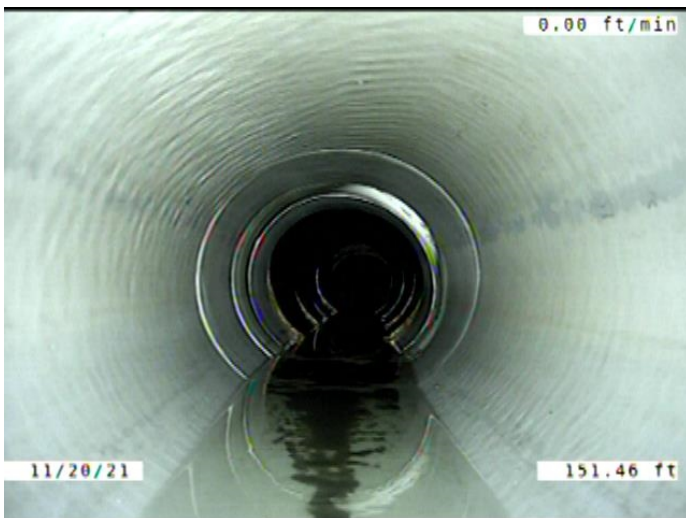
Code:	<b>FM</b>
Description:	<b>Fracture Multiple</b>
Distance (ft):	<b>151.5</b>
Structural Grade:	<b>4</b>
O&M Grade:	<b>0</b>
Clock Start/From:	<b>12</b>
Clock To:	<b>12</b>
1st Value:	
2nd Value:	
Value Percent:	
Continuous Index:	<b>F06</b>
Within 8" of Joint:	<b>YES</b>
Remarks:

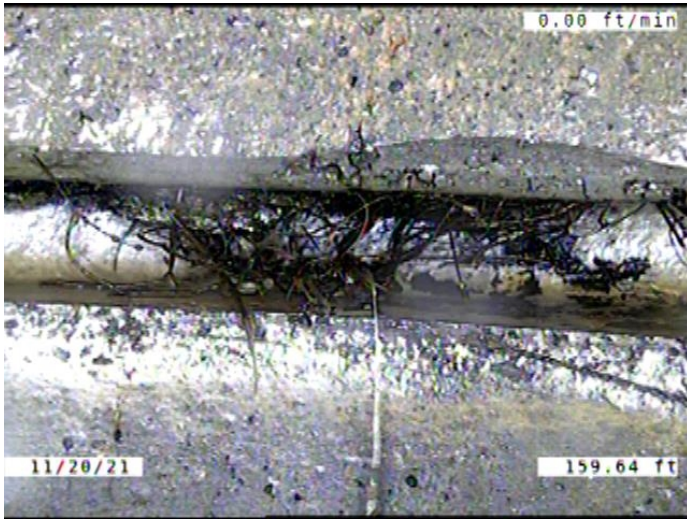
Code: **RFJ**  
Description: **Roots Fine Joint**

Distance (ft): **159.6**  
Structural Grade: **0**  
O&M Grade: **1**  
Clock Start/From: **9**  
Clock To: **3**  
1st Value:  
2nd Value:  
Value Percent:  
Continuous Index:  
Within 8" of Joint: **YES**  
Remarks:

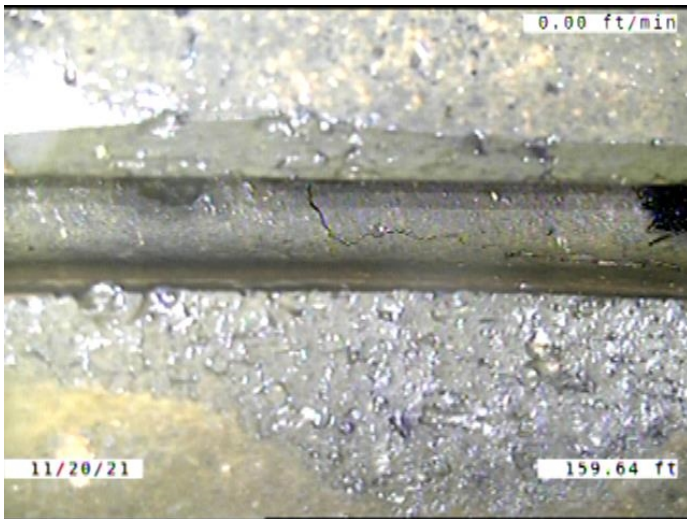
Code: **CM**  
Description: **Crack Multiple**

Distance (ft): **159.6**  
Structural Grade: **3**  
O&M Grade: **0**  
Clock Start/From: **9**  
Clock To: **3**  
1st Value:  
2nd Value:  
Value Percent:  
Continuous Index:  
Within 8" of Joint: **YES**  
Remarks:

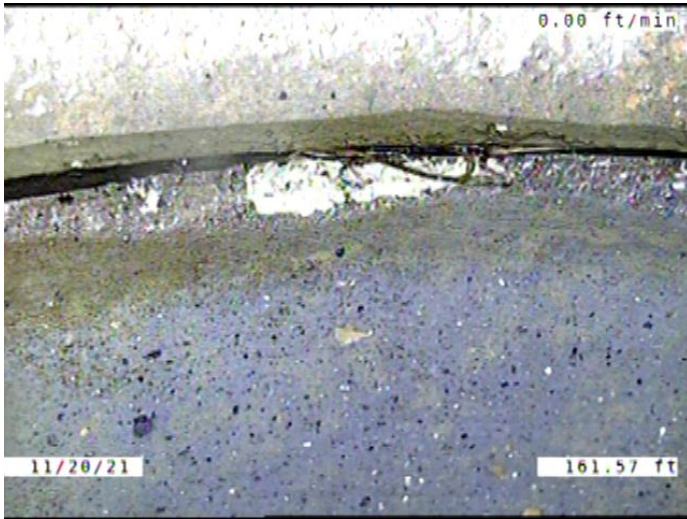
Code: **RFJ**  
Description: **Roots Fine Joint**

Distance (ft): **161.6**  
Structural Grade: **0**  
O&M Grade: **1**  
Clock Start/From: **10**  
Clock To:  
1st Value:  
2nd Value:  
Value Percent:  
Continuous Index:  
Within 8" of Joint: **YES**  
Remarks:

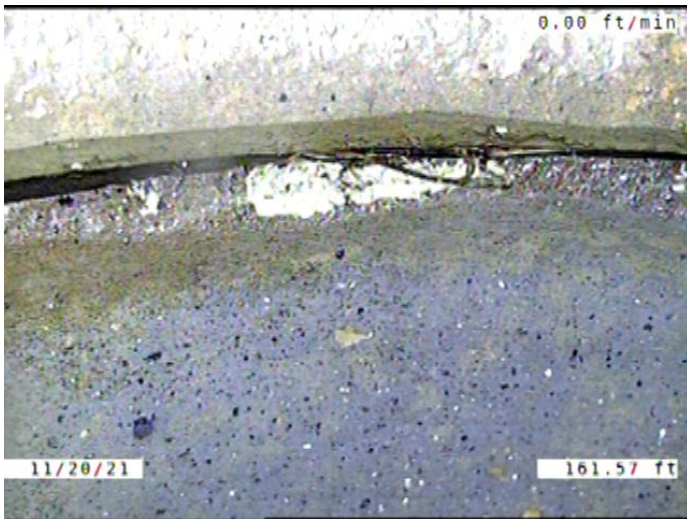
Code: **DAE**  
Description: **Deposits Attached Encrustation**

Distance (ft): **161.6**  
Structural Grade: **0**  
O&M Grade: **2**  
Clock Start/From: **10**  
Clock To:  
1st Value:  
2nd Value:  
Value Percent: **5.000**  
Continuous Index:  
Within 8" of Joint: **YES**  
Remarks:

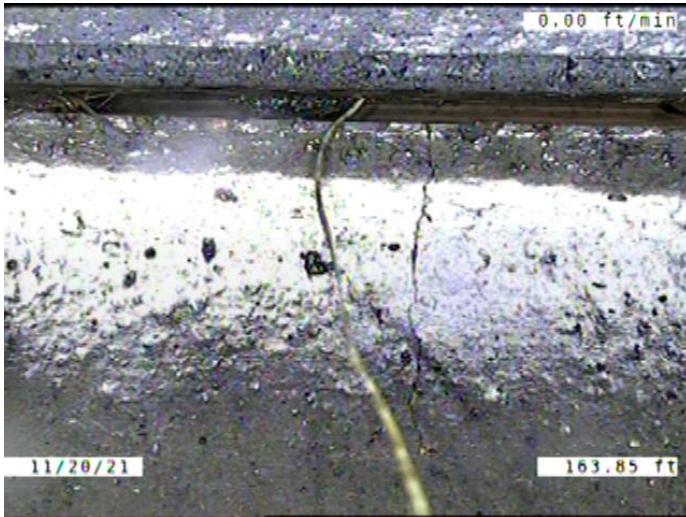
Code: **RFJ**  
 Description: **Roots Fine Joint**

Distance (ft): **163.8**  
 Structural Grade: **0**  
 O&M Grade: **1**  
 Clock Start/From: **9**  
 Clock To: **3**  
 1st Value:  
 2nd Value:  
 Value Percent:  
 Continuous Index:  
 Within 8" of Joint: **YES**  
 Remarks:

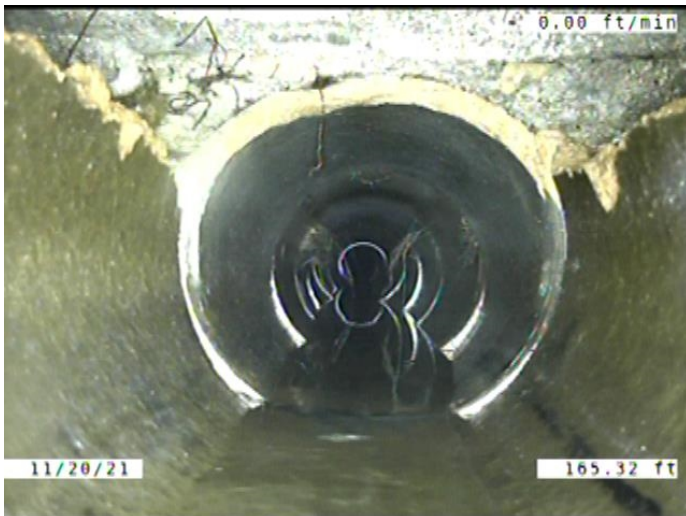
Code: **DSF**  
 Description: **Deposits Settled Fine**

Distance (ft): **165.3**  
 Structural Grade: **0**  
 O&M Grade: **2**  
 Clock Start/From: **5**  
 Clock To: **7**  
 1st Value:  
 2nd Value:  
 Value Percent: **5.000**  
 Continuous Index: **F04**  
 Within 8" of Joint: **YES**  
 Remarks:
