## Profile/Photo Observation Report

Street:	<b>N PENNSYLVANIA ST</b>	Flow Control:	<b>Not Controlled</b>
City:	<b>Hobart, IN</b>	Year Renewed:	
Location:	<b>Light Highway</b>	Tape/Media #:	
Purpose:	<b>Not Known</b>	Dia/Height:	<b>12"</b>
Use:	<b>Sanitary</b>	Material:	<b>VCP</b>
Drain Area:	<b>NA</b>	Lining:	
Category:	<b>NA</b>		
Comment:

Location Details:		Direction of Survey:	<b>Downstream</b>
US MH:	<b>M-604-096</b>	DS MH:	<b>M-604-097</b>
		Total Length Surveyed (ft):	<b>55.8</b>

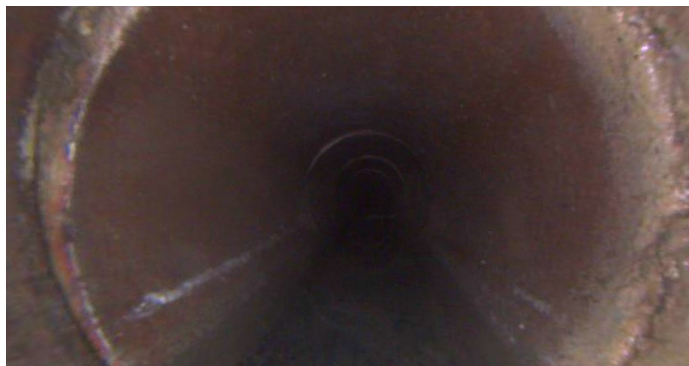
Code: **AMH**  
Description: **Manhole**

Distance (ft): **.0**  
Structural Grade: **0**  
O&M Grade: **0**  
Clock Start/From:  
Clock To:  
1st Value:  
2nd Value:  
Value Percent:  
Continuous Index:  
Within 8" of Joint: **NO**  
Remarks: **M-604-096**

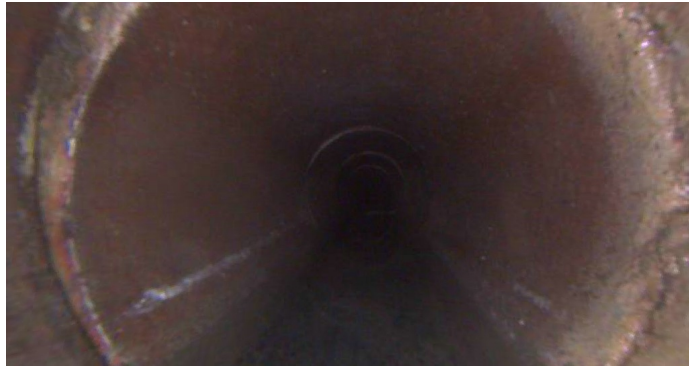
Code: **MWL**  
Description: **Water Level**

Distance (ft): **.0**  
Structural Grade: **0**  
O&M Grade: **0**  
Clock Start/From:  
Clock To:  
1st Value:  
2nd Value:  
Value Percent: **10.000**  
Continuous Index:  
Within 8" of Joint: **NO**  
Remarks:

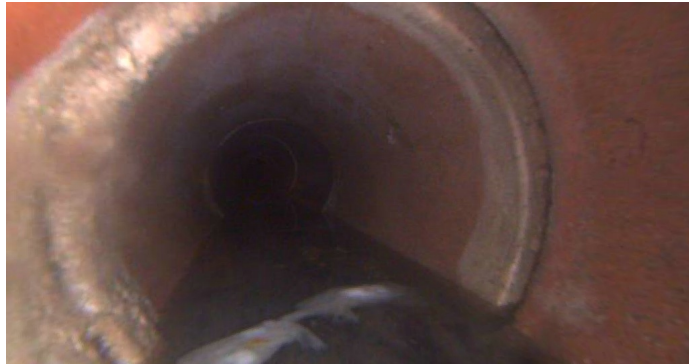
Code: **DAZ**  
Description: **Deposits Attached Other**

Distance (ft): **23.5**  
Structural Grade: **0**  
O&M Grade: **2**  
Clock Start/From: **7**  
Clock To: **12**  
1st Value:  
2nd Value:  
Value Percent: **5.000**  
Continuous Index:  
Within 8" of Joint: **YES**  
Remarks:

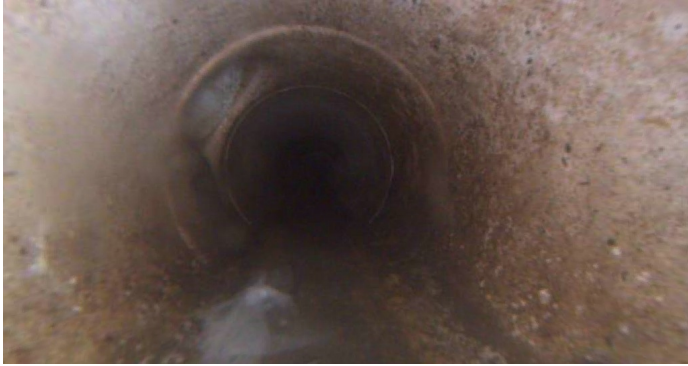
Code: **MMC**  
Description: **Material Change**

Distance (ft): **36.3**  
Structural Grade: **0**  
O&M Grade: **0**  
Clock Start/From:  
Clock To:  
1st Value:  
2nd Value:  
Value Percent:  
Continuous Index:  
Within 8" of Joint: **NO**  
Remarks: **PVC**

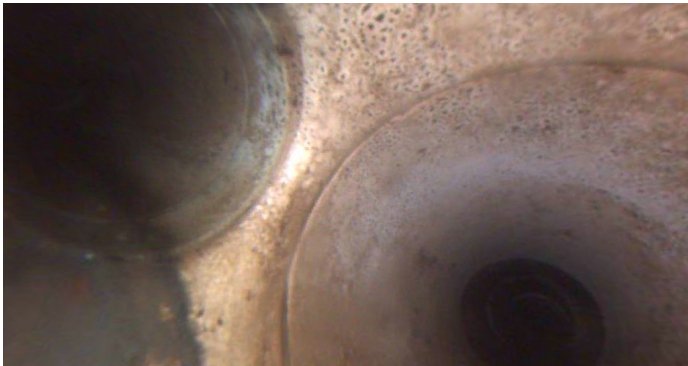
Code: **TF**  
Description: **Tap Factory**

Distance (ft): **37.5**  
Structural Grade: **0**  
O&M Grade: **0**  
Clock Start/From: **10**  
Clock To:  
1st Value: **4.000**  
2nd Value:  
Value Percent:  
Continuous Index:  
Within 8" of Joint:  
Remarks:

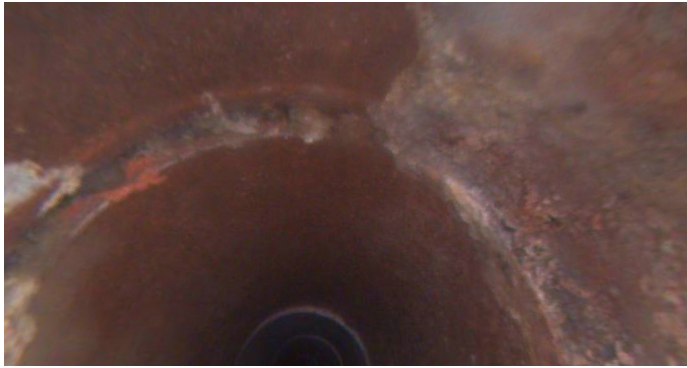
Code: **CL**  
Description: **Crack Longitudinal**

Distance (ft): **42.0**  
Structural Grade: **2**  
O&M Grade: **0**  
Clock Start/From: **1**  
Clock To:  
1st Value:  
2nd Value:  
Value Percent:  
Continuous Index:  
Within 8" of Joint: **YES**  
Remarks:

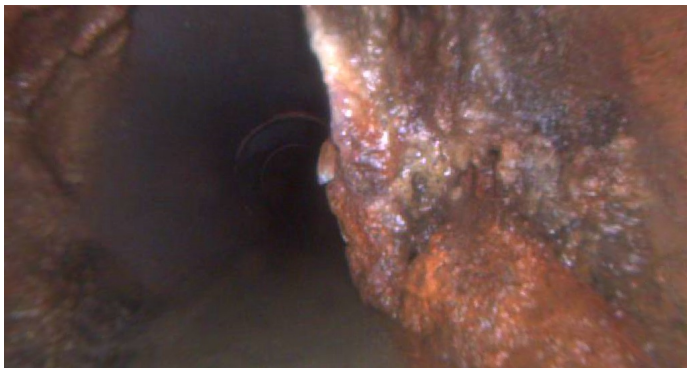
Code: **DAZ**  
Description: **Deposits Attached Other**

Distance (ft): **54.4**  
Structural Grade: **0**  
O&M Grade: **3**  
Clock Start/From: **7**  
Clock To: **5**  
1st Value:  
2nd Value:  
Value Percent: **15.000**  
Continuous Index:  
Within 8" of Joint: **NO**  
Remarks:

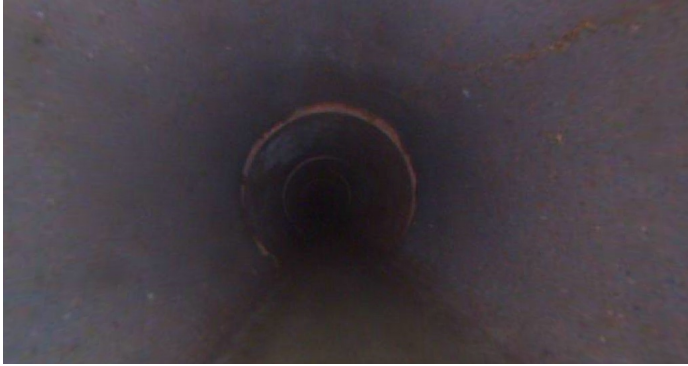
Code:	<b>MSA</b>
Description:	<b>Abandoned Survey</b>
Distance (ft):	<b>55.8</b>
Structural Grade:	<b>0</b>
O&M Grade:	<b>0</b>
Clock Start/From:	
Clock To:	
1st Value:	
2nd Value:	
Value Percent:	
Continuous Index:	
Within 8" of Joint:	<b>NO</b>
Remarks:	<b>DAZ</b>
