Profile/Photo Observation Report

Date:	04/22/2018	Weather:		Coding:	PACP 6.0
Pipe Length (ft):	232.3	Owner:	NA	Pre Clean:	Not Known
P.O.#:		Surveyor:	Brandon Helbling	PSR:	P-604-097-096
Customer:		Clean Date:	01/01/1900	Shape:	C

Street:	Summerlin	Flow Control:	Not Controlled
City:	Hobart, IN	Year Renewed:	
Location:	Light Highway	Tape/Media #:	
Purpose:	Not Known	Dia/Height:	12"
Use:	Sanitary	Material:	VCP
Drain Area:	NA	Lining:	
Category:	NA		
Comment:

Location Details:		Direction of Survey:	Downstream
US MH:	M-604-096	DS MH:	M-604-097
		Total Length Surveyed (ft):	55.8

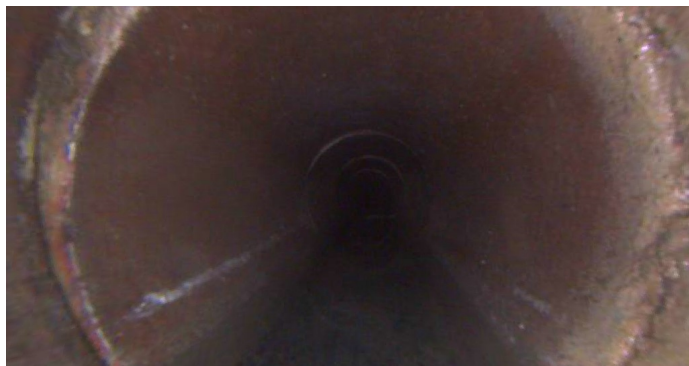
Code: **AMH**
 Description: **Manhole**

Distance (ft): **.0**
 Structural Grade: **0**
 O&M Grade: **0**
 Clock Start/From:
 Clock To:
 1st Value:
 2nd Value:
 Value Percent:
 Continuous Index:
 Within 8" of Joint: **NO**
 Remarks: **M-604-096**

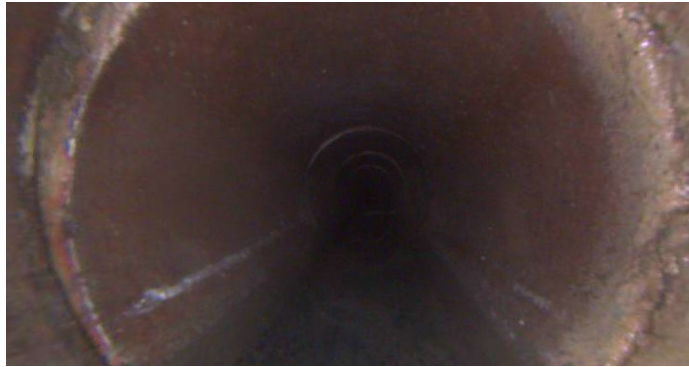
Code: **MWL**
Description: **Water Level**

Distance (ft): **.0**
Structural Grade: **0**
O&M Grade: **0**
Clock Start/From:
Clock To:
1st Value:
2nd Value:
Value Percent: **10.000**
Continuous Index:
Within 8" of Joint: **NO**
Remarks:

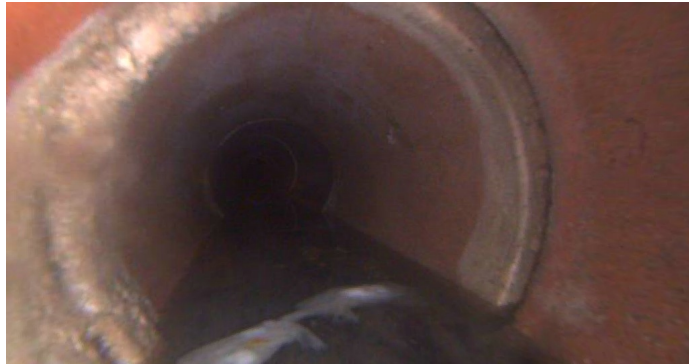
Code: **DAZ**
Description: **Deposits Attached Other**

Distance (ft): **23.5**
Structural Grade: **0**
O&M Grade: **2**
Clock Start/From: **7**
Clock To: **12**
1st Value:
2nd Value:
Value Percent: **5.000**
Continuous Index:
Within 8" of Joint: **YES**
Remarks:

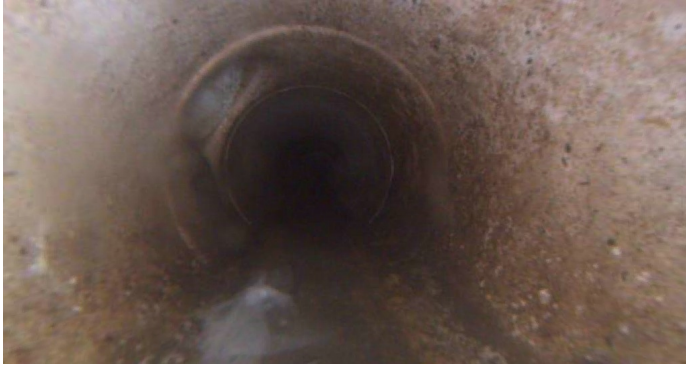
Code: **MMC**
Description: **Material Change**

Distance (ft): **36.3**
Structural Grade: **0**
O&M Grade: **0**
Clock Start/From:
Clock To:
1st Value:
2nd Value:
Value Percent:
Continuous Index:
Within 8" of Joint: **NO**
Remarks: **PVC**

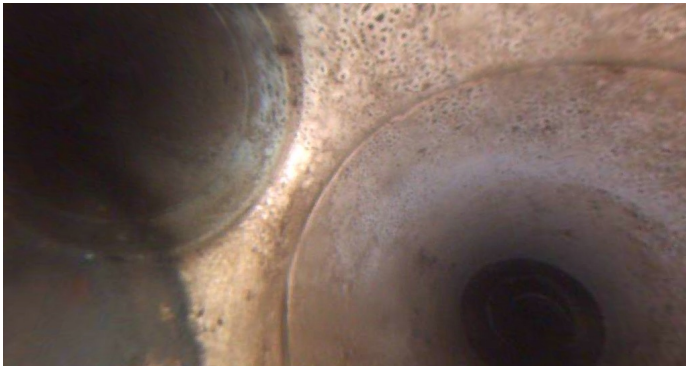
Code: **TF**
Description: **Tap Factory**

Distance (ft): **37.5**
Structural Grade: **0**
O&M Grade: **0**
Clock Start/From: **10**
Clock To:
1st Value: **4.000**
2nd Value:
Value Percent:
Continuous Index:
Within 8" of Joint:
Remarks:

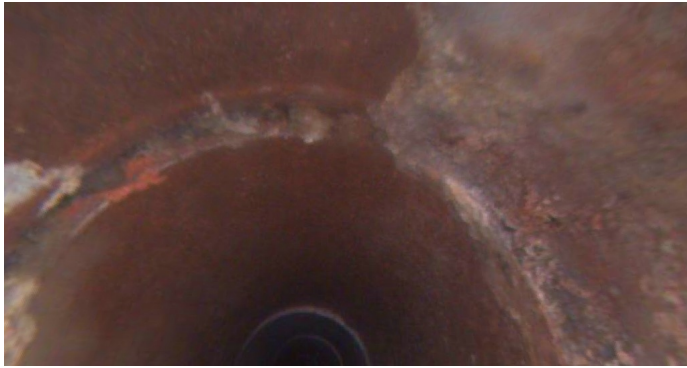
Code: **CL**
Description: **Crack Longitudinal**

Distance (ft): **42.0**
Structural Grade: **2**
O&M Grade: **0**
Clock Start/From: **1**
Clock To:
1st Value:
2nd Value:
Value Percent:
Continuous Index:
Within 8" of Joint: **YES**
Remarks:

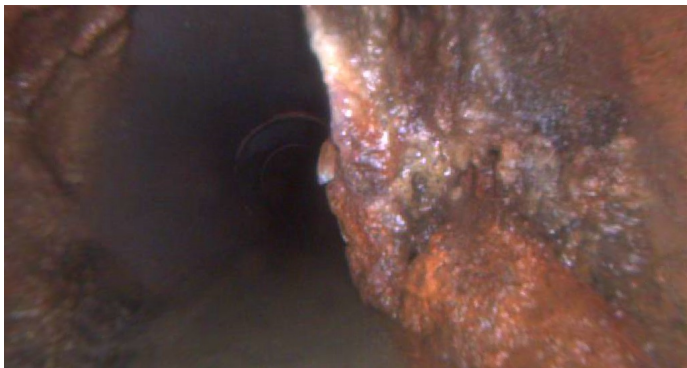
Code: **DAZ**
Description: **Deposits Attached Other**

Distance (ft): **54.4**
Structural Grade: **0**
O&M Grade: **3**
Clock Start/From: **7**
Clock To: **5**
1st Value:
2nd Value:
Value Percent: **15.000**
Continuous Index:
Within 8" of Joint: **NO**
Remarks:

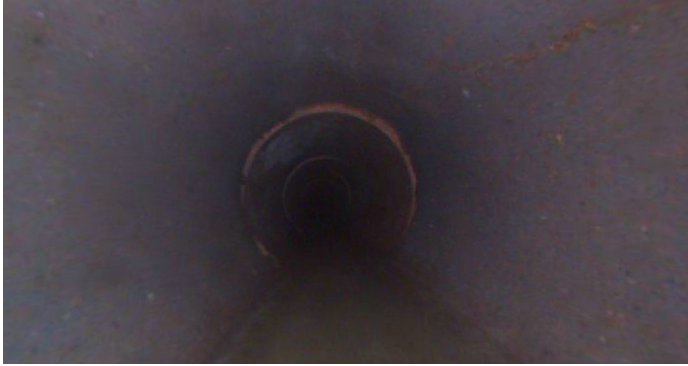
Code:	MSA
Description:	Abandoned Survey
Distance (ft):	55.8
Structural Grade:	0
O&M Grade:	0
Clock Start/From:	
Clock To:	
1st Value:	
2nd Value:	
Value Percent:	
Continuous Index:	
Within 8" of Joint:	NO
Remarks:	DAZ
