## Profile/Photo Observation Report

Street:	<b>N PENNSYLVANIA ST</b>	Flow Control:	<b>Not Controlled</b>
City:	<b>Hobart, IN</b>	Year Renewed:	
Location:	<b>Light Highway</b>	Tape/Media #:	
Purpose:	<b>Not Known</b>	Dia/Height:	<b>12"</b>
Use:	<b>Sanitary</b>	Material:	<b>PVC</b>
Drain Area:	<b>NA</b>	Lining:	
Category:	<b>NA</b>		
Comment:

Location Details:		Direction of Survey:	<b>Downstream</b>
US MH:	<b>M-604-097</b>	DS MH:	<b>M-604-098</b>
		Total Length Surveyed (ft):	<b>279.0</b>

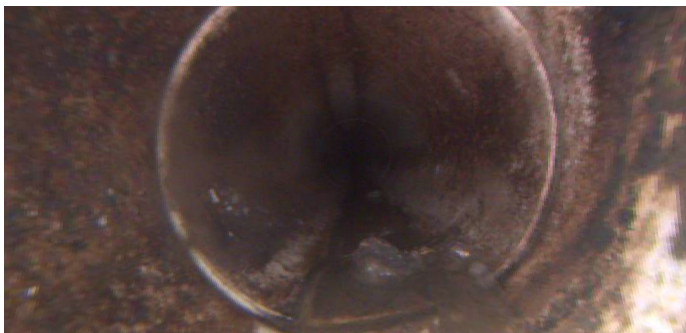
Code: **AMH**  
Description: **Manhole**

Distance (ft): **.0**  
Structural Grade: **0**  
O&M Grade: **0**  
Clock Start/From:  
Clock To:  
1st Value:  
2nd Value:  
Value Percent:  
Continuous Index:  
Within 8" of Joint: **NO**  
Remarks: **M-604-097**

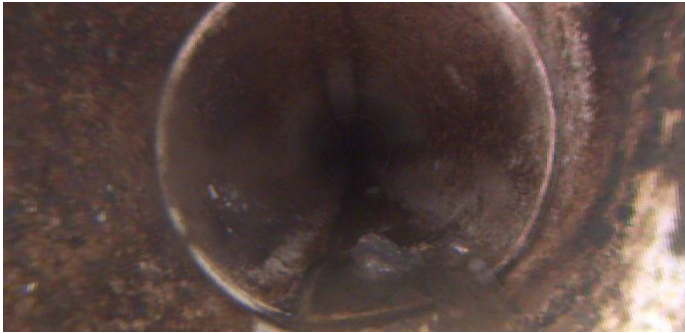
Code:	<b>MWL</b>
Description:	<b>Water Level</b>

Distance (ft):	<b>.0</b>
Structural Grade:	<b>0</b>
O&M Grade:	<b>0</b>
Clock Start/From:	
Clock To:	
1st Value:	
2nd Value:	
Value Percent:	<b>5.000</b>
Continuous Index:	
Within 8" of Joint:	<b>NO</b>
Remarks:

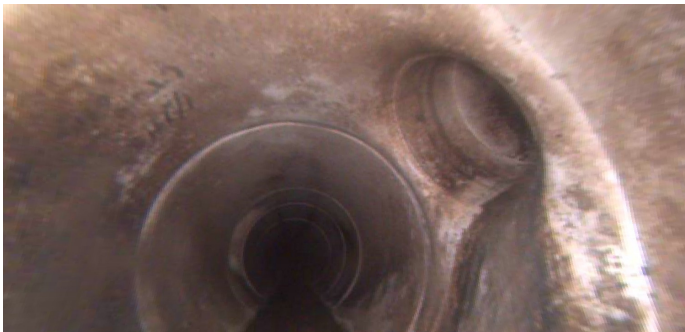
Code:	<b>TF</b>
Description:	<b>Tap Factory</b>

Distance (ft):	<b>92.4</b>
Structural Grade:	<b>0</b>
O&M Grade:	<b>0</b>
Clock Start/From:	<b>1</b>
Clock To:	
1st Value:	<b>4.000</b>
2nd Value:	
Value Percent:	
Continuous Index:	
Within 8" of Joint:	<b>YES</b>
Remarks:

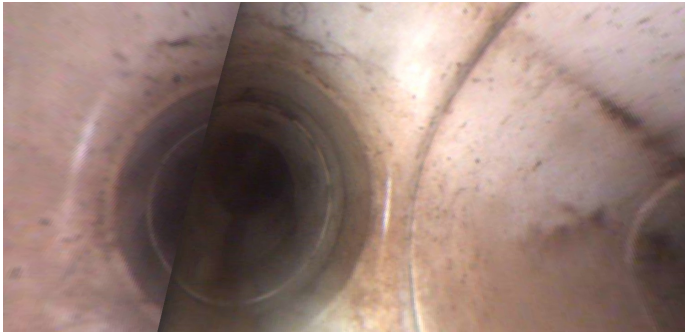
Code: **TF**  
Description: **Tap Factory**

Distance (ft): **94.8**  
Structural Grade: **0**  
O&M Grade: **0**  
Clock Start/From: **10**  
Clock To:  
1st Value: **4.000**  
2nd Value:  
Value Percent:  
Continuous Index:  
Within 8" of Joint: **YES**  
Remarks:

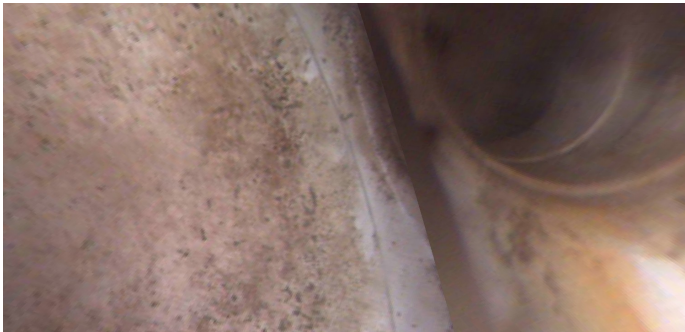
Code: **TF**  
Description: **Tap Factory**

Distance (ft): **147.3**  
Structural Grade: **0**  
O&M Grade: **0**  
Clock Start/From: **2**  
Clock To:  
1st Value: **4.000**  
2nd Value:  
Value Percent:  
Continuous Index:  
Within 8" of Joint: **YES**  
Remarks:

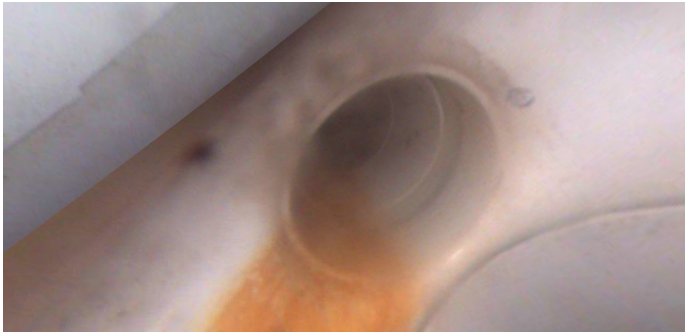
Code: **TF**  
Description: **Tap Factory**

Distance (ft): **173.5**  
Structural Grade: **0**  
O&M Grade: **0**  
Clock Start/From: **1**  
Clock To:  
1st Value: **4.000**  
2nd Value:  
Value Percent:  
Continuous Index:  
Within 8" of Joint: **YES**  
Remarks:

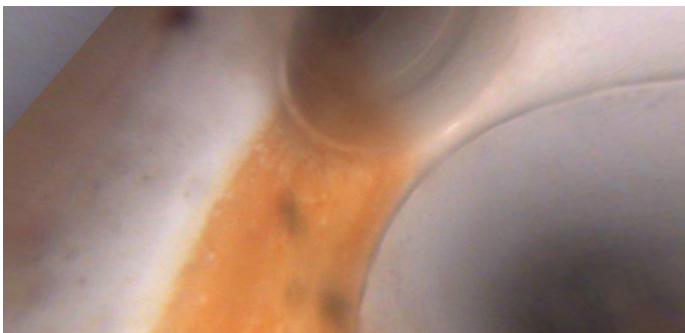
Code: **IS**  
Description: **Infil Stain**

Distance (ft): **173.5**  
Structural Grade: **0**  
O&M Grade: **0**  
Clock Start/From: **2**  
Clock To: **5**  
1st Value:  
2nd Value:  
Value Percent:  
Continuous Index:  
Within 8" of Joint: **NO**  
Remarks:

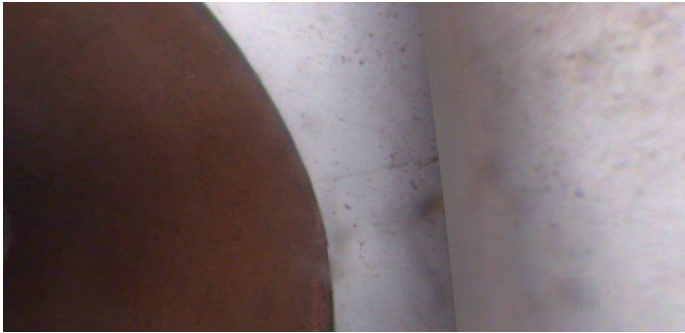
Code: **MMC**  
Description: **Material Change**

Distance (ft): **187.6**  
Structural Grade: **0**  
O&M Grade: **0**  
Clock Start/From:  
Clock To:  
1st Value:  
2nd Value:  
Value Percent:  
Continuous Index:  
Within 8" of Joint: **NO**  
Remarks: **vcp**

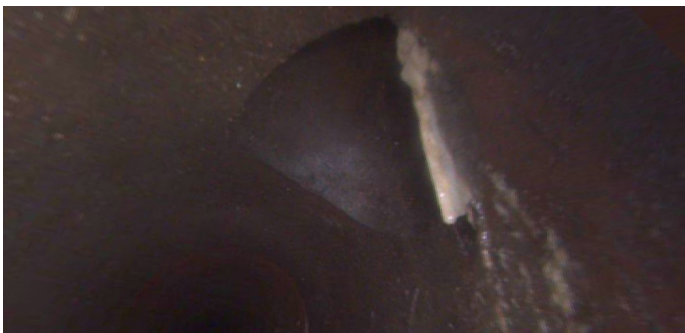
Code: **TF**  
Description: **Tap Factory**

Distance (ft): **194.1**  
Structural Grade: **0**  
O&M Grade: **0**  
Clock Start/From: **1**  
Clock To:  
1st Value: **4.000**  
2nd Value:  
Value Percent:  
Continuous Index:  
Within 8" of Joint:  
Remarks:

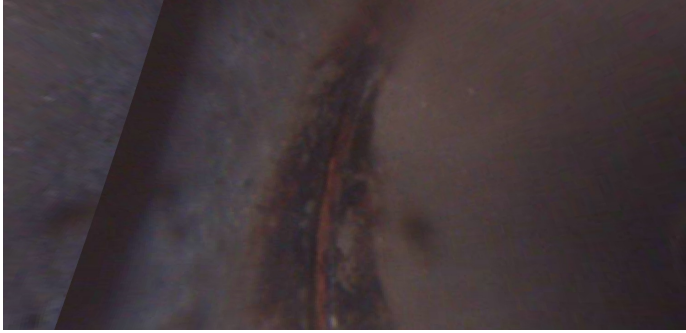
Code: **IS**  
Description: **Infil Stain**

Distance (ft): **214.6**  
Structural Grade: **0**  
O&M Grade: **0**  
Clock Start/From: **2**  
Clock To: **5**  
1st Value:  
2nd Value:  
Value Percent:  
Continuous Index:  
Within 8" of Joint: **YES**  
Remarks:

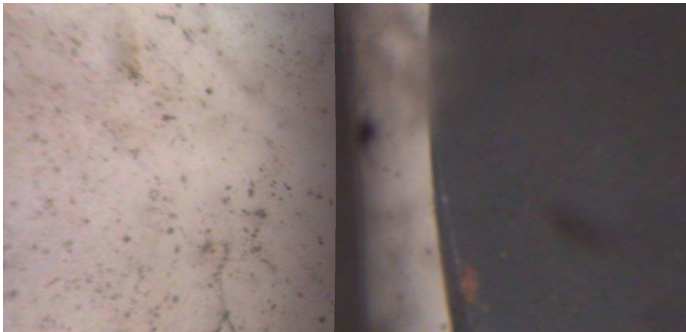
Code: **MMC**  
Description: **Material Change**

Distance (ft): **222.7**  
Structural Grade: **0**  
O&M Grade: **0**  
Clock Start/From:  
Clock To:  
1st Value:  
2nd Value:  
Value Percent:  
Continuous Index:  
Within 8" of Joint: **NO**  
Remarks: **pvc**

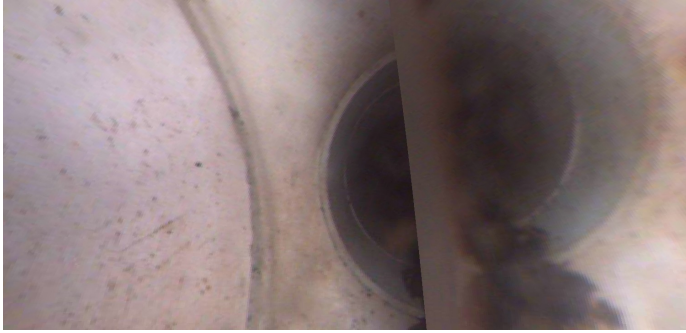
Code: **TF**  
Description: **Tap Factory**

Distance (ft): **244.1**  
Structural Grade: **0**  
O&M Grade: **0**  
Clock Start/From: **2**  
Clock To:  
1st Value: **4.000**  
2nd Value:  
Value Percent:  
Continuous Index:  
Within 8" of Joint: **YES**  
Remarks:

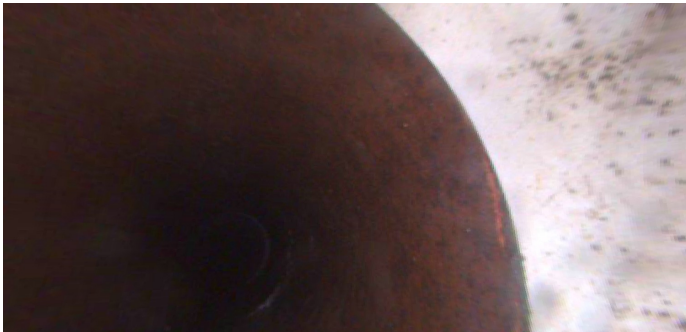
Code: **MMC**  
Description: **Material Change**

Distance (ft): **253.1**  
Structural Grade: **0**  
O&M Grade: **0**  
Clock Start/From:  
Clock To:  
1st Value:  
2nd Value:  
Value Percent:  
Continuous Index:  
Within 8" of Joint: **NO**  
Remarks: **vcp**

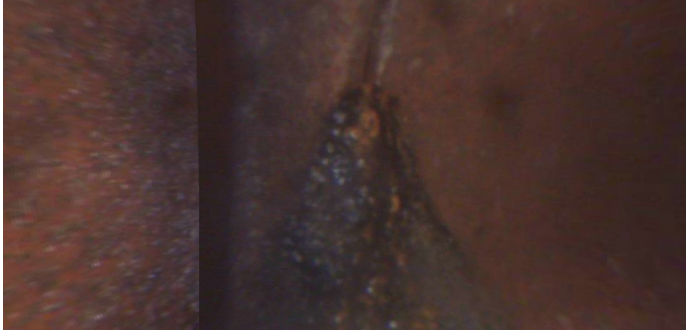
Code: **DAE**  
Description: **Deposits Attached Encrustation**

Distance (ft): **255.5**  
Structural Grade: **0**  
O&M Grade: **2**  
Clock Start/From: **3**  
Clock To: **5**  
1st Value:  
2nd Value:  
Value Percent: **5.000**  
Continuous Index:  
Within 8" of Joint: **YES**  
Remarks:

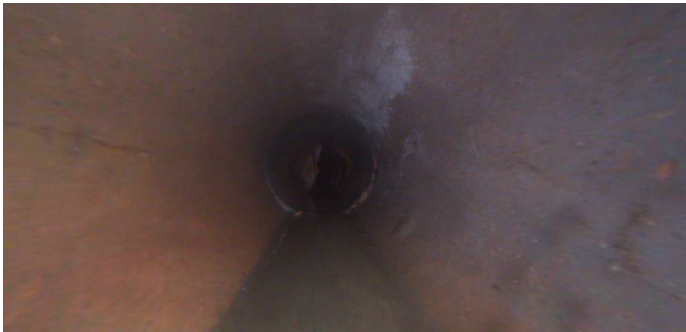
Code: **CM**  
Description: **Crack Multiple**

Distance (ft): **273.6**  
Structural Grade: **3**  
O&M Grade: **0**  
Clock Start/From: **9**  
Clock To: **3**  
1st Value:  
2nd Value:  
Value Percent:  
Continuous Index: **S01**  
Within 8" of Joint: **YES**  
Remarks: **wandering**

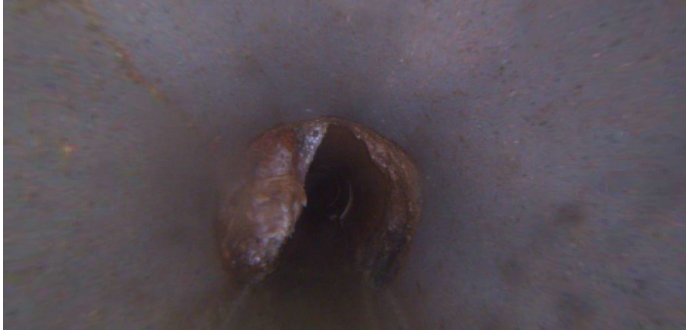
Code: **DAE**  
Description: **Deposits Attached Encrustation**

Distance (ft): **276.2**  
Structural Grade: **0**  
O&M Grade: **4**  
Clock Start/From: **7**  
Clock To: **5**  
1st Value:  
2nd Value:  
Value Percent: **25.000**  
Continuous Index:  
Within 8" of Joint: **YES**  
Remarks:

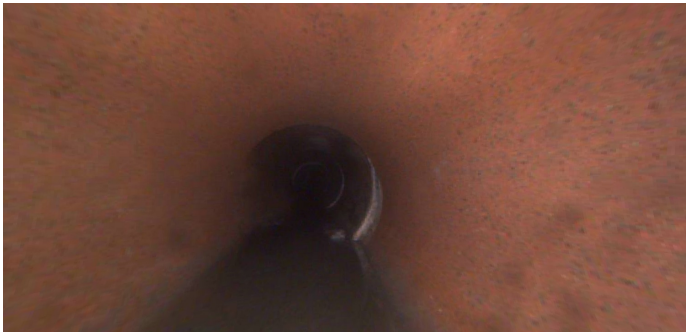
Code: **MSA**  
Description: **Abandoned Survey**

Distance (ft): **279.0**  
Structural Grade: **0**  
O&M Grade: **0**  
Clock Start/From:  
Clock To:  
1st Value:  
2nd Value:  
Value Percent:  
Continuous Index:  
Within 8" of Joint: **NO**  
Remarks: **dae**

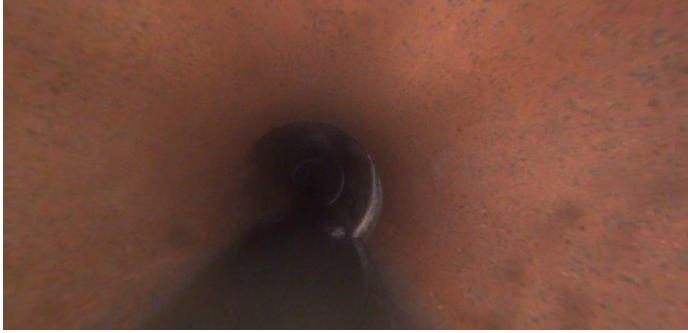
Code:	<b>CM</b>
Description:	<b>Crack Multiple</b>
Distance (ft):	<b>279.0</b>
Structural Grade:	<b>3</b>
O&M Grade:	<b>0</b>
Clock Start/From:	<b>9</b>
Clock To:	<b>3</b>
1st Value:	
2nd Value:	
Value Percent:	
Continuous Index:	<b>F01</b>
Within 8" of Joint:	<b>YES</b>
Remarks:	<b>wandering</b>
