Profile/Photo Observation Report

Date:	04/22/2018	Weather:		Coding:	PACP 6.0
Pipe Length (ft):	106.2	Owner:	NA	Pre Clean:	Not Known
P.O.#:		Surveyor:	Byrd Fitzgerald	PSR:	P-604-098-097
Customer:		Clean Date:	01/01/1900	Shape:	C

Street:	Summerlin	Flow Control:	Not Controlled
City:	Hobart, IN	Year Renewed:	
Location:	Light Highway	Tape/Media #:	
Purpose:	Not Known	Dia/Height:	12"
Use:	Sanitary	Material:	PVC
Drain Area:	NA	Lining:	
Category:	NA		
Comment:

Location Details:		Direction of Survey:	Downstream
US MH:	M-604-097	DS MH:	M-604-098
		Total Length Surveyed (ft):	279.0

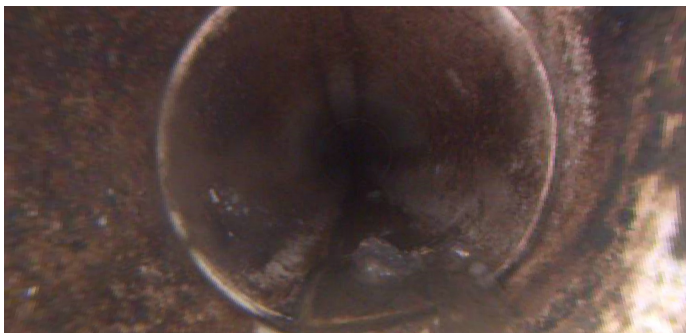
Code: **AMH**
Description: **Manhole**

Distance (ft): **.0**
Structural Grade: **0**
O&M Grade: **0**
Clock Start/From:
Clock To:
1st Value:
2nd Value:
Value Percent:
Continuous Index:
Within 8" of Joint: **NO**
Remarks: **M-604-097**

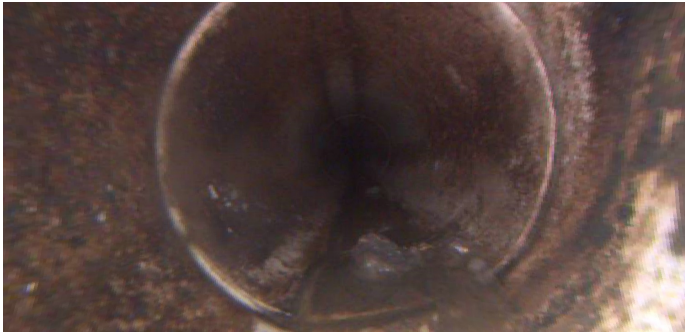
Code:	MWL
Description:	Water Level

Distance (ft):	.0
Structural Grade:	0
O&M Grade:	0
Clock Start/From:	
Clock To:	
1st Value:	
2nd Value:	
Value Percent:	5.000
Continuous Index:	
Within 8" of Joint:	NO
Remarks:

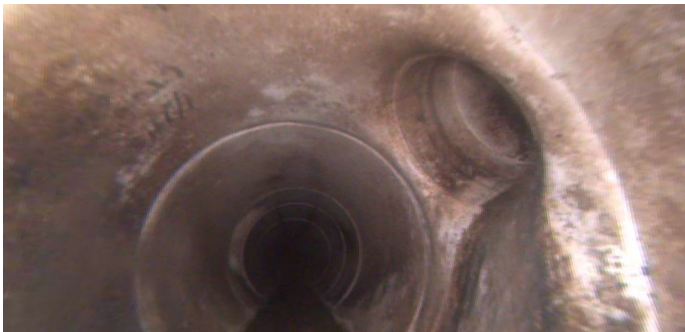
Code:	TF
Description:	Tap Factory

Distance (ft):	92.4
Structural Grade:	0
O&M Grade:	0
Clock Start/From:	1
Clock To:	
1st Value:	4.000
2nd Value:	
Value Percent:	
Continuous Index:	
Within 8" of Joint:	YES
Remarks:

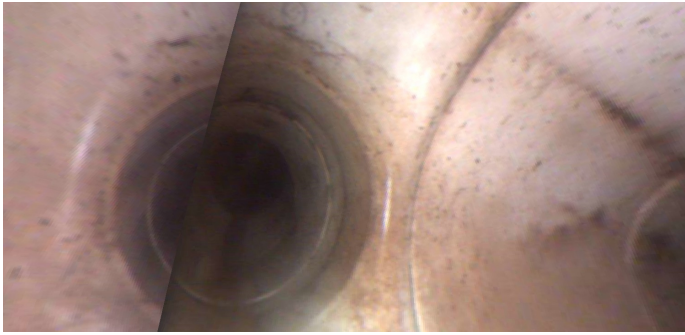
Code: **TF**
Description: **Tap Factory**

Distance (ft): **94.8**
Structural Grade: **0**
O&M Grade: **0**
Clock Start/From: **10**
Clock To:
1st Value: **4.000**
2nd Value:
Value Percent:
Continuous Index:
Within 8" of Joint: **YES**
Remarks:

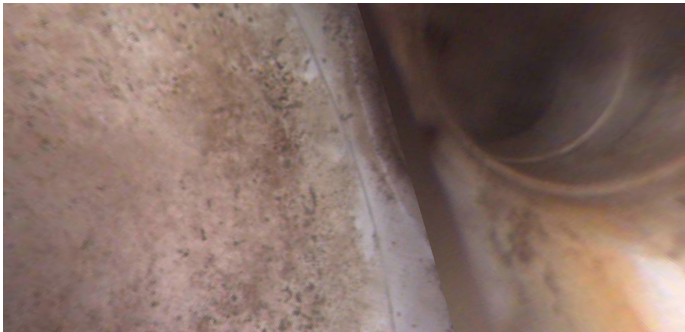
Code: **TF**
Description: **Tap Factory**

Distance (ft): **147.3**
Structural Grade: **0**
O&M Grade: **0**
Clock Start/From: **2**
Clock To:
1st Value: **4.000**
2nd Value:
Value Percent:
Continuous Index:
Within 8" of Joint: **YES**
Remarks:

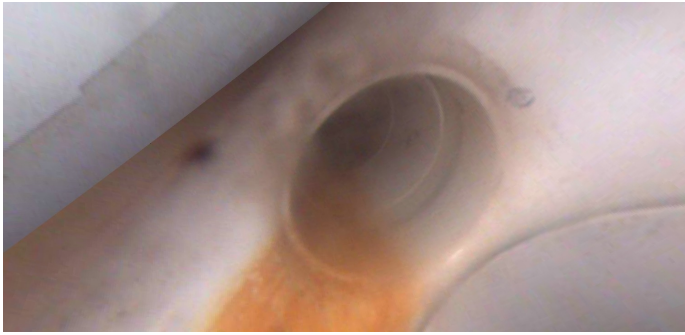
Code: **TF**
Description: **Tap Factory**

Distance (ft): **173.5**
Structural Grade: **0**
O&M Grade: **0**
Clock Start/From: **1**
Clock To:
1st Value: **4.000**
2nd Value:
Value Percent:
Continuous Index:
Within 8" of Joint: **YES**
Remarks:

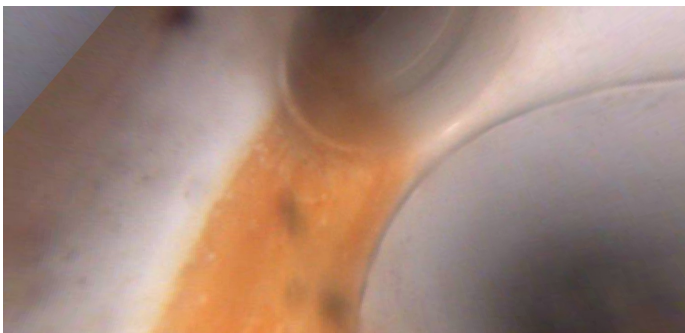
Code: **IS**
Description: **Infil Stain**

Distance (ft): **173.5**
Structural Grade: **0**
O&M Grade: **0**
Clock Start/From: **2**
Clock To: **5**
1st Value:
2nd Value:
Value Percent:
Continuous Index:
Within 8" of Joint: **NO**
Remarks:

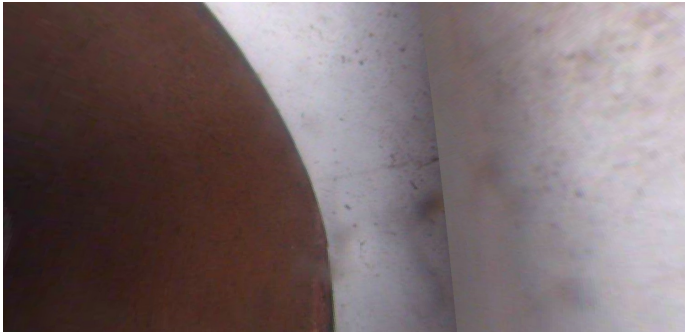
Code: **MMC**
Description: **Material Change**

Distance (ft): **187.6**
Structural Grade: **0**
O&M Grade: **0**
Clock Start/From:
Clock To:
1st Value:
2nd Value:
Value Percent:
Continuous Index:
Within 8" of Joint: **NO**
Remarks: **vcp**

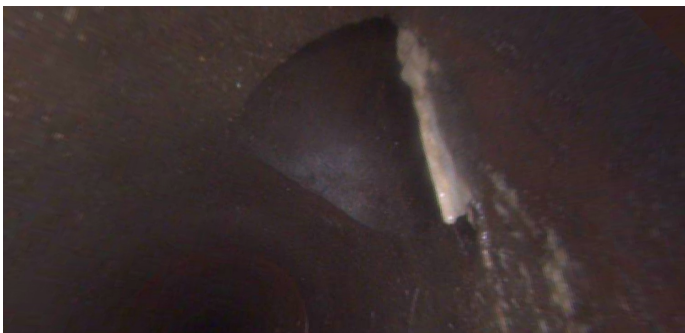
Code: **TF**
Description: **Tap Factory**

Distance (ft): **194.1**
Structural Grade: **0**
O&M Grade: **0**
Clock Start/From: **1**
Clock To:
1st Value: **4.000**
2nd Value:
Value Percent:
Continuous Index:
Within 8" of Joint:
Remarks:

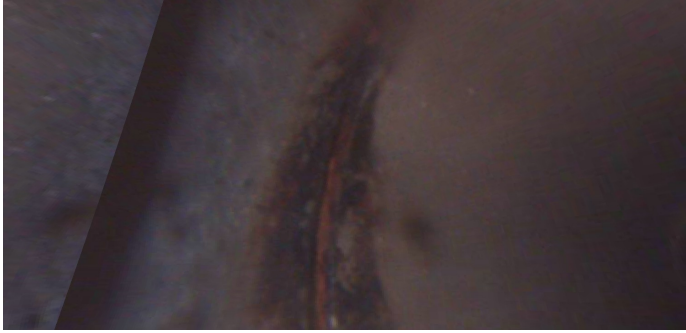
Code: **IS**
Description: **Infil Stain**

Distance (ft): **214.6**
Structural Grade: **0**
O&M Grade: **0**
Clock Start/From: **2**
Clock To: **5**
1st Value:
2nd Value:
Value Percent:
Continuous Index:
Within 8" of Joint: **YES**
Remarks:

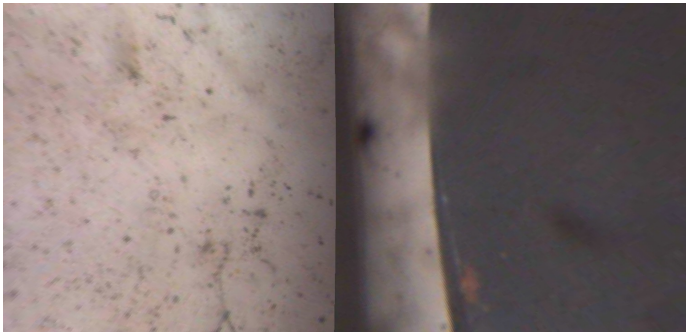
Code: **MMC**
Description: **Material Change**

Distance (ft): **222.7**
Structural Grade: **0**
O&M Grade: **0**
Clock Start/From:
Clock To:
1st Value:
2nd Value:
Value Percent:
Continuous Index:
Within 8" of Joint: **NO**
Remarks: **pvc**

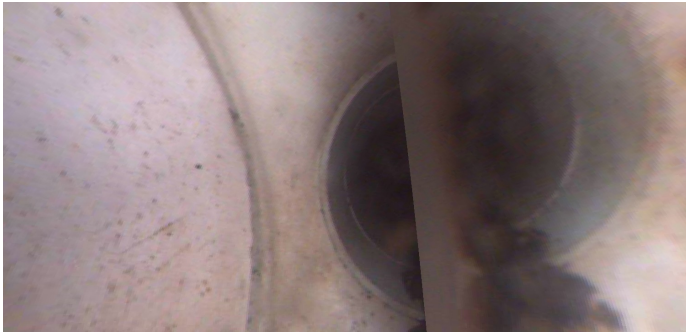
Code: **TF**
Description: **Tap Factory**

Distance (ft): **244.1**
Structural Grade: **0**
O&M Grade: **0**
Clock Start/From: **2**
Clock To:
1st Value: **4.000**
2nd Value:
Value Percent:
Continuous Index:
Within 8" of Joint: **YES**
Remarks:

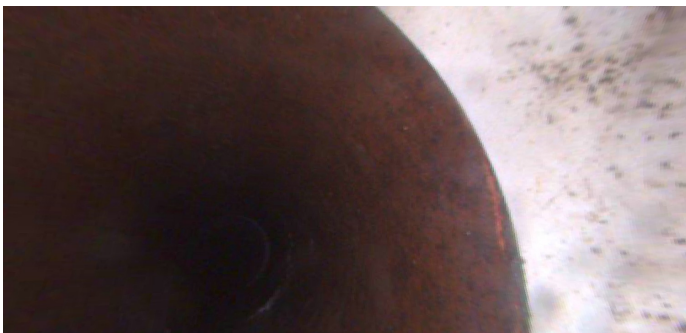
Code: **MMC**
Description: **Material Change**

Distance (ft): **253.1**
Structural Grade: **0**
O&M Grade: **0**
Clock Start/From:
Clock To:
1st Value:
2nd Value:
Value Percent:
Continuous Index:
Within 8" of Joint: **NO**
Remarks: **vcp**

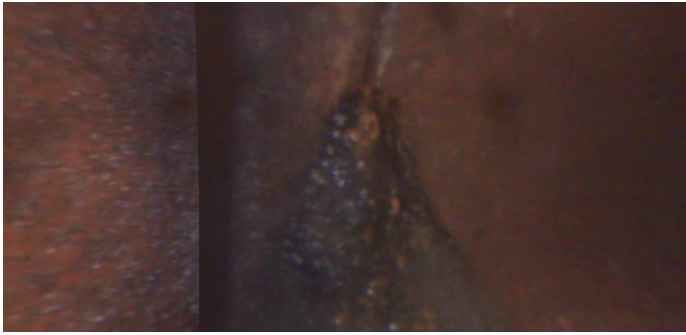
Code: **DAE**
Description: **Deposits Attached Encrustation**

Distance (ft): **255.5**
Structural Grade: **0**
O&M Grade: **2**
Clock Start/From: **3**
Clock To: **5**
1st Value:
2nd Value:
Value Percent: **5.000**
Continuous Index:
Within 8" of Joint: **YES**
Remarks:

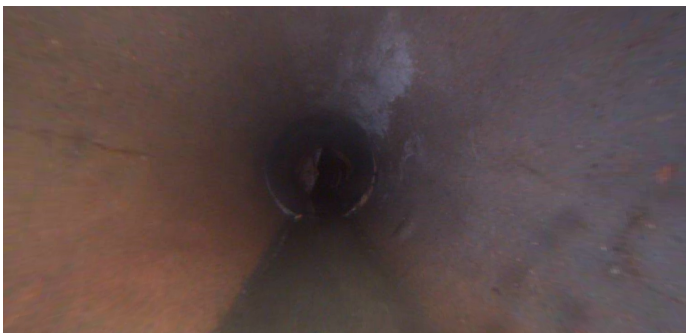
Code: **CM**
Description: **Crack Multiple**

Distance (ft): **273.6**
Structural Grade: **3**
O&M Grade: **0**
Clock Start/From: **9**
Clock To: **3**
1st Value:
2nd Value:
Value Percent:
Continuous Index: **S01**
Within 8" of Joint: **YES**
Remarks: **wandering**

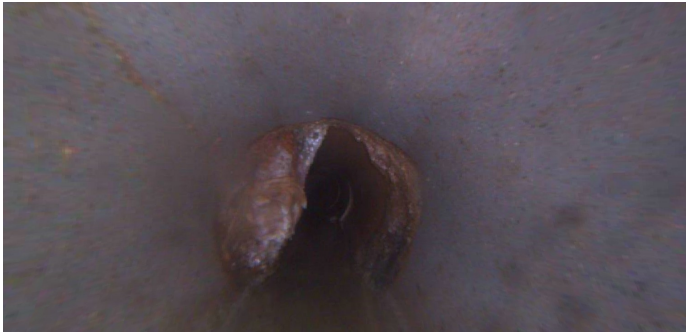
Code: **DAE**
Description: **Deposits Attached Encrustation**

Distance (ft): **276.2**
Structural Grade: **0**
O&M Grade: **4**
Clock Start/From: **7**
Clock To: **5**
1st Value:
2nd Value:
Value Percent: **25.000**
Continuous Index:
Within 8" of Joint: **YES**
Remarks:

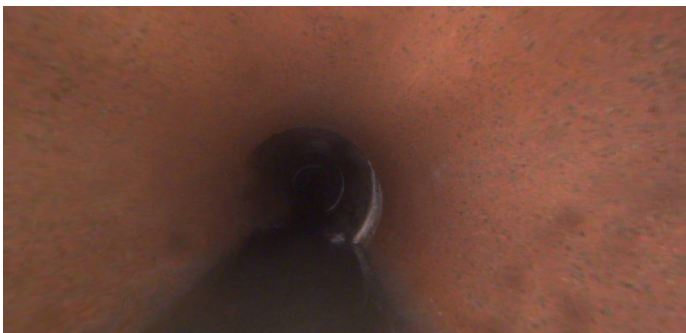
Code: **MSA**
Description: **Abandoned Survey**

Distance (ft): **279.0**
Structural Grade: **0**
O&M Grade: **0**
Clock Start/From:
Clock To:
1st Value:
2nd Value:
Value Percent:
Continuous Index:
Within 8" of Joint: **NO**
Remarks: **dae**

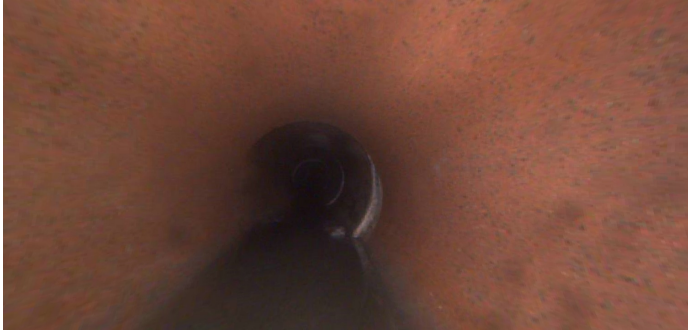
Code:	CM
Description:	Crack Multiple
Distance (ft):	279.0
Structural Grade:	3
O&M Grade:	0
Clock Start/From:	9
Clock To:	3
1st Value:	
2nd Value:	
Value Percent:	
Continuous Index:	F01
Within 8" of Joint:	YES
Remarks:	wandering
