# Profile/Photo Observation Report

Date:	<b>11/19/2021</b>	Weather:		Coding:	<b>PACP 7.0</b>
Pipe Length (ft):	<b>336.6</b>	Owner:	<b>City of Hobart</b>	Pre Clean:	<b>Heavy Cleaning</b>
P.O.#:	<b>YES502259</b>	Surveyor:	<b>S. Bucklin</b>	PSR:	<b>P-604-098-097</b>
Customer:	<b>City of Hobart</b>	Clean Date:	<b>11/19/2021</b>	Shape:	<b>C</b>

Street:	<b>North Pennsylvania Street</b>	Flow Control:	<b>Not Controlled</b>
City:	<b>Hobart, IN</b>	Year Renewed:	
Location:	<b>Local rural streets with light traffic, t</b>	Tape/Media #:	
Purpose:	<b>Routine Assessment</b>	Dia/Height:	<b>12"</b>
Use:	<b>Sanitary Sewage Pipe</b>	Material:	<b>PVC</b>
Drain Area:		Lining:	<b>None</b>
Category:	<b>NA</b>		
Comment:			
Location Details:		Direction of Survey:	<b>Downstream</b>
US MH:	<b>M-604-097</b>	DS MH:	<b>M-604-098</b>
		Total Length Surveyed (ft):	<b>336.6</b>

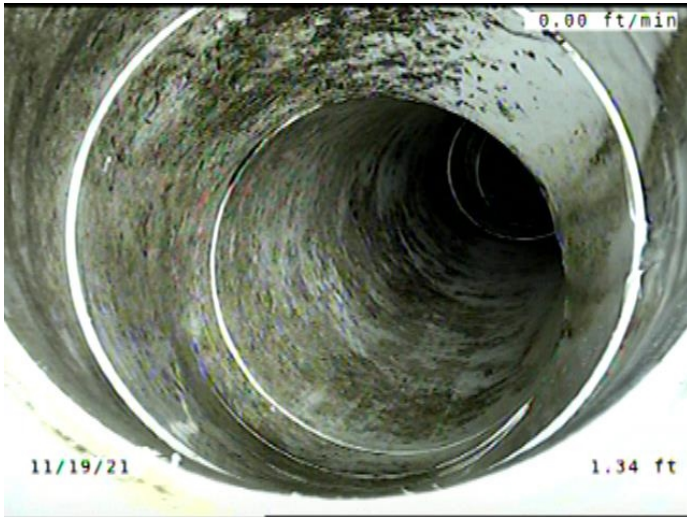
Code:	<b>TF</b>
Description:	<b>Tap Factory</b>
Distance (ft):	<b>1.3</b>
Structural Grade:	<b>0</b>
O&M Grade:	<b>0</b>
Clock Start/From:	<b>2</b>
Clock To:	
1st Value:	<b>4.000</b>
2nd Value:	
Value Percent:	
Continuous Index:	
Within 8" of Joint:	<b>YES</b>
Remarks:	<b>CONSTANTLY RUNNING WATER.</b>

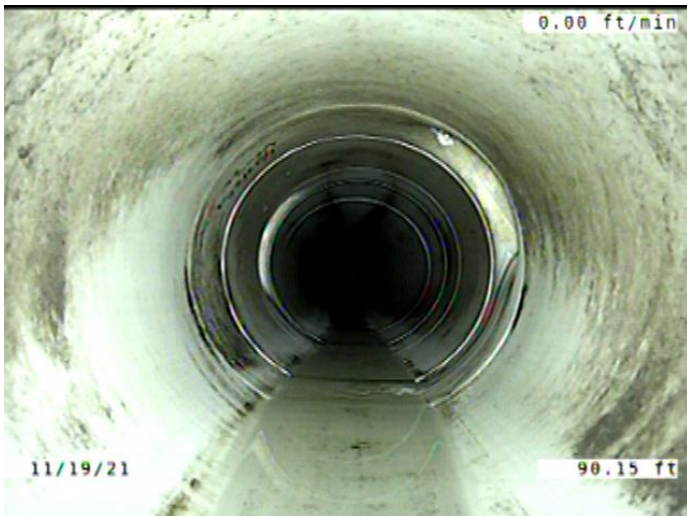
Code:	<b>MWLS</b>
Description:	<b>Miscellaneous Water Level Sag</b>
Distance (ft):	<b>90.2</b>
Structural Grade:	<b>2</b>
O&M Grade:	<b>0</b>
Clock Start/From:	
Clock To:	
1st Value:	
2nd Value:	
Value Percent:	<b>5.000</b>
Continuous Index:	
Within 8" of Joint:	<b>NO</b>
Remarks:

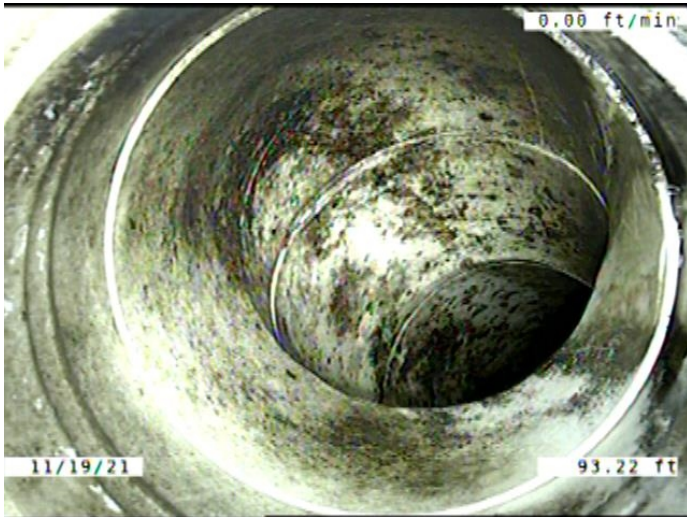
Code: **TF**  
Description: **Tap Factory**

Distance (ft): **93.2**  
Structural Grade: **0**  
O&M Grade: **0**  
Clock Start/From: **2**  
Clock To:  
1st Value: **4.000**  
2nd Value:  
Value Percent:  
Continuous Index:  
Within 8" of Joint: **YES**  
Remarks: **CONSTANTLY RUNNING WATER.**

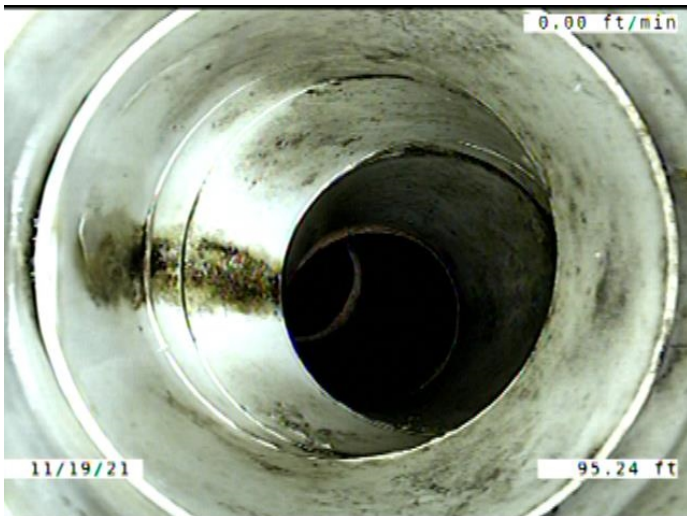
Code: **TF**  
Description: **Tap Factory**

Distance (ft): **95.2**  
Structural Grade: **0**  
O&M Grade: **0**  
Clock Start/From: **10**  
Clock To:  
1st Value: **4.000**  
2nd Value:  
Value Percent:  
Continuous Index:  
Within 8" of Joint: **YES**  
Remarks:

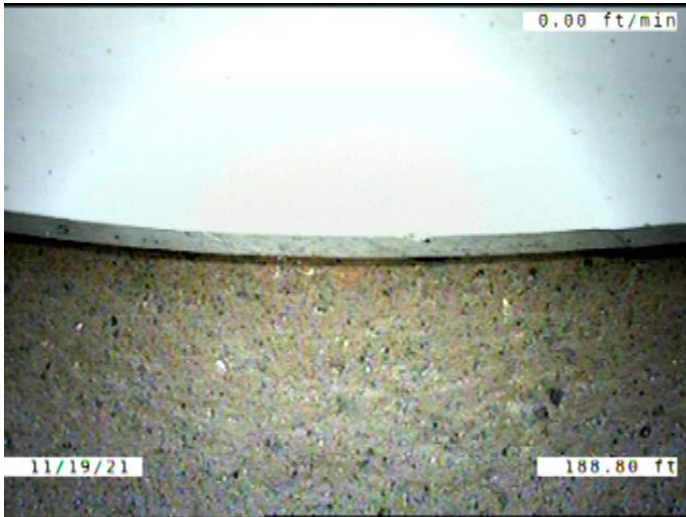
Code: **MMC**  
 Description: **Miscellaneous Material Change**

Distance (ft): **188.8**  
 Structural Grade: **0**  
 O&M Grade: **0**  
 Clock Start/From:  
 Clock To:  
 1st Value:  
 2nd Value:  
 Value Percent:  
 Continuous Index:  
 Within 8" of Joint: **NO**  
 Remarks: **PVC TO VCP**

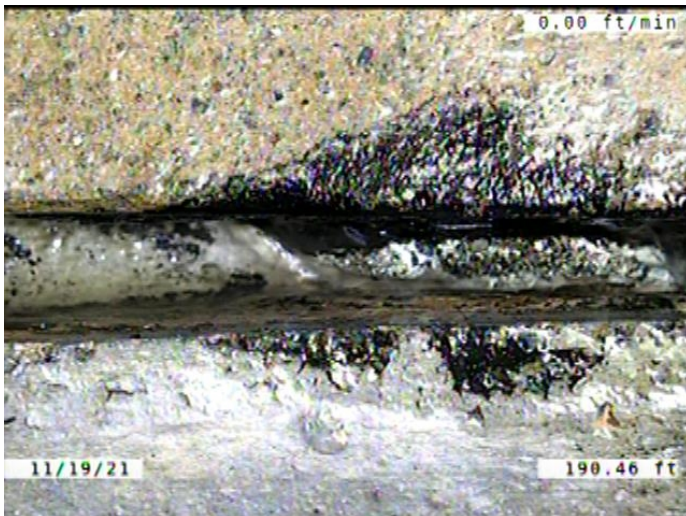
Code: **IRJ**  
 Description: **Infiltration Runner Joint**

Distance (ft): **190.5**  
 Structural Grade: **0**  
 O&M Grade: **4**  
 Clock Start/From: **3**  
 Clock To:  
 1st Value:  
 2nd Value:  
 Value Percent:  
 Continuous Index:  
 Within 8" of Joint: **YES**  
 Remarks:

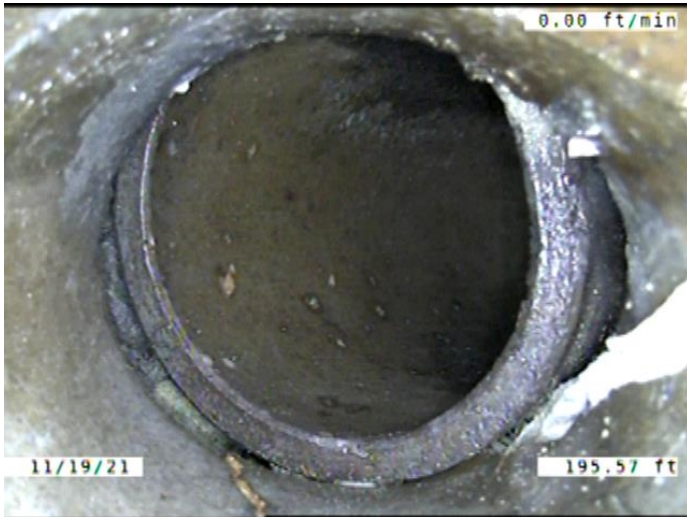
Code:	<b>TF</b>
Description:	<b>Tap Factory</b>
Distance (ft):	<b>195.6</b>
Structural Grade:	<b>0</b>
O&M Grade:	<b>0</b>
Clock Start/From:	<b>1</b>
Clock To:	
1st Value:	<b>4.000</b>
2nd Value:	
Value Percent:	
Continuous Index:	
Within 8" of Joint:	<b>YES</b>
Remarks:	<b>BROKEN. OFFSET. SOIL AND ROOTS VISIBLE</b>

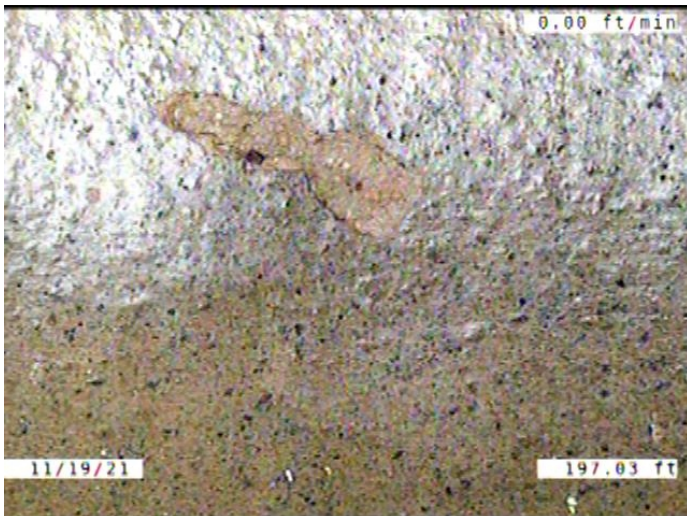
Code:	<b>SSS</b>
Description:	<b>Surface Damage Surface Spalling</b>
Distance (ft):	<b>197.0</b>
Structural Grade:	<b>2</b>
O&M Grade:	<b>0</b>
Clock Start/From:	<b>11</b>
Clock To:	
1st Value:	
2nd Value:	
Value Percent:	
Continuous Index:	
Within 8" of Joint:	<b>YES</b>
Remarks:

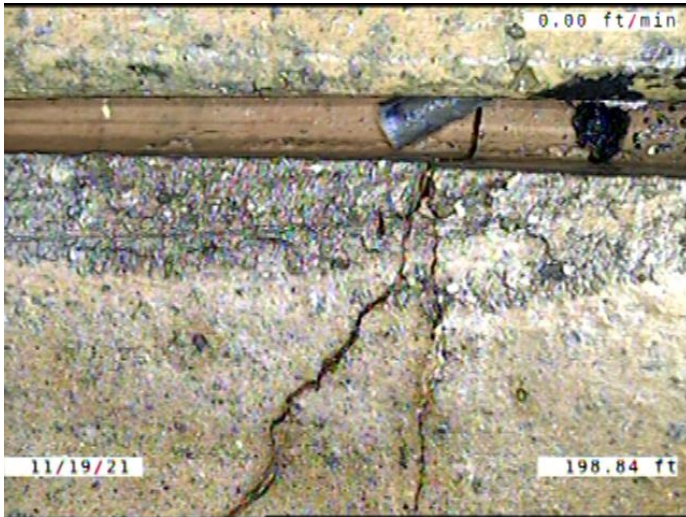
Code: **FM**  
 Description: **Fracture Multiple**

Distance (ft): **198.8**  
 Structural Grade: **4**  
 O&M Grade: **0**  
 Clock Start/From: **12**  
 Clock To: **3**  
 1st Value:  
 2nd Value:  
 Value Percent:  
 Continuous Index:  
 Within 8" of Joint: **YES**  
 Remarks:

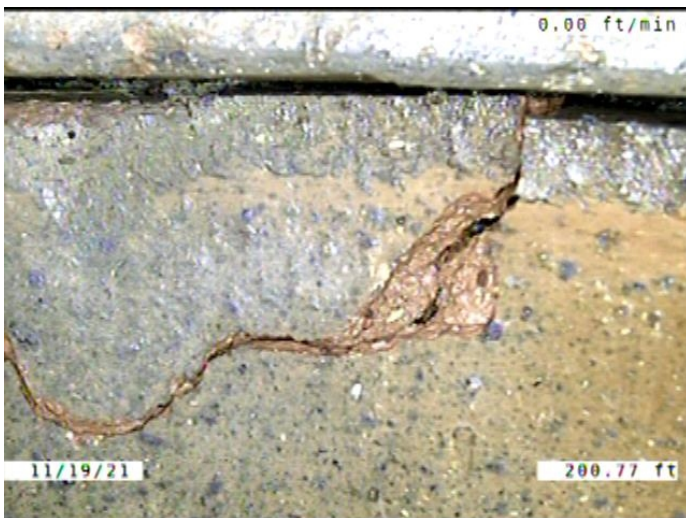
Code: **B**  
 Description: **Broken**

Distance (ft): **200.8**  
 Structural Grade: **4**  
 O&M Grade: **0**  
 Clock Start/From: **8**  
 Clock To: **3**  
 1st Value:  
 2nd Value:  
 Value Percent:  
 Continuous Index:  
 Within 8" of Joint: **YES**  
 Remarks:

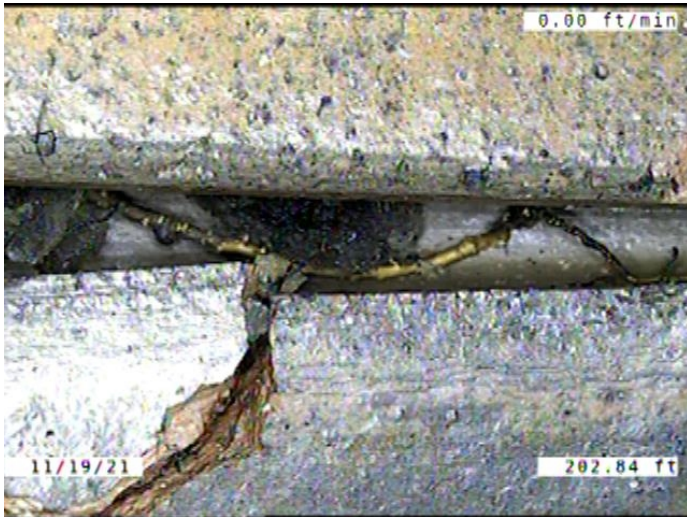
Code: **RFJ**  
Description: **Roots Fine Joint**

Distance (ft): **202.8**  
Structural Grade: **0**  
O&M Grade: **1**  
Clock Start/From: **10**  
Clock To: **11**  
1st Value:  
2nd Value:  
Value Percent:  
Continuous Index:  
Within 8" of Joint: **YES**  
Remarks:

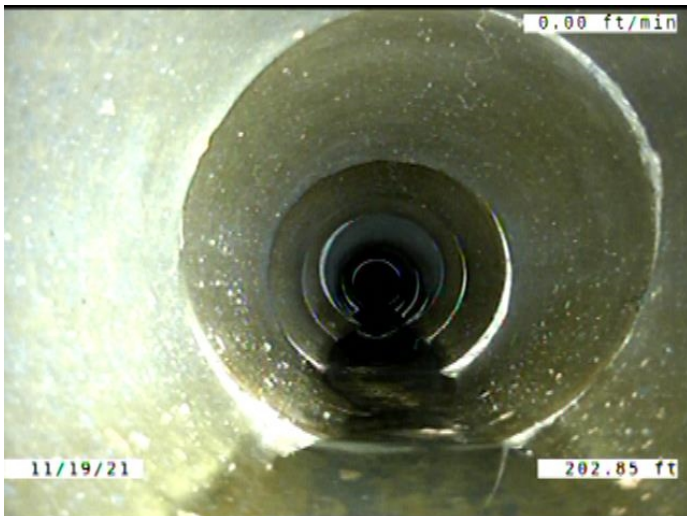
Code: **MWLS**  
Description: **Miscellaneous Water Level Sag**

Distance (ft): **202.8**  
Structural Grade: **2**  
O&M Grade: **0**  
Clock Start/From:  
Clock To:  
1st Value:  
2nd Value:  
Value Percent: **5.000**  
Continuous Index: **F01**  
Within 8" of Joint: **NO**  
Remarks:

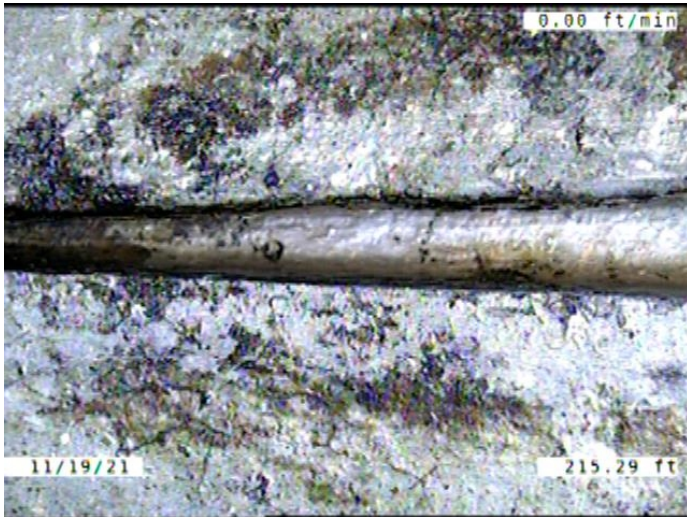
Code: **ISJ**  
Description: **Infiltration Stain Joint**

Distance (ft): **215.3**  
Structural Grade: **0**  
O&M Grade: **1**  
Clock Start/From: **12**  
Clock To: **4**  
1st Value:  
2nd Value:  
Value Percent:  
Continuous Index:  
Within 8" of Joint: **YES**  
Remarks:

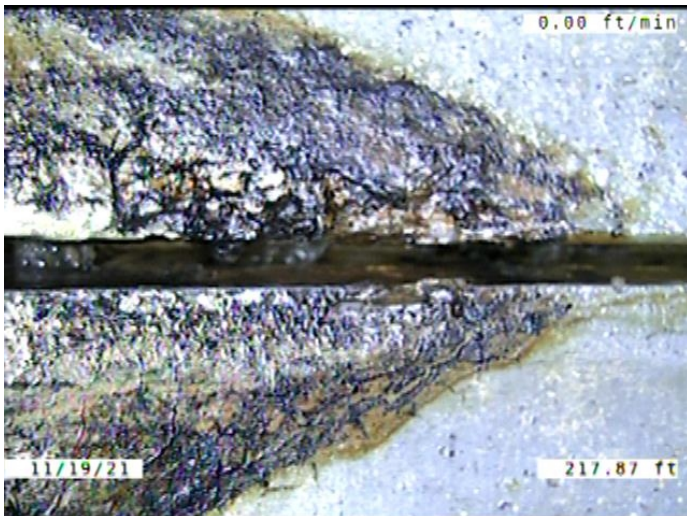
Code: **ISJ**  
Description: **Infiltration Stain Joint**

Distance (ft): **217.9**  
Structural Grade: **0**  
O&M Grade: **1**  
Clock Start/From: **7**  
Clock To: **10**  
1st Value:  
2nd Value:  
Value Percent:  
Continuous Index:  
Within 8" of Joint: **YES**  
Remarks:

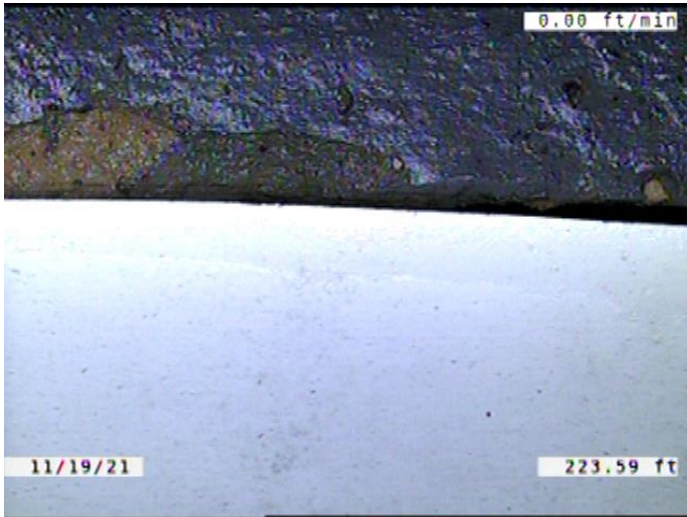
Code:	<b>MMC</b>
Description:	<b>Miscellaneous Material Change</b>
Distance (ft):	<b>223.6</b>
Structural Grade:	<b>0</b>
O&M Grade:	<b>0</b>
Clock Start/From:	
Clock To:	
1st Value:	
2nd Value:	
Value Percent:	
Continuous Index:	
Within 8" of Joint:	<b>NO</b>
Remarks:	<b>VCP TO PVC</b>

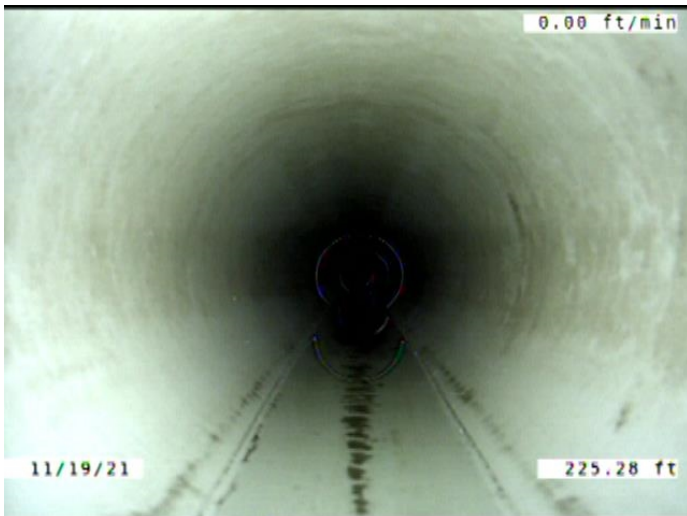
Code:	<b>FM</b>
Description:	<b>Fracture Multiple</b>
Distance (ft):	<b>225.3</b>
Structural Grade:	<b>4</b>
O&M Grade:	<b>0</b>
Clock Start/From:	<b>9</b>
Clock To:	<b>4</b>
1st Value:	
2nd Value:	
Value Percent:	
Continuous Index:	<b>F03</b>
Within 8" of Joint:	<b>YES</b>
Remarks:

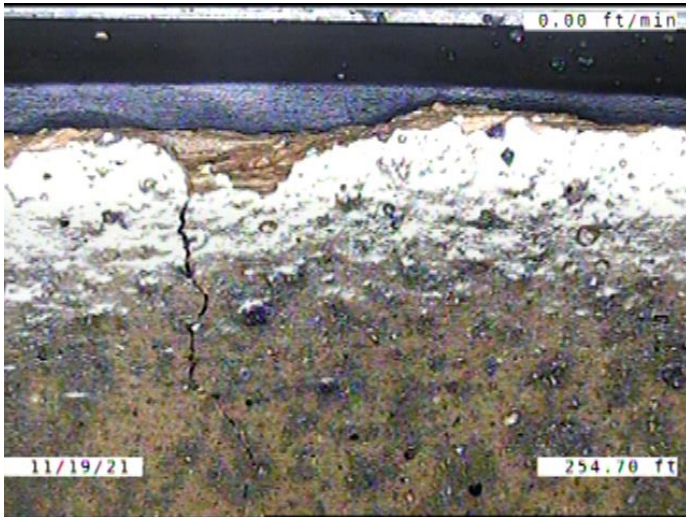
Code: **FM**  
 Description: **Fracture Multiple**

Distance (ft): **254.7**  
 Structural Grade: **4**  
 O&M Grade: **0**  
 Clock Start/From: **12**  
 Clock To: **12**  
 1st Value:  
 2nd Value:  
 Value Percent:  
 Continuous Index: **S05**  
 Within 8" of Joint: **YES**  
 Remarks:

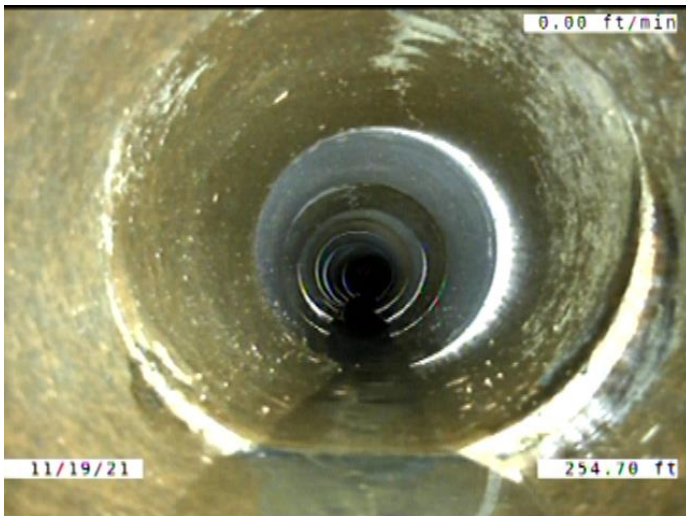
Code: **MWLS**  
 Description: **Miscellaneous Water Level Sag**

Distance (ft): **254.7**  
 Structural Grade: **2**  
 O&M Grade: **0**  
 Clock Start/From:  
 Clock To:  
 1st Value:  
 2nd Value:  
 Value Percent: **5.000**  
 Continuous Index: **F04**  
 Within 8" of Joint: **NO**  
 Remarks:

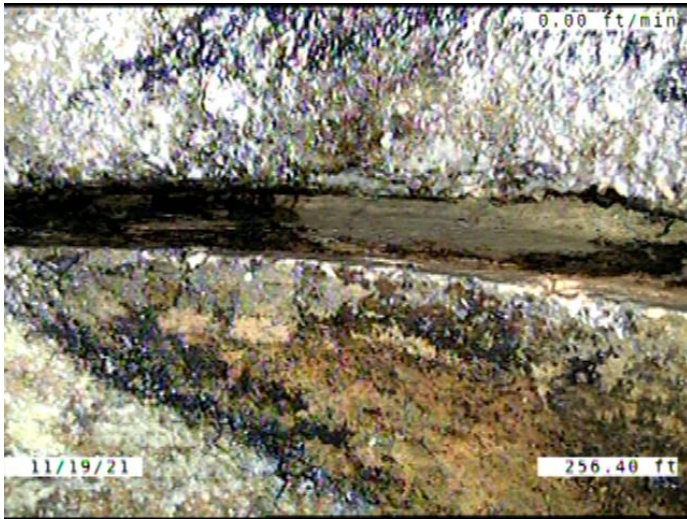
Code: **DAE**  
 Description: **Deposits Attached Encrustation**

Distance (ft): **256.4**  
 Structural Grade: **0**  
 O&M Grade: **2**  
 Clock Start/From: **2**  
 Clock To: **10**  
 1st Value:  
 2nd Value:  
 Value Percent: **5.000**  
 Continuous Index:  
 Within 8" of Joint: **YES**  
 Remarks:

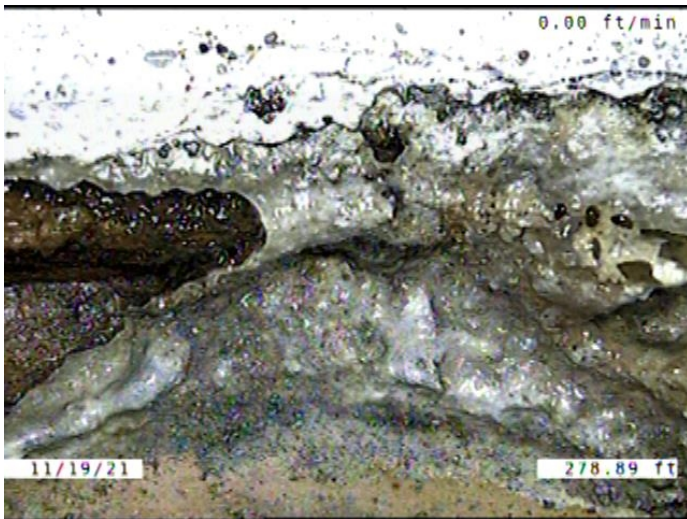
Code: **DAE**  
 Description: **Deposits Attached Encrustation**

Distance (ft): **278.9**  
 Structural Grade: **0**  
 O&M Grade: **2**  
 Clock Start/From: **7**  
 Clock To: **4**  
 1st Value:  
 2nd Value:  
 Value Percent: **10.000**  
 Continuous Index:  
 Within 8" of Joint: **YES**  
 Remarks:

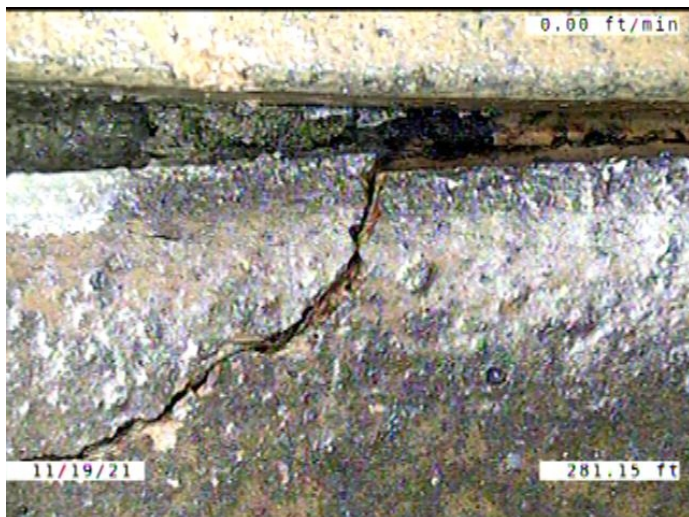
Code: **B**  
 Description: **Broken**

Distance (ft): **281.1**  
 Structural Grade: **4**  
 O&M Grade: **0**  
 Clock Start/From: **8**  
 Clock To: **10**  
 1st Value:  
 2nd Value:  
 Value Percent:  
 Continuous Index:  
 Within 8" of Joint: **YES**  
 Remarks:

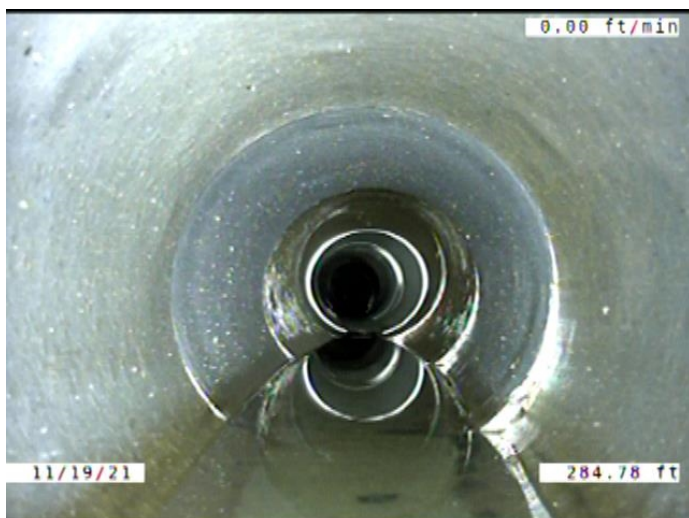
Code: **MWLS**  
 Description: **Miscellaneous Water Level Sag**

Distance (ft): **284.8**  
 Structural Grade: **2**  
 O&M Grade: **0**  
 Clock Start/From:  
 Clock To:  
 1st Value:  
 2nd Value:  
 Value Percent: **5.000**  
 Continuous Index: **S06**  
 Within 8" of Joint: **NO**  
 Remarks:

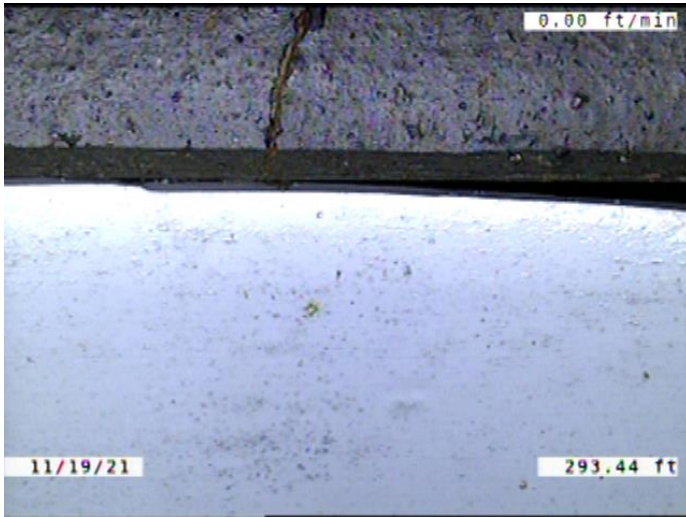
Code: **MMC**  
 Description: **Miscellaneous Material Change**

Distance (ft): **293.4**  
 Structural Grade: **0**  
 O&M Grade: **0**  
 Clock Start/From:  
 Clock To:  
 1st Value:  
 2nd Value:  
 Value Percent:  
 Continuous Index:  
 Within 8" of Joint: **NO**  
 Remarks: **VCP TO PVC**

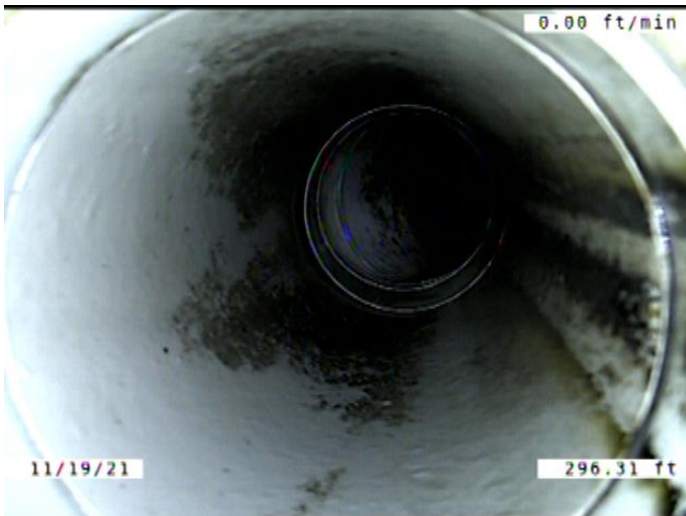
Code: **TF**  
 Description: **Tap Factory**

Distance (ft): **296.3**  
 Structural Grade: **0**  
 O&M Grade: **0**  
 Clock Start/From: **2**  
 Clock To:  
 1st Value: **4.000**  
 2nd Value:  
 Value Percent:  
 Continuous Index:  
 Within 8" of Joint: **YES**  
 Remarks:

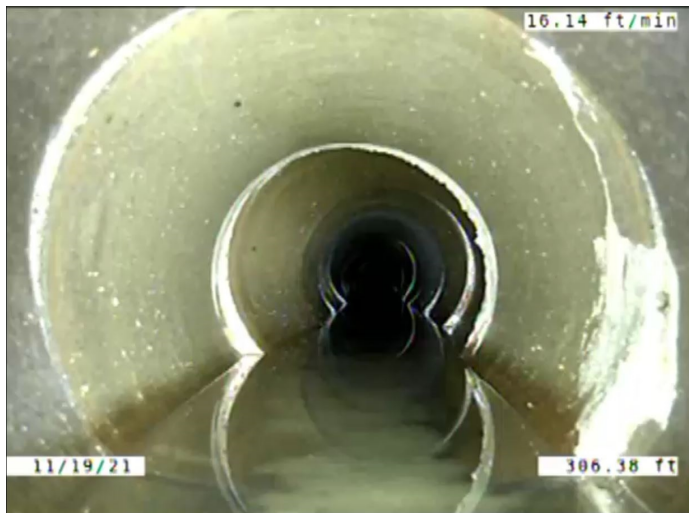
Code: **CM**  
 Description: **Crack Multiple**

Distance (ft): **306.4**  
 Structural Grade: **3**  
 O&M Grade: **0**  
 Clock Start/From: **1**  
 Clock To: **3**  
 1st Value:  
 2nd Value:  
 Value Percent:  
 Continuous Index:  
 Within 8" of Joint: **YES**  
 Remarks:

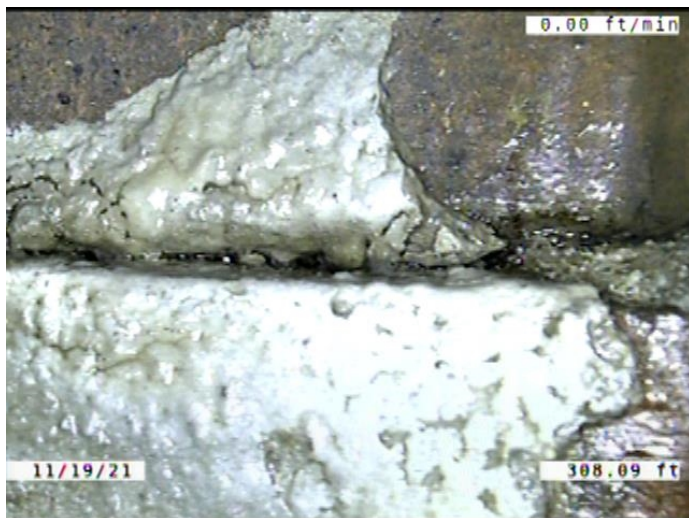
Code: **DAE**  
 Description: **Deposits Attached Encrustation**

Distance (ft): **308.1**  
 Structural Grade: **0**  
 O&M Grade: **2**  
 Clock Start/From: **1**  
 Clock To: **4**  
 1st Value:  
 2nd Value:  
 Value Percent: **5.000**  
 Continuous Index:  
 Within 8" of Joint: **YES**  
 Remarks:
