Profile/Photo Observation Report

Date:	11/19/2021	Weather:		Coding:	PACP 7.0
Pipe Length (ft):	336.6	Owner:	City of Hobart	Pre Clean:	Heavy Cleaning
P.O.#:	YES502259	Surveyor:	S. Bucklin	PSR:	P-604-098-097
Customer:	City of Hobart	Clean Date:	11/19/2021	Shape:	C

Street:	North Pennsylvania Street	Flow Control:	Not Controlled
City:	Hobart, IN	Year Renewed:	
Location:	Local rural streets with light traffic, t	Tape/Media #:	
Purpose:	Routine Assessment	Dia/Height:	12"
Use:	Sanitary Sewage Pipe	Material:	PVC
Drain Area:		Lining:	None
Category:	NA		
Comment:			
Location Details:		Direction of Survey:	Downstream
US MH:	M-604-097	DS MH:	M-604-098
		Total Length Surveyed (ft):	336.6

O&M Index:	1.90	O&M Quick:	412E	O&M Rating:	78.00
Structural Index:	2.93	Structural Quick:	4B35	Structural Rating:	117.00
Overall Index:	2.41	Overall Quick:	4B35	Overall Rating:	195.00

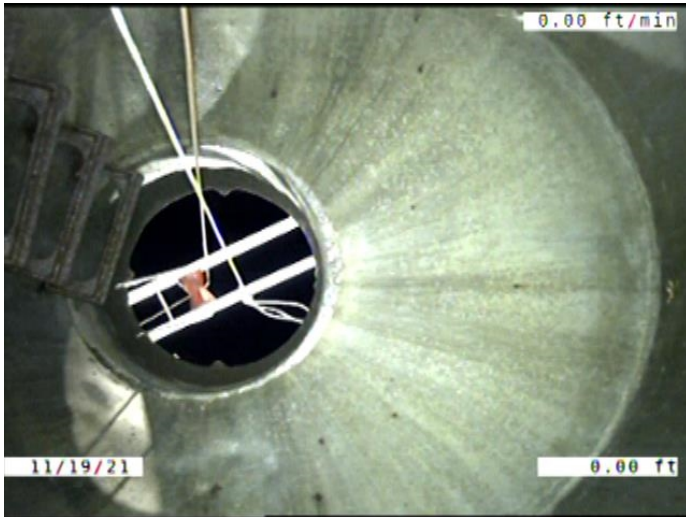
Code: **AMH**
 Description: **Manhole**

Distance (ft): **.0**
 Structural Grade: **0**
 O&M Grade: **0**
 Clock Start/From:
 Clock To:
 1st Value:
 2nd Value:
 Value Percent:
 Continuous Index:
 Within 8" of Joint: **NO**
 Remarks: **M-604-097**

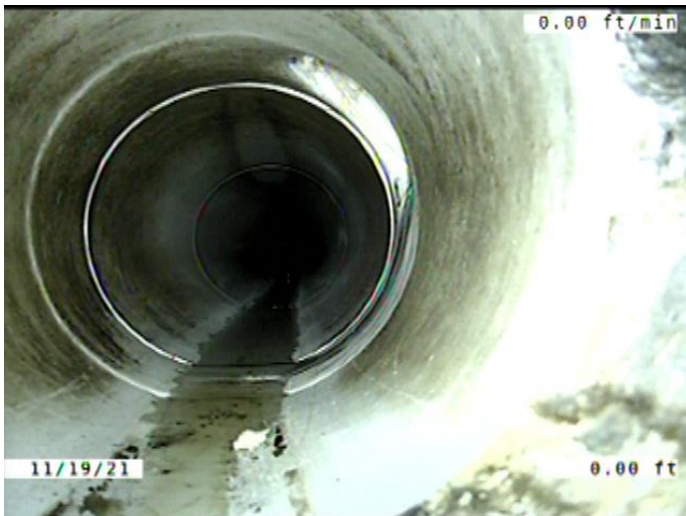
Code: **MWL**
 Description: **Miscellaneous Water Level**

Distance (ft): **.0**
 Structural Grade: **0**
 O&M Grade: **0**
 Clock Start/From:
 Clock To:
 1st Value:
 2nd Value:
 Value Percent: **5.000**
 Continuous Index:
 Within 8" of Joint: **NO**
 Remarks:

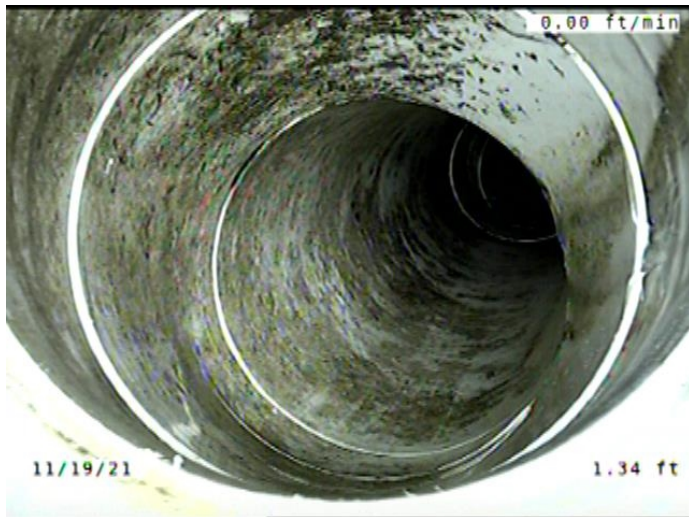
Code: **TF**
 Description: **Tap Factory**

Distance (ft): **1.3**
 Structural Grade: **0**
 O&M Grade: **0**
 Clock Start/From: **2**
 Clock To:
 1st Value: **4.000**
 2nd Value:
 Value Percent:
 Continuous Index:
 Within 8" of Joint: **YES**
 Remarks: **CONSTANTLY RUNNING WATER.**

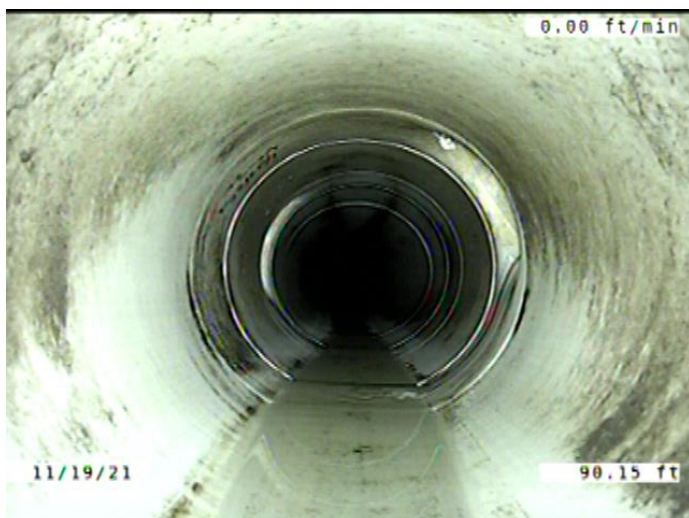
Code: **MWLS**
 Description: **Miscellaneous Water Level Sag**

Distance (ft): **90.2**
 Structural Grade: **2**
 O&M Grade: **0**
 Clock Start/From:
 Clock To:
 1st Value:
 2nd Value:
 Value Percent: **5.000**
 Continuous Index:
 Within 8" of Joint: **NO**
 Remarks:

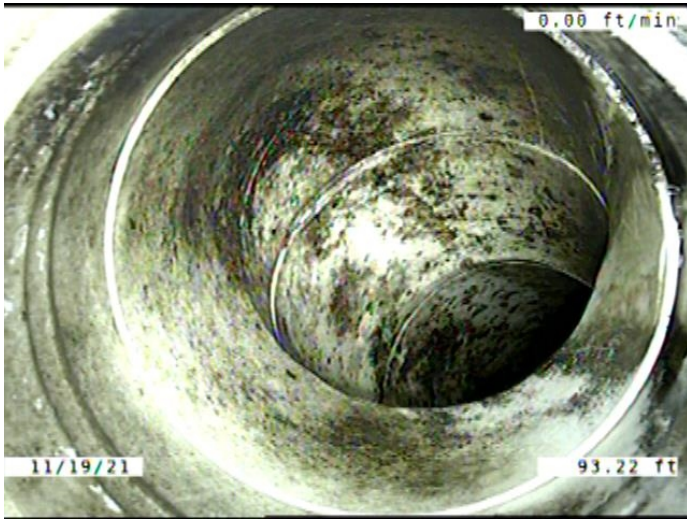
Code: **TF**
Description: **Tap Factory**

Distance (ft): **93.2**
Structural Grade: **0**
O&M Grade: **0**
Clock Start/From: **2**
Clock To:
1st Value: **4.000**
2nd Value:
Value Percent:
Continuous Index:
Within 8" of Joint: **YES**
Remarks: **CONSTANTLY RUNNING WATER.**

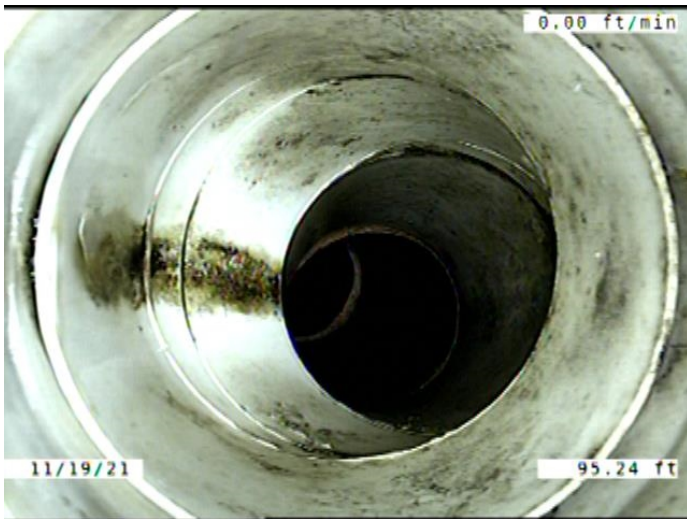
Code: **TF**
Description: **Tap Factory**

Distance (ft): **95.2**
Structural Grade: **0**
O&M Grade: **0**
Clock Start/From: **10**
Clock To:
1st Value: **4.000**
2nd Value:
Value Percent:
Continuous Index:
Within 8" of Joint: **YES**
Remarks:

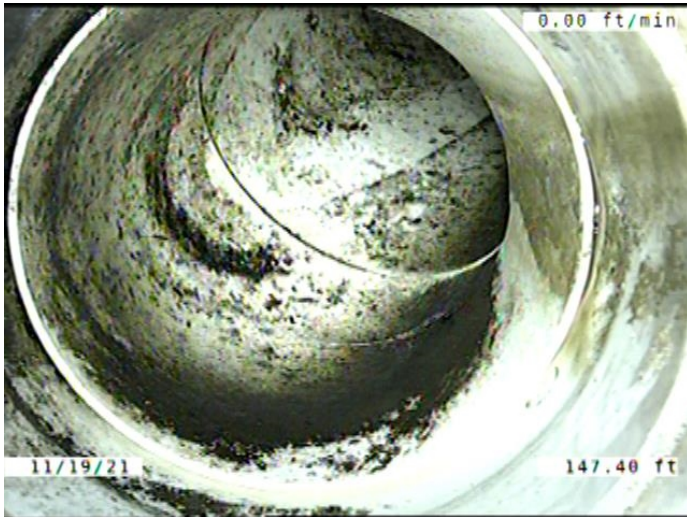
Code: **TF**
Description: **Tap Factory**

Distance (ft): **147.4**
Structural Grade: **0**
O&M Grade: **0**
Clock Start/From: **1**
Clock To:
1st Value: **4.000**
2nd Value:
Value Percent:
Continuous Index:
Within 8" of Joint: **YES**
Remarks:

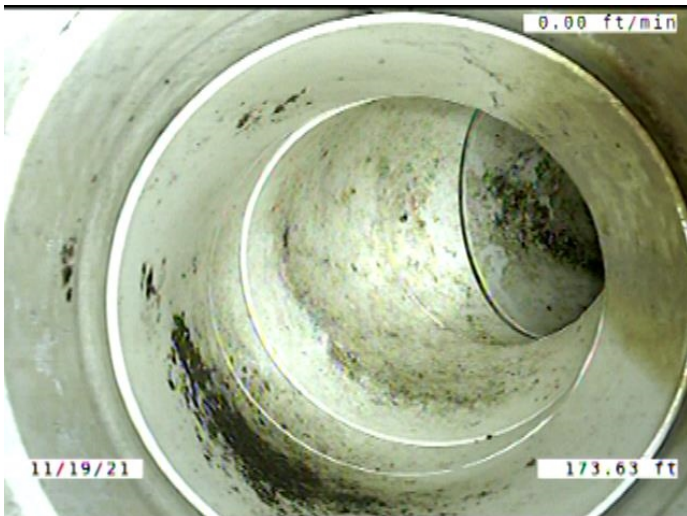
Code: **TF**
Description: **Tap Factory**

Distance (ft): **173.6**
Structural Grade: **0**
O&M Grade: **0**
Clock Start/From: **1**
Clock To:
1st Value: **4.000**
2nd Value:
Value Percent:
Continuous Index:
Within 8" of Joint: **YES**
Remarks:

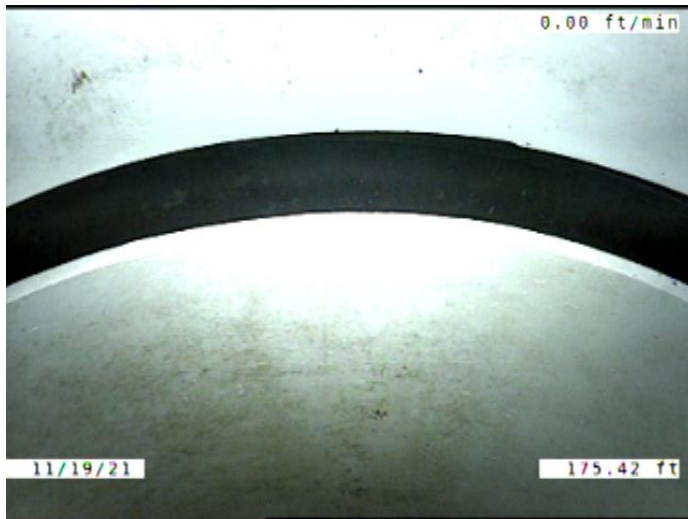
Code: **JOL**
Description: **Joint Offset Large**

Distance (ft): **175.4**
Structural Grade: **4**
O&M Grade: **0**
Clock Start/From:
Clock To:
1st Value: **1.000**
2nd Value:
Value Percent:
Continuous Index:
Within 8" of Joint: **NO**
Remarks:

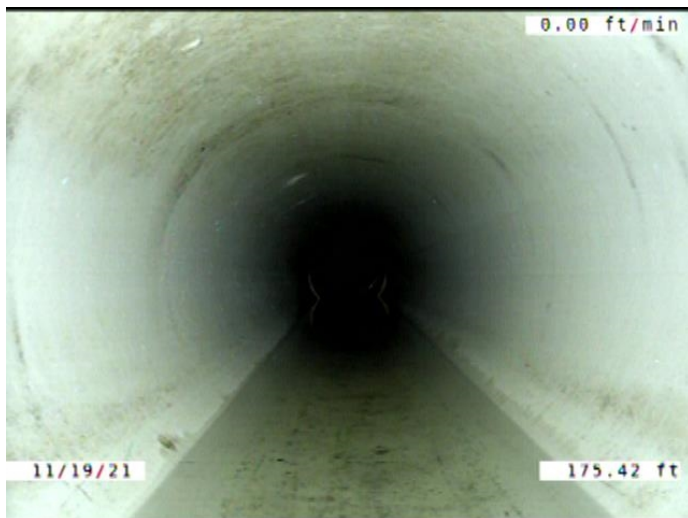
Code: **MWLS**
Description: **Miscellaneous Water Level Sag**

Distance (ft): **175.4**
Structural Grade: **2**
O&M Grade: **0**
Clock Start/From:
Clock To:
1st Value:
2nd Value:
Value Percent: **5.000**
Continuous Index: **S01**
Within 8" of Joint: **NO**
Remarks:

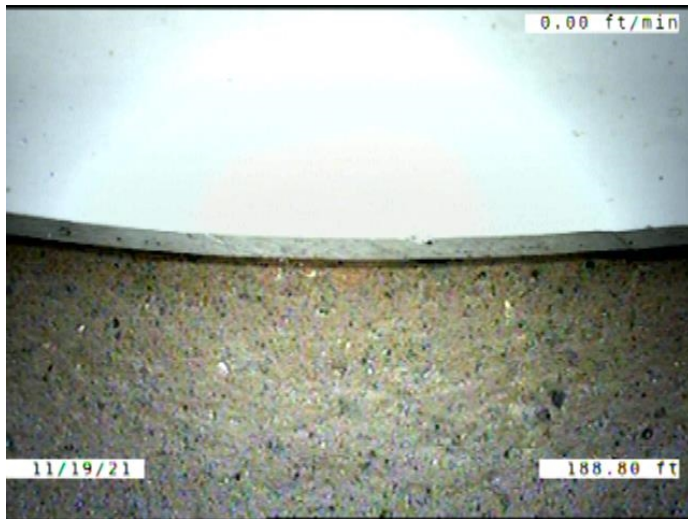
Code: **MMC**
 Description: **Miscellaneous Material Change**

Distance (ft): **188.8**
 Structural Grade: **0**
 O&M Grade: **0**
 Clock Start/From:
 Clock To:
 1st Value:
 2nd Value:
 Value Percent:
 Continuous Index:
 Within 8" of Joint: **NO**
 Remarks: **PVC TO VCP**

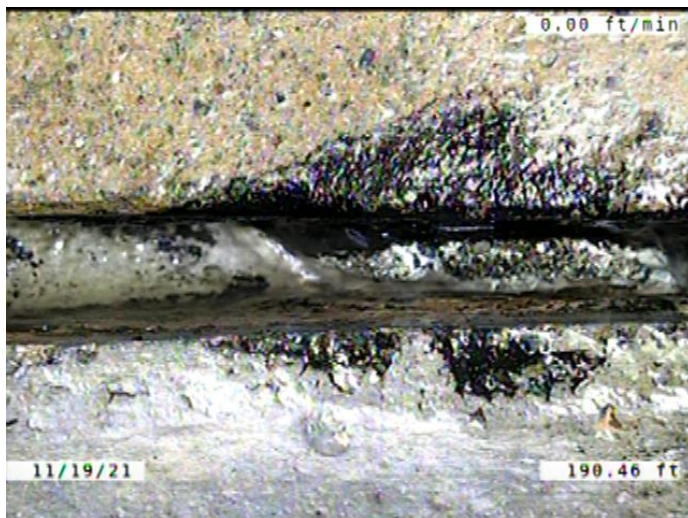
Code: **IRJ**
 Description: **Infiltration Runner Joint**

Distance (ft): **190.5**
 Structural Grade: **0**
 O&M Grade: **4**
 Clock Start/From: **3**
 Clock To:
 1st Value:
 2nd Value:
 Value Percent:
 Continuous Index:
 Within 8" of Joint: **YES**
 Remarks:

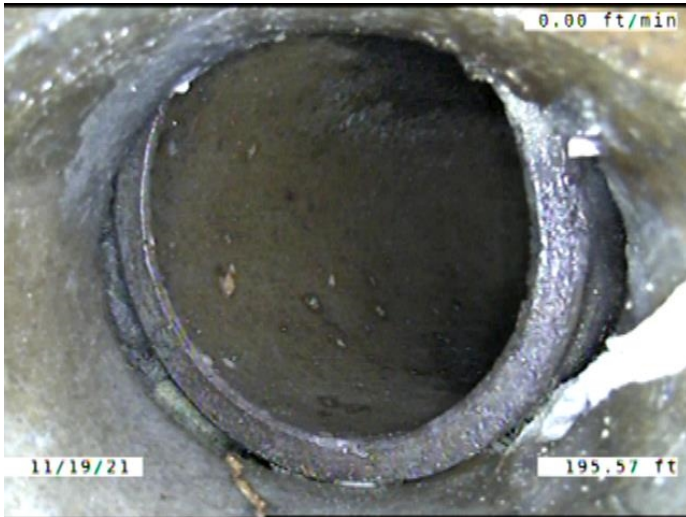
Code:	TF
Description:	Tap Factory
Distance (ft):	195.6
Structural Grade:	0
O&M Grade:	0
Clock Start/From:	1
Clock To:	
1st Value:	4.000
2nd Value:	
Value Percent:	
Continuous Index:	
Within 8" of Joint:	YES
Remarks:	BROKEN. OFFSET. SOIL AND ROOTS VISIBLE

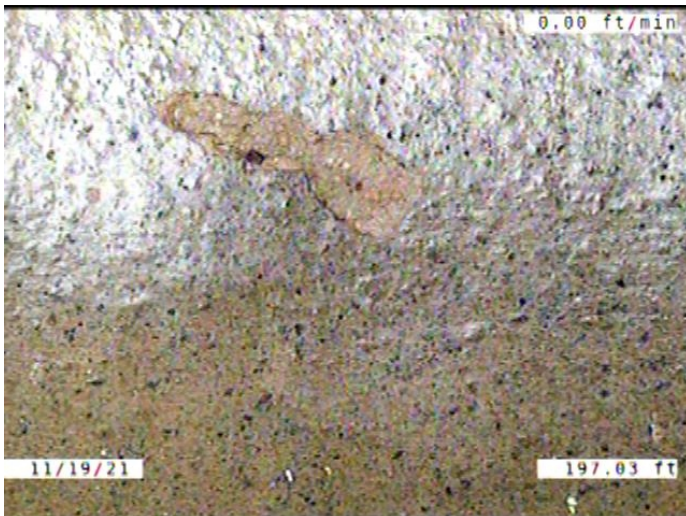
Code:	SSS
Description:	Surface Damage Surface Spalling
Distance (ft):	197.0
Structural Grade:	2
O&M Grade:	0
Clock Start/From:	11
Clock To:	
1st Value:	
2nd Value:	
Value Percent:	
Continuous Index:	
Within 8" of Joint:	YES
Remarks:

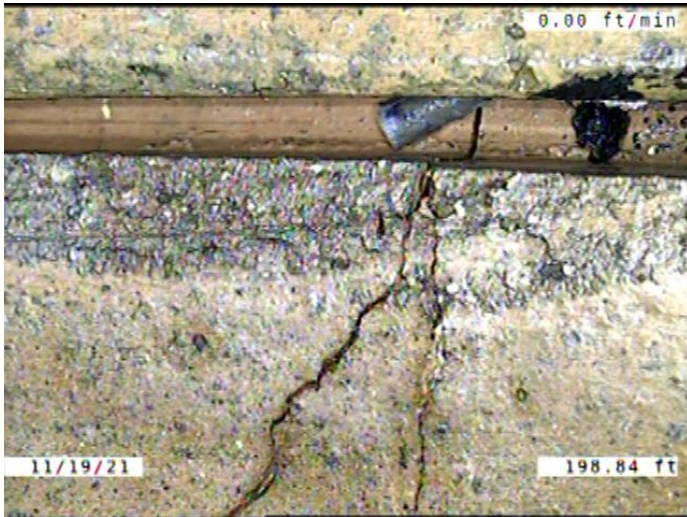
Code: **FM**
 Description: **Fracture Multiple**

Distance (ft): **198.8**
 Structural Grade: **4**
 O&M Grade: **0**
 Clock Start/From: **12**
 Clock To: **3**
 1st Value:
 2nd Value:
 Value Percent:
 Continuous Index:
 Within 8" of Joint: **YES**
 Remarks:

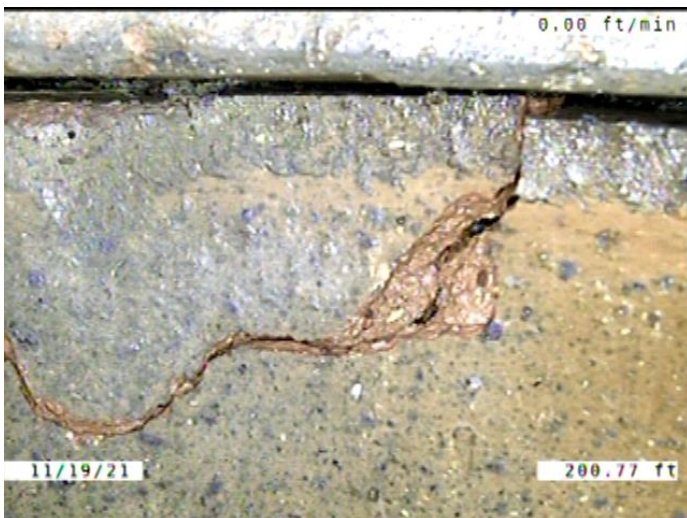
Code: **B**
 Description: **Broken**

Distance (ft): **200.8**
 Structural Grade: **4**
 O&M Grade: **0**
 Clock Start/From: **8**
 Clock To: **3**
 1st Value:
 2nd Value:
 Value Percent:
 Continuous Index:
 Within 8" of Joint: **YES**
 Remarks:

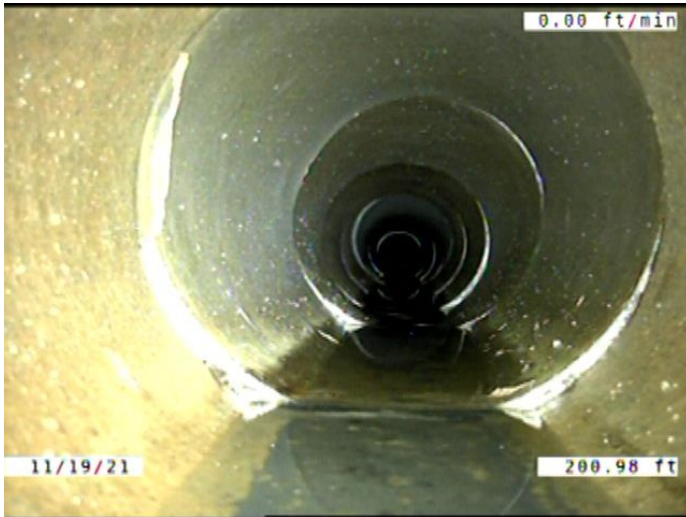
Code: **DSF**
 Description: **Deposits Settled Fine**

Distance (ft): **201.0**
 Structural Grade: **0**
 O&M Grade: **2**
 Clock Start/From: **5**
 Clock To: **7**
 1st Value:
 2nd Value:
 Value Percent: **5.000**
 Continuous Index: **S02**
 Within 8" of Joint: **YES**
 Remarks:

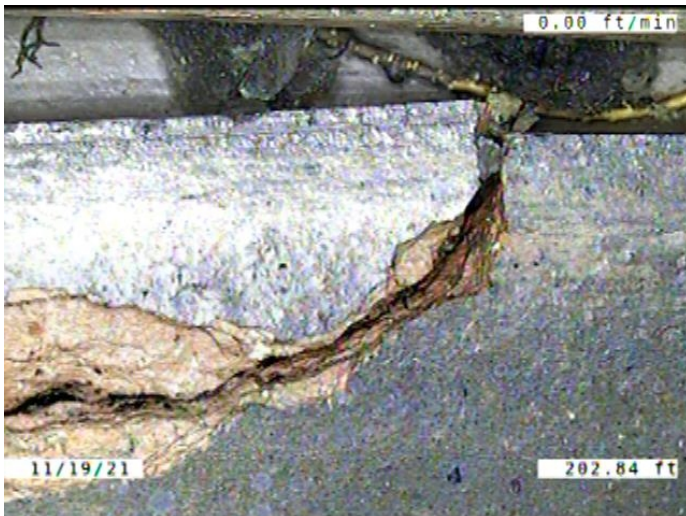
Code: **B**
 Description: **Broken**

Distance (ft): **202.8**
 Structural Grade: **4**
 O&M Grade: **0**
 Clock Start/From: **8**
 Clock To: **10**
 1st Value:
 2nd Value:
 Value Percent:
 Continuous Index:
 Within 8" of Joint: **YES**
 Remarks:

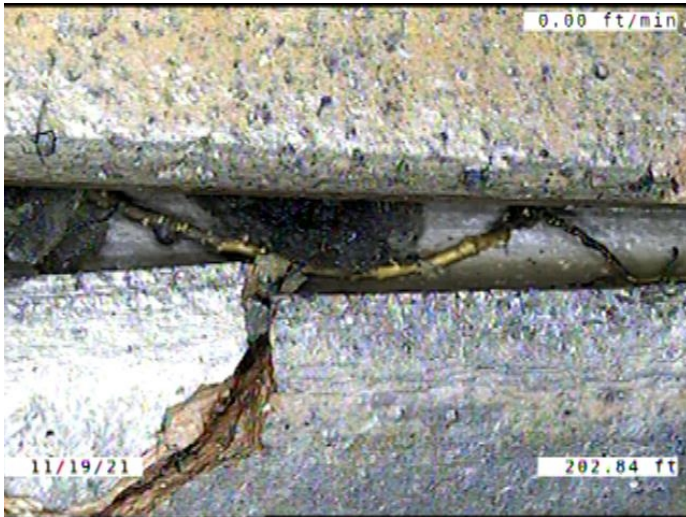
Code: **RFJ**
 Description: **Roots Fine Joint**

Distance (ft): **202.8**
 Structural Grade: **0**
 O&M Grade: **1**
 Clock Start/From: **10**
 Clock To: **11**
 1st Value:
 2nd Value:
 Value Percent:
 Continuous Index:
 Within 8" of Joint: **YES**
 Remarks:

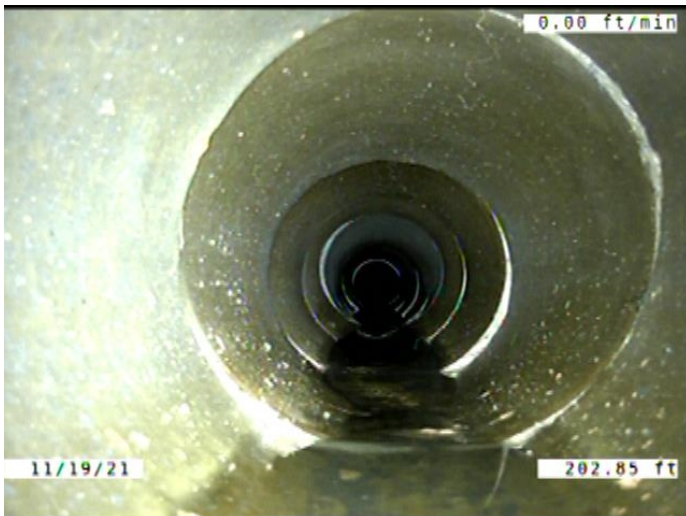
Code: **MWLS**
 Description: **Miscellaneous Water Level Sag**

Distance (ft): **202.8**
 Structural Grade: **2**
 O&M Grade: **0**
 Clock Start/From:
 Clock To:
 1st Value:
 2nd Value:
 Value Percent: **5.000**
 Continuous Index: **F01**
 Within 8" of Joint: **NO**
 Remarks:

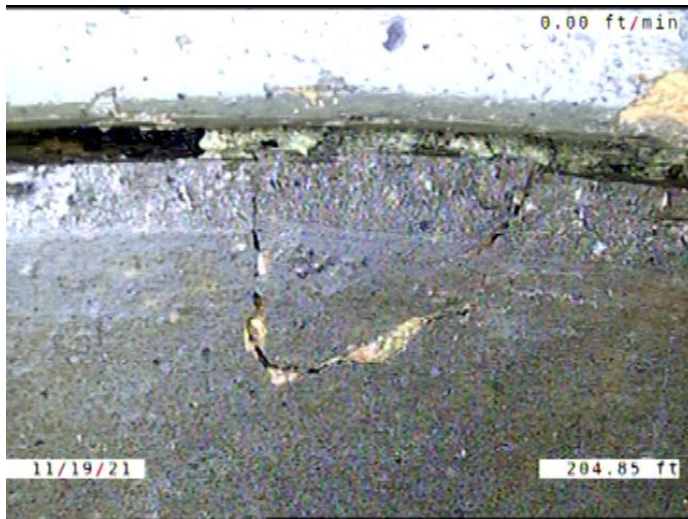
Code: **FM**
Description: **Fracture Multiple**

Distance (ft): **204.8**
Structural Grade: **4**
O&M Grade: **0**
Clock Start/From: **9**
Clock To: **4**
1st Value:
2nd Value:
Value Percent:
Continuous Index: **S03**
Within 8" of Joint: **YES**
Remarks:

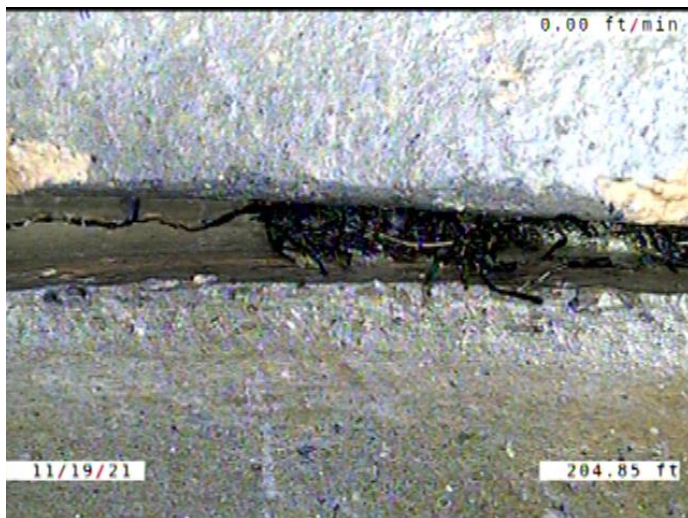
Code: **RFJ**
Description: **Roots Fine Joint**

Distance (ft): **204.9**
Structural Grade: **0**
O&M Grade: **1**
Clock Start/From: **2**
Clock To: **3**
1st Value:
2nd Value:
Value Percent:
Continuous Index:
Within 8" of Joint: **YES**
Remarks:

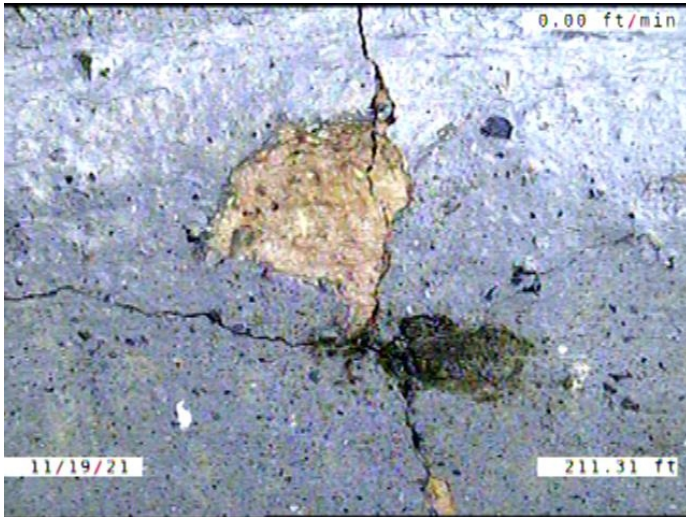
Code: **SSS**
 Description: **Surface Damage Surface Spalling**

Distance (ft): **211.3**
 Structural Grade: **2**
 O&M Grade: **0**
 Clock Start/From: **2**
 Clock To:
 1st Value:
 2nd Value:
 Value Percent:
 Continuous Index:
 Within 8" of Joint: **YES**
 Remarks:

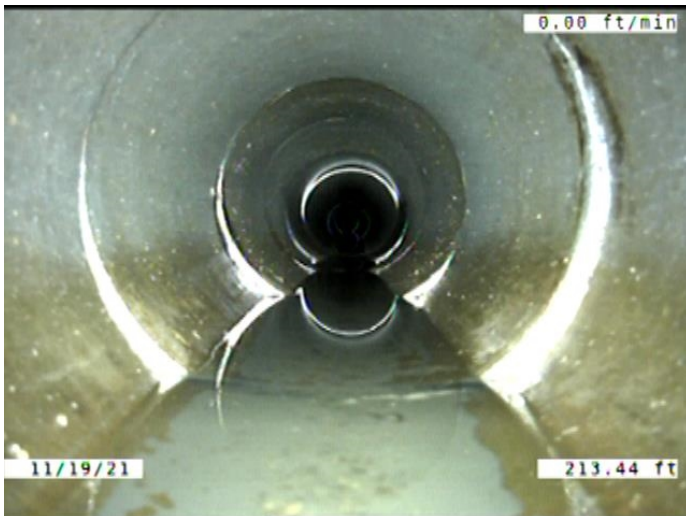
Code: **MWLS**
 Description: **Miscellaneous Water Level Sag**

Distance (ft): **213.4**
 Structural Grade: **2**
 O&M Grade: **0**
 Clock Start/From:
 Clock To:
 1st Value:
 2nd Value:
 Value Percent: **5.000**
 Continuous Index: **S04**
 Within 8" of Joint: **NO**
 Remarks:

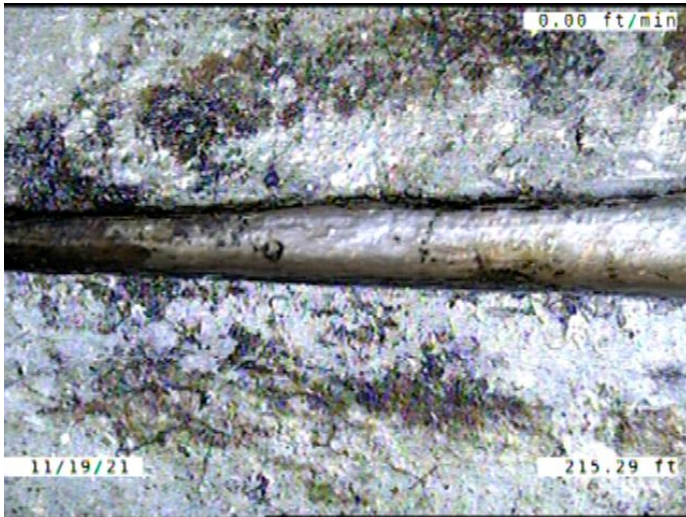
Code: **ISJ**
 Description: **Infiltration Stain Joint**

Distance (ft): **215.3**
 Structural Grade: **0**
 O&M Grade: **1**
 Clock Start/From: **12**
 Clock To: **4**
 1st Value:
 2nd Value:
 Value Percent:
 Continuous Index:
 Within 8" of Joint: **YES**
 Remarks:

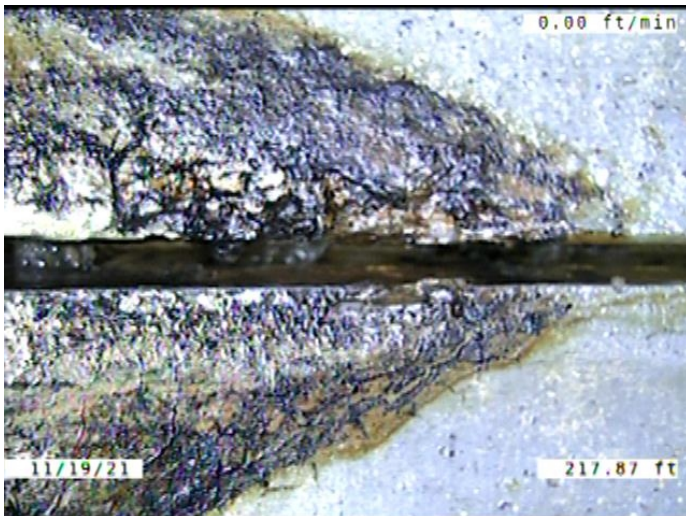
Code: **ISJ**
 Description: **Infiltration Stain Joint**

Distance (ft): **217.9**
 Structural Grade: **0**
 O&M Grade: **1**
 Clock Start/From: **7**
 Clock To: **10**
 1st Value:
 2nd Value:
 Value Percent:
 Continuous Index:
 Within 8" of Joint: **YES**
 Remarks:

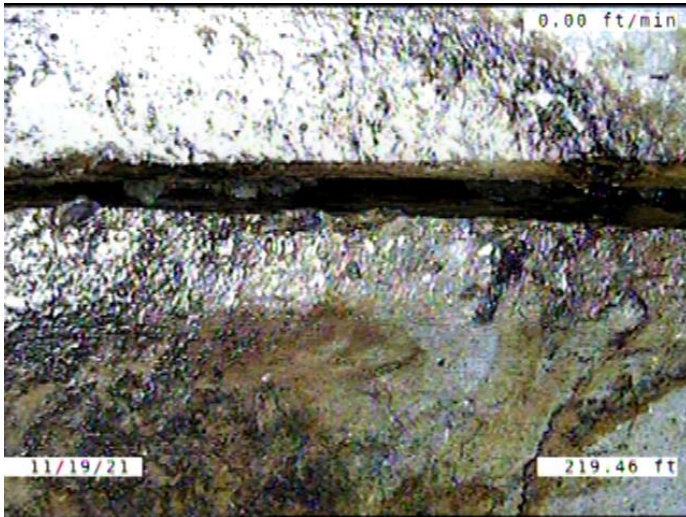
Code: **ISJ**
Description: **Infiltration Stain Joint**

Distance (ft): **219.5**
Structural Grade: **0**
O&M Grade: **1**
Clock Start/From: **7**
Clock To: **9**
1st Value:
2nd Value:
Value Percent:
Continuous Index:
Within 8" of Joint: **YES**
Remarks:

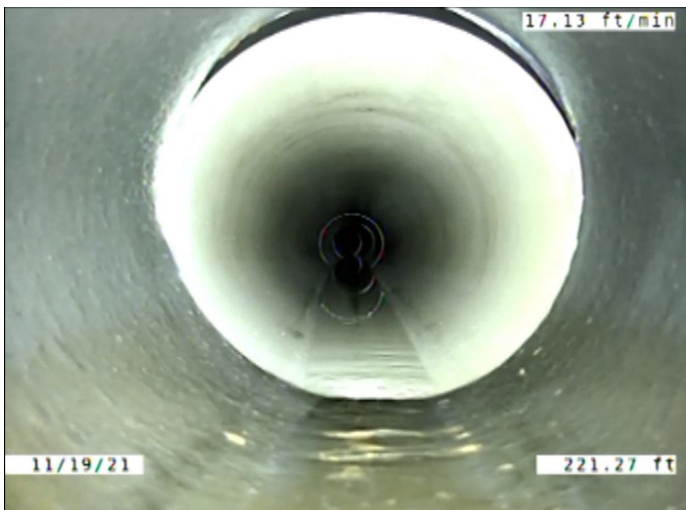
Code: **JOM**
Description: **Joint Offset Medium**

Distance (ft): **221.3**
Structural Grade: **3**
O&M Grade: **0**
Clock Start/From:
Clock To:
1st Value:
2nd Value:
Value Percent:
Continuous Index:
Within 8" of Joint: **NO**
Remarks:

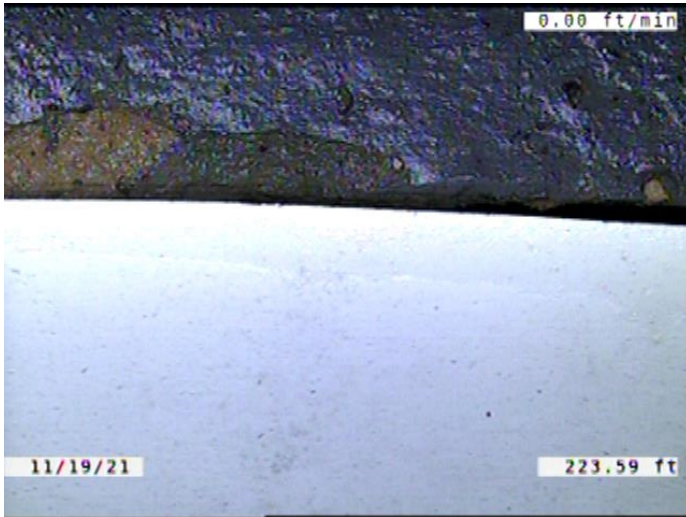
Code:	MMC
Description:	Miscellaneous Material Change
Distance (ft):	223.6
Structural Grade:	0
O&M Grade:	0
Clock Start/From:	
Clock To:	
1st Value:	
2nd Value:	
Value Percent:	
Continuous Index:	
Within 8" of Joint:	NO
Remarks:	VCP TO PVC

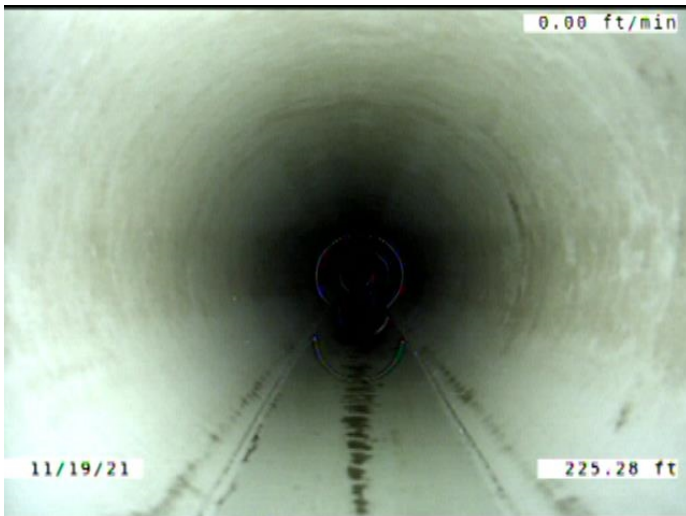
Code:	FM
Description:	Fracture Multiple
Distance (ft):	225.3
Structural Grade:	4
O&M Grade:	0
Clock Start/From:	9
Clock To:	4
1st Value:	
2nd Value:	
Value Percent:	
Continuous Index:	F03
Within 8" of Joint:	YES
Remarks:

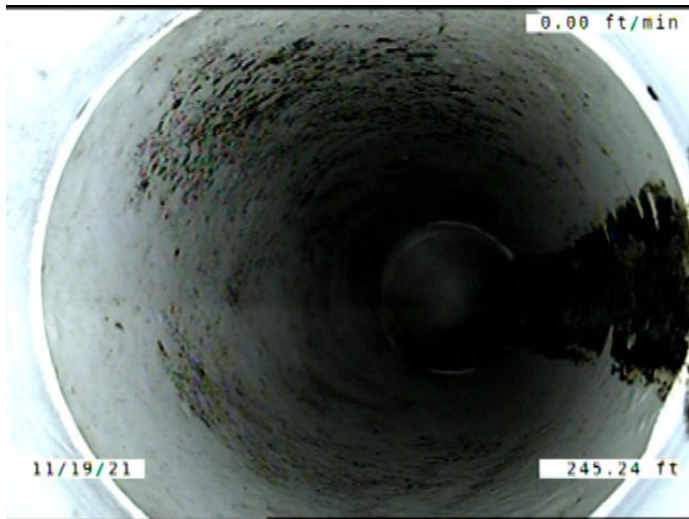
Code: **TF**
Description: **Tap Factory**

Distance (ft): **245.2**
Structural Grade: **0**
O&M Grade: **0**
Clock Start/From: **2**
Clock To:
1st Value: **4.000**
2nd Value:
Value Percent:
Continuous Index:
Within 8" of Joint: **YES**
Remarks:

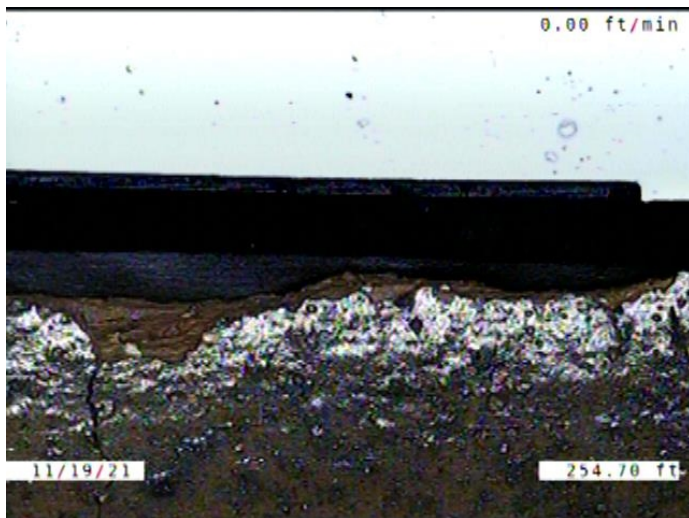
Code: **MMC**
Description: **Miscellaneous Material Change**

Distance (ft): **254.7**
Structural Grade: **0**
O&M Grade: **0**
Clock Start/From:
Clock To:
1st Value:
2nd Value:
Value Percent:
Continuous Index:
Within 8" of Joint: **NO**
Remarks: **PVC TO VCP**

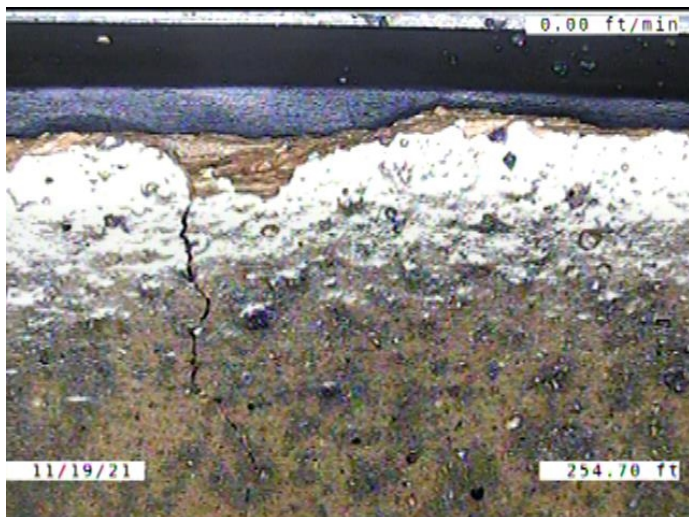
Code: **FM**
 Description: **Fracture Multiple**

Distance (ft): **254.7**
 Structural Grade: **4**
 O&M Grade: **0**
 Clock Start/From: **12**
 Clock To: **12**
 1st Value:
 2nd Value:
 Value Percent:
 Continuous Index: **S05**
 Within 8" of Joint: **YES**
 Remarks:

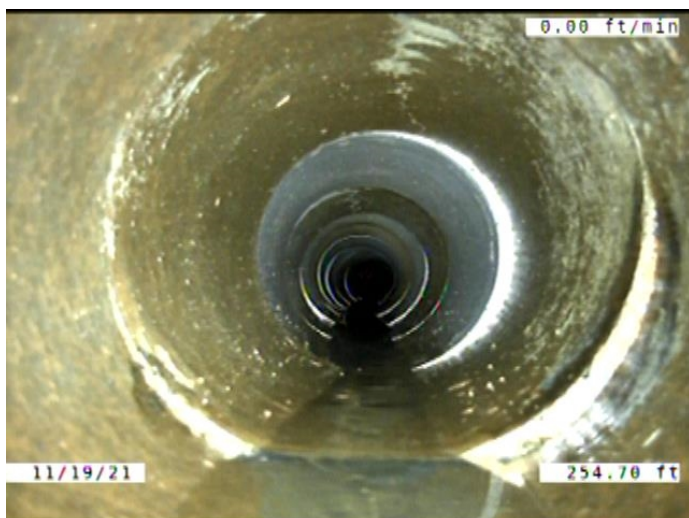
Code: **MWLS**
 Description: **Miscellaneous Water Level Sag**

Distance (ft): **254.7**
 Structural Grade: **2**
 O&M Grade: **0**
 Clock Start/From:
 Clock To:
 1st Value:
 2nd Value:
 Value Percent: **5.000**
 Continuous Index: **F04**
 Within 8" of Joint: **NO**
 Remarks:

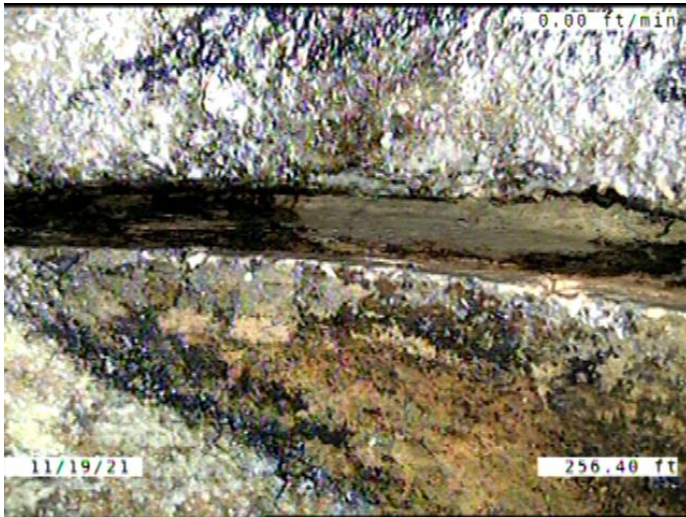
Code: **DAE**
 Description: **Deposits Attached Encrustation**

Distance (ft): **256.4**
 Structural Grade: **0**
 O&M Grade: **2**
 Clock Start/From: **2**
 Clock To: **10**
 1st Value:
 2nd Value:
 Value Percent: **5.000**
 Continuous Index:
 Within 8" of Joint: **YES**
 Remarks:

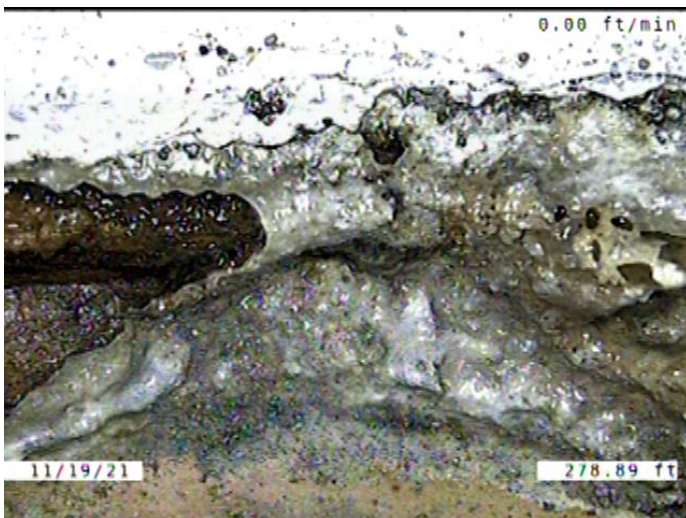
Code: **DAE**
 Description: **Deposits Attached Encrustation**

Distance (ft): **278.9**
 Structural Grade: **0**
 O&M Grade: **2**
 Clock Start/From: **7**
 Clock To: **4**
 1st Value:
 2nd Value:
 Value Percent: **10.000**
 Continuous Index:
 Within 8" of Joint: **YES**
 Remarks:

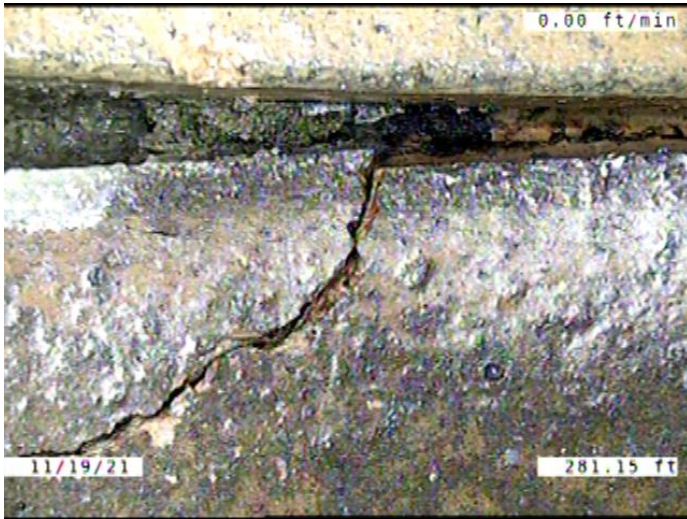
Code: **B**
Description: **Broken**

Distance (ft): **281.1**
Structural Grade: **4**
O&M Grade: **0**
Clock Start/From: **8**
Clock To: **10**
1st Value:
2nd Value:
Value Percent:
Continuous Index:
Within 8" of Joint: **YES**
Remarks:

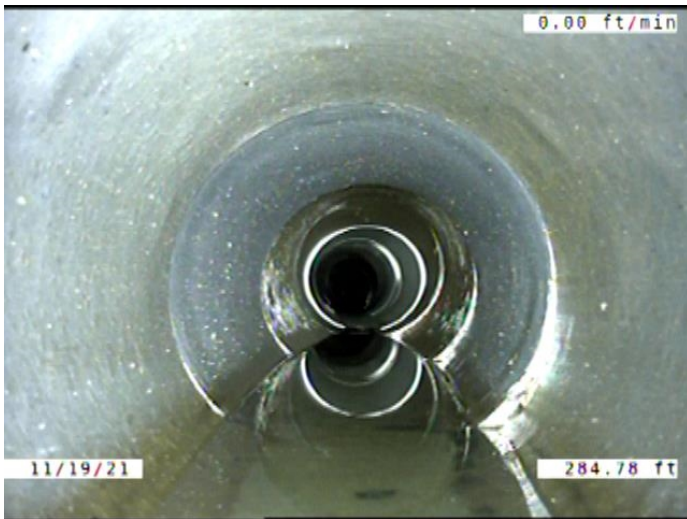
Code: **MWLS**
Description: **Miscellaneous Water Level Sag**

Distance (ft): **284.8**
Structural Grade: **2**
O&M Grade: **0**
Clock Start/From:
Clock To:
1st Value:
2nd Value:
Value Percent: **5.000**
Continuous Index: **S06**
Within 8" of Joint: **NO**
Remarks:

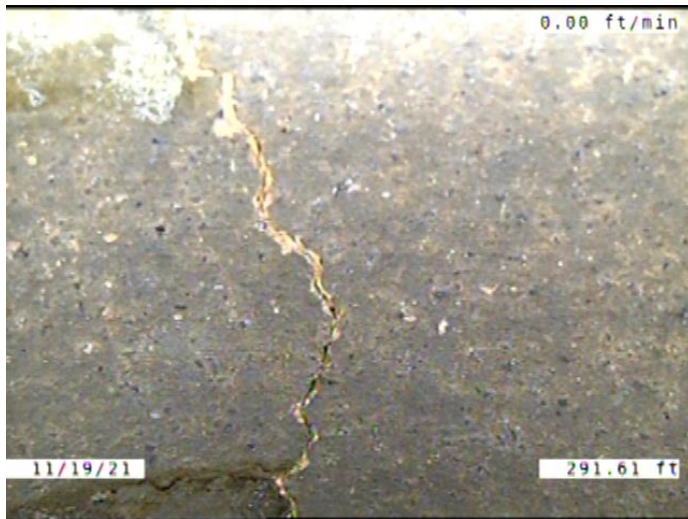
Code: **FM**
 Description: **Fracture Multiple**

Distance (ft): **291.6**
 Structural Grade: **4**
 O&M Grade: **0**
 Clock Start/From: **12**
 Clock To: **12**
 1st Value:
 2nd Value:
 Value Percent:
 Continuous Index: **F05**
 Within 8" of Joint: **YES**
 Remarks:

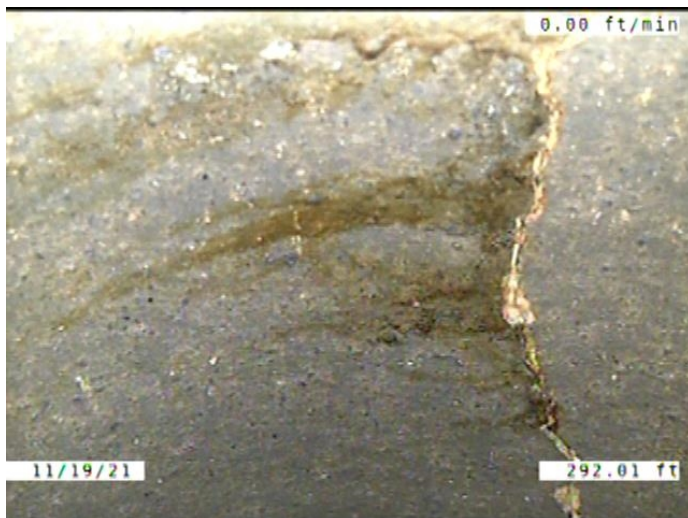
Code: **ISB**
 Description: **Infiltration Stain Barrel**

Distance (ft): **292.0**
 Structural Grade: **0**
 O&M Grade: **1**
 Clock Start/From: **9**
 Clock To: **12**
 1st Value:
 2nd Value:
 Value Percent:
 Continuous Index:
 Within 8" of Joint: **NO**
 Remarks:

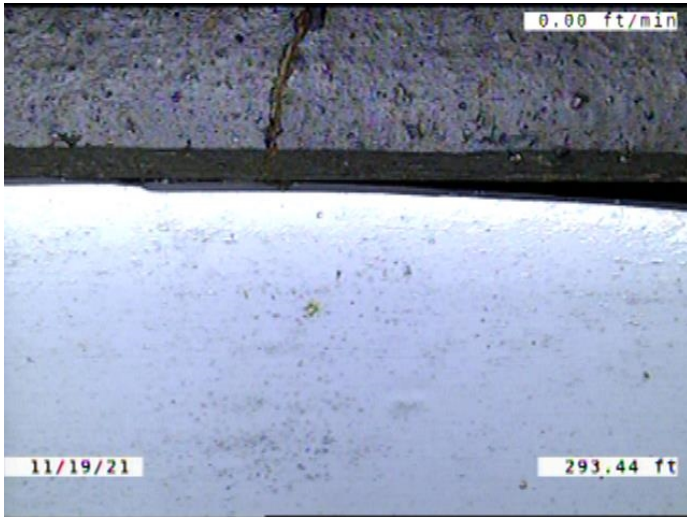
Code: **MMC**
 Description: **Miscellaneous Material Change**

Distance (ft): **293.4**
 Structural Grade: **0**
 O&M Grade: **0**
 Clock Start/From:
 Clock To:
 1st Value:
 2nd Value:
 Value Percent:
 Continuous Index:
 Within 8" of Joint: **NO**
 Remarks: **VCP TO PVC**

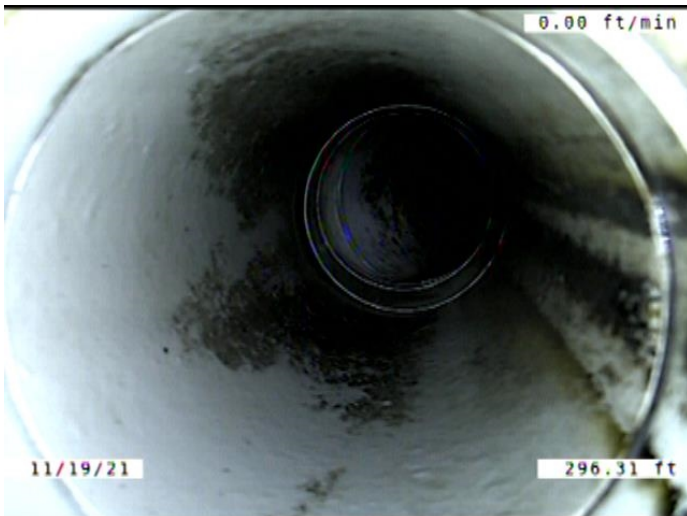
Code: **TF**
 Description: **Tap Factory**

Distance (ft): **296.3**
 Structural Grade: **0**
 O&M Grade: **0**
 Clock Start/From: **2**
 Clock To:
 1st Value: **4.000**
 2nd Value:
 Value Percent:
 Continuous Index:
 Within 8" of Joint: **YES**
 Remarks:

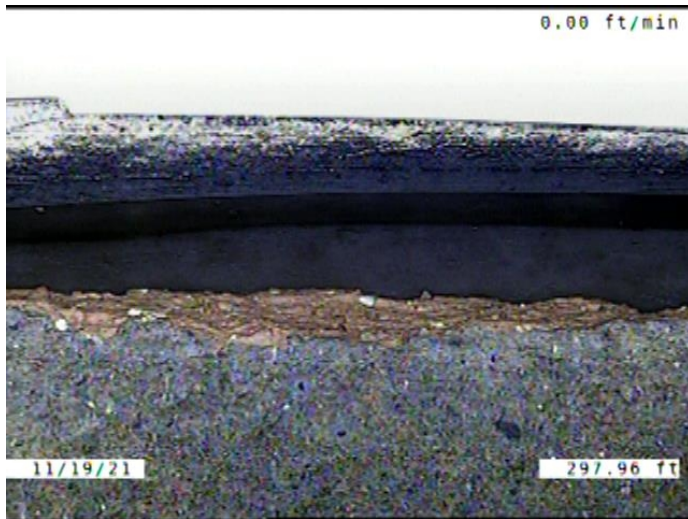
Code: **MMC**
 Description: **Miscellaneous Material Change**

Distance (ft): **298.0**
 Structural Grade: **0**
 O&M Grade: **0**
 Clock Start/From:
 Clock To:
 1st Value:
 2nd Value:
 Value Percent:
 Continuous Index:
 Within 8" of Joint: **NO**
 Remarks: **PVC TO VCP**

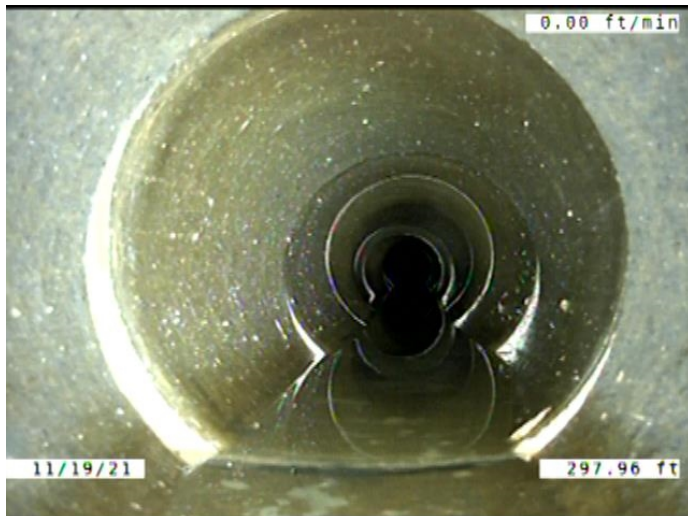
Code: **MWLS**
 Description: **Miscellaneous Water Level Sag**

Distance (ft): **298.0**
 Structural Grade: **2**
 O&M Grade: **0**
 Clock Start/From:
 Clock To:
 1st Value:
 2nd Value:
 Value Percent: **5.000**
 Continuous Index: **F06**
 Within 8" of Joint: **NO**
 Remarks:

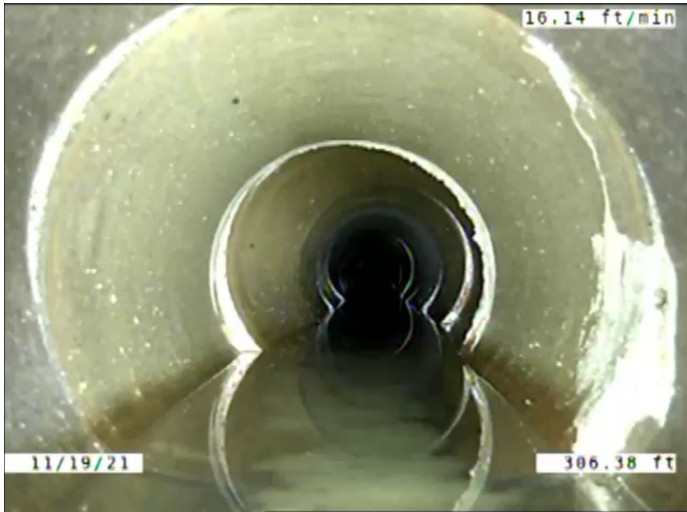
Code: **CM**
Description: **Crack Multiple**

Distance (ft): **306.4**
Structural Grade: **3**
O&M Grade: **0**
Clock Start/From: **1**
Clock To: **3**
1st Value:
2nd Value:
Value Percent:
Continuous Index:
Within 8" of Joint: **YES**
Remarks:

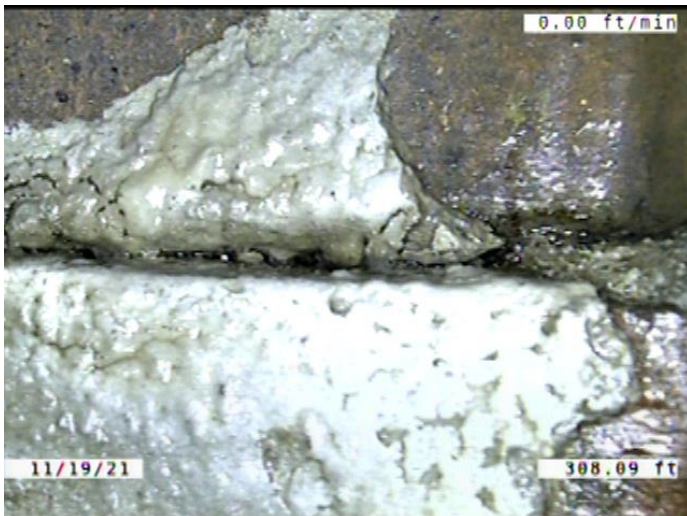
Code: **DAE**
Description: **Deposits Attached Encrustation**

Distance (ft): **308.1**
Structural Grade: **0**
O&M Grade: **2**
Clock Start/From: **1**
Clock To: **4**
1st Value:
2nd Value:
Value Percent: **5.000**
Continuous Index:
Within 8" of Joint: **YES**
Remarks:

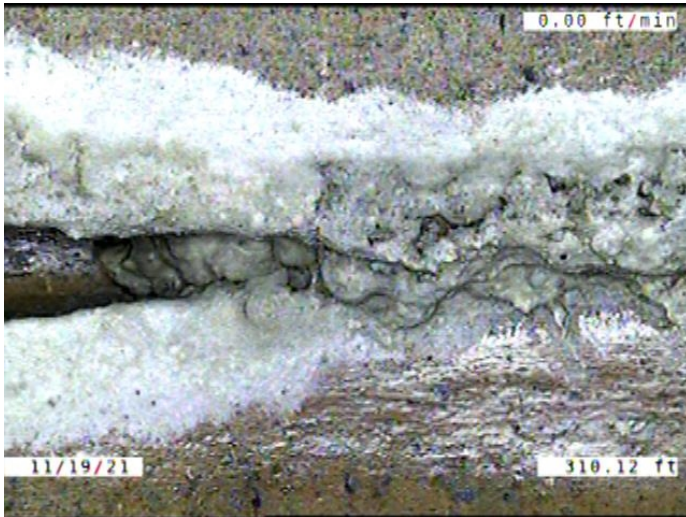
Code: **DAE**
 Description: **Deposits Attached Encrustation**

Distance (ft): **310.1**
 Structural Grade: **0**
 O&M Grade: **2**
 Clock Start/From: **7**
 Clock To: **5**
 1st Value:
 2nd Value:
 Value Percent: **5.000**
 Continuous Index:
 Within 8" of Joint: **YES**
 Remarks:

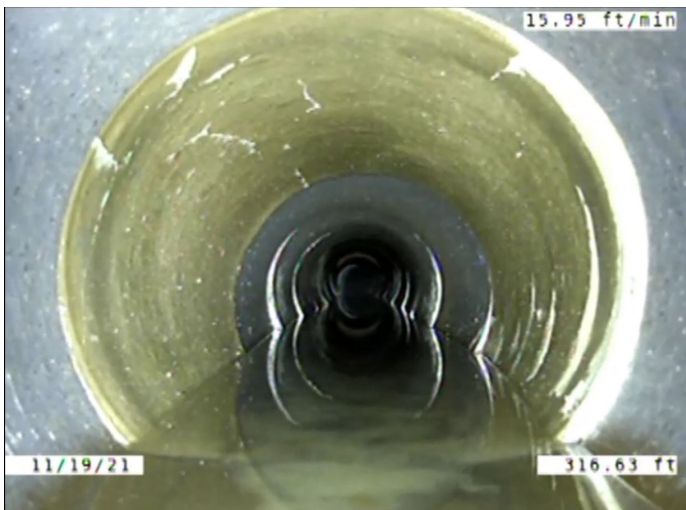
Code: **CM**
 Description: **Crack Multiple**

Distance (ft): **316.6**
 Structural Grade: **3**
 O&M Grade: **0**
 Clock Start/From: **8**
 Clock To: **4**
 1st Value:
 2nd Value:
 Value Percent:
 Continuous Index: **S08**
 Within 8" of Joint: **YES**
 Remarks: **Wandering**

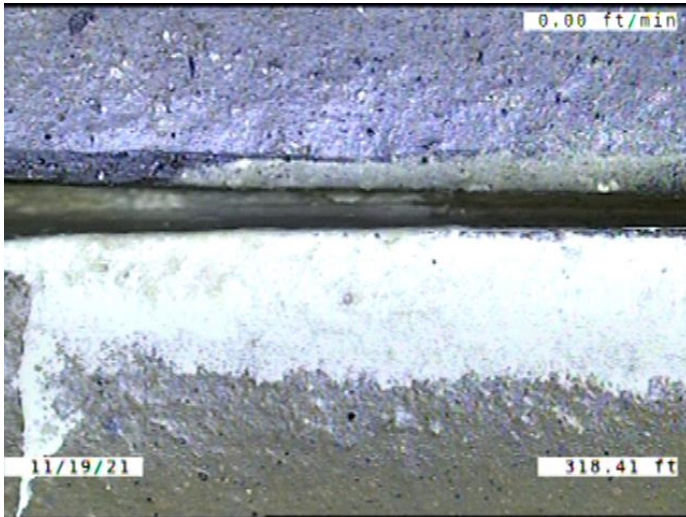
Code: **DAE**
 Description: **Deposits Attached Encrustation**

Distance (ft): **318.4**
 Structural Grade: **0**
 O&M Grade: **2**
 Clock Start/From: **8**
 Clock To: **4**
 1st Value:
 2nd Value:
 Value Percent: **5.000**
 Continuous Index: **S07**
 Within 8" of Joint: **YES**
 Remarks:

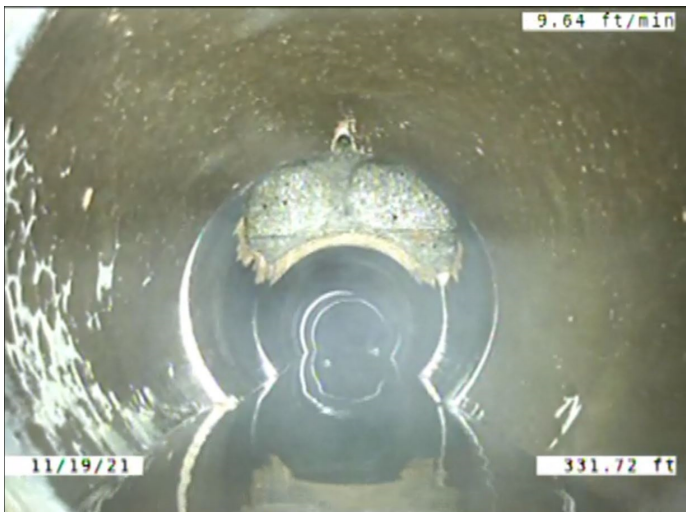
Code: **CM**
 Description: **Crack Multiple**

Distance (ft): **331.7**
 Structural Grade: **3**
 O&M Grade: **0**
 Clock Start/From: **8**
 Clock To: **4**
 1st Value:
 2nd Value:
 Value Percent:
 Continuous Index: **F08**
 Within 8" of Joint: **YES**
 Remarks: **Wandering**

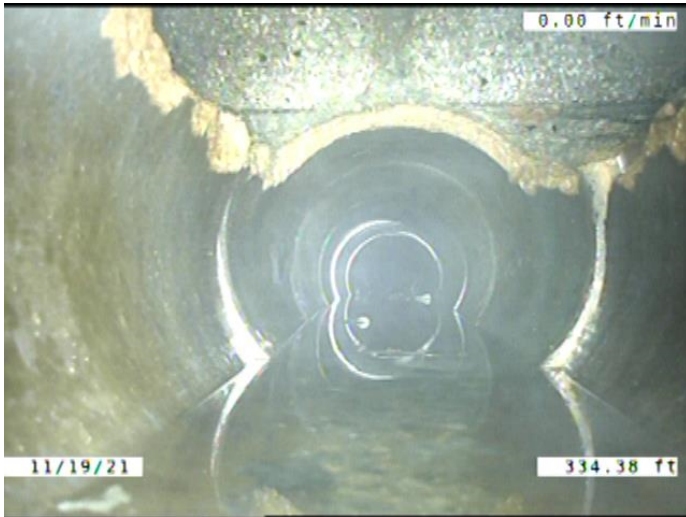
Code: **DSF**
Description: **Deposits Settled Fine**

Distance (ft): **334.4**
Structural Grade: **0**
O&M Grade: **2**
Clock Start/From: **5**
Clock To: **7**
1st Value:
2nd Value:
Value Percent: **5.000**
Continuous Index: **F02**
Within 8" of Joint: **YES**
Remarks:

Code: **DAE**
Description: **Deposits Attached Encrustation**

Distance (ft): **334.4**
Structural Grade: **0**
O&M Grade: **2**
Clock Start/From: **8**
Clock To: **4**
1st Value:
2nd Value:
Value Percent: **5.000**
Continuous Index: **F07**
Within 8" of Joint: **YES**
Remarks:

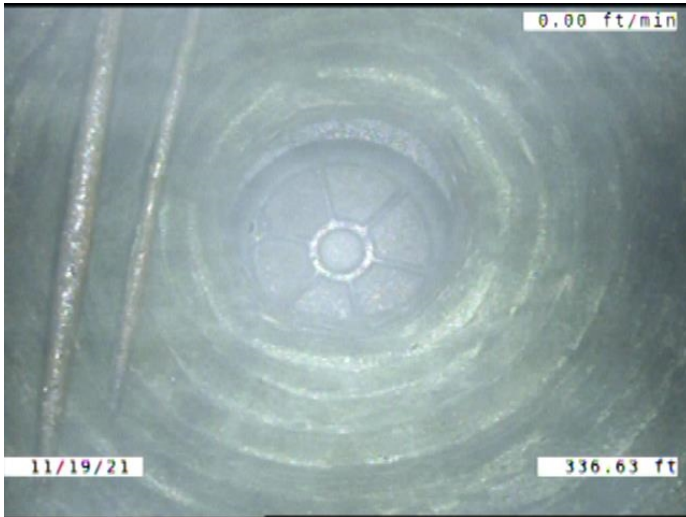
Code:	AMH
Description:	Manhole
Distance (ft):	336.6
Structural Grade:	0
O&M Grade:	0
Clock Start/From:	
Clock To:	
1st Value:	
2nd Value:	
Value Percent:	
Continuous Index:	
Within 8" of Joint:	NO
Remarks:	M-604-098
