## Profile/Photo Observation Report

Street:	<b>ALLEY BETWEEN N WISCONSIN ST &amp;</b>	Flow Control:	<b>Not Controlled</b>
City:	<b>Hobart, IN</b>	Year Renewed:	
Location:	<b>Light Highway</b>	Tape/Media #:	
Purpose:	<b>Not Known</b>	Dia/Height:	<b>12"</b>
Use:	<b>Sanitary</b>	Material:	<b>VCP</b>
Drain Area:	<b>NA</b>	Lining:	
Category:	<b>NA</b>		
Comment:

Location Details:		Direction of Survey:	<b>Downstream</b>
US MH:	<b>M-604-099</b>	DS MH:	<b>M-604-085</b>
		Total Length Surveyed (ft):	<b>25.3</b>

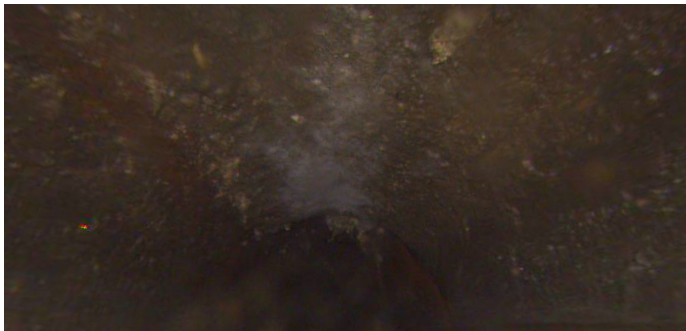
Code: **AMH**  
Description: **Manhole**

Distance (ft): **.0**  
Structural Grade: **0**  
O&M Grade: **0**  
Clock Start/From:  
Clock To:  
1st Value:  
2nd Value:  
Value Percent:  
Continuous Index:  
Within 8" of Joint: **NO**  
Remarks: **M-604-099**

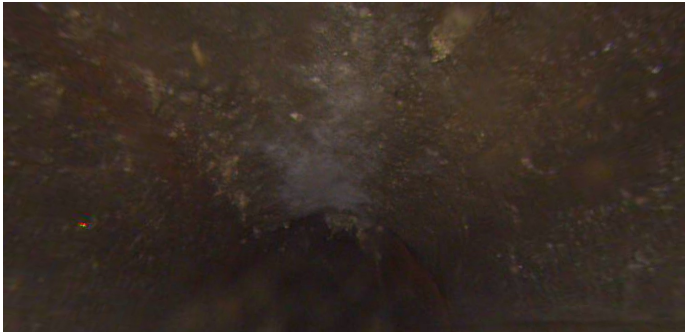
Code:	<b>MWL</b>
Description:	<b>Water Level</b>

Distance (ft):	<b>.0</b>
Structural Grade:	<b>0</b>
O&M Grade:	<b>0</b>
Clock Start/From:	
Clock To:	
1st Value:	
2nd Value:	
Value Percent:	<b>30.000</b>
Continuous Index:	
Within 8" of Joint:	<b>NO</b>
Remarks:

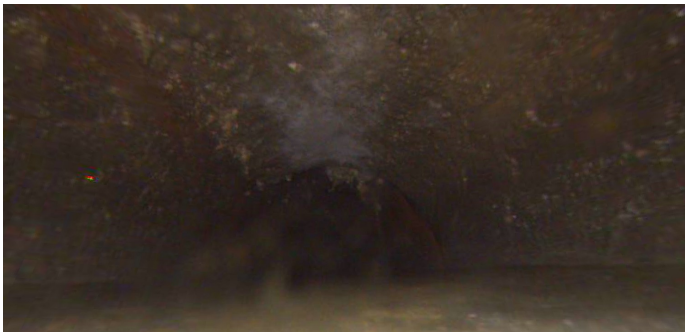
Code:	<b>DAGS</b>
Description:	<b>Deposits Attached Grease</b>

Distance (ft):	<b>.0</b>
Structural Grade:	<b>0</b>
O&M Grade:	<b>2</b>
Clock Start/From:	<b>8</b>
Clock To:	<b>4</b>
1st Value:	
2nd Value:	
Value Percent:	<b>5.000</b>
Continuous Index:	
Within 8" of Joint:	<b>NO</b>
Remarks:

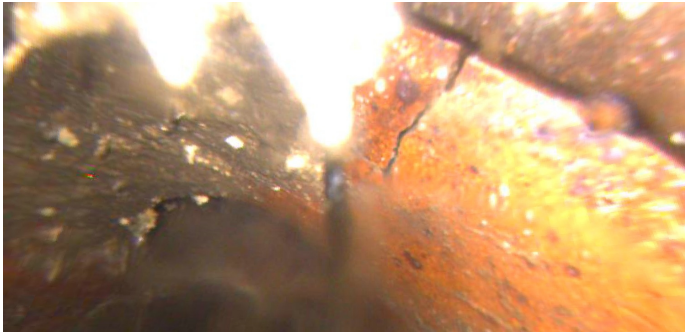
Code: **FL**  
Description: **Fracture Longitudinal**

Distance (ft): **2.4**  
Structural Grade: **3**  
O&M Grade: **0**  
Clock Start/From: **1**  
Clock To:  
1st Value:  
2nd Value:  
Value Percent:  
Continuous Index:  
Within 8" of Joint:  
Remarks:

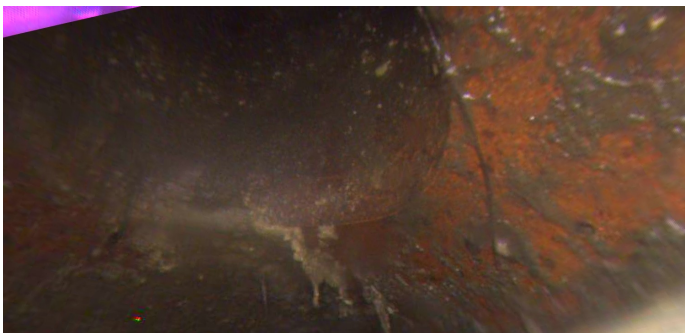
Code: **TF**  
Description: **Tap Factory**

Distance (ft): **2.8**  
Structural Grade: **0**  
O&M Grade: **0**  
Clock Start/From: **12**  
Clock To:  
1st Value: **4.000**  
2nd Value:  
Value Percent:  
Continuous Index:  
Within 8" of Joint:  
Remarks:

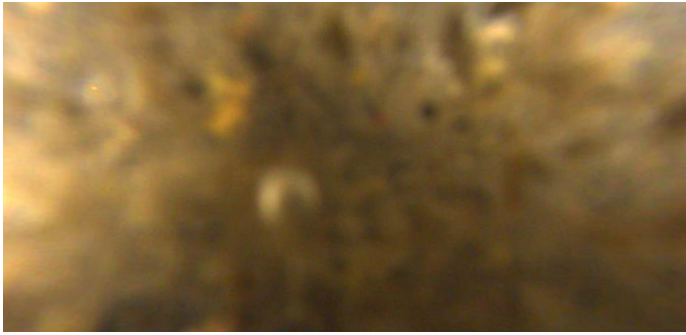
Code: **MWL**  
Description: **Water Level**

Distance (ft): **7.7**  
Structural Grade: **0**  
O&M Grade: **0**  
Clock Start/From:  
Clock To:  
1st Value:  
2nd Value:  
Value Percent: **100.000**  
Continuous Index:  
Within 8" of Joint: **NO**  
Remarks:

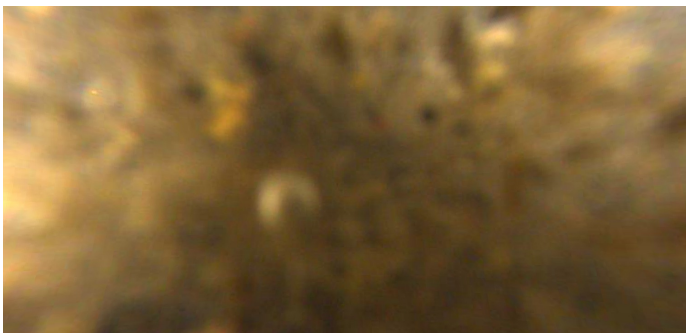
Code: **MCU**  
Description: **Camera Underwater**

Distance (ft): **7.7**  
Structural Grade: **0**  
O&M Grade: **4**  
Clock Start/From:  
Clock To:  
1st Value:  
2nd Value:  
Value Percent:  
Continuous Index: **S01**  
Within 8" of Joint: **NO**  
Remarks:
