Profile/Photo Observation Report

Street:	Summerlin	Flow Control:	Not Controlled
City:	Hobart, IN	Year Renewed:	
Location:	Light Highway	Tape/Media #:	
Purpose:	Not Known	Dia/Height:	12"
Use:	Sanitary	Material:	VCP
Drain Area:	NA	Lining:	
Category:	NA		
Comment:

Location Details:		Direction of Survey:	Downstream
US MH:	M-604-099	DS MH:	M-604-085
		Total Length Surveyed (ft):	25.3

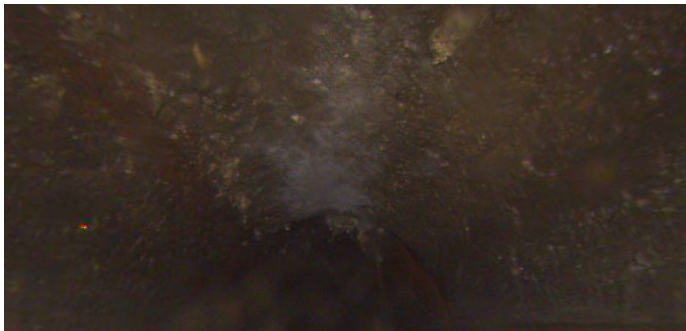
Code: **AMH**
Description: **Manhole**

Distance (ft): **.0**
Structural Grade: **0**
O&M Grade: **0**
Clock Start/From:
Clock To:
1st Value:
2nd Value:
Value Percent:
Continuous Index:
Within 8" of Joint: **NO**
Remarks: **M-604-099**

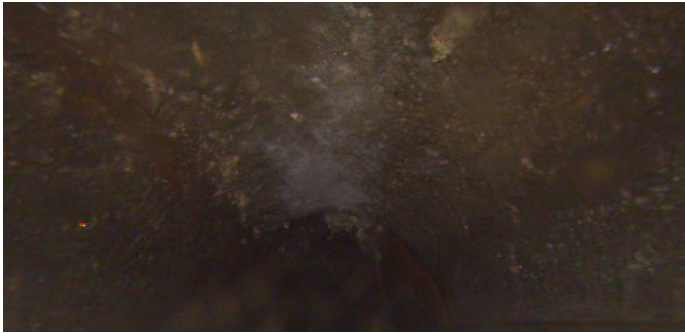
Code:	MWL
Description:	Water Level

Distance (ft):	.0
Structural Grade:	0
O&M Grade:	0
Clock Start/From:	
Clock To:	
1st Value:	
2nd Value:	
Value Percent:	30.000
Continuous Index:	
Within 8" of Joint:	NO
Remarks:

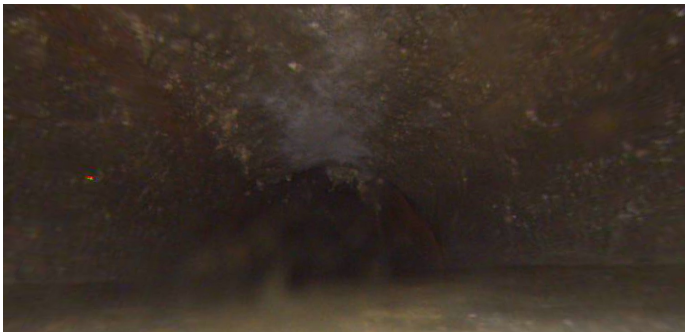
Code:	DAGS
Description:	Deposits Attached Grease

Distance (ft):	.0
Structural Grade:	0
O&M Grade:	2
Clock Start/From:	8
Clock To:	4
1st Value:	
2nd Value:	
Value Percent:	5.000
Continuous Index:	
Within 8" of Joint:	NO
Remarks:

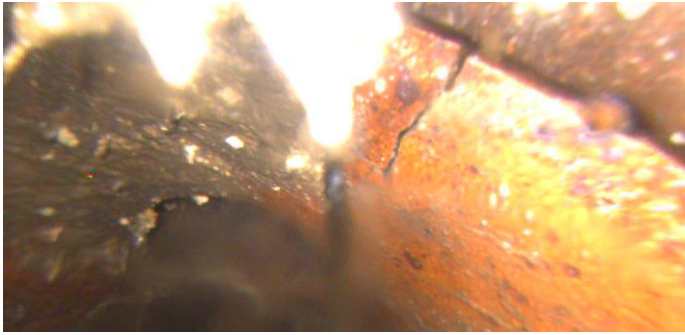
Code: **FL**
Description: **Fracture Longitudinal**

Distance (ft): **2.4**
Structural Grade: **3**
O&M Grade: **0**
Clock Start/From: **1**
Clock To:
1st Value:
2nd Value:
Value Percent:
Continuous Index:
Within 8" of Joint:
Remarks:

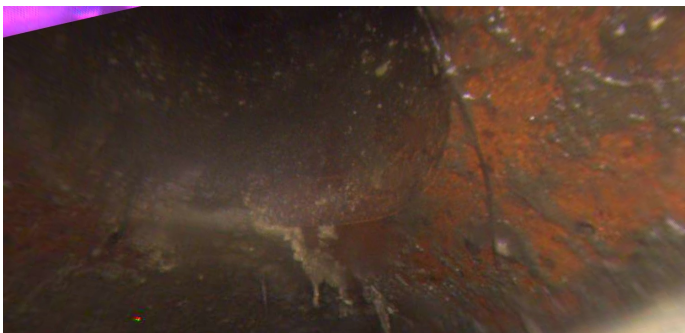
Code: **TF**
Description: **Tap Factory**

Distance (ft): **2.8**
Structural Grade: **0**
O&M Grade: **0**
Clock Start/From: **12**
Clock To:
1st Value: **4.000**
2nd Value:
Value Percent:
Continuous Index:
Within 8" of Joint:
Remarks:

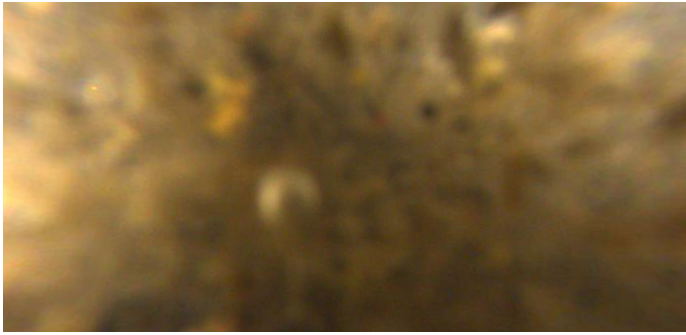
Code: **MWL**
Description: **Water Level**

Distance (ft): **7.7**
Structural Grade: **0**
O&M Grade: **0**
Clock Start/From:
Clock To:
1st Value:
2nd Value:
Value Percent: **100.000**
Continuous Index:
Within 8" of Joint: **NO**
Remarks:

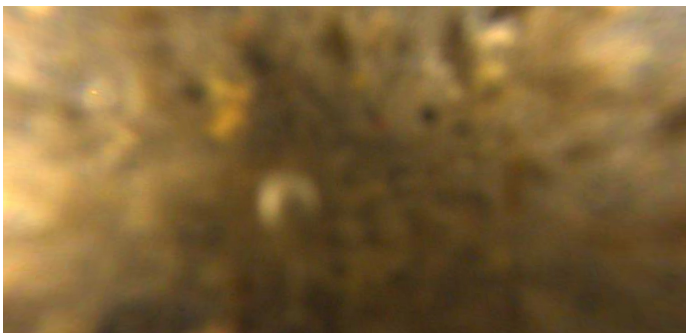
Code: **MCU**
Description: **Camera Underwater**

Distance (ft): **7.7**
Structural Grade: **0**
O&M Grade: **4**
Clock Start/From:
Clock To:
1st Value:
2nd Value:
Value Percent:
Continuous Index: **S01**
Within 8" of Joint: **NO**
Remarks:
