Profile/Photo Observation Report

| Street: | ALLEY BETWEEN N WISCONSIN ST & | Flow Control: | Not Controlled |
| City: | Hobart, IN | Year Renewed: | |

| US MH: | M-604-099 | DS MH: | M-604-085 |

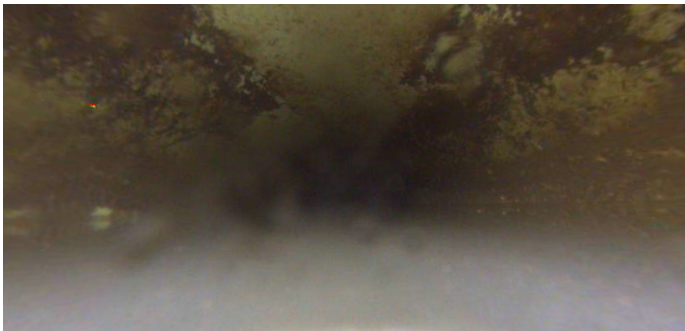
Code: **AMH**
Description: **Manhole**

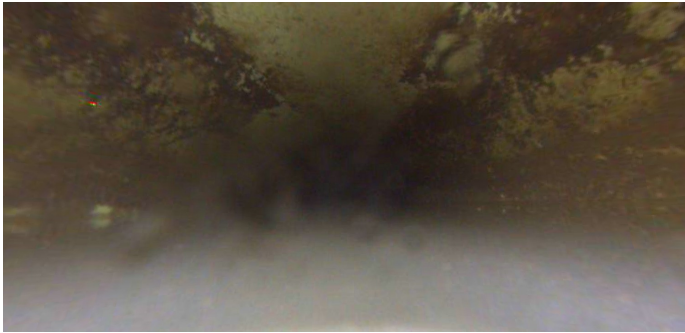
| Code: | MWL |
| Description: | Water Level |

| Value Percent: | 40.000 |

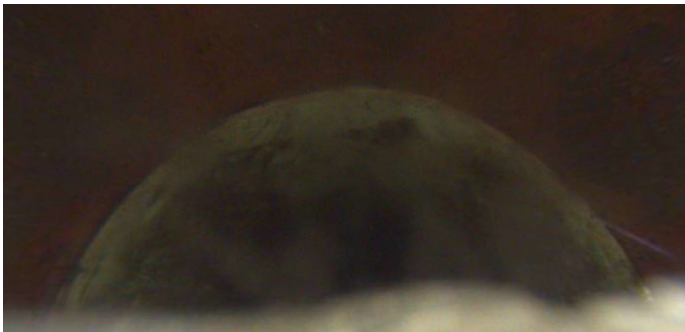
| Code: | MMC |
| Description: | Material Change |

| Remarks: | VCP |

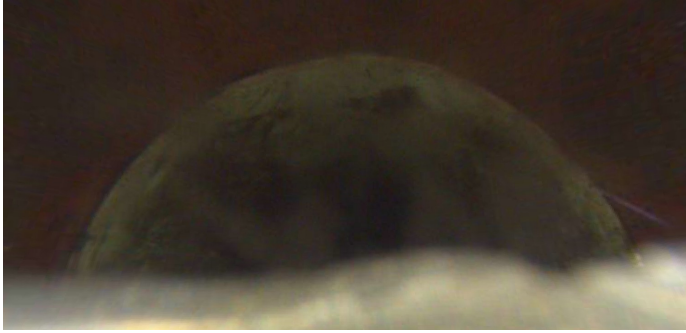
Code: **MGO**
Description: **General Observation**

Distance (ft): **3.8**
Structural Grade: **0**
O&M Grade: **0**
Clock Start/From:
Clock To:
1st Value:
2nd Value:
Value Percent:
Continuous Index:
Within 8" of Joint: **NO**
Remarks: **REAR CAMERA**

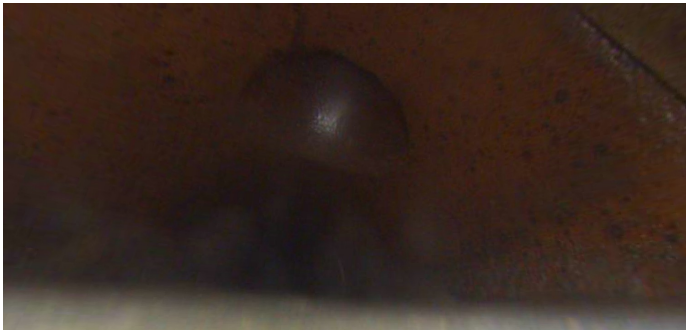
Code: **TF**
Description: **Tap Factory**

Distance (ft): **11.5**
Structural Grade: **0**
O&M Grade: **0**
Clock Start/From: **12**
Clock To:
1st Value: **4.000**
2nd Value:
Value Percent:
Continuous Index:
Within 8" of Joint:
Remarks:
