Profile/Photo Observation Report

Date:	04/22/2018	Weather:		Coding:	PACP 6.0
Pipe Length (ft):	135.4	Owner:	NA	Pre Clean:	Not Known
P.O.#:		Surveyor:	Jen Costello	PSR:	P-604-099-085
Customer:		Clean Date:	01/01/1900	Shape:	C

Street:	Summerlin	Flow Control:	Not Controlled
City:	Hobart, IN	Year Renewed:	
Location:	Light Highway	Tape/Media #:	
Purpose:	Not Known	Dia/Height:	12"
Use:	Sanitary	Material:	PVC
Drain Area:	NA	Lining:	
Category:	NA		
Comment:

Location Details:		Direction of Survey:	Upstream
US MH:	M-604-099	DS MH:	M-604-085
		Total Length Surveyed (ft):	27.8

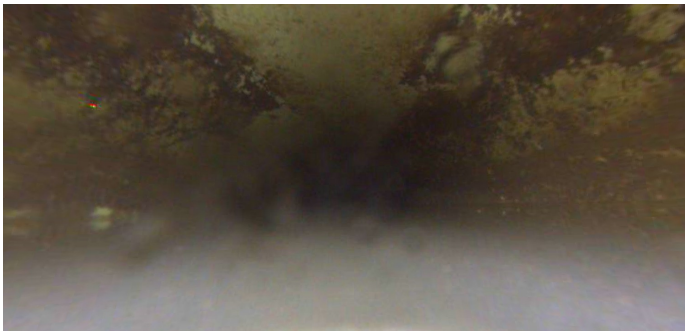
Code: **AMH**
Description: **Manhole**

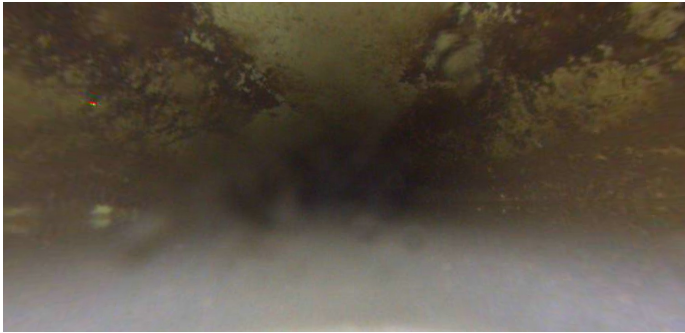
Code:	MWL
Description:	Water Level

Distance (ft):	.0
Structural Grade:	0
O&M Grade:	0
Clock Start/From:	
Clock To:	
1st Value:	
2nd Value:	
Value Percent:	40.000
Continuous Index:	
Within 8" of Joint:	NO
Remarks:

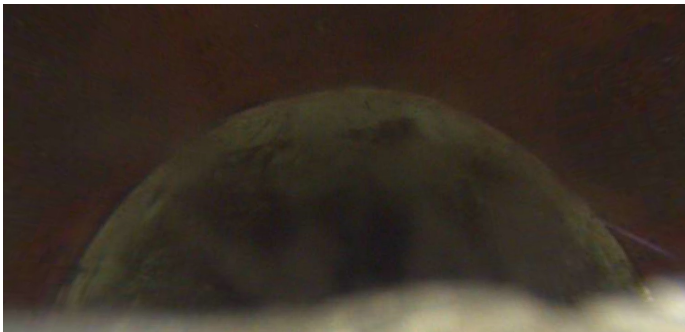
Code:	MMC
Description:	Material Change

Distance (ft):	3.8
Structural Grade:	0
O&M Grade:	0
Clock Start/From:	
Clock To:	
1st Value:	
2nd Value:	
Value Percent:	
Continuous Index:	
Within 8" of Joint:	NO
Remarks:	VCP

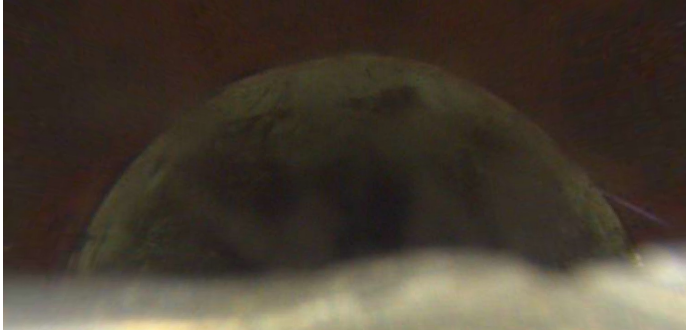
Code: **MGO**
Description: **General Observation**

Distance (ft): **3.8**
Structural Grade: **0**
O&M Grade: **0**
Clock Start/From:
Clock To:
1st Value:
2nd Value:
Value Percent:
Continuous Index:
Within 8" of Joint: **NO**
Remarks: **REAR CAMERA**

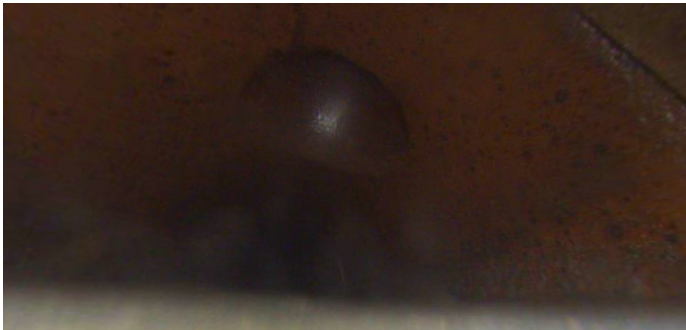
Code: **TF**
Description: **Tap Factory**

Distance (ft): **11.5**
Structural Grade: **0**
O&M Grade: **0**
Clock Start/From: **12**
Clock To:
1st Value: **4.000**
2nd Value:
Value Percent:
Continuous Index:
Within 8" of Joint:
Remarks:
