Profile/Photo Observation Report

Date:	04/22/2018	Weather:		Coding:	PACP 6.0
Pipe Length (ft):	229.6	Owner:	NA	Pre Clean:	Not Known
P.O.#:		Surveyor:	Jen Costello	PSR:	P-604-100-099
Customer:		Clean Date:	01/01/1900	Shape:	C

Street:	ALLEY BETWEEN N WISCONSIN ST &	Flow Control:	Not Controlled
City:	Hobart, IN	Year Renewed:	
Location:	Light Highway	Tape/Media #:	
Purpose:	Not Known	Dia/Height:	12"
Use:	Sanitary	Material:	VCP
Drain Area:	NA	Lining:	
Category:	NA		
Comment:

Location Details:		Direction of Survey:	Upstream
US MH:	M-604-100	DS MH:	M-604-099
		Total Length Surveyed (ft):	24.7

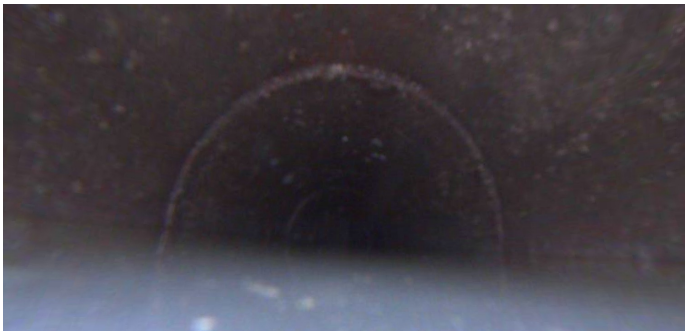
Code: **AMH**
Description: **Manhole**

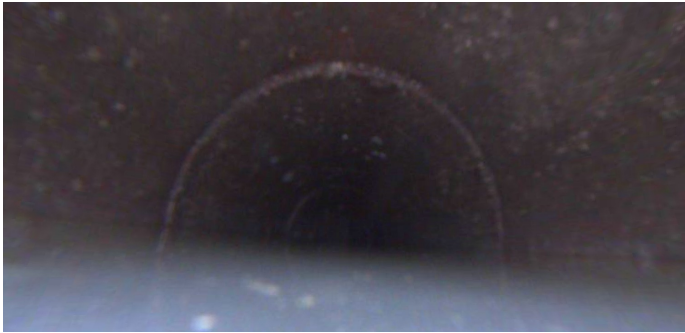
Code:	MWL
Description:	Water Level

Distance (ft):	.0
Structural Grade:	0
O&M Grade:	0
Clock Start/From:	
Clock To:	
1st Value:	
2nd Value:	
Value Percent:	40.000
Continuous Index:	
Within 8" of Joint:	NO
Remarks:

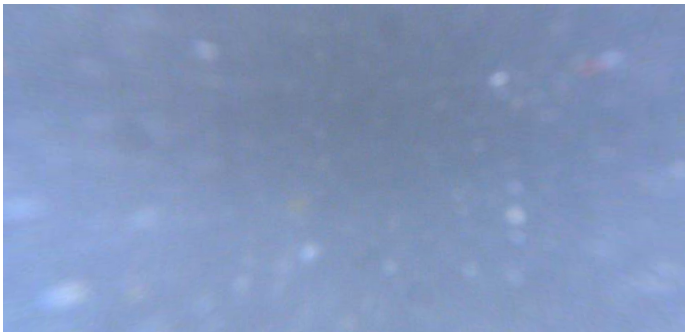
Code:	MCU
Description:	Camera Underwater

Distance (ft):	3.2
Structural Grade:	0
O&M Grade:	4
Clock Start/From:	
Clock To:	
1st Value:	
2nd Value:	
Value Percent:	
Continuous Index:	S01
Within 8" of Joint:	NO
Remarks:

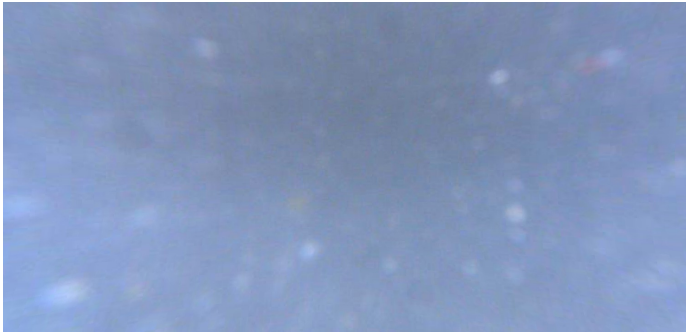
Code: **MWL**
Description: **Water Level**

Distance (ft): **3.2**
Structural Grade: **0**
O&M Grade: **0**
Clock Start/From:
Clock To:
1st Value:
2nd Value:
Value Percent: **100.000**
Continuous Index:
Within 8" of Joint: **NO**
Remarks:

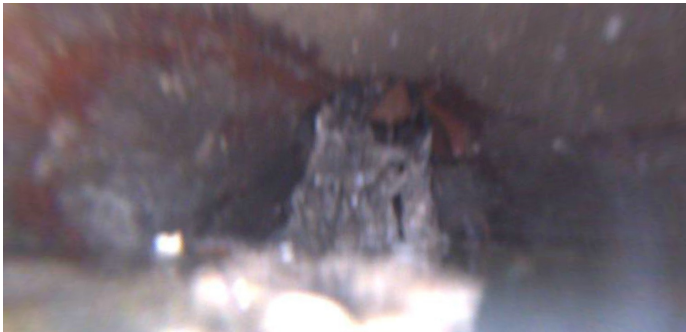
Code: **FM**
Description: **Fracture Multiple**

Distance (ft): **4.2**
Structural Grade: **4**
O&M Grade: **0**
Clock Start/From: **8**
Clock To: **4**
1st Value:
2nd Value:
Value Percent:
Continuous Index:
Within 8" of Joint:
Remarks:

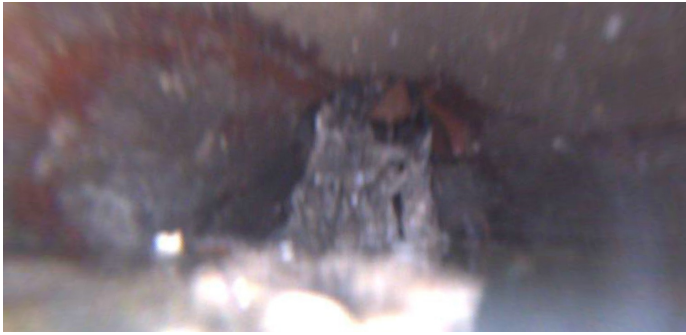
Code: **TBD**
Description: **Tap Break-in Defective**

Distance (ft): **4.2**
Structural Grade: **0**
O&M Grade: **3**
Clock Start/From: **12**
Clock To:
1st Value: **4.000**
2nd Value:
Value Percent:
Continuous Index:
Within 8" of Joint:
Remarks: **rbl**

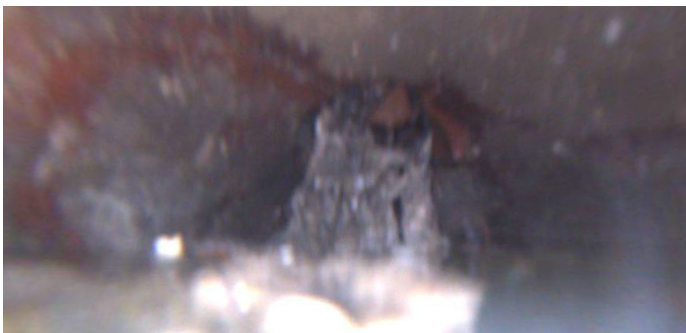
Code: **RBL**
Description: **Roots Ball Lateral**

Distance (ft): **4.2**
Structural Grade: **0**
O&M Grade: **4**
Clock Start/From: **11**
Clock To: **1**
1st Value:
2nd Value:
Value Percent: **70.000**
Continuous Index:
Within 8" of Joint: **NO**
Remarks:

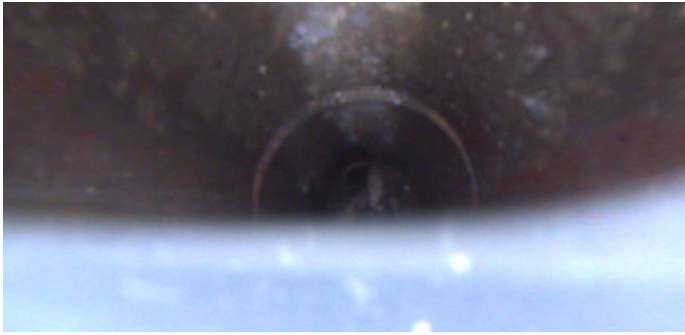
Code: **MCU**
Description: **Camera Underwater**

Distance (ft): **20.9**
Structural Grade: **0**
O&M Grade: **4**
Clock Start/From:
Clock To:
1st Value:
2nd Value:
Value Percent:
Continuous Index: **F01**
Within 8" of Joint: **NO**
Remarks:

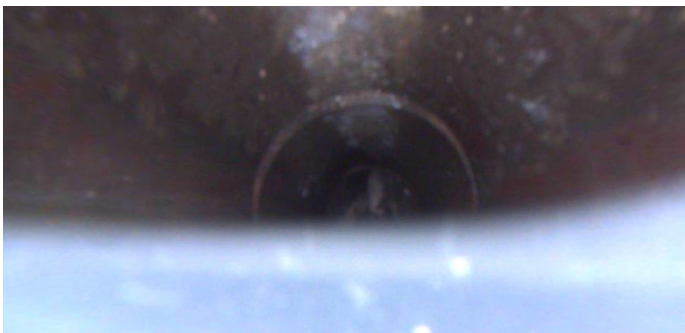
Code: **MWL**
Description: **Water Level**

Distance (ft): **20.9**
Structural Grade: **0**
O&M Grade: **0**
Clock Start/From:
Clock To:
1st Value:
2nd Value:
Value Percent: **40.000**
Continuous Index:
Within 8" of Joint: **NO**
Remarks:

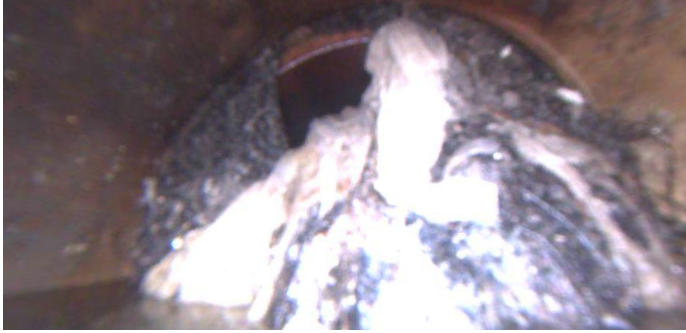
Code: **RBJ**
Description: **Roots Ball Joint**

Distance (ft): **23.5**
Structural Grade: **0**
O&M Grade: **4**
Clock Start/From: **8**
Clock To: **4**
1st Value:
2nd Value:
Value Percent: **90.000**
Continuous Index:
Within 8" of Joint: **YES**
Remarks:

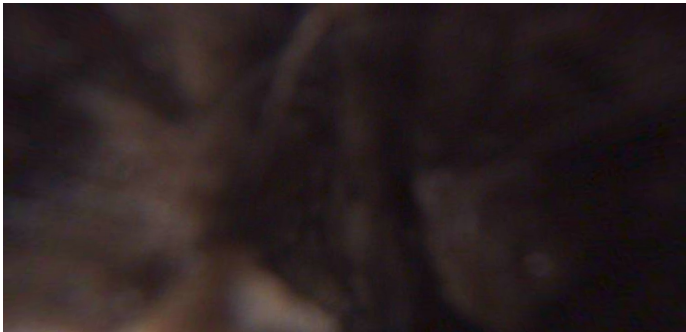
Code: **MSA**
Description: **Abandoned Survey**

Distance (ft): **24.7**
Structural Grade: **0**
O&M Grade: **0**
Clock Start/From:
Clock To:
1st Value:
2nd Value:
Value Percent:
Continuous Index:
Within 8" of Joint: **NO**
Remarks: **rbj**
