Profile/Photo Observation Report

Date:	04/22/2018	Weather:		Coding:	PACP 6.0
Pipe Length (ft):	229.6	Owner:	NA	Pre Clean:	Not Known
P.O.#:		Surveyor:	Jen Costello	PSR:	P-604-100-099
Customer:		Clean Date:	01/01/1900	Shape:	C

Street:	Summerlin	Flow Control:	Not Controlled
City:	Hobart, IN	Year Renewed:	
Location:	Light Highway	Tape/Media #:	
Purpose:	Not Known	Dia/Height:	12"
Use:	Sanitary	Material:	VCP
Drain Area:	NA	Lining:	
Category:	NA		
Comment:

Location Details:		Direction of Survey:	Upstream
US MH:	M-604-100	DS MH:	M-604-099
		Total Length Surveyed (ft):	24.7

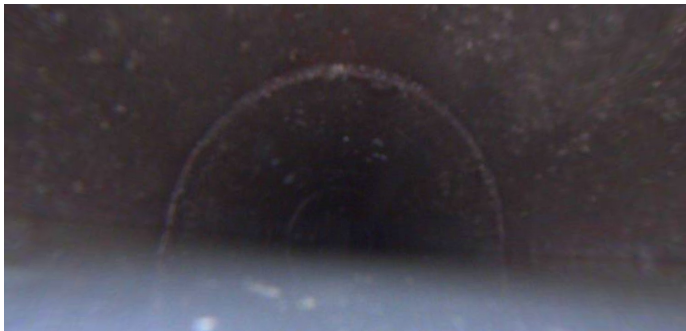
Code: **AMH**
Description: **Manhole**

Distance (ft): **.0**
Structural Grade: **0**
O&M Grade: **0**
Clock Start/From:
Clock To:
1st Value:
2nd Value:
Value Percent:
Continuous Index:
Within 8" of Joint: **NO**
Remarks: **M-604-100**

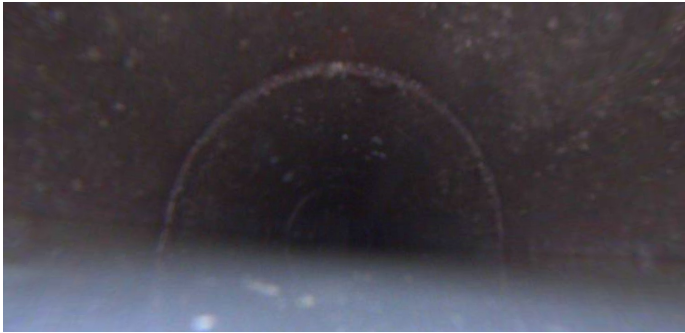
Code:	MWL
Description:	Water Level

Distance (ft):	.0
Structural Grade:	0
O&M Grade:	0
Clock Start/From:	
Clock To:	
1st Value:	
2nd Value:	
Value Percent:	40.000
Continuous Index:	
Within 8" of Joint:	NO
Remarks:

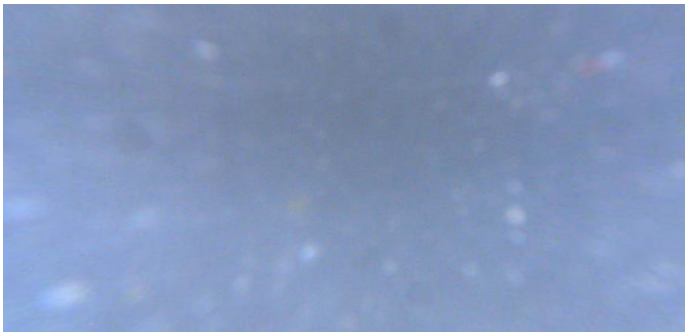
Code:	MCU
Description:	Camera Underwater

Distance (ft):	3.2
Structural Grade:	0
O&M Grade:	4
Clock Start/From:	
Clock To:	
1st Value:	
2nd Value:	
Value Percent:	
Continuous Index:	S01
Within 8" of Joint:	NO
Remarks:

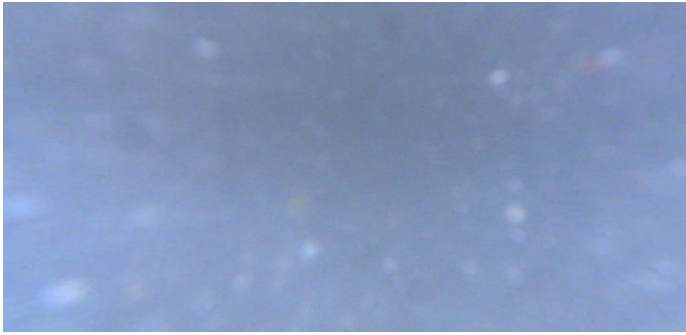
Code: **MWL**
Description: **Water Level**

Distance (ft): **3.2**
Structural Grade: **0**
O&M Grade: **0**
Clock Start/From:
Clock To:
1st Value:
2nd Value:
Value Percent: **100.000**
Continuous Index:
Within 8" of Joint: **NO**
Remarks:

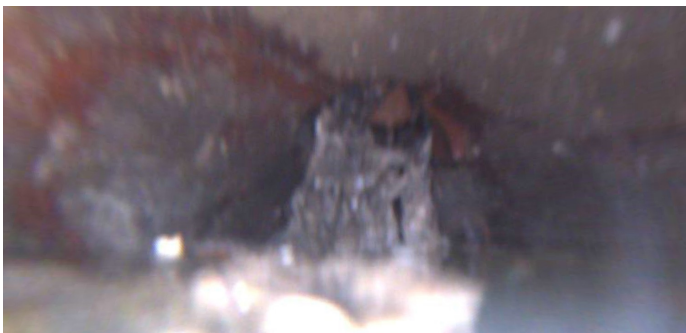
Code: **FM**
Description: **Fracture Multiple**

Distance (ft): **4.2**
Structural Grade: **4**
O&M Grade: **0**
Clock Start/From: **8**
Clock To: **4**
1st Value:
2nd Value:
Value Percent:
Continuous Index:
Within 8" of Joint:
Remarks:

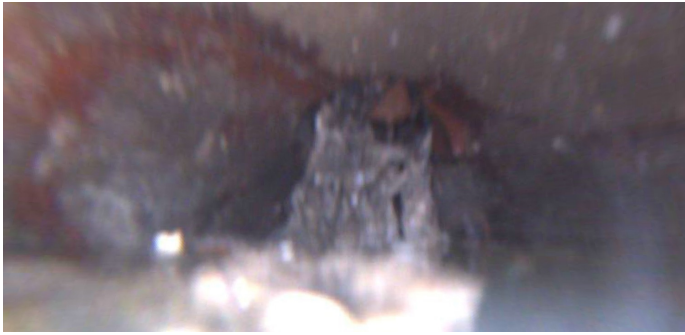
Code: **TBD**
Description: **Tap Break-in Defective**

Distance (ft): **4.2**
Structural Grade: **0**
O&M Grade: **3**
Clock Start/From: **12**
Clock To:
1st Value: **4.000**
2nd Value:
Value Percent:
Continuous Index:
Within 8" of Joint:
Remarks: **rbl**

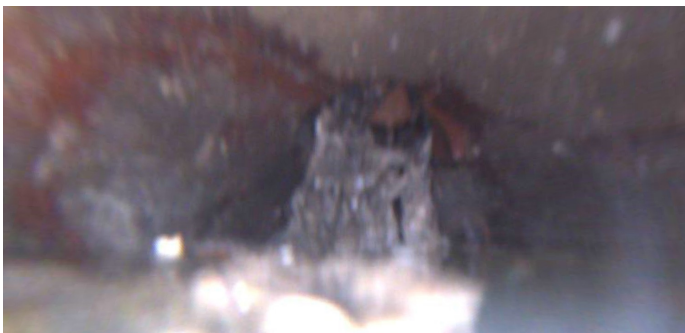
Code: **RBL**
Description: **Roots Ball Lateral**

Distance (ft): **4.2**
Structural Grade: **0**
O&M Grade: **4**
Clock Start/From: **11**
Clock To: **1**
1st Value:
2nd Value:
Value Percent: **70.000**
Continuous Index:
Within 8" of Joint: **NO**
Remarks:

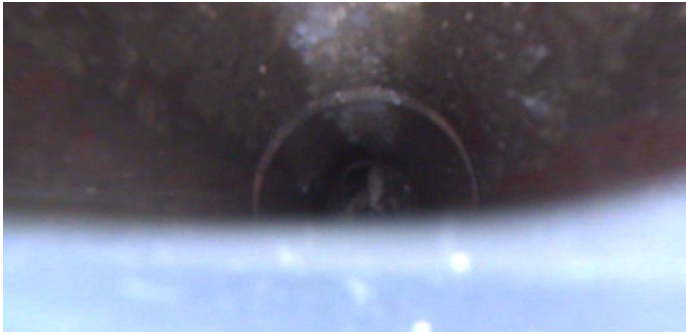
Code: **MCU**
Description: **Camera Underwater**

Distance (ft): **20.9**
Structural Grade: **0**
O&M Grade: **4**
Clock Start/From:
Clock To:
1st Value:
2nd Value:
Value Percent:
Continuous Index: **F01**
Within 8" of Joint: **NO**
Remarks:

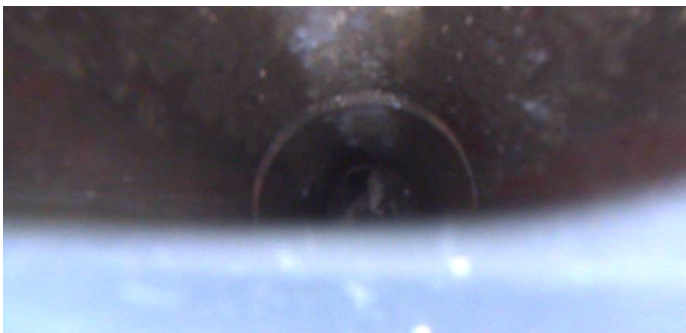
Code: **MWL**
Description: **Water Level**

Distance (ft): **20.9**
Structural Grade: **0**
O&M Grade: **0**
Clock Start/From:
Clock To:
1st Value:
2nd Value:
Value Percent: **40.000**
Continuous Index:
Within 8" of Joint: **NO**
Remarks:

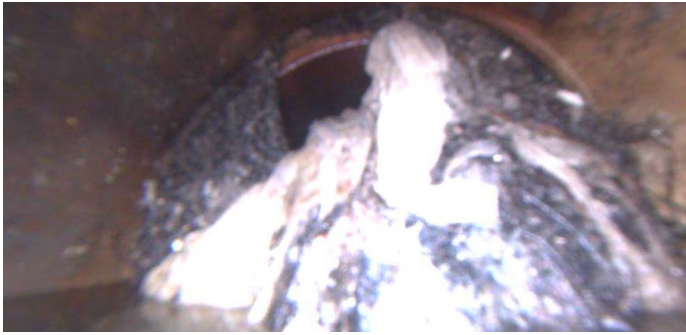
Code: **RBJ**
Description: **Roots Ball Joint**

Distance (ft): **23.5**
Structural Grade: **0**
O&M Grade: **4**
Clock Start/From: **8**
Clock To: **4**
1st Value:
2nd Value:
Value Percent: **90.000**
Continuous Index:
Within 8" of Joint: **YES**
Remarks:

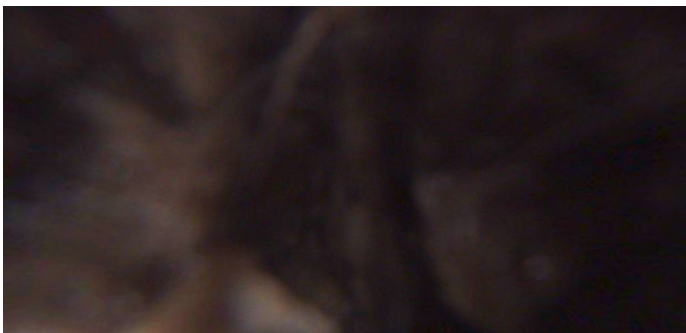
Code: **MSA**
Description: **Abandoned Survey**

Distance (ft): **24.7**
Structural Grade: **0**
O&M Grade: **0**
Clock Start/From:
Clock To:
1st Value:
2nd Value:
Value Percent:
Continuous Index:
Within 8" of Joint: **NO**
Remarks: **rbj**
