Profile/Photo Observation Report

Street:	N ASH ST	Flow Control:	Not Controlled
City:	Hobart, IN	Year Renewed:	
Location:	Other	Tape/Media #:	
Purpose:	Not Known	Dia/Height:	12"
Use:	Sanitary	Material:	VCP
Drain Area:	NA	Lining:	
Category:	NA		
Comment:

Location Details:		Direction of Survey:	Upstream
US MH:	M-604-107	DS MH:	M-604-111
		Total Length Surveyed (ft):	12.8

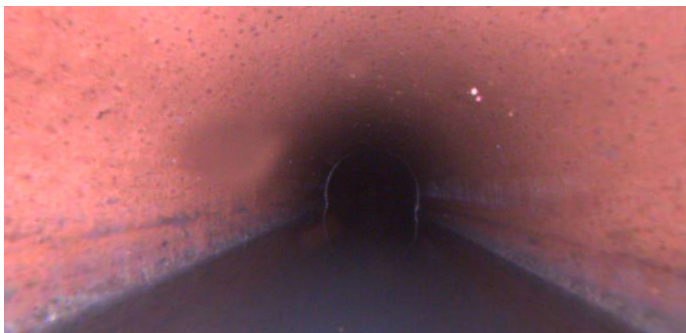
Code: **AMH**
Description: **Manhole**

Distance (ft): **.0**
Structural Grade: **0**
O&M Grade: **0**
Clock Start/From:
Clock To:
1st Value:
2nd Value:
Value Percent:
Continuous Index:
Within 8" of Joint: **NO**
Remarks: **M-604-111**

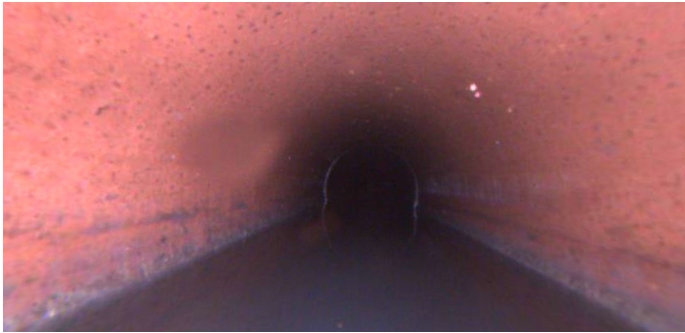
Code:	MWL
Description:	Water Level

Distance (ft):	.0
Structural Grade:	0
O&M Grade:	0
Clock Start/From:	
Clock To:	
1st Value:	
2nd Value:	
Value Percent:	30.000
Continuous Index:	
Within 8" of Joint:	NO
Remarks:

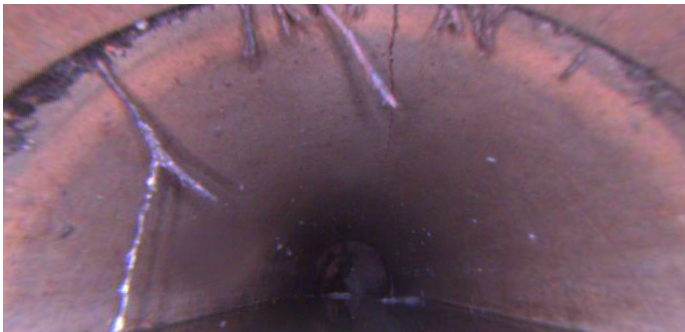
Code:	FL
Description:	Fracture Longitudinal

Distance (ft):	8.8
Structural Grade:	3
O&M Grade:	0
Clock Start/From:	12
Clock To:	
1st Value:	
2nd Value:	
Value Percent:	
Continuous Index:	
Within 8" of Joint:	YES
Remarks:

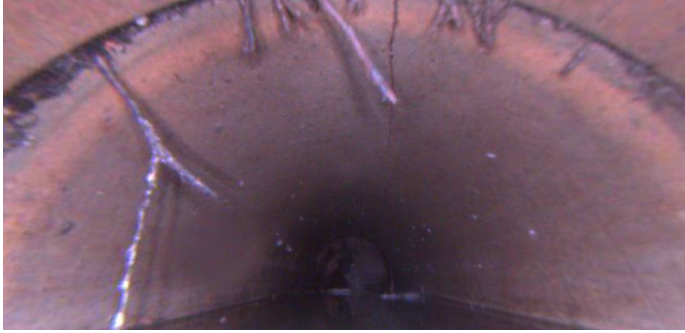
Code: **RFJ**
Description: **Roots Fine Joint**

Distance (ft): **8.8**
Structural Grade: **0**
O&M Grade: **1**
Clock Start/From: **8**
Clock To: **4**
1st Value:
2nd Value:
Value Percent:
Continuous Index:
Within 8" of Joint: **YES**
Remarks:

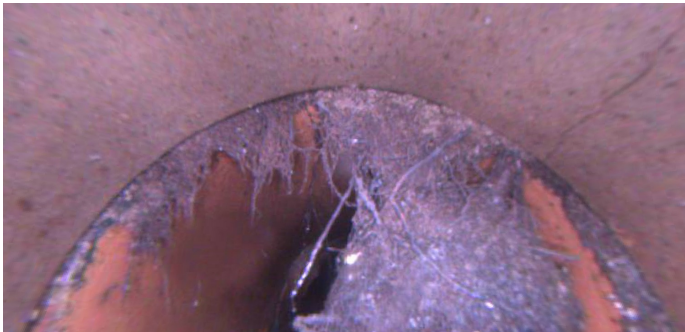
Code: **FL**
Description: **Fracture Longitudinal**

Distance (ft): **11.6**
Structural Grade: **3**
O&M Grade: **0**
Clock Start/From: **1**
Clock To:
1st Value:
2nd Value:
Value Percent:
Continuous Index:
Within 8" of Joint: **YES**
Remarks:

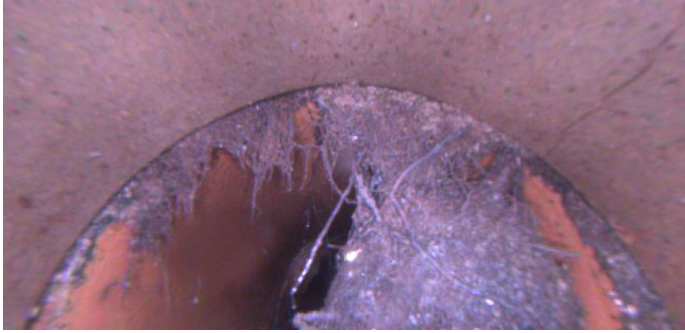
Code: **RMJ**
Description: **Roots Medium Joint**

Distance (ft): **11.6**
Structural Grade: **0**
O&M Grade: **3**
Clock Start/From: **8**
Clock To: **4**
1st Value:
2nd Value:
Value Percent: **40.000**
Continuous Index:
Within 8" of Joint: **YES**
Remarks:

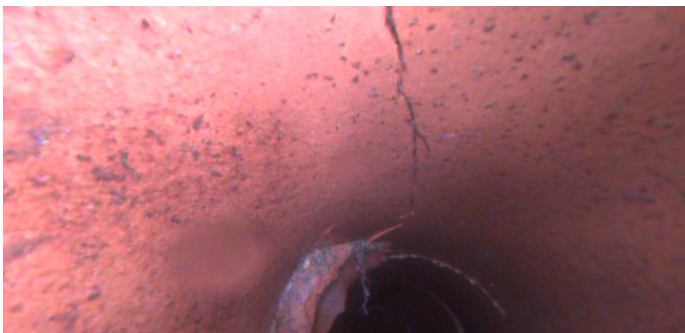
Code: **MSA**
Description: **Abandoned Survey**

Distance (ft): **12.8**
Structural Grade: **0**
O&M Grade: **0**
Clock Start/From:
Clock To:
1st Value:
2nd Value:
Value Percent:
Continuous Index:
Within 8" of Joint: **NO**
Remarks: **ROOTS**
