Profile/Photo Observation Report

Street:	N ASH ST	Flow Control:	Not Controlled
City:	Hobart, IN	Year Renewed:	
Location:	Other	Tape/Media #:	
Purpose:	Not Known	Dia/Height:	12"
Use:	Sanitary	Material:	VCP
Drain Area:	NA	Lining:	
Category:	NA		
Comment:

Location Details:		Direction of Survey:	Downstream
US MH:	M-604-107	DS MH:	M-604-111
		Total Length Surveyed (ft):	49.4

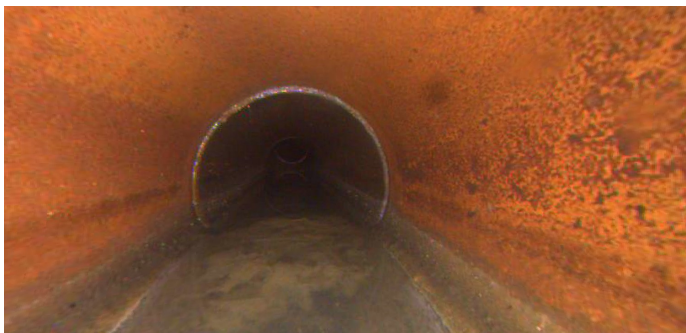
Code: **AMH**
Description: **Manhole**

Distance (ft): **.0**
Structural Grade: **0**
O&M Grade: **0**
Clock Start/From:
Clock To:
1st Value:
2nd Value:
Value Percent:
Continuous Index:
Within 8" of Joint: **NO**
Remarks: **M-604-107**

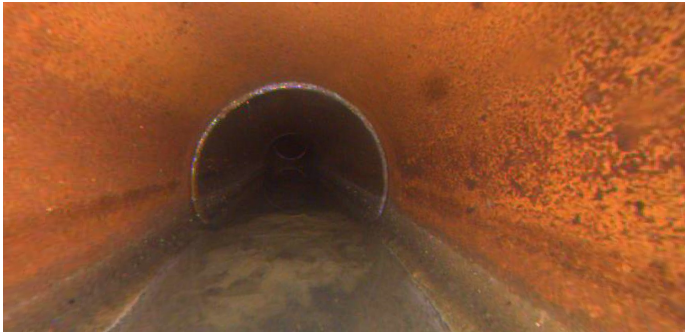
Code:	MWL
Description:	Water Level

Distance (ft):	.0
Structural Grade:	0
O&M Grade:	0
Clock Start/From:	
Clock To:	
1st Value:	
2nd Value:	
Value Percent:	20.000
Continuous Index:	
Within 8" of Joint:	NO
Remarks:

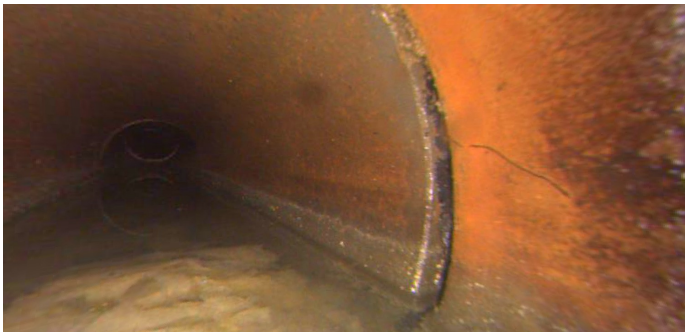
Code:	RFJ
Description:	Roots Fine Joint

Distance (ft):	2.2
Structural Grade:	0
O&M Grade:	1
Clock Start/From:	3
Clock To:	
1st Value:	
2nd Value:	
Value Percent:	
Continuous Index:	
Within 8" of Joint:	YES
Remarks:

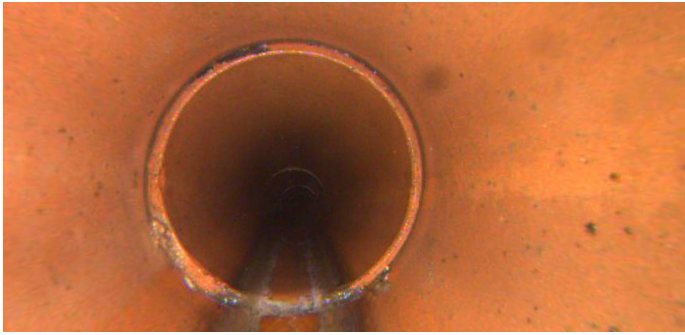
Code: **MWL**
Description: **Water Level**

Distance (ft): **7.7**
Structural Grade: **0**
O&M Grade: **0**
Clock Start/From:
Clock To:
1st Value:
2nd Value:
Value Percent: **5.000**
Continuous Index:
Within 8" of Joint: **NO**
Remarks:

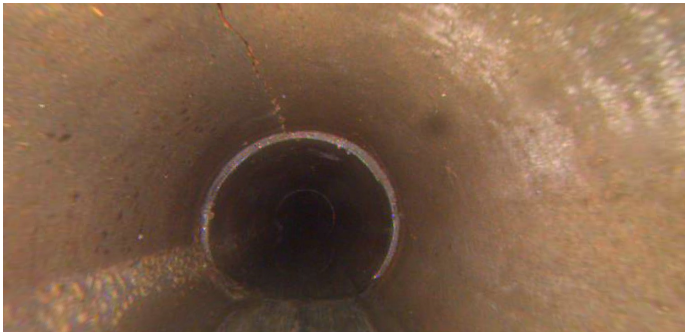
Code: **FL**
Description: **Fracture Longitudinal**

Distance (ft): **13.3**
Structural Grade: **3**
O&M Grade: **0**
Clock Start/From: **12**
Clock To:
1st Value:
2nd Value:
Value Percent:
Continuous Index:
Within 8" of Joint: **YES**
Remarks:

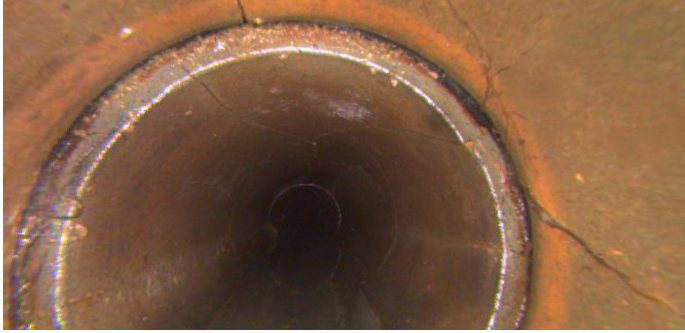
Code: **FM**
Description: **Fracture Multiple**

Distance (ft): **14.0**
Structural Grade: **4**
O&M Grade: **0**
Clock Start/From: **8**
Clock To: **4**
1st Value:
2nd Value:
Value Percent:
Continuous Index: **S01**
Within 8" of Joint: **YES**
Remarks:

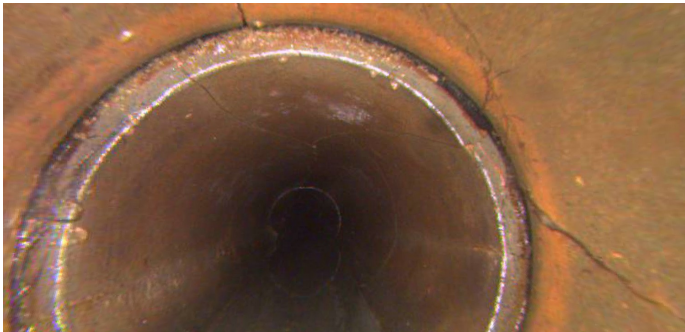
Code: **RFJ**
Description: **Roots Fine Joint**

Distance (ft): **14.0**
Structural Grade: **0**
O&M Grade: **1**
Clock Start/From: **1**
Clock To: **3**
1st Value:
2nd Value:
Value Percent:
Continuous Index:
Within 8" of Joint: **YES**
Remarks:

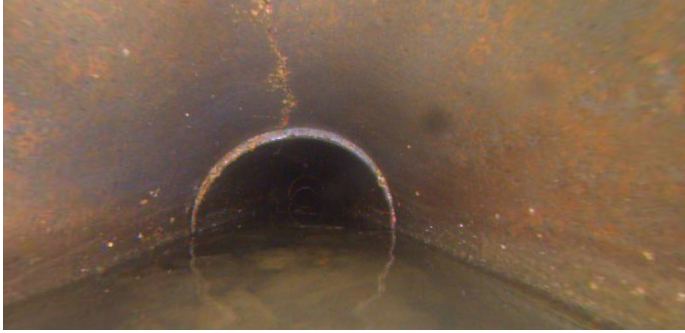
Code: **MWL**
Description: **Water Level**

Distance (ft): **37.0**
Structural Grade: **0**
O&M Grade: **0**
Clock Start/From:
Clock To:
1st Value:
2nd Value:
Value Percent: **40.000**
Continuous Index:
Within 8" of Joint: **NO**
Remarks:

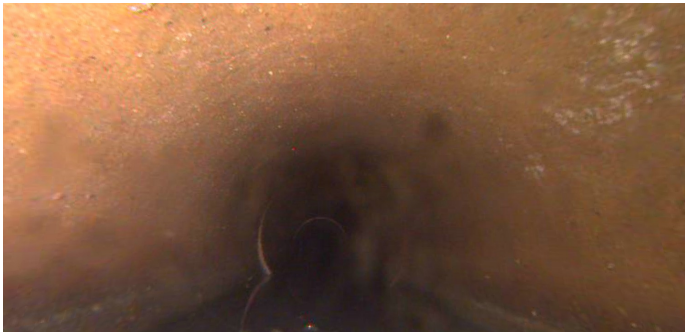
Code: **MSA**
Description: **Abandoned Survey**

Distance (ft): **49.4**
Structural Grade: **0**
O&M Grade: **0**
Clock Start/From:
Clock To:
1st Value:
2nd Value:
Value Percent:
Continuous Index:
Within 8" of Joint: **NO**
Remarks: **debris under water**

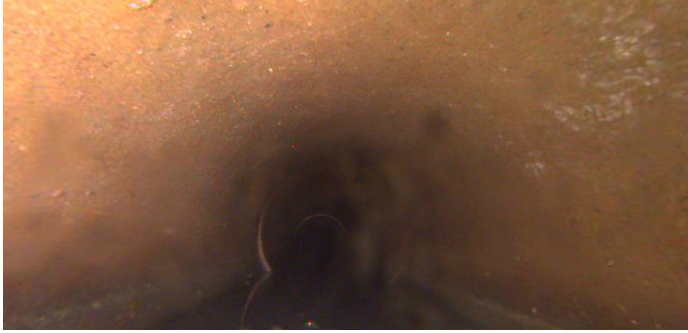
Code:	FM
Description:	Fracture Multiple
Distance (ft):	49.4
Structural Grade:	4
O&M Grade:	0
Clock Start/From:	8
Clock To:	4
1st Value:	
2nd Value:	
Value Percent:	
Continuous Index:	F01
Within 8" of Joint:	YES
Remarks:
