Profile/Photo Observation Report

Date:	04/24/2018	Weather:		Coding:	PACP 6.0
Pipe Length (ft):	177.5	Owner:	NA	Pre Clean:	Not Known
P.O.#:		Surveyor:	Jen Costello	PSR:	P-604-111-107
Customer:		Clean Date:	01/01/1900	Shape:	C

Street:	N Ash St,	Flow Control:	Not Controlled
City:	Hobart, IN	Year Renewed:	
Location:	Other	Tape/Media #:	
Purpose:	Not Known	Dia/Height:	12"
Use:	Sanitary	Material:	VCP
Drain Area:	NA	Lining:	
Category:	NA		
Comment:

Location Details:		Direction of Survey:	Downstream
US MH:	M-604-107	DS MH:	M-604-111
		Total Length Surveyed (ft):	49.4

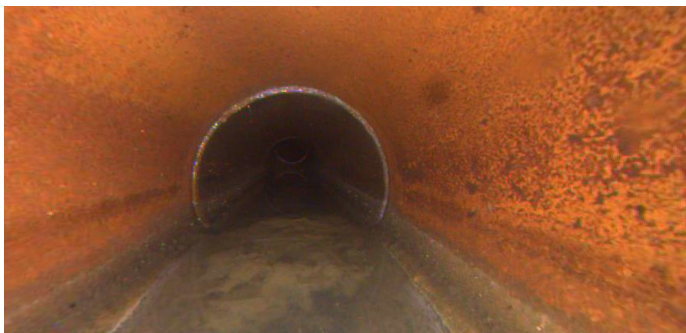
Code: **AMH**
Description: **Manhole**

Distance (ft): **.0**
Structural Grade: **0**
O&M Grade: **0**
Clock Start/From:
Clock To:
1st Value:
2nd Value:
Value Percent:
Continuous Index:
Within 8" of Joint: **NO**
Remarks: **M-604-107**

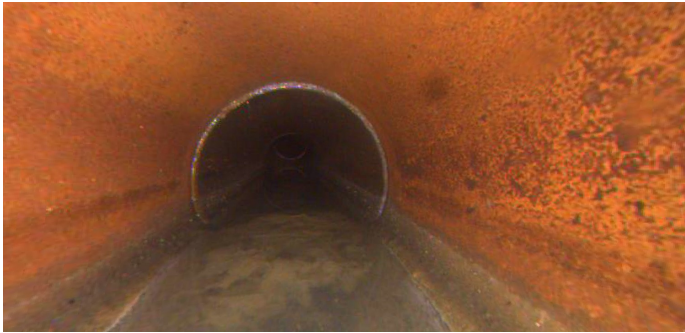
Code:	MWL
Description:	Water Level

Distance (ft):	.0
Structural Grade:	0
O&M Grade:	0
Clock Start/From:	
Clock To:	
1st Value:	
2nd Value:	
Value Percent:	20.000
Continuous Index:	
Within 8" of Joint:	NO
Remarks:

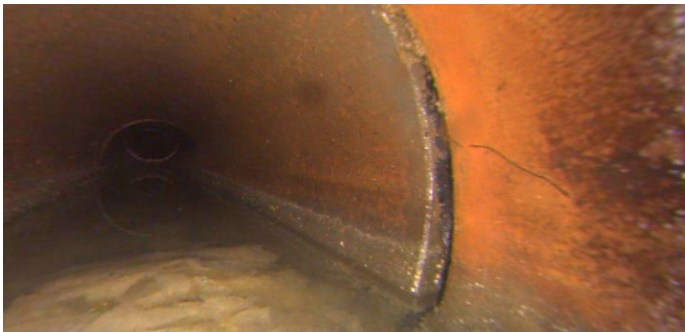
Code:	RFJ
Description:	Roots Fine Joint

Distance (ft):	2.2
Structural Grade:	0
O&M Grade:	1
Clock Start/From:	3
Clock To:	
1st Value:	
2nd Value:	
Value Percent:	
Continuous Index:	
Within 8" of Joint:	YES
Remarks:

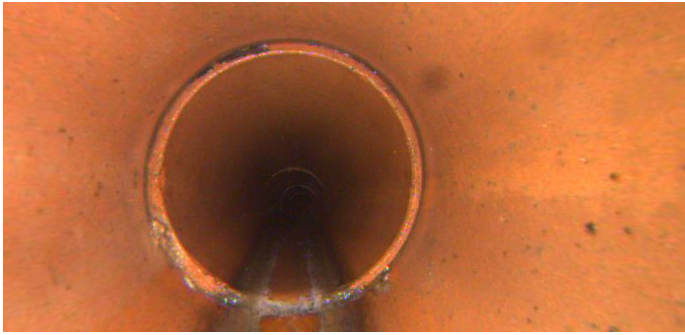
Code: **MWL**
Description: **Water Level**

Distance (ft): **7.7**
Structural Grade: **0**
O&M Grade: **0**
Clock Start/From:
Clock To:
1st Value:
2nd Value:
Value Percent: **5.000**
Continuous Index:
Within 8" of Joint: **NO**
Remarks:

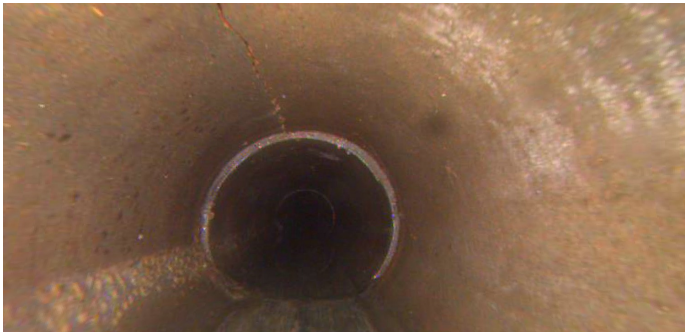
Code: **FL**
Description: **Fracture Longitudinal**

Distance (ft): **13.3**
Structural Grade: **3**
O&M Grade: **0**
Clock Start/From: **12**
Clock To:
1st Value:
2nd Value:
Value Percent:
Continuous Index:
Within 8" of Joint: **YES**
Remarks:

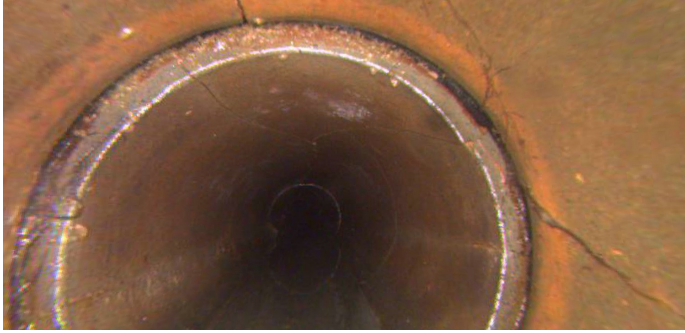
Code: **FM**
Description: **Fracture Multiple**

Distance (ft): **14.0**
Structural Grade: **4**
O&M Grade: **0**
Clock Start/From: **8**
Clock To: **4**
1st Value:
2nd Value:
Value Percent:
Continuous Index: **S01**
Within 8" of Joint: **YES**
Remarks:

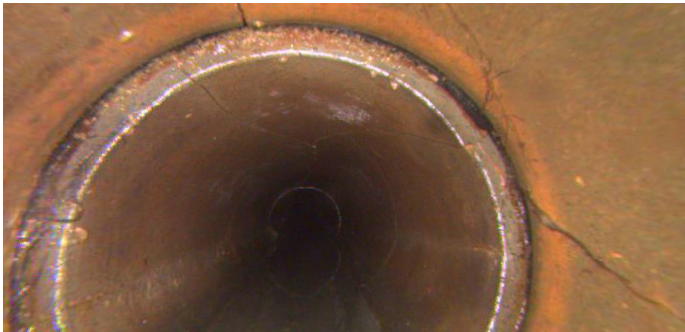
Code: **RFJ**
Description: **Roots Fine Joint**

Distance (ft): **14.0**
Structural Grade: **0**
O&M Grade: **1**
Clock Start/From: **1**
Clock To: **3**
1st Value:
2nd Value:
Value Percent:
Continuous Index:
Within 8" of Joint: **YES**
Remarks:

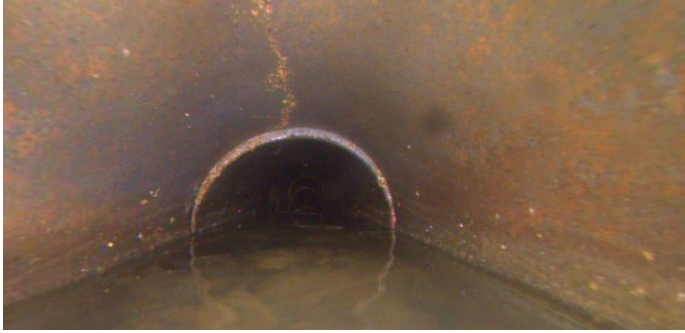
Code: **MWL**
Description: **Water Level**

Distance (ft): **37.0**
Structural Grade: **0**
O&M Grade: **0**
Clock Start/From:
Clock To:
1st Value:
2nd Value:
Value Percent: **40.000**
Continuous Index:
Within 8" of Joint: **NO**
Remarks:

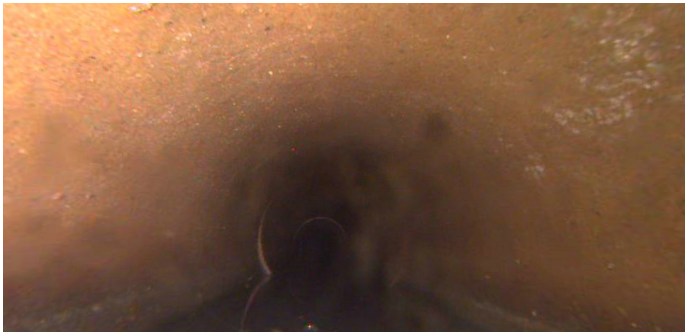
Code: **MSA**
Description: **Abandoned Survey**

Distance (ft): **49.4**
Structural Grade: **0**
O&M Grade: **0**
Clock Start/From:
Clock To:
1st Value:
2nd Value:
Value Percent:
Continuous Index:
Within 8" of Joint: **NO**
Remarks: **debris under water**

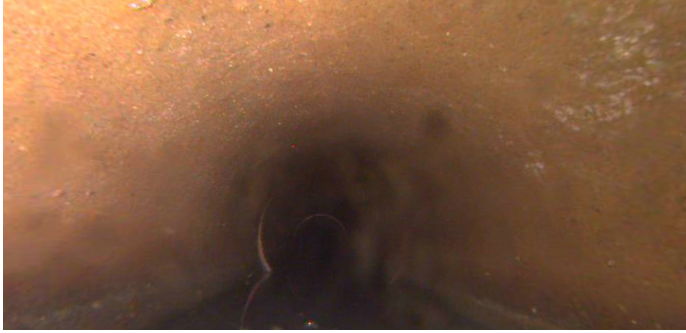
Code:	FM
Description:	Fracture Multiple
Distance (ft):	49.4
Structural Grade:	4
O&M Grade:	0
Clock Start/From:	8
Clock To:	4
1st Value:	
2nd Value:	
Value Percent:	
Continuous Index:	F01
Within 8" of Joint:	YES
Remarks:
