Profile/Photo Observation Report

Date: **11/09/2021** Weather: _____ Coding: **PACP 7.0**
 Pipe Length (ft): **173.1** Owner: **City of Hobart** Pre Clean: **Heavy Cleaning**
 P.O.#: **YES502259** Surveyor: **Steven Bucklin** PSR: **P-604-111-107**
 Customer: **City of Hobart, IN (Red** Clean Date: **11/09/2021** Shape: **C**

Street: **North Ash Street** Flow Control: **Not Controlled**
 City: **City of Hobart** Year Renewed: _____
 Location: **Local rural streets with light traffic, t** Tape/Media #: _____
 Purpose: **Routine Assessment** Dia/Height: **10"**
 Use: **Sanitary Sewage Pipe** Material: **VCP**
 Drain Area: _____ Lining: **None**
 Category: **NA**
 Comment: _____
 Location Details: _____ Direction of Survey: **Upstream**
 US MH: **M-604-107** DS MH: **M-604-111** Total Length Surveyed (ft): **173.1**

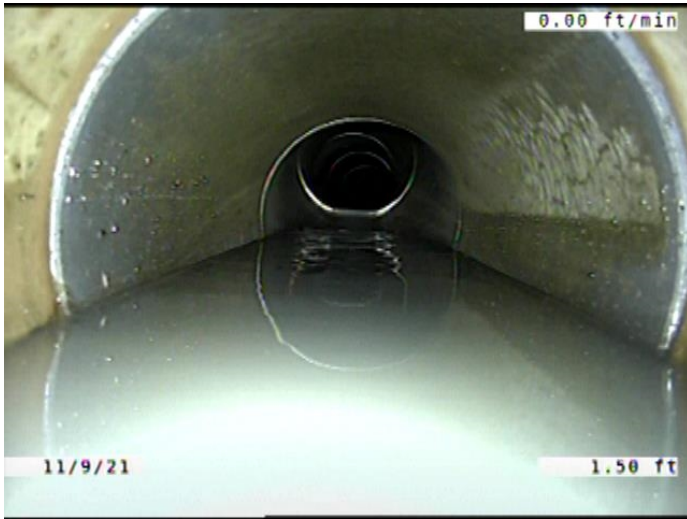
Code: **MGO**
Description: **Miscellaneous General Observation**

Distance (ft): **1.5**
Structural Grade: **0**
O&M Grade: **0**
Clock Start/From:
Clock To:
1st Value:
2nd Value:
Value Percent:
Continuous Index:
Within 8" of Joint: **NO**
Remarks: **DROP INTO THE MANHOLE. HAD TO START IN THE PIPE.**

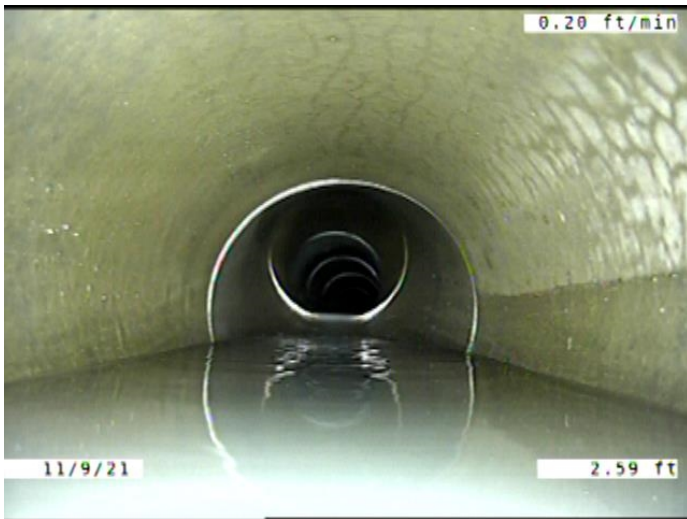
Code: **MWLS**
Description: **Miscellaneous Water Level Sag**

Distance (ft): **2.6**
Structural Grade: **2**
O&M Grade: **0**
Clock Start/From:
Clock To:
1st Value:
2nd Value:
Value Percent: **20.000**
Continuous Index: **S01**
Within 8" of Joint: **NO**
Remarks:

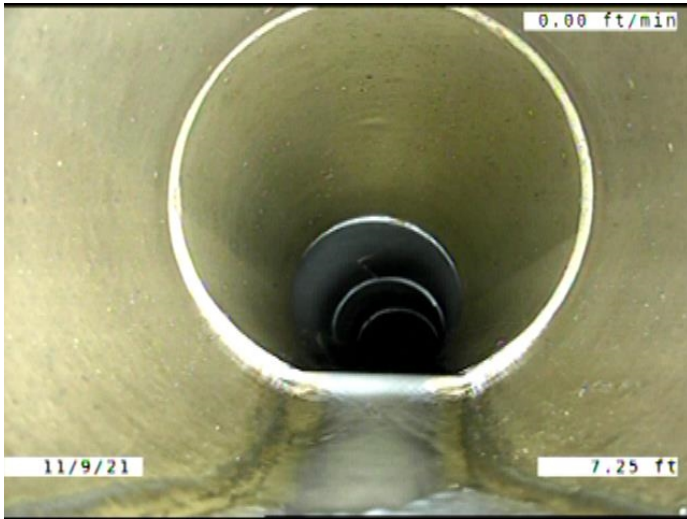
Code: **LU**
Description: **Line Up**

Distance (ft): **7.3**
Structural Grade: **0**
O&M Grade: **1**
Clock Start/From:
Clock To:
1st Value:
2nd Value:
Value Percent: **5.000**
Continuous Index:
Within 8" of Joint: **NO**
Remarks:

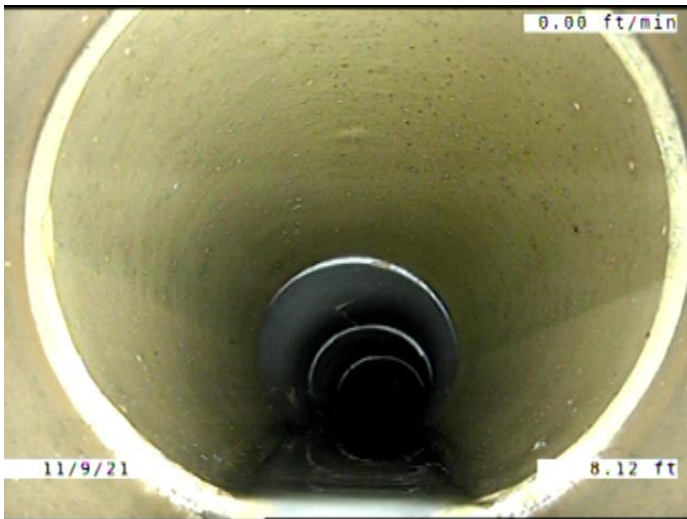
Code: **MWLS**
Description: **Miscellaneous Water Level Sag**

Distance (ft): **8.1**
Structural Grade: **2**
O&M Grade: **0**
Clock Start/From:
Clock To:
1st Value:
2nd Value:
Value Percent: **20.000**
Continuous Index: **F01**
Within 8" of Joint: **NO**
Remarks:

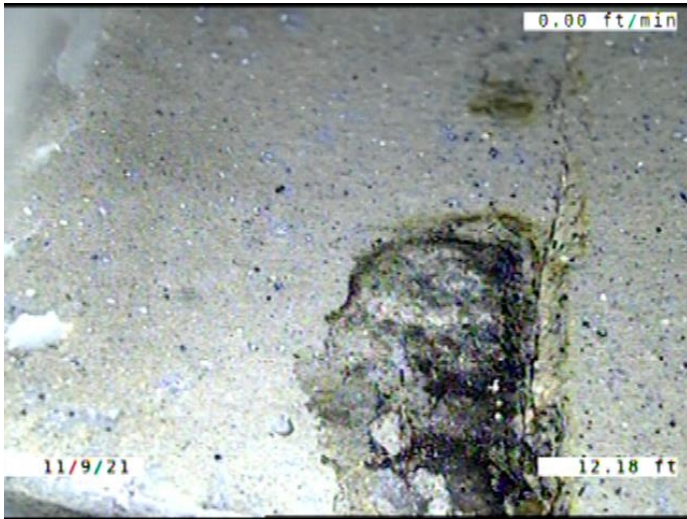
Code: **ISB**
Description: **Infiltration Stain Barrel**

Distance (ft): **12.2**
Structural Grade: **0**
O&M Grade: **1**
Clock Start/From: **3**
Clock To: **5**
1st Value:
2nd Value:
Value Percent:
Continuous Index: **S02**
Within 8" of Joint: **YES**
Remarks:

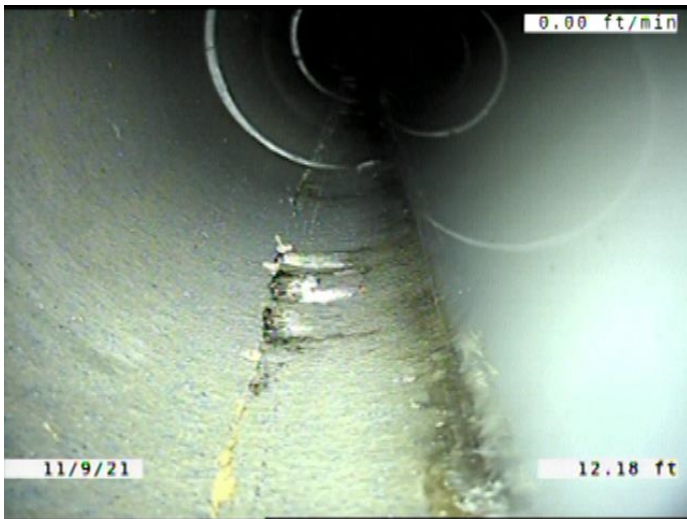
Code: **ISB**
Description: **Infiltration Stain Barrel**

Distance (ft): **12.2**
Structural Grade: **0**
O&M Grade: **1**
Clock Start/From: **7**
Clock To: **9**
1st Value:
2nd Value:
Value Percent:
Continuous Index: **S03**
Within 8" of Joint: **YES**
Remarks:

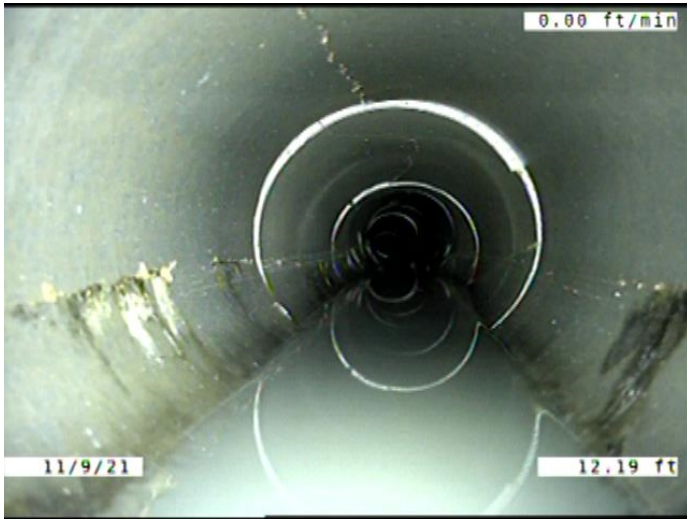
Code: **FM**
Description: **Fracture Multiple**

Distance (ft): **12.2**
Structural Grade: **4**
O&M Grade: **0**
Clock Start/From: **7**
Clock To: **5**
1st Value:
2nd Value:
Value Percent:
Continuous Index: **S04**
Within 8" of Joint: **YES**
Remarks:

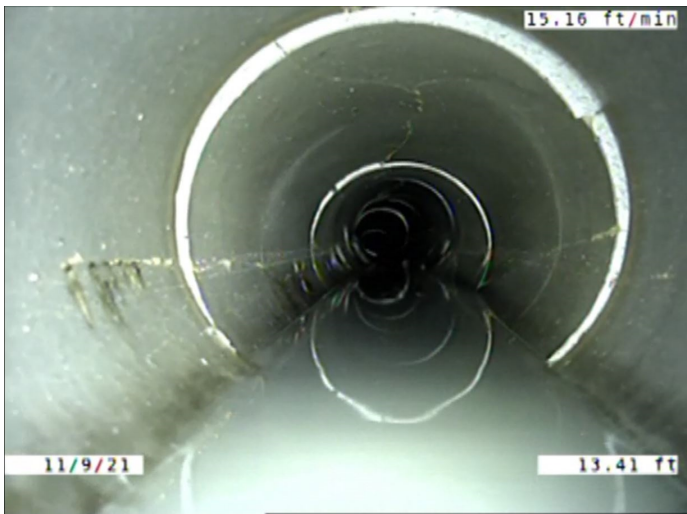
Code: **B**
Description: **Broken**

Distance (ft): **13.4**
Structural Grade: **4**
O&M Grade: **0**
Clock Start/From: **11**
Clock To: **2**
1st Value:
2nd Value:
Value Percent:
Continuous Index:
Within 8" of Joint: **YES**
Remarks:

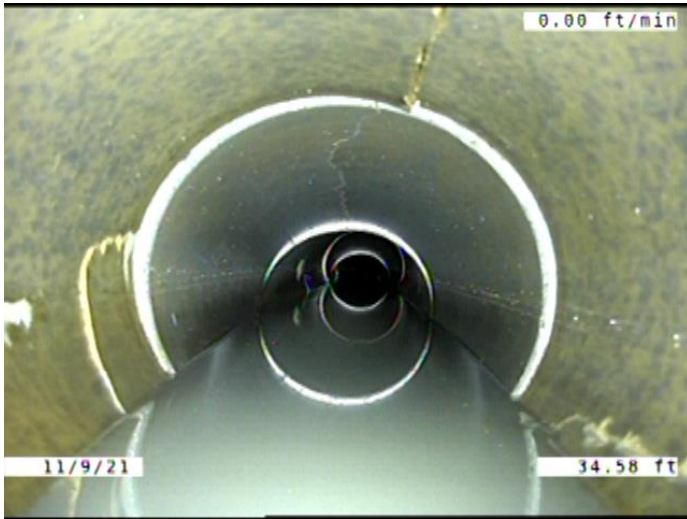
Code: **MWLS**
Description: **Miscellaneous Water Level Sag**

Distance (ft): **34.6**
Structural Grade: **2**
O&M Grade: **0**
Clock Start/From:
Clock To:
1st Value:
2nd Value:
Value Percent: **30.000**
Continuous Index: **S05**
Within 8" of Joint: **NO**
Remarks:

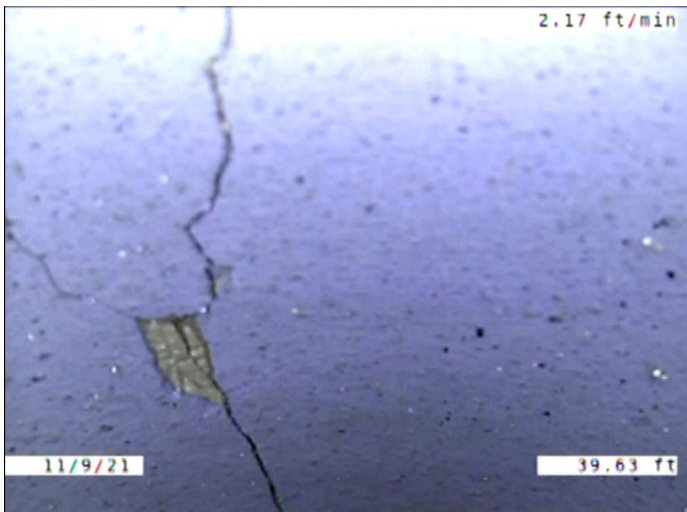
Code: **SSS**
Description: **Surface Damage Surface Spalling**

Distance (ft): **39.6**
Structural Grade: **2**
O&M Grade: **0**
Clock Start/From: **12**
Clock To:
1st Value:
2nd Value:
Value Percent:
Continuous Index:
Within 8" of Joint: **NO**
Remarks:

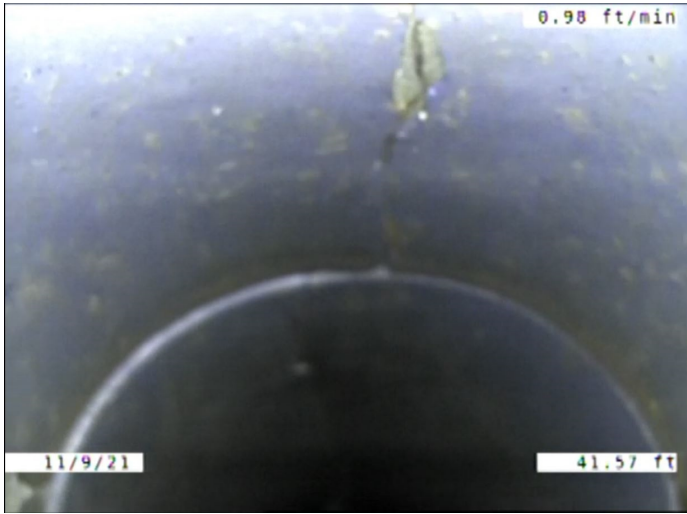
Code: **SSS**
Description: **Surface Damage Surface Spalling**

Distance (ft): **41.6**
Structural Grade: **2**
O&M Grade: **0**
Clock Start/From: **12**
Clock To:
1st Value:
2nd Value:
Value Percent:
Continuous Index:
Within 8" of Joint: **NO**
Remarks:

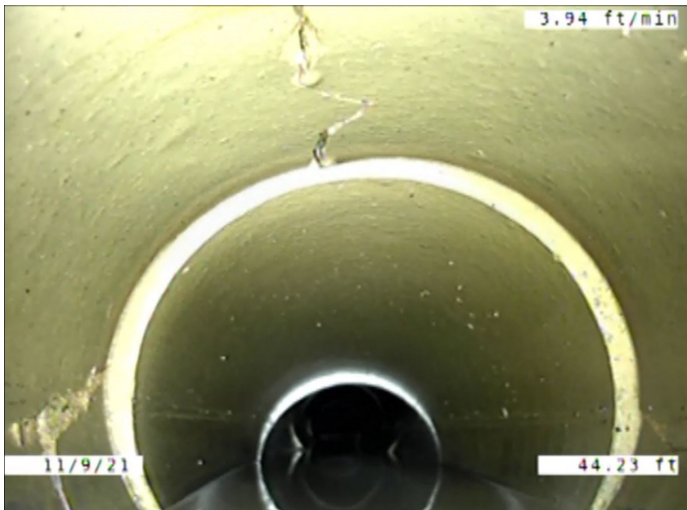
Code: **SSS**
Description: **Surface Damage Surface Spalling**

Distance (ft): **44.2**
Structural Grade: **2**
O&M Grade: **0**
Clock Start/From: **12**
Clock To:
1st Value:
2nd Value:
Value Percent:
Continuous Index:
Within 8" of Joint: **NO**
Remarks:

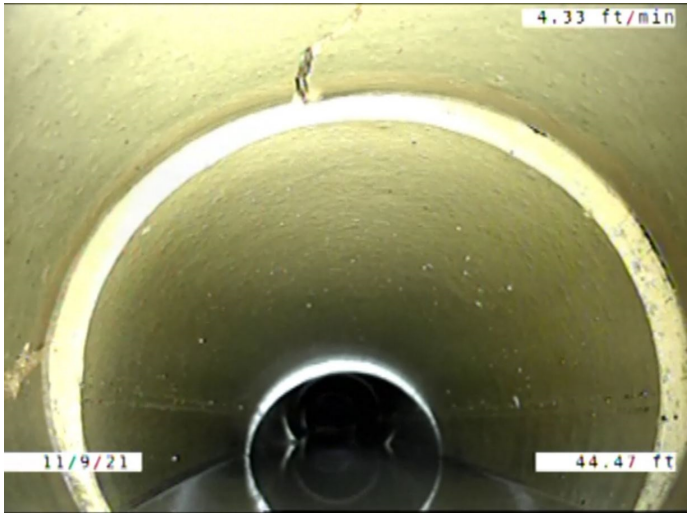
Code: **B**
Description: **Broken**

Distance (ft): **44.5**
Structural Grade: **4**
O&M Grade: **0**
Clock Start/From: **12**
Clock To:
1st Value:
2nd Value:
Value Percent:
Continuous Index:
Within 8" of Joint: **YES**
Remarks:

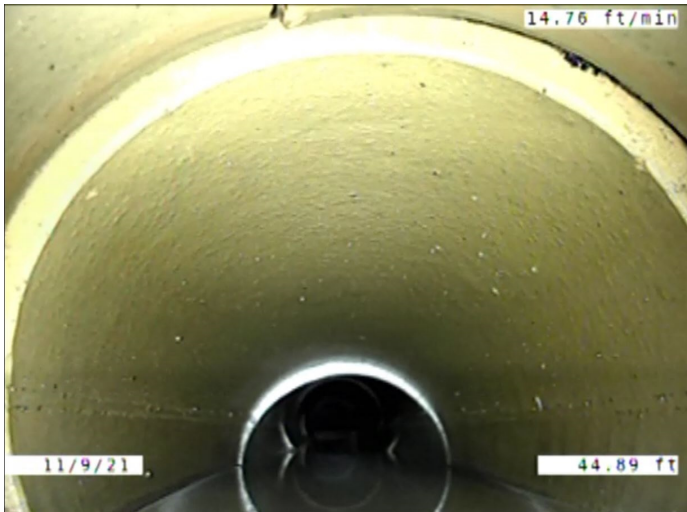
Code: **FM**
Description: **Fracture Multiple**

Distance (ft): **44.9**
Structural Grade: **4**
O&M Grade: **0**
Clock Start/From: **7**
Clock To: **5**
1st Value:
2nd Value:
Value Percent:
Continuous Index: **F04**
Within 8" of Joint: **YES**
Remarks:

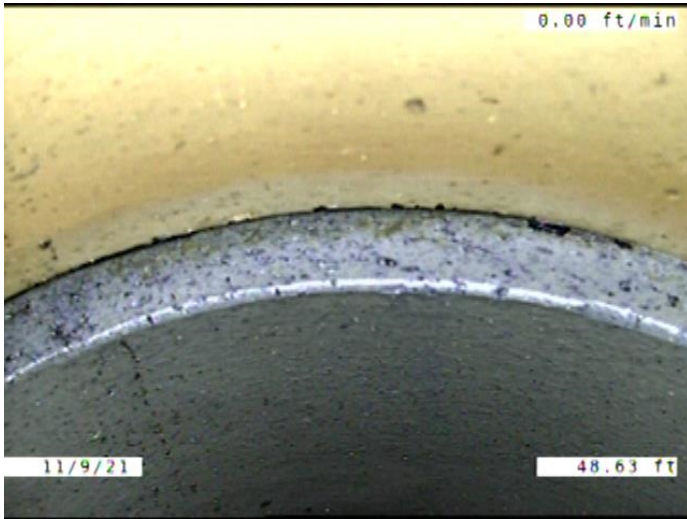
Code: **JOM**
Description: **Joint Offset Medium**

Distance (ft): **48.6**
Structural Grade: **3**
O&M Grade: **0**
Clock Start/From:
Clock To:
1st Value:
2nd Value:
Value Percent:
Continuous Index:
Within 8" of Joint: **NO**
Remarks:

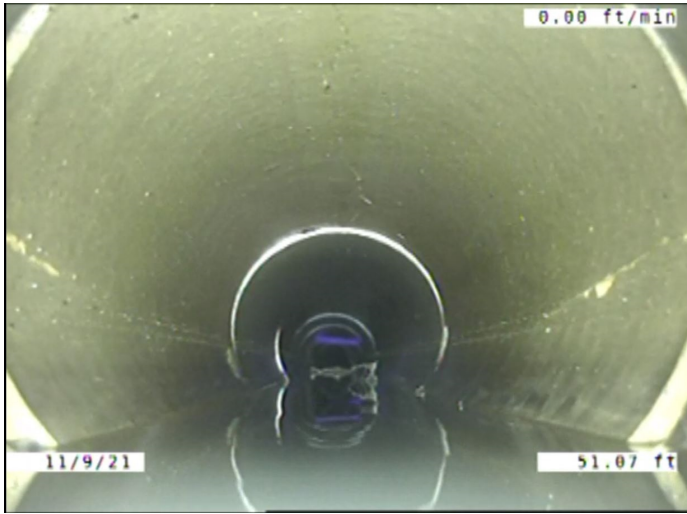
Code: **CM**
Description: **Crack Multiple**

Distance (ft): **51.1**
Structural Grade: **3**
O&M Grade: **0**
Clock Start/From: **8**
Clock To: **4**
1st Value:
2nd Value:
Value Percent:
Continuous Index:
Within 8" of Joint: **YES**
Remarks:

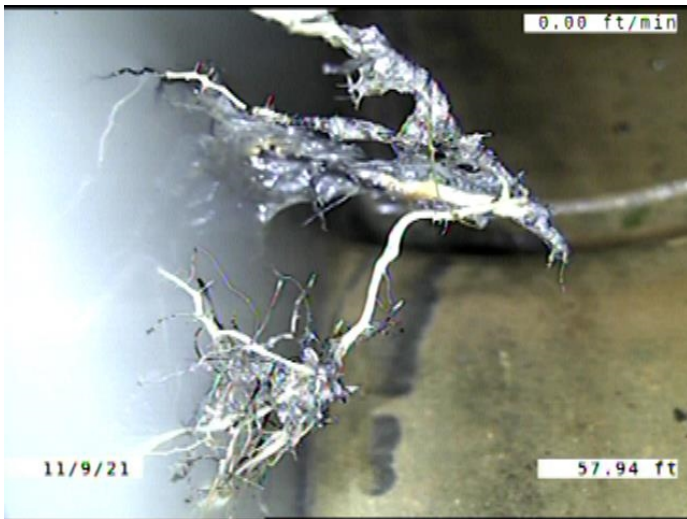
Code: **OBZ**
Description: **Obstruction Other**

Distance (ft): **57.9**
Structural Grade: **0**
O&M Grade: **2**
Clock Start/From: **5**
Clock To: **6**
1st Value:
2nd Value:
Value Percent: **5.000**
Continuous Index:
Within 8" of Joint: **YES**
Remarks: **ROOTS THAT HAVE BEEN CUT**

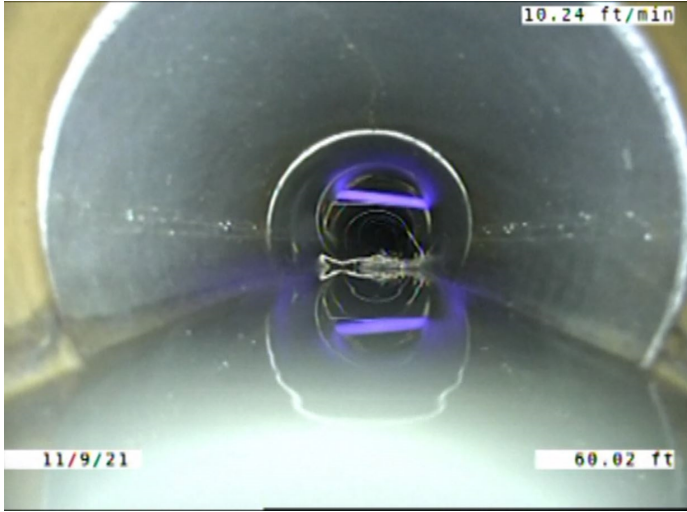
Code: **CS**
 Description: **Crack Spiral**

Distance (ft): **60.0**
 Structural Grade: **2**
 O&M Grade: **0**
 Clock Start/From: **11**
 Clock To: **12**
 1st Value:
 2nd Value:
 Value Percent:
 Continuous Index:
 Within 8" of Joint: **YES**
 Remarks:

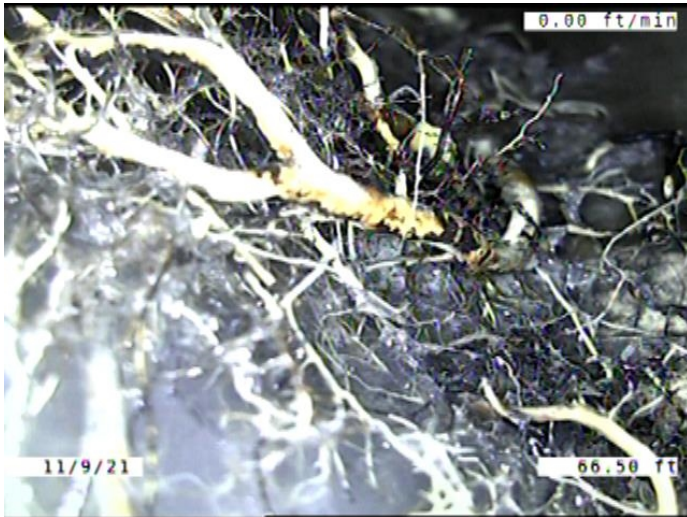
Code: **OBZ**
 Description: **Obstruction Other**

Distance (ft): **66.5**
 Structural Grade: **0**
 O&M Grade: **2**
 Clock Start/From: **4**
 Clock To: **8**
 1st Value:
 2nd Value:
 Value Percent: **5.000**
 Continuous Index:
 Within 8" of Joint: **YES**
 Remarks: **ROOTS THAT HAVE BEEN CUT**

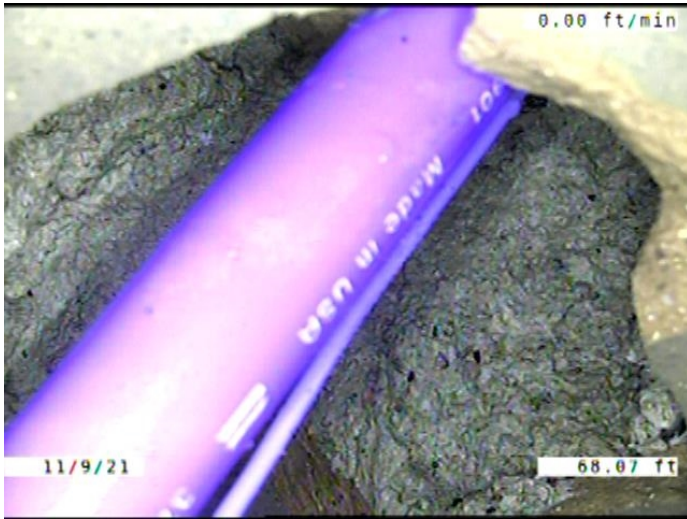
Code: **HSV**
 Description: **Hole Soil Visible**

Distance (ft): **68.1**
 Structural Grade: **5**
 O&M Grade: **0**
 Clock Start/From: **1**
 Clock To: **3**
 1st Value:
 2nd Value:
 Value Percent:
 Continuous Index:
 Within 8" of Joint: **YES**
 Remarks:

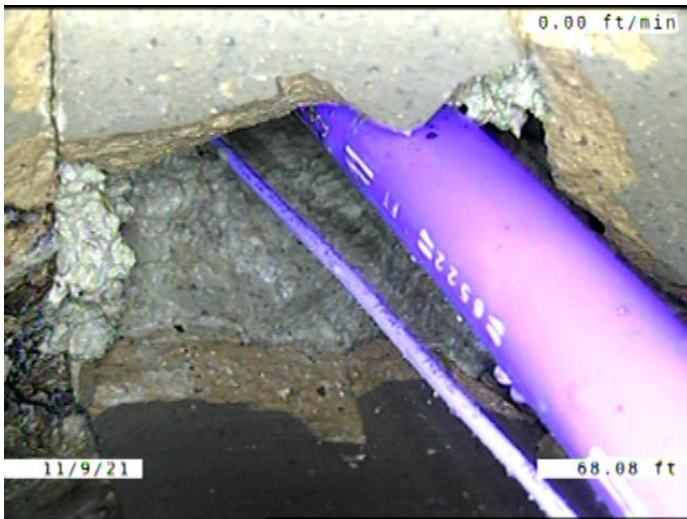
Code: **HSV**
 Description: **Hole Soil Visible**

Distance (ft): **68.1**
 Structural Grade: **5**
 O&M Grade: **0**
 Clock Start/From: **10**
 Clock To: **11**
 1st Value:
 2nd Value:
 Value Percent:
 Continuous Index:
 Within 8" of Joint: **YES**
 Remarks:

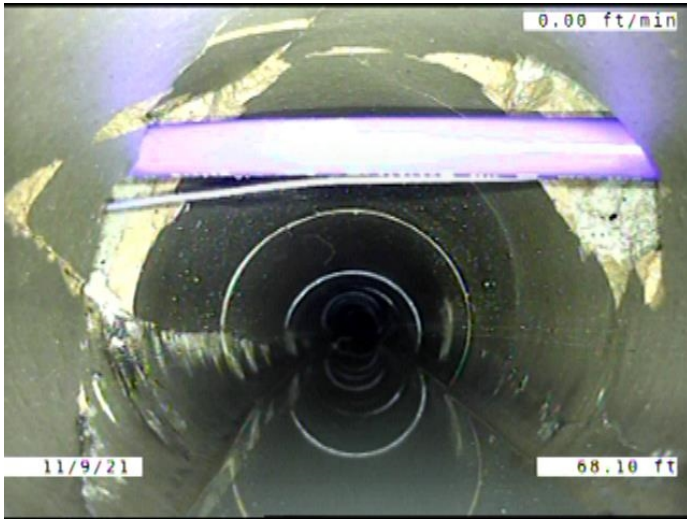
Code: **OBP**
 Description: **Obstruction External Pipe or Cable**

Distance (ft): **68.1**
 Structural Grade: **0**
 O&M Grade: **2**
 Clock Start/From: **10**
 Clock To: **2**
 1st Value:
 2nd Value:
 Value Percent: **10.000**
 Continuous Index:
 Within 8" of Joint: **YES**
 Remarks:

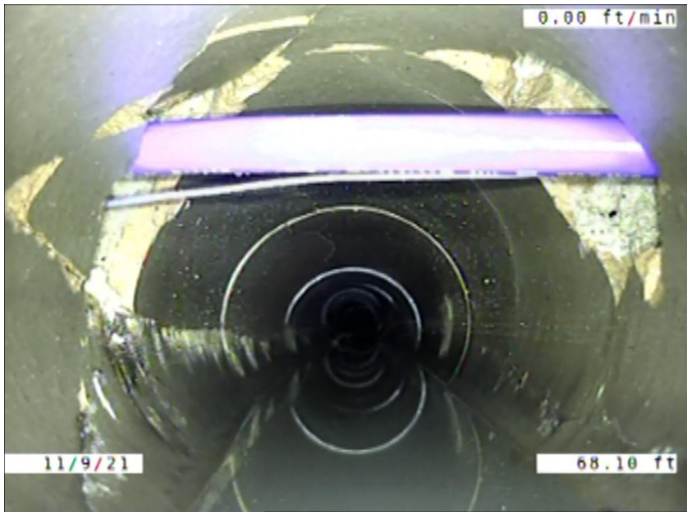
Code: **B**
 Description: **Broken**

Distance (ft): **68.1**
 Structural Grade: **4**
 O&M Grade: **0**
 Clock Start/From: **8**
 Clock To: **4**
 1st Value:
 2nd Value:
 Value Percent:
 Continuous Index:
 Within 8" of Joint: **NO**
 Remarks:

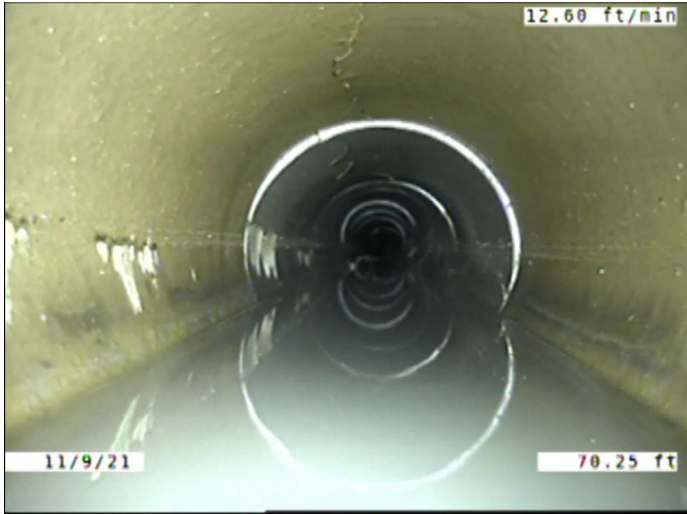
Code: **FM**
Description: **Fracture Multiple**

Distance (ft): **70.3**
Structural Grade: **4**
O&M Grade: **0**
Clock Start/From: **8**
Clock To: **4**
1st Value:
2nd Value:
Value Percent:
Continuous Index: **S09**
Within 8" of Joint: **YES**
Remarks:

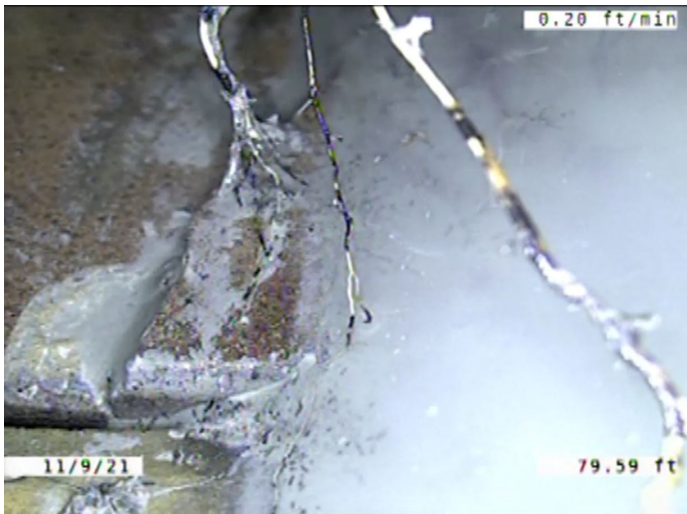
Code: **B**
Description: **Broken**

Distance (ft): **79.6**
Structural Grade: **4**
O&M Grade: **0**
Clock Start/From: **8**
Clock To:
1st Value:
2nd Value:
Value Percent:
Continuous Index:
Within 8" of Joint: **YES**
Remarks:

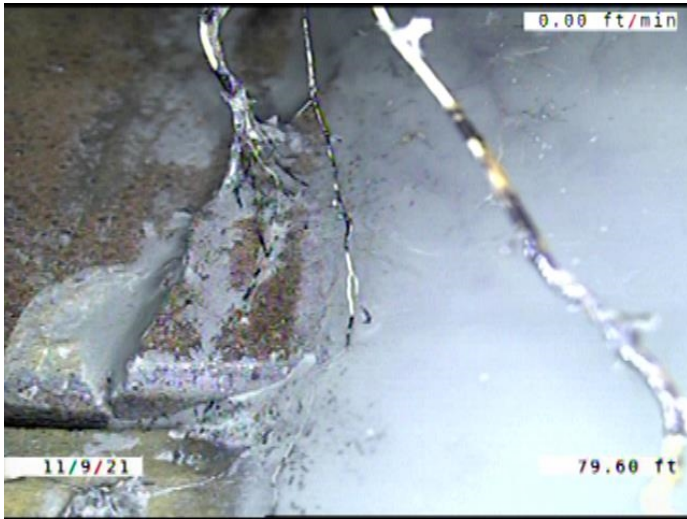
Code: **OBZ**
Description: **Obstruction Other**

Distance (ft): **79.6**
Structural Grade: **0**
O&M Grade: **2**
Clock Start/From: **6**
Clock To: **7**
1st Value:
2nd Value:
Value Percent: **5.000**
Continuous Index:
Within 8" of Joint: **YES**
Remarks: **ROOTS THAT HAVE BEEN CUT**

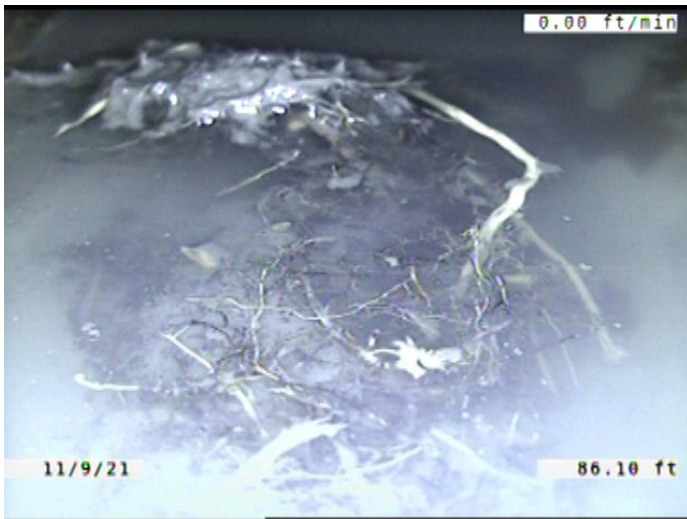
Code: **OBZ**
Description: **Obstruction Other**

Distance (ft): **86.1**
Structural Grade: **0**
O&M Grade: **2**
Clock Start/From: **6**
Clock To: **7**
1st Value:
2nd Value:
Value Percent: **5.000**
Continuous Index:
Within 8" of Joint: **YES**
Remarks: **ROOTS THAT HAVE BEEN CUT**

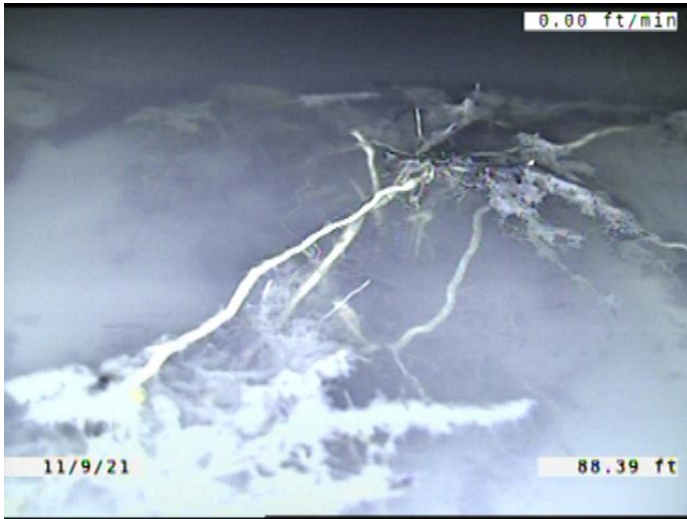
Code: **OBZ**
Description: **Obstruction Other**

Distance (ft): **88.4**
Structural Grade: **0**
O&M Grade: **2**
Clock Start/From: **6**
Clock To: **7**
1st Value:
2nd Value:
Value Percent: **5.000**
Continuous Index:
Within 8" of Joint: **YES**
Remarks: **ROOTS THAT HAVE BEEN CUT**

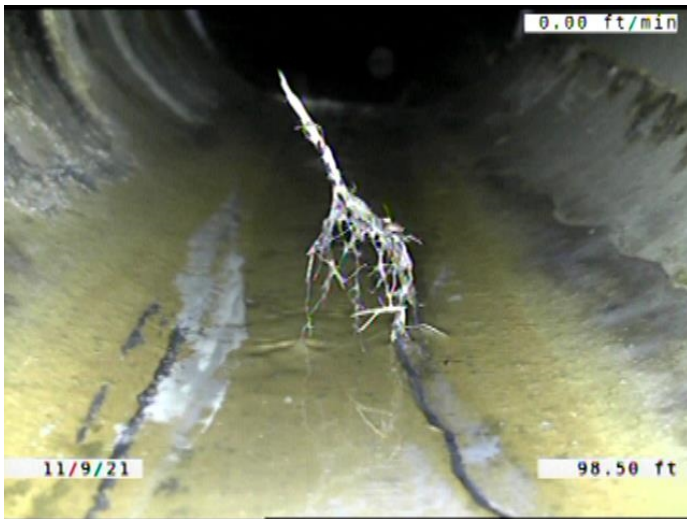
Code: **OBZ**
Description: **Obstruction Other**

Distance (ft): **98.5**
Structural Grade: **0**
O&M Grade: **2**
Clock Start/From: **6**
Clock To:
1st Value:
2nd Value:
Value Percent: **5.000**
Continuous Index:
Within 8" of Joint: **YES**
Remarks: **ROOTS THAT HAVE BEEN CUT**

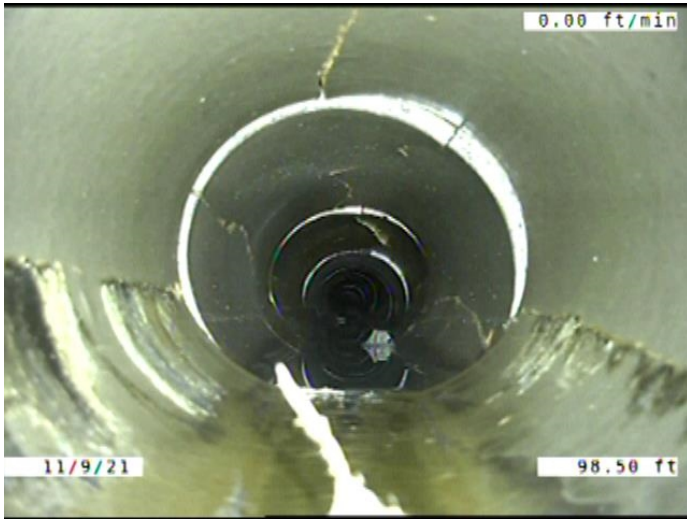
Code: **MWLS**
Description: **Miscellaneous Water Level Sag**

Distance (ft): **98.5**
Structural Grade: **2**
O&M Grade: **0**
Clock Start/From:
Clock To:
1st Value:
2nd Value:
Value Percent: **30.000**
Continuous Index: **F05**
Within 8" of Joint: **NO**
Remarks:

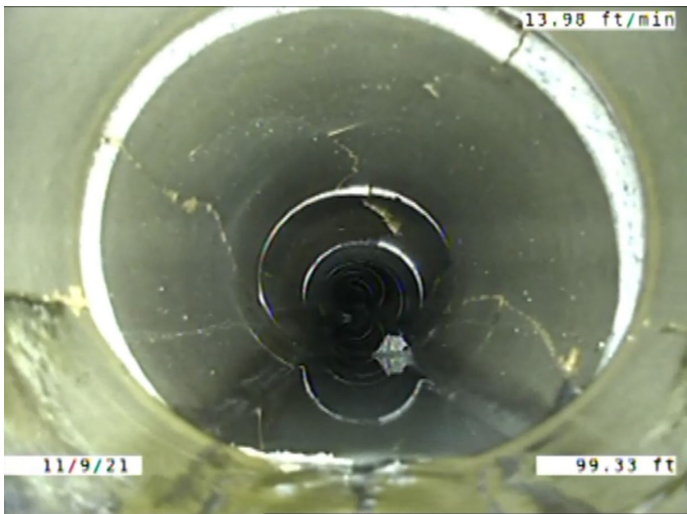
Code: **B**
Description: **Broken**

Distance (ft): **99.3**
Structural Grade: **4**
O&M Grade: **0**
Clock Start/From: **1**
Clock To: **2**
1st Value:
2nd Value:
Value Percent:
Continuous Index: **S10**
Within 8" of Joint: **YES**
Remarks:

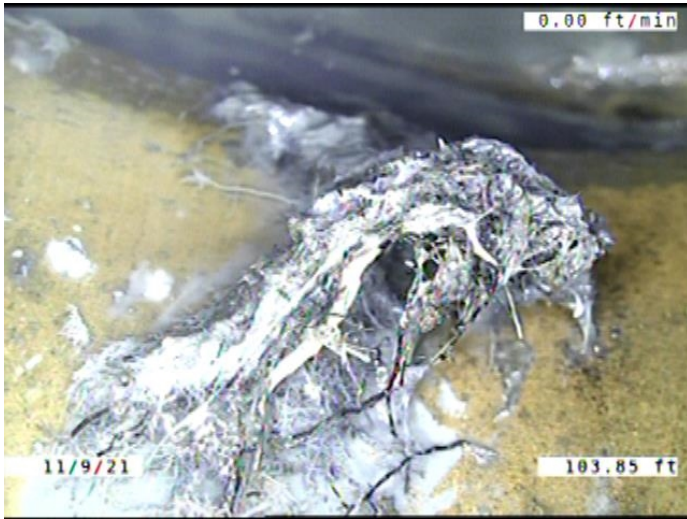
Code: **OBZ**
Description: **Obstruction Other**

Distance (ft): **103.8**
Structural Grade: **0**
O&M Grade: **2**
Clock Start/From: **5**
Clock To: **6**

Continuous Index:
Within 8" of Joint: **YES**
Remarks: **ROOTS THAT HAVE BEEN CUT**

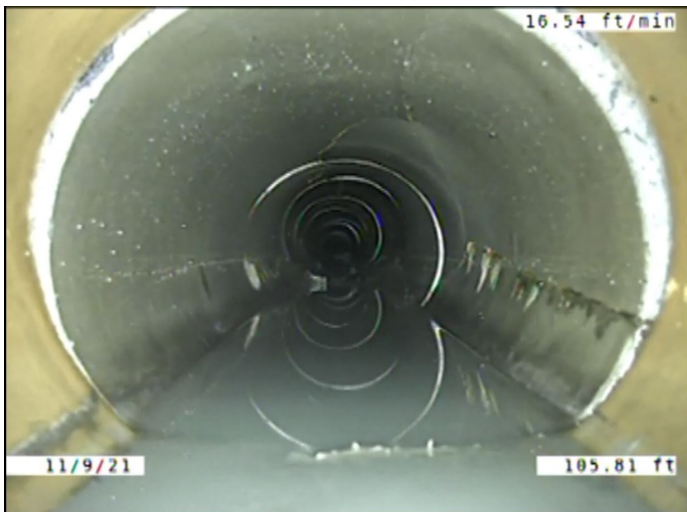
Code: **B**
Description: **Broken**

Distance (ft): **105.8**
Structural Grade: **4**
O&M Grade: **0**
Clock Start/From: **1**
Clock To: **2**

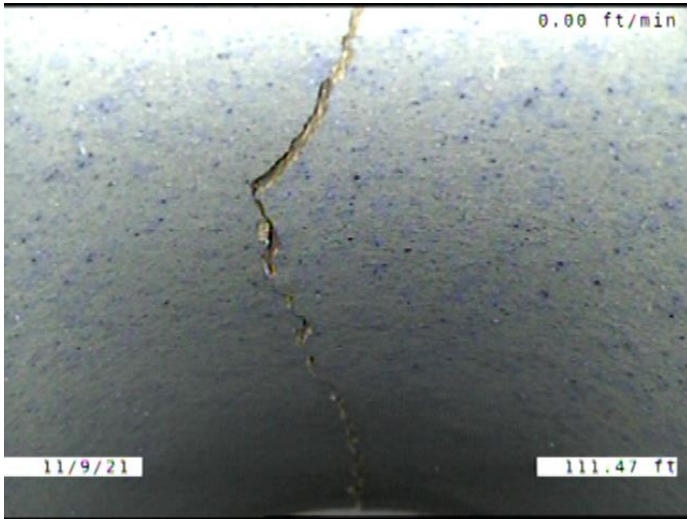
Code: **DR**
Description: **Deformed Rigid**

Distance (ft): **111.5**
Structural Grade: **4**
O&M Grade: **0**
Clock Start/From:
Clock To:
1st Value:
2nd Value:
Value Percent: **5.000**
Continuous Index:
Within 8" of Joint: **NO**
Remarks:

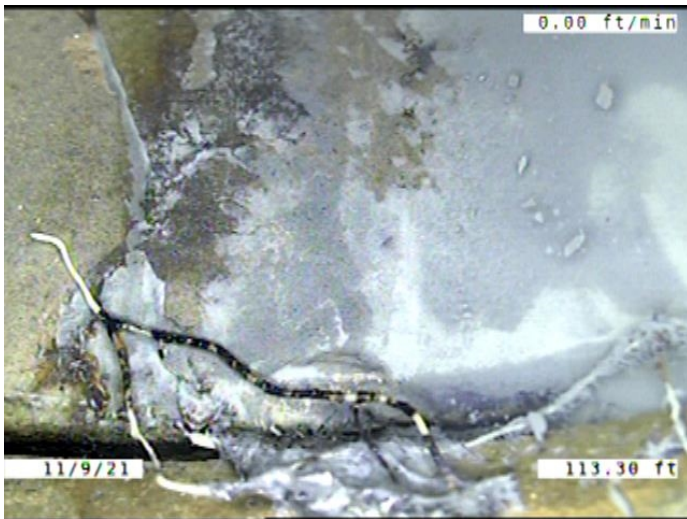
Code: **OBZ**
Description: **Obstruction Other**

Distance (ft): **113.3**
Structural Grade: **0**
O&M Grade: **2**
Clock Start/From: **7**
Clock To:
1st Value:
2nd Value:
Value Percent: **5.000**
Continuous Index:
Within 8" of Joint: **YES**
Remarks: **ROOTS THAT HAVE BEEN CUT**

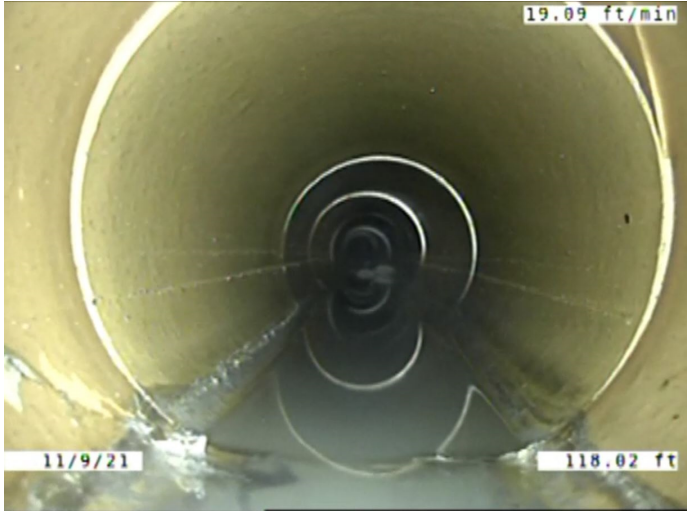
Code: **FM**
 Description: **Fracture Multiple**

Distance (ft): **118.0**
 Structural Grade: **4**
 O&M Grade: **0**
 Clock Start/From: **8**
 Clock To: **4**
 1st Value:
 2nd Value:
 Value Percent:
 Continuous Index: **F09**
 Within 8" of Joint: **YES**
 Remarks:

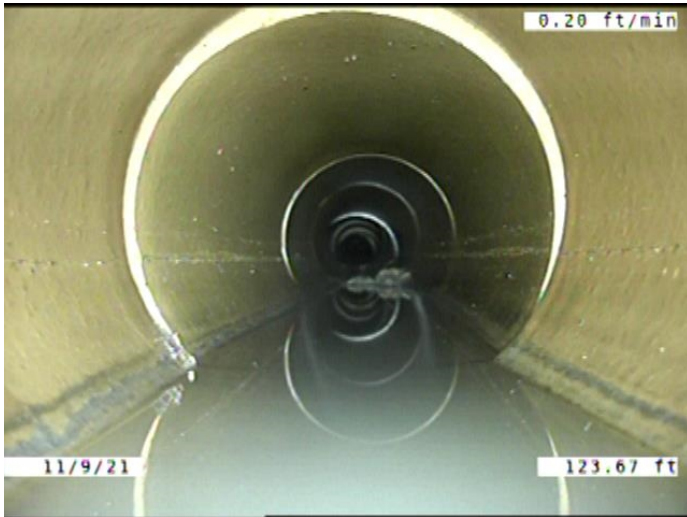
Code: **MWLS**
 Description: **Miscellaneous Water Level Sag**

Distance (ft): **123.7**
 Structural Grade: **2**
 O&M Grade: **0**
 Clock Start/From:
 Clock To:
 1st Value:
 2nd Value:
 Value Percent: **10.000**
 Continuous Index: **S06**
 Within 8" of Joint: **NO**
 Remarks:

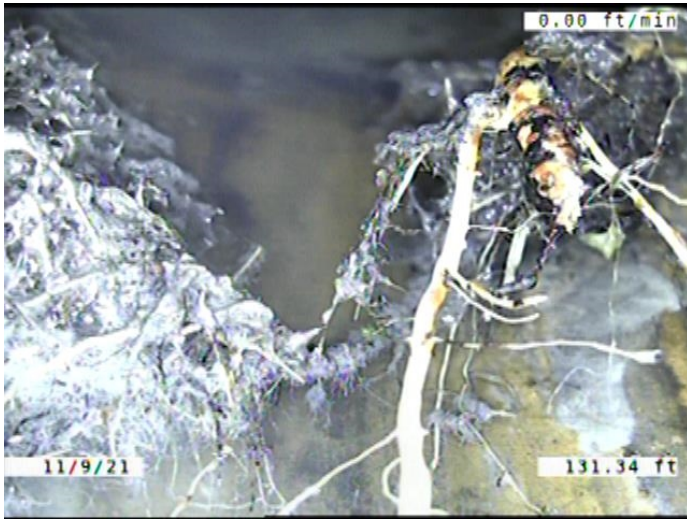
Code: **OBZ**
 Description: **Obstruction Other**

Distance (ft): **131.3**
 Structural Grade: **0**
 O&M Grade: **2**
 Clock Start/From: **5**
 Clock To: **7**

Continuous Index:
 Within 8" of Joint: **YES**
 Remarks: **ROOTS THAT HAVE BEEN CUT**

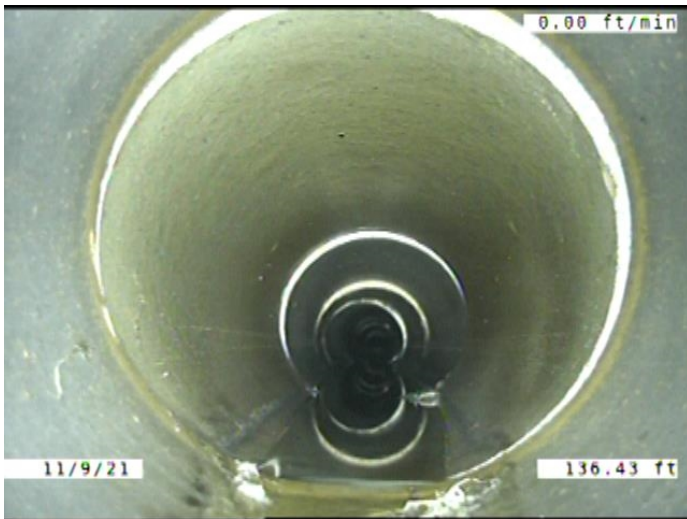
Code: **MWLS**
 Description: **Miscellaneous Water Level Sag**

Distance (ft): **136.4**
 Structural Grade: **2**
 O&M Grade: **0**
 Clock Start/From:
 Clock To:

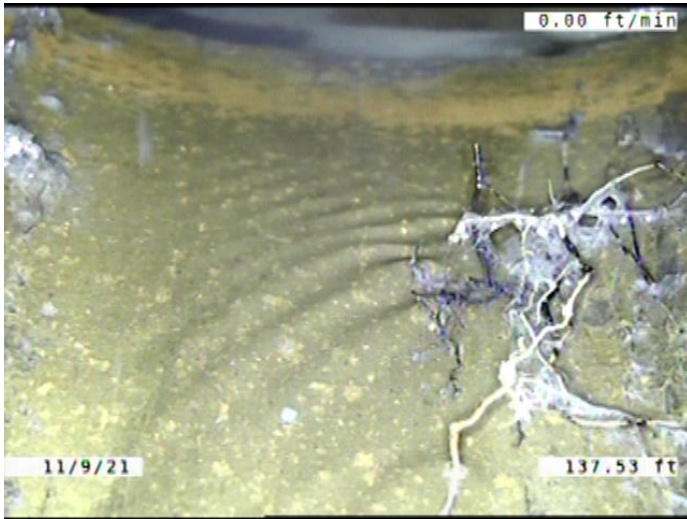
Code: **OBZ**
Description: **Obstruction Other**

Distance (ft): **137.5**
Structural Grade: **0**
O&M Grade: **2**
Clock Start/From: **5**
Clock To: **7**
1st Value:
2nd Value:
Value Percent: **5.000**
Continuous Index: **S07**
Within 8" of Joint: **YES**
Remarks: **ROOTS THAT HAVE BEEN CUT**

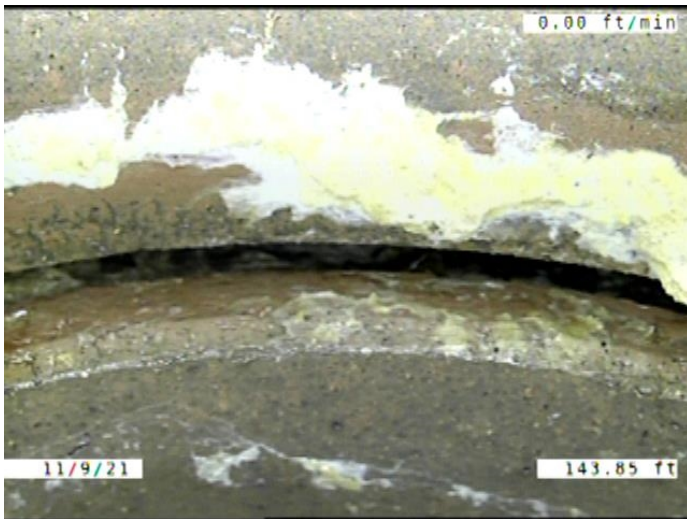
Code: **DAE**
Description: **Deposits Attached Encrustation**

Distance (ft): **143.8**
Structural Grade: **0**
O&M Grade: **2**
Clock Start/From: **8**
Clock To: **4**
1st Value:
2nd Value:
Value Percent: **5.000**
Continuous Index:
Within 8" of Joint: **YES**
Remarks:

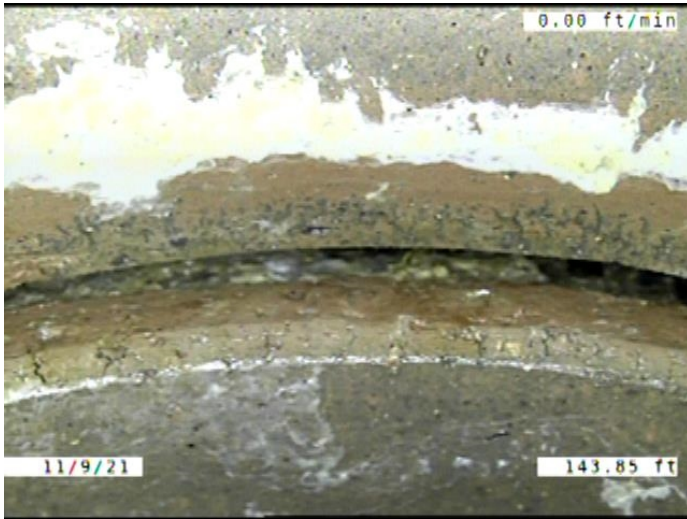
Code: **JOSD**
 Description: **Joint Offset Small Defective**

Distance (ft): **143.8**
 Structural Grade: **0**
 O&M Grade: **0**
 Clock Start/From:
 Clock To:
 1st Value:
 2nd Value:
 Value Percent:
 Continuous Index:
 Within 8" of Joint: **NO**
 Remarks: **SOIL VISIBLE**

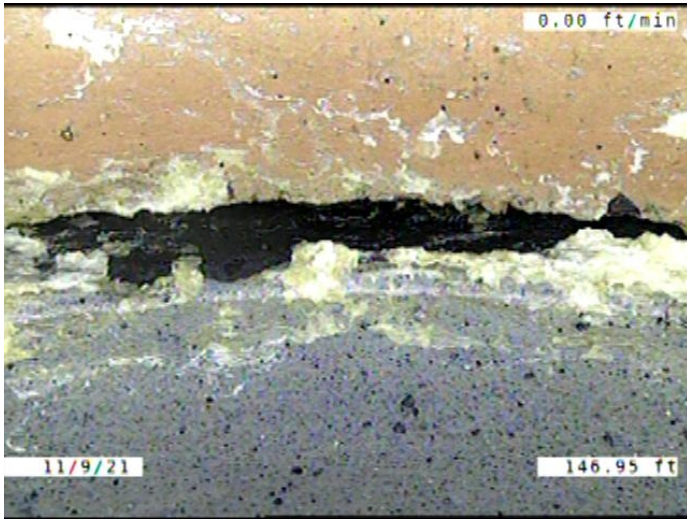
Code: **DAE**
Description: **Deposits Attached Encrustation**

Distance (ft): **146.9**
Structural Grade: **0**
O&M Grade: **2**
Clock Start/From: **8**
Clock To: **4**
1st Value:
2nd Value:
Value Percent: **5.000**
Continuous Index:
Within 8" of Joint: **YES**
Remarks:

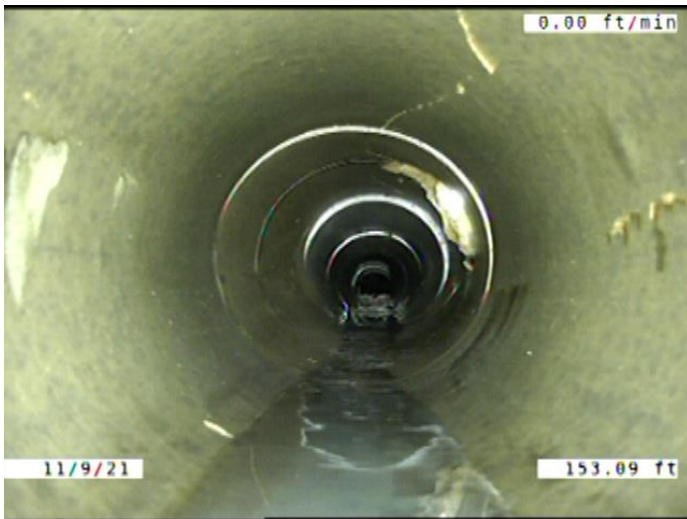
Code: **B**
Description: **Broken**

Distance (ft): **153.1**
Structural Grade: **4**
O&M Grade: **0**
Clock Start/From: **12**
Clock To: **12**
1st Value:
2nd Value:
Value Percent:
Continuous Index: **S08**
Within 8" of Joint: **YES**
Remarks:

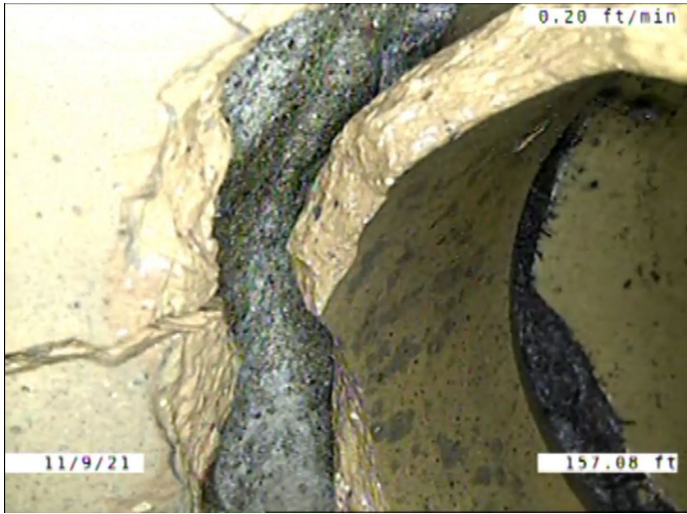
Code: **SSS**
 Description: **Surface Damage Surface Spalling**

Distance (ft): **157.1**
 Structural Grade: **2**
 O&M Grade: **0**
 Clock Start/From: **1**
 Clock To: **3**
 1st Value:
 2nd Value:
 Value Percent:
 Continuous Index:
 Within 8" of Joint: **NO**
 Remarks:

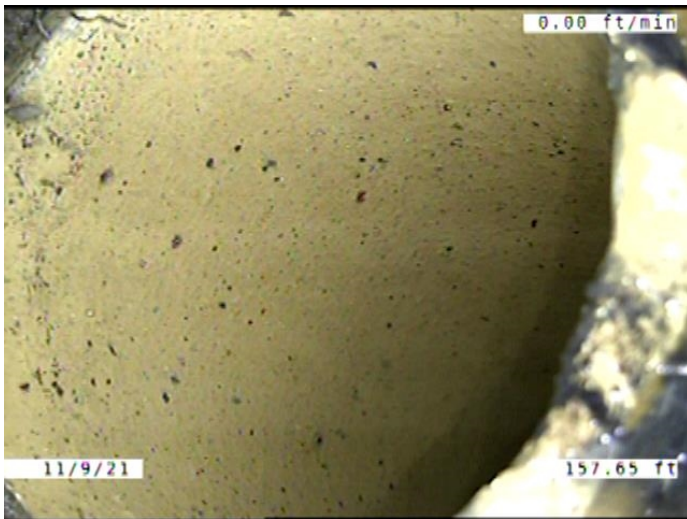
Code: **TBI**
 Description: **Tap Break-in Intruding**

Distance (ft): **157.7**
 Structural Grade: **0**
 O&M Grade: **2**
 Clock Start/From: **2**
 Clock To:
 1st Value: **4.000**
 2nd Value: **1.000**
 Value Percent:
 Continuous Index:
 Within 8" of Joint: **YES**
 Remarks: **CONSTANTLY RUNNING WATER.**

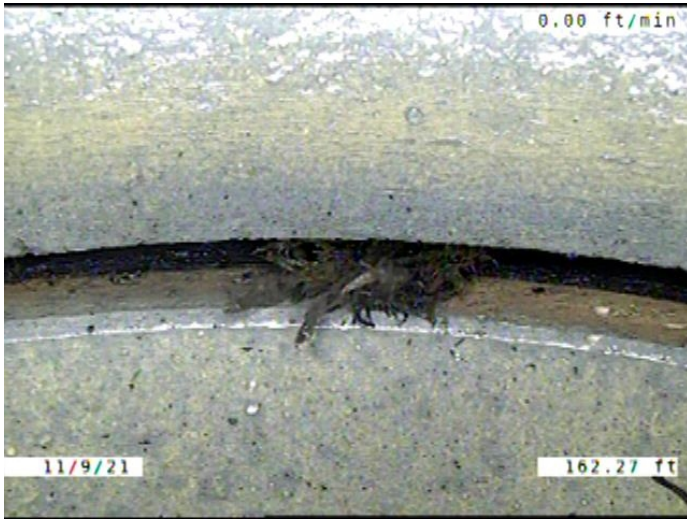
Code: **RFJ**
 Description: **Roots Fine Joint**

Distance (ft): **162.3**
 Structural Grade: **0**
 O&M Grade: **1**
 Clock Start/From: **12**
 Clock To: **1**
 1st Value:
 2nd Value:
 Value Percent:
 Continuous Index:
 Within 8" of Joint: **YES**
 Remarks:

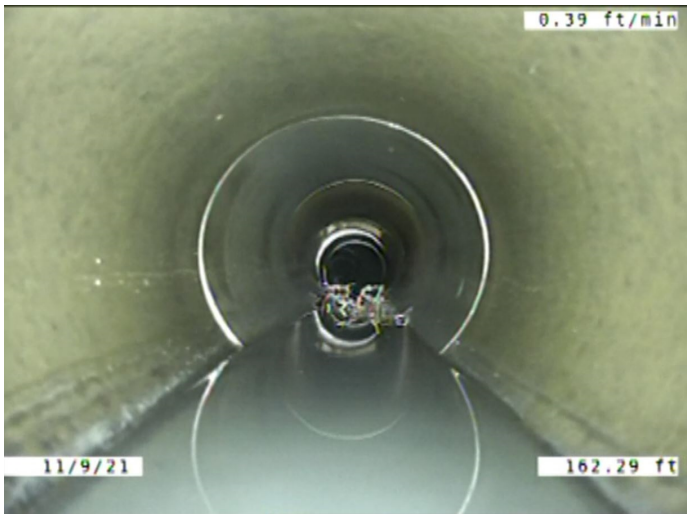
Code: **B**
 Description: **Broken**

Distance (ft): **162.3**
 Structural Grade: **4**
 O&M Grade: **0**
 Clock Start/From: **12**
 Clock To: **12**
 1st Value:
 2nd Value:
 Value Percent:
 Continuous Index: **F08**
 Within 8" of Joint: **YES**
 Remarks:

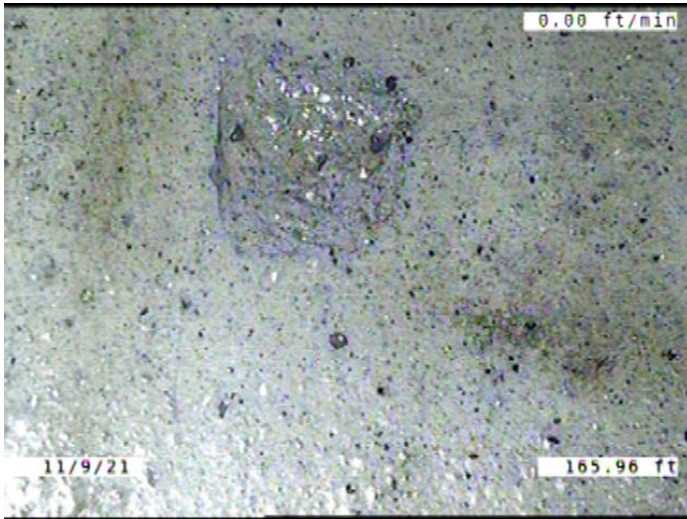
Code: **SSS**
Description: **Surface Damage Surface Spalling**

Distance (ft): **166.0**
Structural Grade: **2**
O&M Grade: **0**
Clock Start/From: **3**
Clock To:
1st Value:
2nd Value:
Value Percent:
Continuous Index:
Within 8" of Joint: **NO**
Remarks:

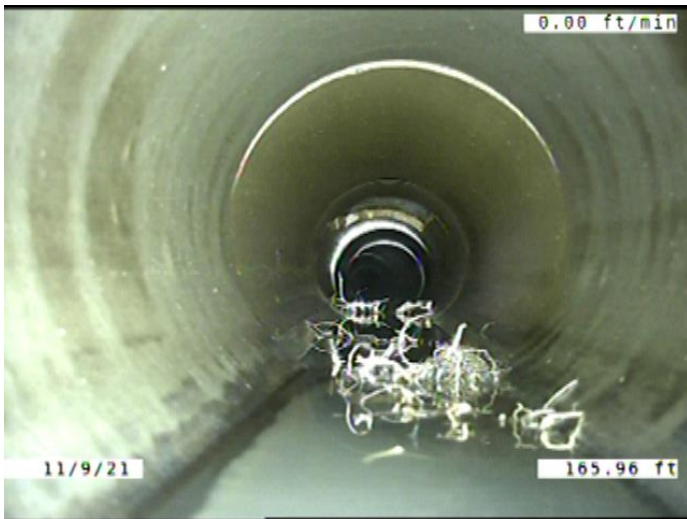
Code: **ISB**
Description: **Infiltration Stain Barrel**

Distance (ft): **166.0**
Structural Grade: **0**
O&M Grade: **1**
Clock Start/From: **7**
Clock To: **9**
1st Value:
2nd Value:
Value Percent:
Continuous Index: **F03**
Within 8" of Joint: **YES**
Remarks:

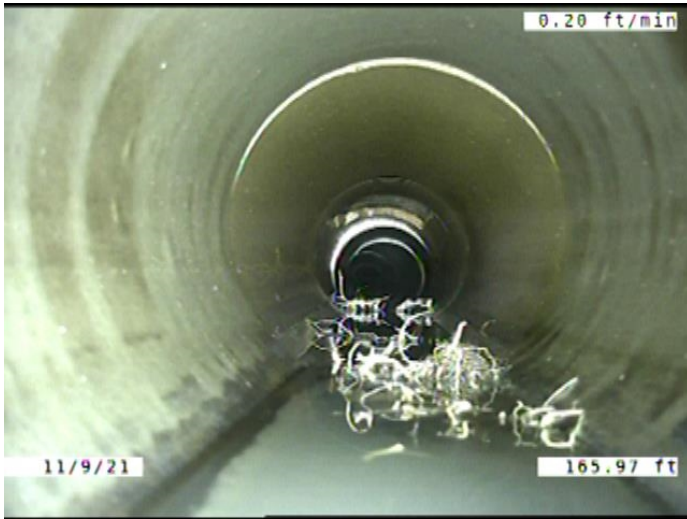
Code: **ISB**
Description: **Infiltration Stain Barrel**

Distance (ft): **166.0**
Structural Grade: **0**
O&M Grade: **1**
Clock Start/From: **3**
Clock To: **5**
1st Value:
2nd Value:
Value Percent:
Continuous Index: **F02**
Within 8" of Joint: **YES**
Remarks:

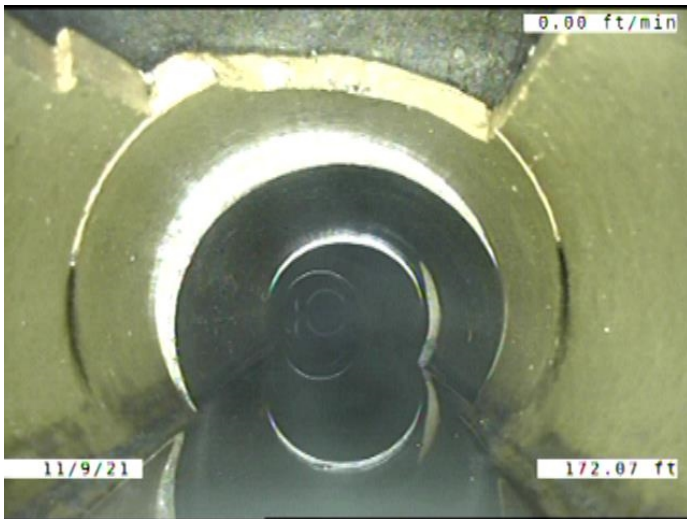
Code: **OBZ**
Description: **Obstruction Other**

Distance (ft): **172.1**
Structural Grade: **0**
O&M Grade: **2**
Clock Start/From: **5**
Clock To: **7**
1st Value:
2nd Value:
Value Percent: **5.000**
Continuous Index: **F07**
Within 8" of Joint: **YES**
Remarks: **ROOTS THAT HAVE BEEN CUT**
