Profile/Photo Observation Report

Date:	11/09/2021	Weather:		Coding:	PACP 7.0
Pipe Length (ft):	173.1	Owner:	City of Hobart	Pre Clean:	Heavy Cleaning
P.O.#:	YES502259	Surveyor:	Steven Bucklin	PSR:	P-604-111-107
Customer:	City of Hobart, IN (Red	Clean Date:	11/09/2021	Shape:	C

Street:	North Ash Street	Flow Control:	Not Controlled
City:	City of Hobart	Year Renewed:	
Location:	Local rural streets with light traffic, t	Tape/Media #:	
Purpose:	Routine Assessment	Dia/Height:	10"
Use:	Sanitary Sewage Pipe	Material:	VCP
Drain Area:		Lining:	None
Category:	NA		
Comment:			
Location Details:		Direction of Survey:	Upstream
US MH:	M-604-107	DS MH:	M-604-111
		Total Length Surveyed (ft):	173.1

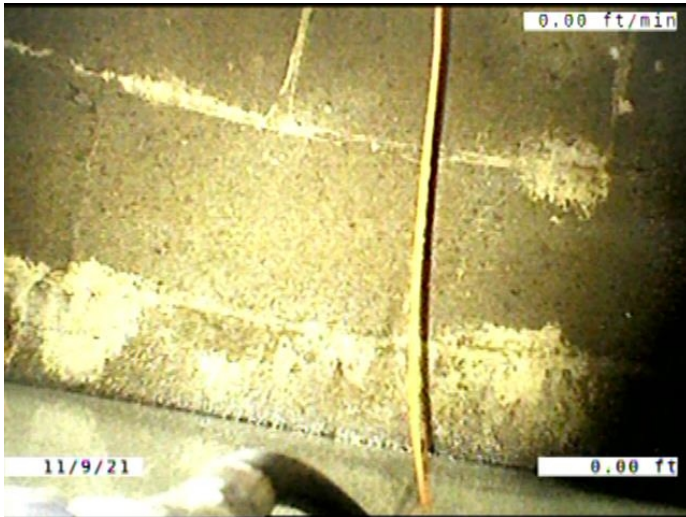
Code: **AMH**
 Description: **Manhole**

Distance (ft): **.0**
 Structural Grade: **0**
 O&M Grade: **0**
 Clock Start/From:
 Clock To:
 1st Value:
 2nd Value:
 Value Percent:
 Continuous Index:
 Within 8" of Joint: **NO**
 Remarks: **M-604-111**

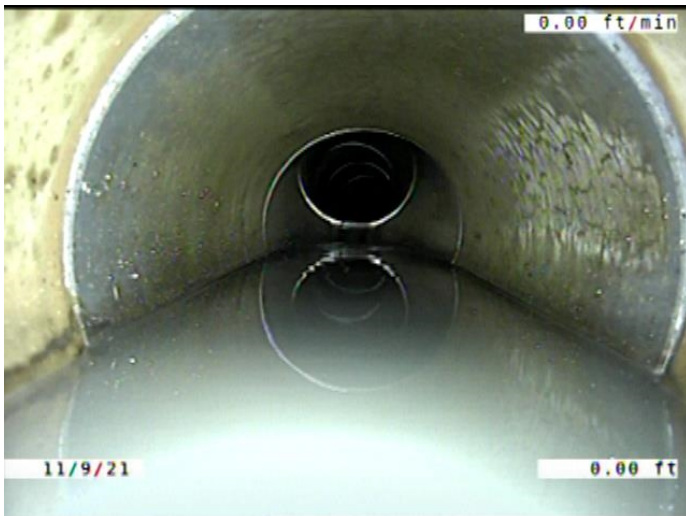
Code: **MWL**
 Description: **Miscellaneous Water Level**

Distance (ft): **.0**
 Structural Grade: **0**
 O&M Grade: **0**
 Clock Start/From:
 Clock To:
 1st Value:
 2nd Value:
 Value Percent: **10.000**
 Continuous Index:
 Within 8" of Joint: **NO**
 Remarks:

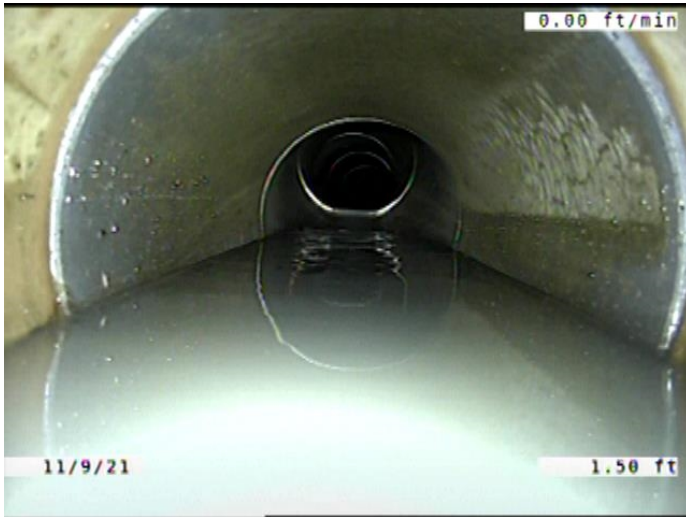
Code: **MGO**
 Description: **Miscellaneous General Observation**

Distance (ft): **1.5**
 Structural Grade: **0**
 O&M Grade: **0**
 Clock Start/From:
 Clock To:
 1st Value:
 2nd Value:
 Value Percent:
 Continuous Index:
 Within 8" of Joint: **NO**
 Remarks: **DROP INTO THE MANHOLE. HAD TO START IN THE PIPE.**

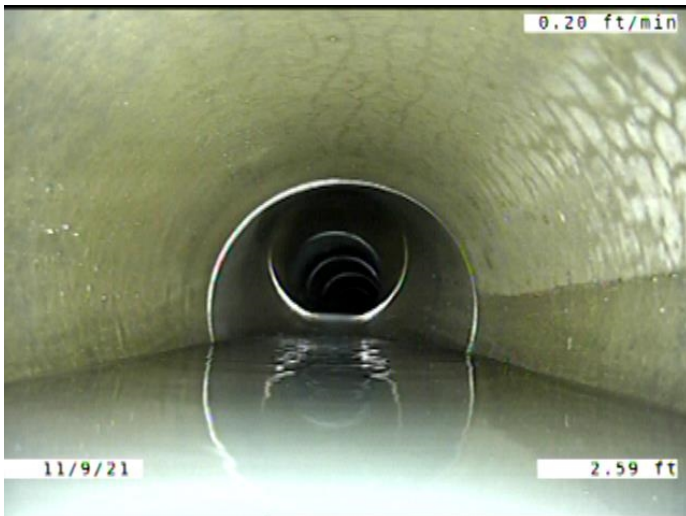
Code: **MWLS**
 Description: **Miscellaneous Water Level Sag**

Distance (ft): **2.6**
 Structural Grade: **2**
 O&M Grade: **0**
 Clock Start/From:
 Clock To:
 1st Value:
 2nd Value:
 Value Percent: **20.000**
 Continuous Index: **S01**
 Within 8" of Joint: **NO**
 Remarks:

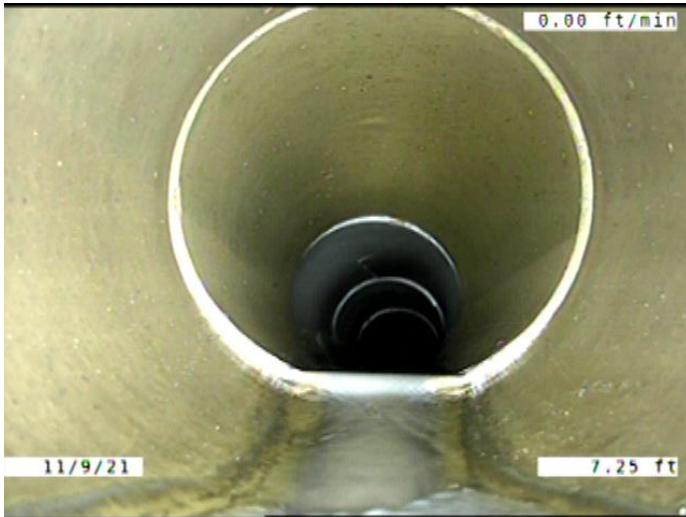
Code: **LU**
Description: **Line Up**

Distance (ft): **7.3**
Structural Grade: **0**
O&M Grade: **1**
Clock Start/From:
Clock To:
1st Value:
2nd Value:
Value Percent: **5.000**
Continuous Index:
Within 8" of Joint: **NO**
Remarks:

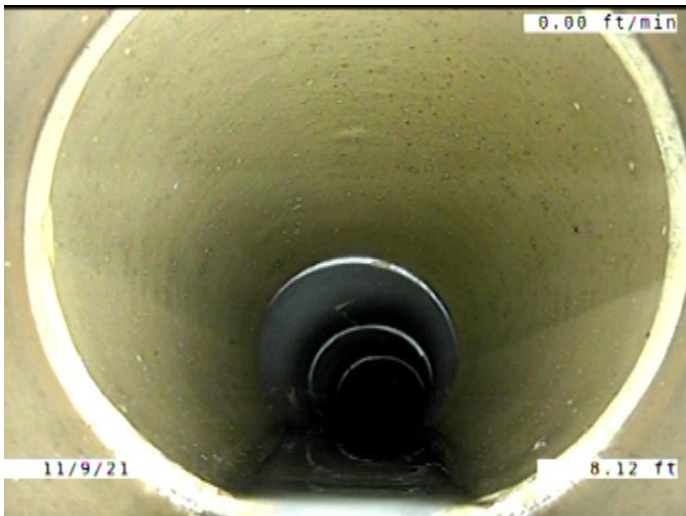
Code: **MWLS**
Description: **Miscellaneous Water Level Sag**

Distance (ft): **8.1**
Structural Grade: **2**
O&M Grade: **0**
Clock Start/From:
Clock To:
1st Value:
2nd Value:
Value Percent: **20.000**
Continuous Index: **F01**
Within 8" of Joint: **NO**
Remarks:

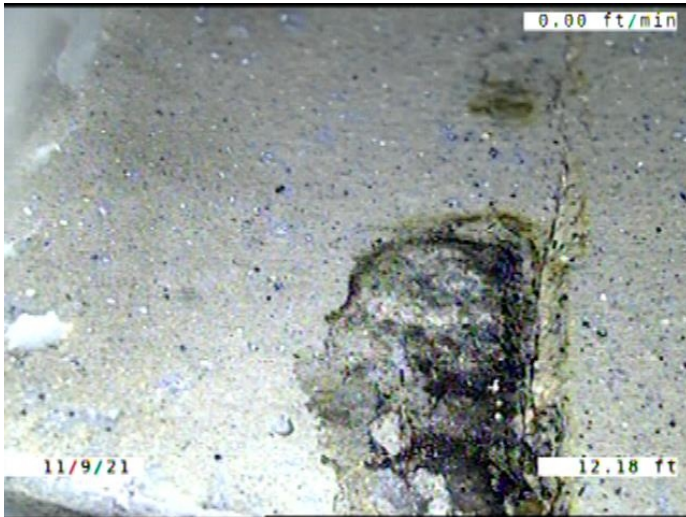
Code: **ISB**
Description: **Infiltration Stain Barrel**

Distance (ft): **12.2**
Structural Grade: **0**
O&M Grade: **1**
Clock Start/From: **3**
Clock To: **5**
1st Value:
2nd Value:
Value Percent:
Continuous Index: **S02**
Within 8" of Joint: **YES**
Remarks:

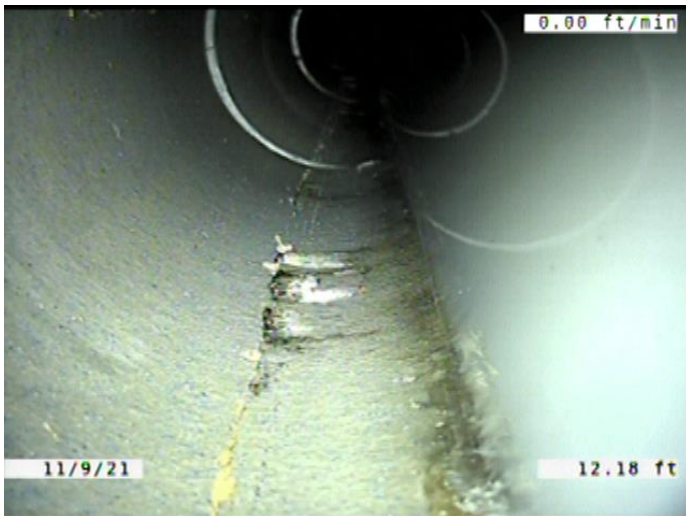
Code: **ISB**
Description: **Infiltration Stain Barrel**

Distance (ft): **12.2**
Structural Grade: **0**
O&M Grade: **1**
Clock Start/From: **7**
Clock To: **9**
1st Value:
2nd Value:
Value Percent:
Continuous Index: **S03**
Within 8" of Joint: **YES**
Remarks:

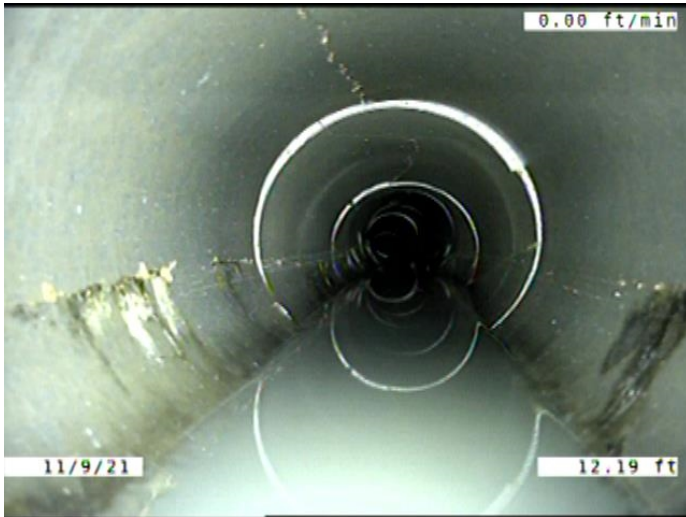
Code: **FM**
 Description: **Fracture Multiple**

Distance (ft): **12.2**
 Structural Grade: **4**
 O&M Grade: **0**
 Clock Start/From: **7**
 Clock To: **5**
 1st Value:
 2nd Value:
 Value Percent:
 Continuous Index: **S04**
 Within 8" of Joint: **YES**
 Remarks:

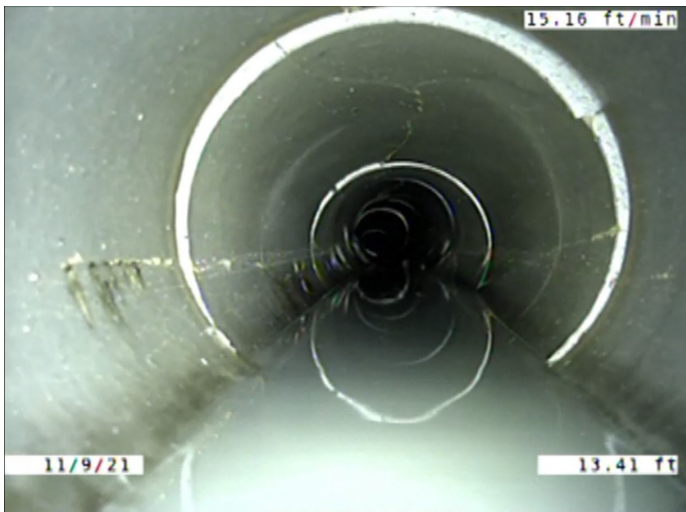
Code: **B**
 Description: **Broken**

Distance (ft): **13.4**
 Structural Grade: **4**
 O&M Grade: **0**
 Clock Start/From: **11**
 Clock To: **2**
 1st Value:
 2nd Value:
 Value Percent:
 Continuous Index:
 Within 8" of Joint: **YES**
 Remarks:

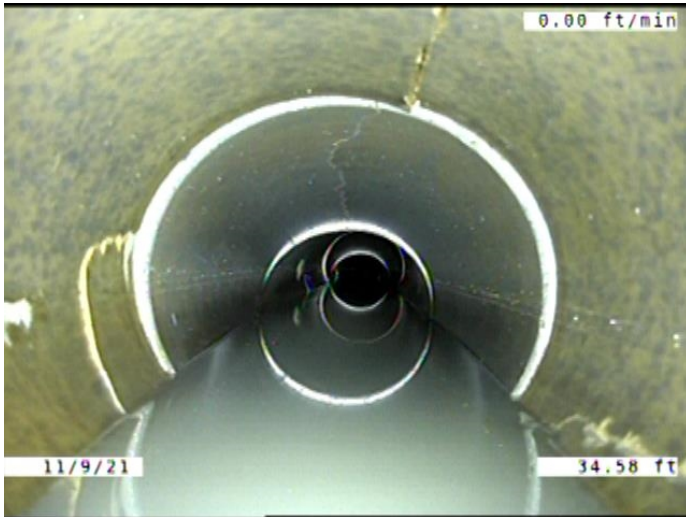
Code: **MWLS**
Description: **Miscellaneous Water Level Sag**

Distance (ft): **34.6**
Structural Grade: **2**
O&M Grade: **0**
Clock Start/From:
Clock To:
1st Value:
2nd Value:
Value Percent: **30.000**
Continuous Index: **S05**
Within 8" of Joint: **NO**
Remarks:

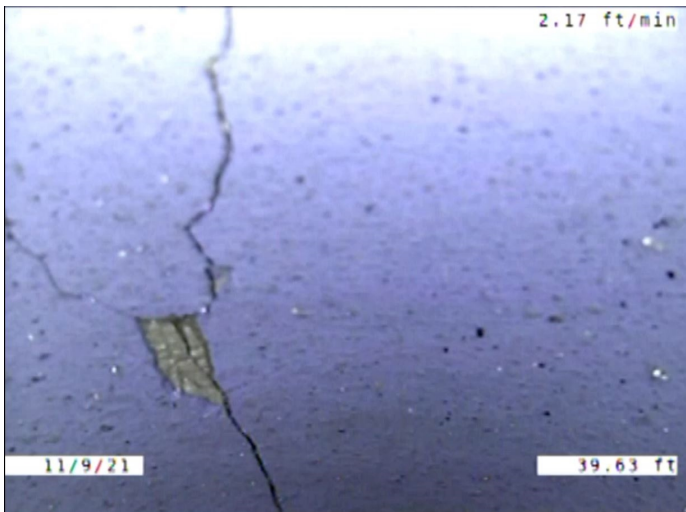
Code: **SSS**
Description: **Surface Damage Surface Spalling**

Distance (ft): **39.6**
Structural Grade: **2**
O&M Grade: **0**
Clock Start/From: **12**
Clock To:
1st Value:
2nd Value:
Value Percent:
Continuous Index:
Within 8" of Joint: **NO**
Remarks:

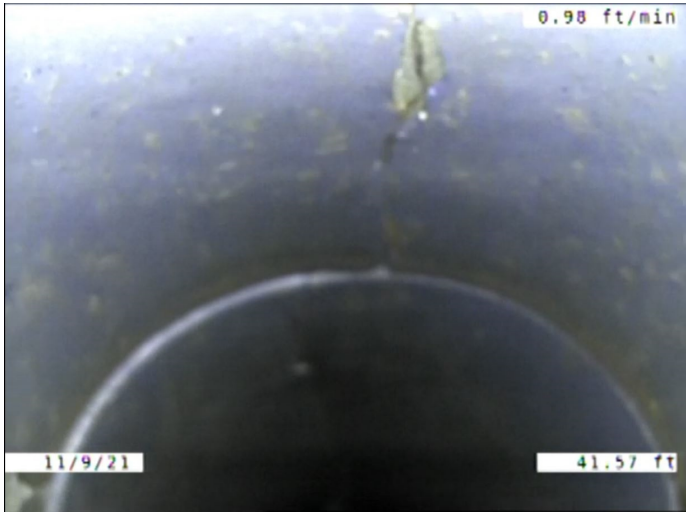
Code: **SSS**
Description: **Surface Damage Surface Spalling**

Distance (ft): **41.6**
Structural Grade: **2**
O&M Grade: **0**
Clock Start/From: **12**
Clock To:
1st Value:
2nd Value:
Value Percent:
Continuous Index:
Within 8" of Joint: **NO**
Remarks:

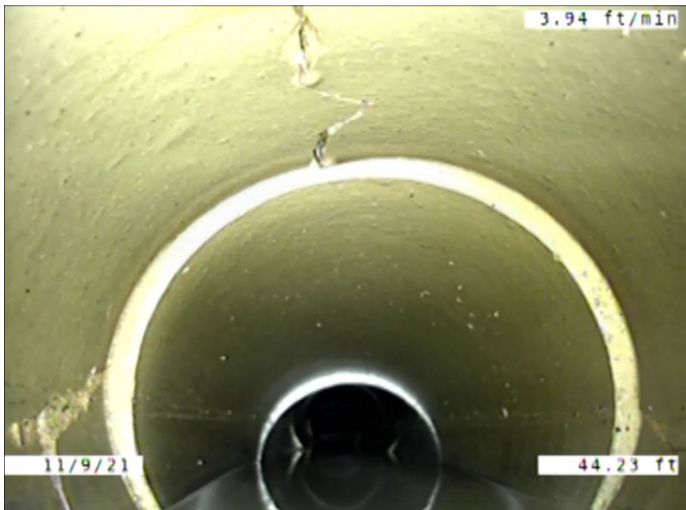
Code: **SSS**
Description: **Surface Damage Surface Spalling**

Distance (ft): **44.2**
Structural Grade: **2**
O&M Grade: **0**
Clock Start/From: **12**
Clock To:
1st Value:
2nd Value:
Value Percent:
Continuous Index:
Within 8" of Joint: **NO**
Remarks:

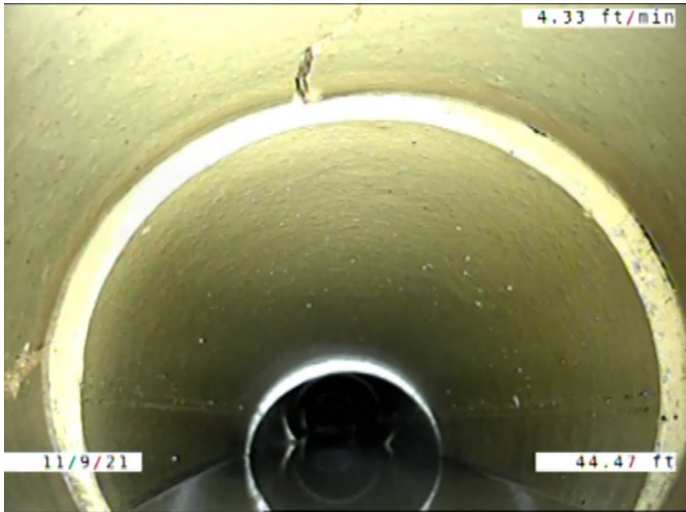
Code: **B**
Description: **Broken**

Distance (ft): **44.5**
Structural Grade: **4**
O&M Grade: **0**
Clock Start/From: **12**
Clock To:
1st Value:
2nd Value:
Value Percent:
Continuous Index:
Within 8" of Joint: **YES**
Remarks:

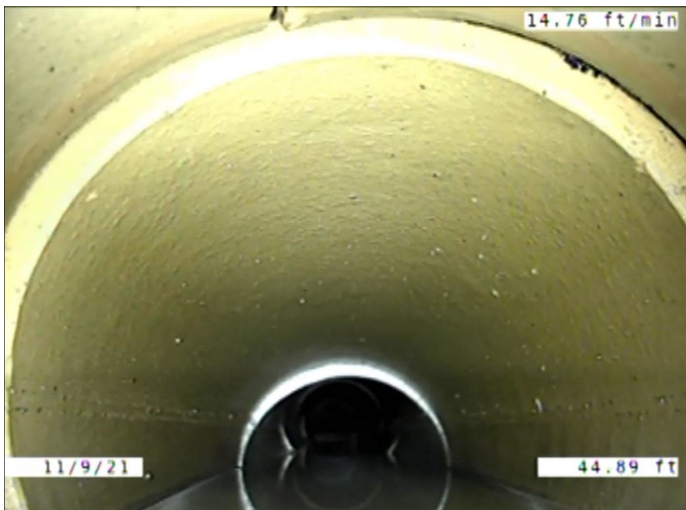
Code: **FM**
Description: **Fracture Multiple**

Distance (ft): **44.9**
Structural Grade: **4**
O&M Grade: **0**
Clock Start/From: **7**
Clock To: **5**
1st Value:
2nd Value:
Value Percent:
Continuous Index: **F04**
Within 8" of Joint: **YES**
Remarks:

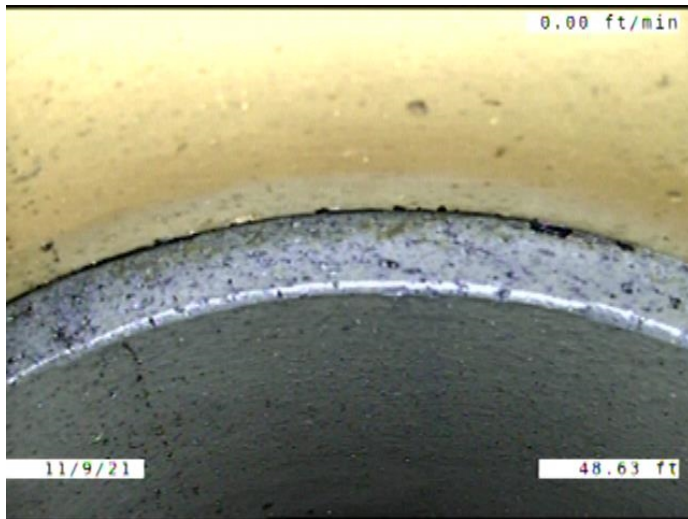
Code: **JOM**
 Description: **Joint Offset Medium**

Distance (ft): **48.6**
 Structural Grade: **3**
 O&M Grade: **0**
 Clock Start/From:
 Clock To:
 1st Value:
 2nd Value:
 Value Percent:
 Continuous Index:
 Within 8" of Joint: **NO**
 Remarks:

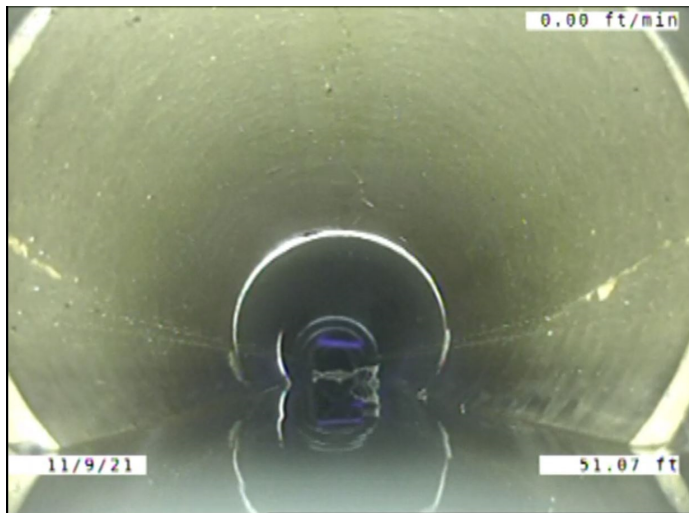
Code: **CM**
 Description: **Crack Multiple**

Distance (ft): **51.1**
 Structural Grade: **3**
 O&M Grade: **0**
 Clock Start/From: **8**
 Clock To: **4**
 1st Value:
 2nd Value:
 Value Percent:
 Continuous Index:
 Within 8" of Joint: **YES**
 Remarks:

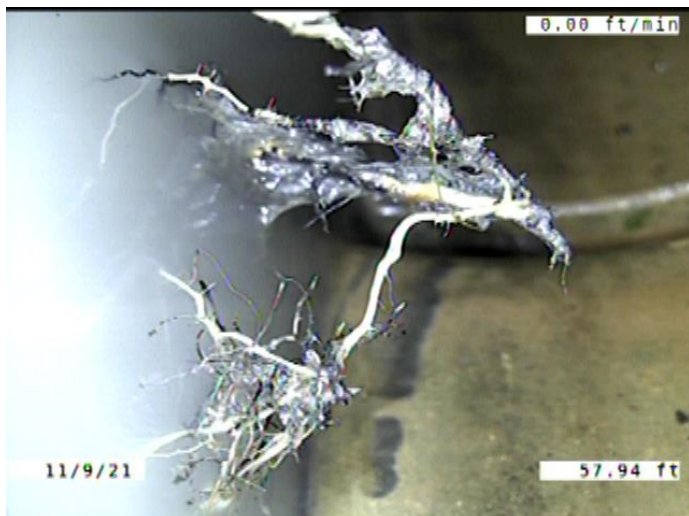
Code: **OBZ**
 Description: **Obstruction Other**

Distance (ft): **57.9**
 Structural Grade: **0**
 O&M Grade: **2**
 Clock Start/From: **5**
 Clock To: **6**
 1st Value:
 2nd Value:
 Value Percent: **5.000**
 Continuous Index:
 Within 8" of Joint: **YES**
 Remarks: **ROOTS THAT HAVE BEEN CUT**

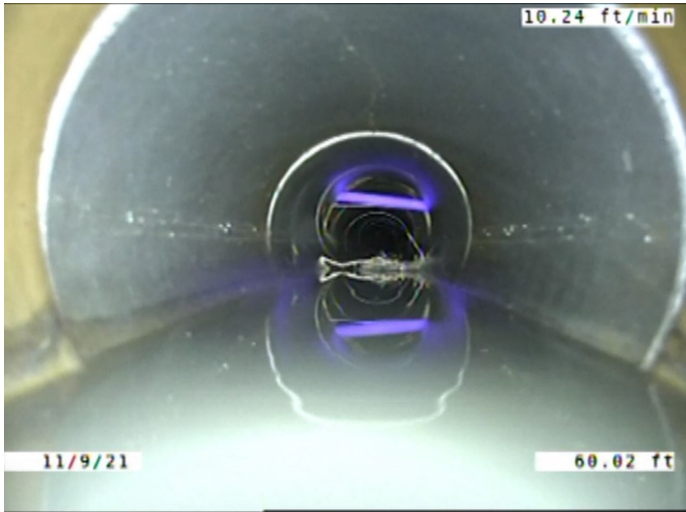
Code: **CS**
Description: **Crack Spiral**

Distance (ft): **60.0**
Structural Grade: **2**
O&M Grade: **0**
Clock Start/From: **11**
Clock To: **12**
1st Value:
2nd Value:
Value Percent:
Continuous Index:
Within 8" of Joint: **YES**
Remarks:

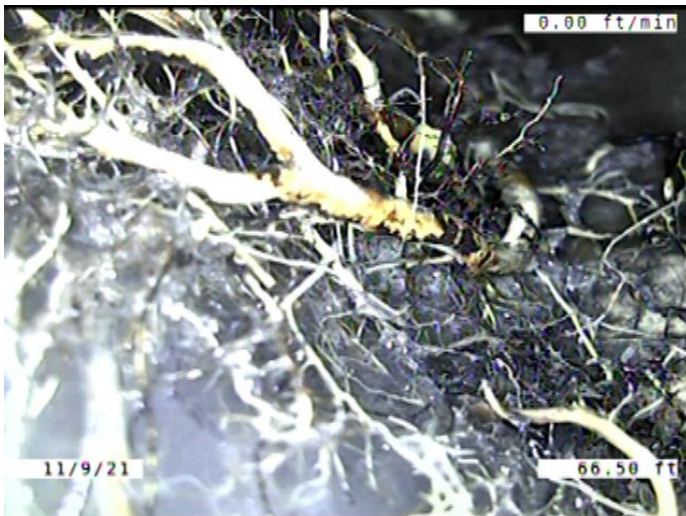
Code: **OBZ**
Description: **Obstruction Other**

Distance (ft): **66.5**
Structural Grade: **0**
O&M Grade: **2**
Clock Start/From: **4**
Clock To: **8**
1st Value:
2nd Value:
Value Percent: **5.000**
Continuous Index:
Within 8" of Joint: **YES**
Remarks: **ROOTS THAT HAVE BEEN CUT**

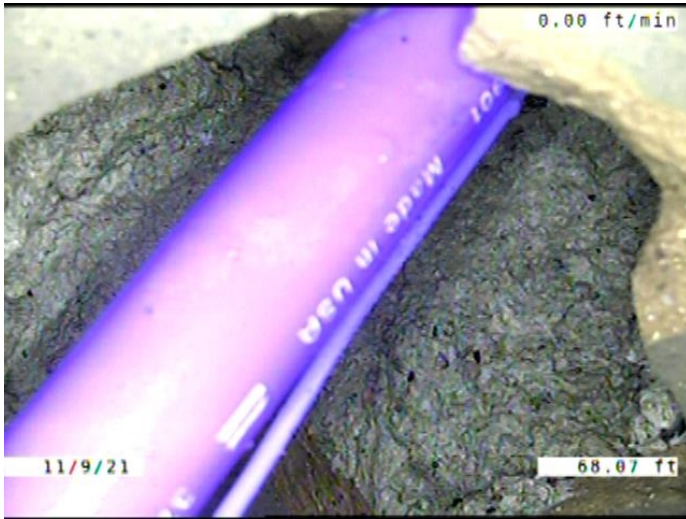
Code: HSV
 Description: Hole Soil Visible

Distance (ft): 68.1
 Structural Grade: 5
 O&M Grade: 0
 Clock Start/From: 1
 Clock To: 3
 1st Value:
 2nd Value:
 Value Percent:
 Continuous Index:
 Within 8" of Joint: YES
 Remarks:

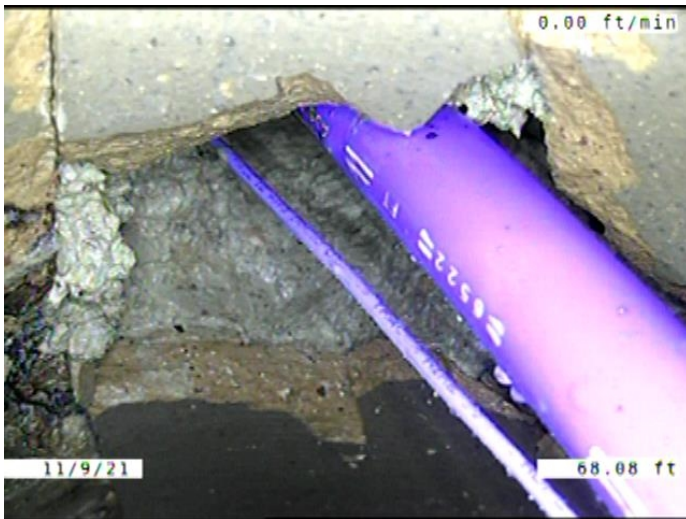
Code: HSV
 Description: Hole Soil Visible

Distance (ft): 68.1
 Structural Grade: 5
 O&M Grade: 0
 Clock Start/From: 10
 Clock To: 11
 1st Value:
 2nd Value:
 Value Percent:
 Continuous Index:
 Within 8" of Joint: YES
 Remarks:

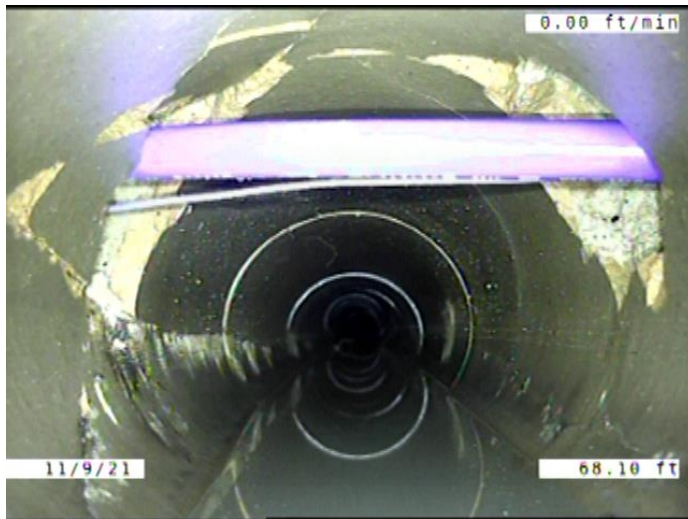
Code: **OBP**
 Description: **Obstruction External Pipe or Cable**

Distance (ft): **68.1**
 Structural Grade: **0**
 O&M Grade: **2**
 Clock Start/From: **10**
 Clock To: **2**
 1st Value:
 2nd Value:
 Value Percent: **10.000**
 Continuous Index:
 Within 8" of Joint: **YES**
 Remarks:

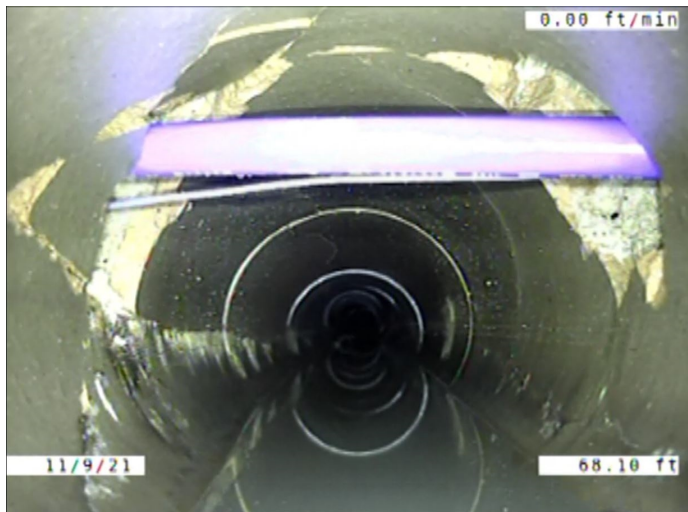
Code: **B**
 Description: **Broken**

Distance (ft): **68.1**
 Structural Grade: **4**
 O&M Grade: **0**
 Clock Start/From: **8**
 Clock To: **4**
 1st Value:
 2nd Value:
 Value Percent:
 Continuous Index:
 Within 8" of Joint: **NO**
 Remarks:

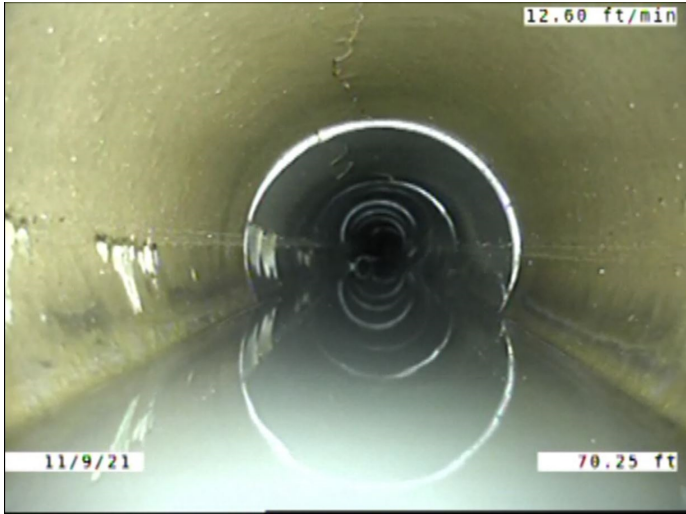
Code: **FM**
Description: **Fracture Multiple**

Distance (ft): **70.3**
Structural Grade: **4**
O&M Grade: **0**
Clock Start/From: **8**
Clock To: **4**
1st Value:
2nd Value:
Value Percent:
Continuous Index: **S09**
Within 8" of Joint: **YES**
Remarks:

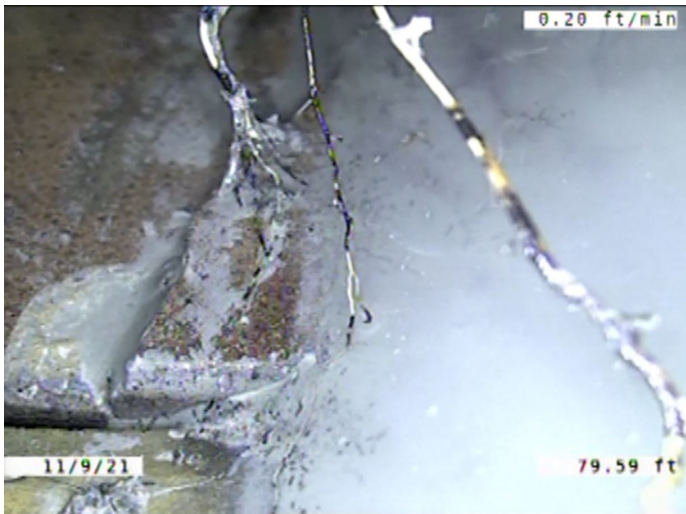
Code: **B**
Description: **Broken**

Distance (ft): **79.6**
Structural Grade: **4**
O&M Grade: **0**
Clock Start/From: **8**
Clock To:
1st Value:
2nd Value:
Value Percent:
Continuous Index:
Within 8" of Joint: **YES**
Remarks:

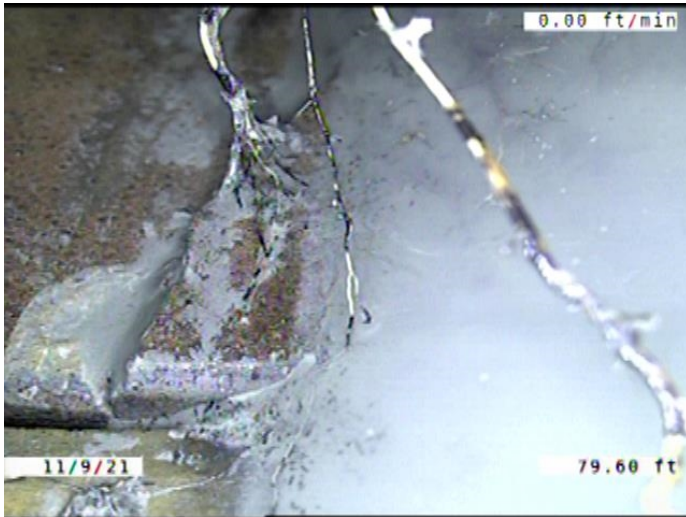
Code: **OBZ**
 Description: **Obstruction Other**

Distance (ft): **79.6**
 Structural Grade: **0**
 O&M Grade: **2**
 Clock Start/From: **6**
 Clock To: **7**
 1st Value:
 2nd Value:
 Value Percent: **5.000**
 Continuous Index:
 Within 8" of Joint: **YES**
 Remarks: **ROOTS THAT HAVE BEEN CUT**

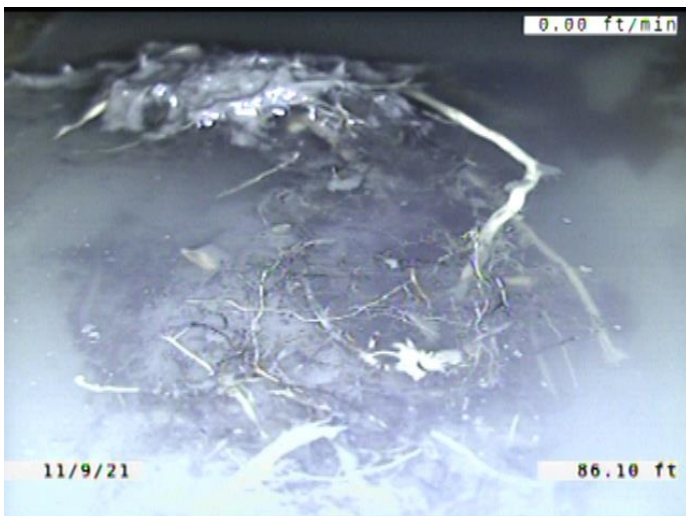
Code: **OBZ**
 Description: **Obstruction Other**

Distance (ft): **86.1**
 Structural Grade: **0**
 O&M Grade: **2**
 Clock Start/From: **6**
 Clock To: **7**
 1st Value:
 2nd Value:
 Value Percent: **5.000**
 Continuous Index:
 Within 8" of Joint: **YES**
 Remarks: **ROOTS THAT HAVE BEEN CUT**

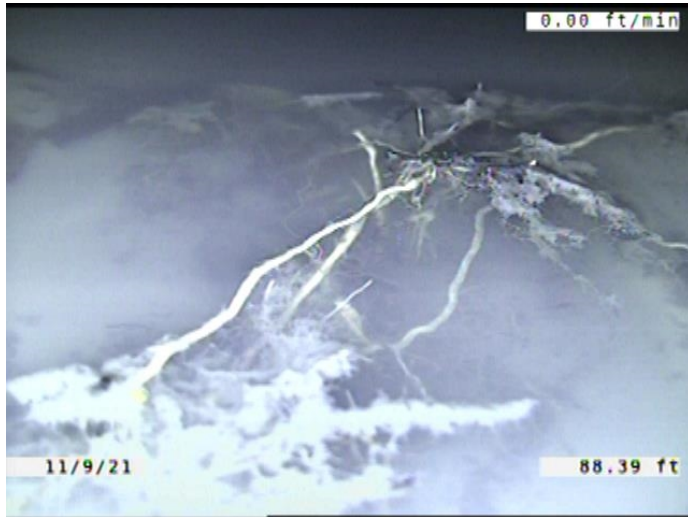
Code:	OBZ
Description:	Obstruction Other
Distance (ft):	88.4
Structural Grade:	0
O&M Grade:	2
Clock Start/From:	6
Clock To:	7
1st Value:	
2nd Value:	
Value Percent:	5.000
Continuous Index:	
Within 8" of Joint:	YES
Remarks:	ROOTS THAT HAVE BEEN CUT

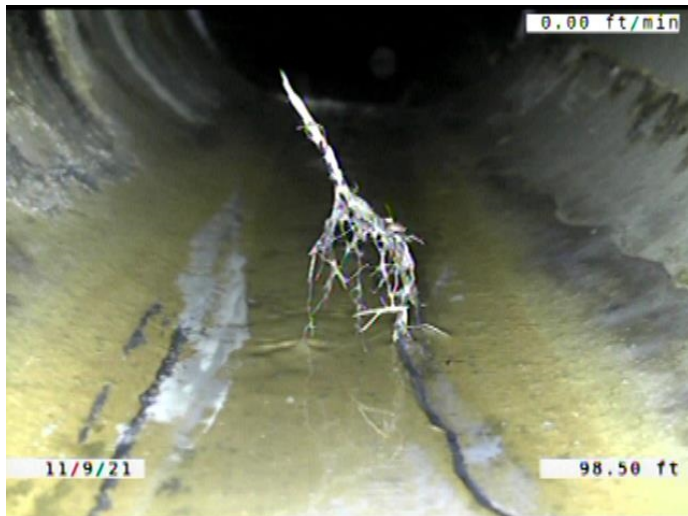
Code:	OBZ
Description:	Obstruction Other
Distance (ft):	98.5
Structural Grade:	0
O&M Grade:	2
Clock Start/From:	6
Clock To:	
1st Value:	
2nd Value:	
Value Percent:	5.000
Continuous Index:	
Within 8" of Joint:	YES
Remarks:	ROOTS THAT HAVE BEEN CUT

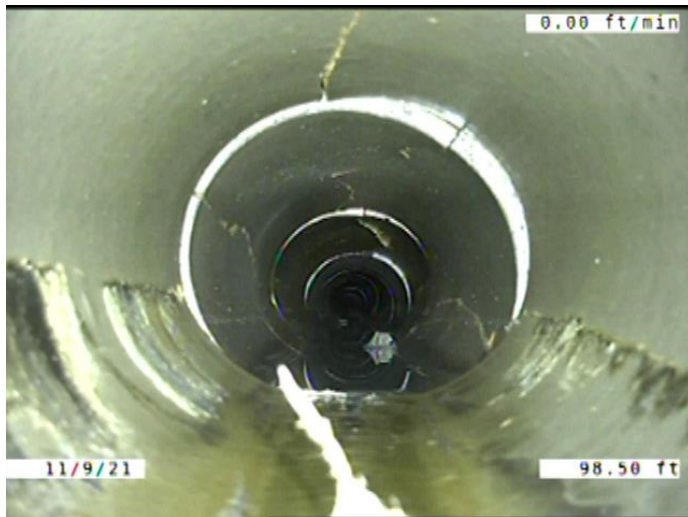
Code: **MWLS**
 Description: **Miscellaneous Water Level Sag**

Distance (ft): **98.5**
 Structural Grade: **2**
 O&M Grade: **0**
 Clock Start/From:
 Clock To:
 1st Value:
 2nd Value:
 Value Percent: **30.000**
 Continuous Index: **F05**
 Within 8" of Joint: **NO**
 Remarks:

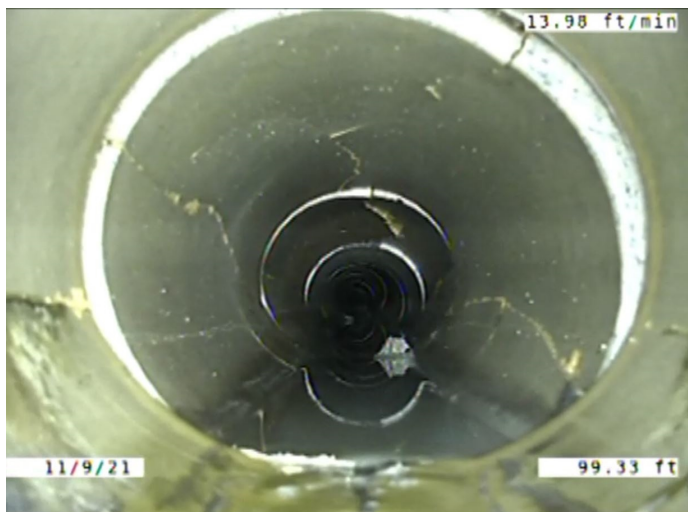
Code: **B**
 Description: **Broken**

Distance (ft): **99.3**
 Structural Grade: **4**
 O&M Grade: **0**
 Clock Start/From: **1**
 Clock To: **2**
 1st Value:
 2nd Value:
 Value Percent:
 Continuous Index: **S10**
 Within 8" of Joint: **YES**
 Remarks:

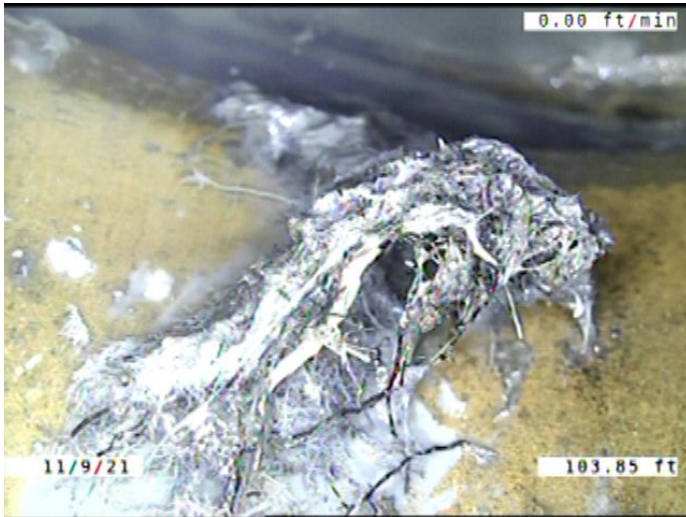
Code: **OBZ**
 Description: **Obstruction Other**

Distance (ft): **103.8**
 Structural Grade: **0**
 O&M Grade: **2**
 Clock Start/From: **5**
 Clock To: **6**
 1st Value:
 2nd Value:
 Value Percent: **5.000**
 Continuous Index:
 Within 8" of Joint: **YES**
 Remarks: **ROOTS THAT HAVE BEEN CUT**

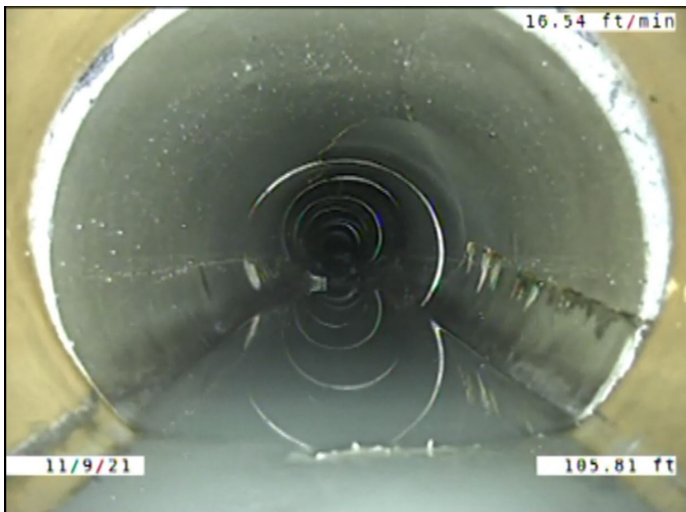
Code: **B**
 Description: **Broken**

Distance (ft): **105.8**
 Structural Grade: **4**
 O&M Grade: **0**
 Clock Start/From: **1**
 Clock To: **2**
 1st Value:
 2nd Value:
 Value Percent:
 Continuous Index: **F10**
 Within 8" of Joint: **YES**
 Remarks:

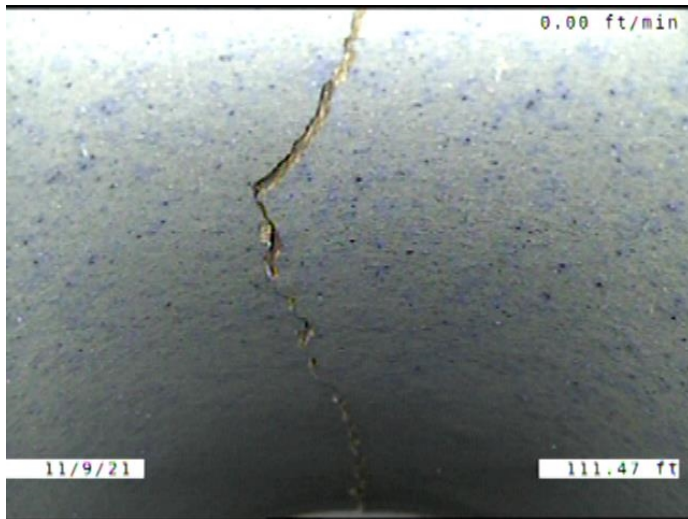
Code: **DR**
Description: **Deformed Rigid**

Distance (ft): **111.5**
Structural Grade: **4**
O&M Grade: **0**
Clock Start/From:
Clock To:
1st Value:
2nd Value:
Value Percent: **5.000**
Continuous Index:
Within 8" of Joint: **NO**
Remarks:

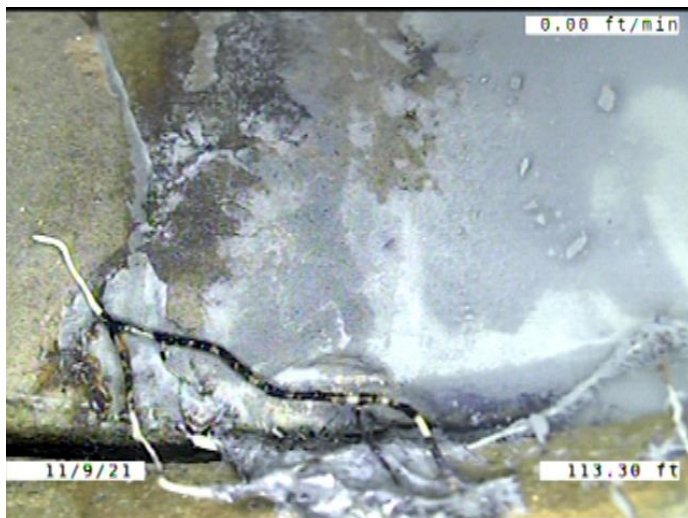
Code: **OBZ**
Description: **Obstruction Other**

Distance (ft): **113.3**
Structural Grade: **0**
O&M Grade: **2**
Clock Start/From: **7**
Clock To:
1st Value:
2nd Value:
Value Percent: **5.000**
Continuous Index:
Within 8" of Joint: **YES**
Remarks: **ROOTS THAT HAVE BEEN CUT**

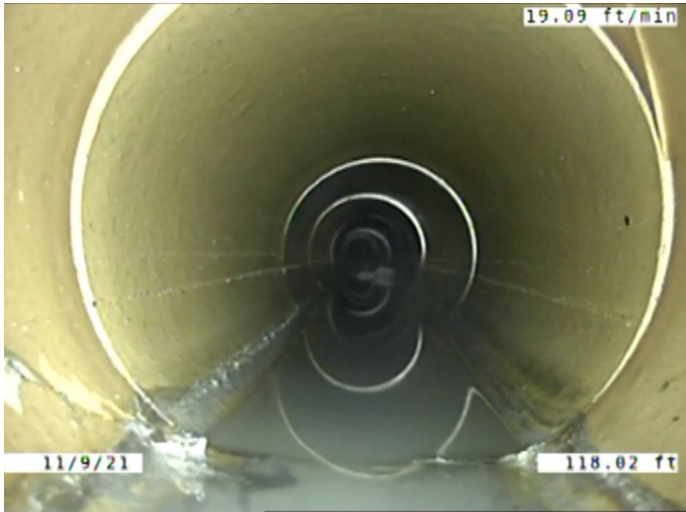
Code: **FM**
Description: **Fracture Multiple**

Distance (ft): **118.0**
Structural Grade: **4**
O&M Grade: **0**
Clock Start/From: **8**
Clock To: **4**
1st Value:
2nd Value:
Value Percent:
Continuous Index: **F09**
Within 8" of Joint: **YES**
Remarks:

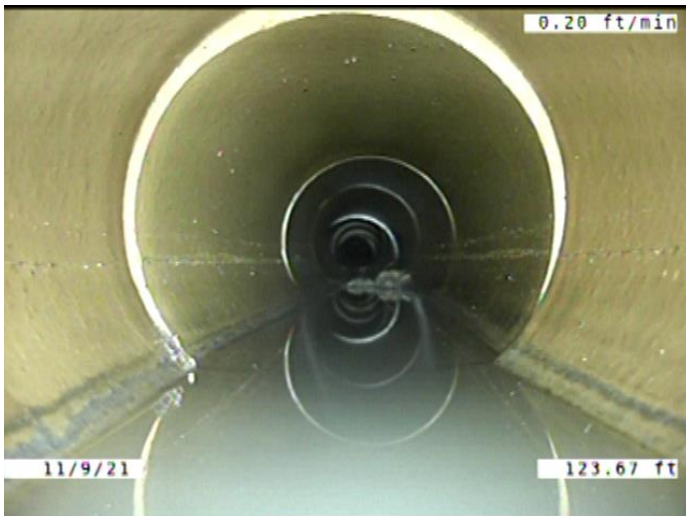
Code: **MWLS**
Description: **Miscellaneous Water Level Sag**

Distance (ft): **123.7**
Structural Grade: **2**
O&M Grade: **0**
Clock Start/From:
Clock To:
1st Value:
2nd Value:
Value Percent: **10.000**
Continuous Index: **S06**
Within 8" of Joint: **NO**
Remarks:

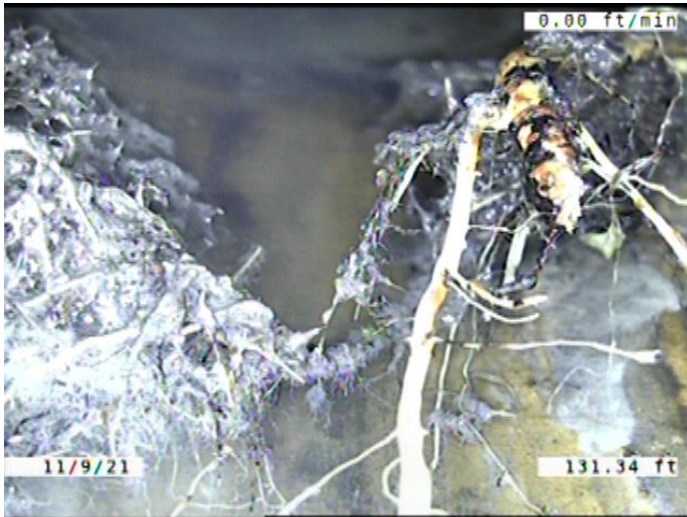
Code: **OBZ**
 Description: **Obstruction Other**

Distance (ft): **131.3**
 Structural Grade: **0**
 O&M Grade: **2**
 Clock Start/From: **5**
 Clock To: **7**
 1st Value:
 2nd Value:
 Value Percent: **5.000**
 Continuous Index:
 Within 8" of Joint: **YES**
 Remarks: **ROOTS THAT HAVE BEEN CUT**

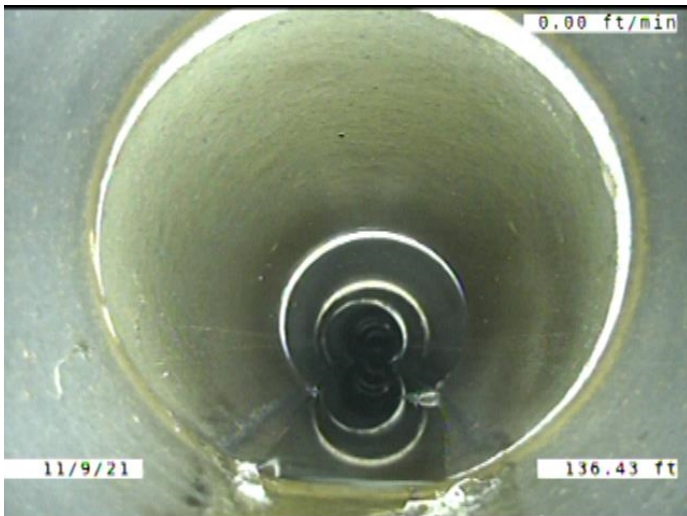
Code: **MWLS**
 Description: **Miscellaneous Water Level Sag**

Distance (ft): **136.4**
 Structural Grade: **2**
 O&M Grade: **0**
 Clock Start/From:
 Clock To:
 1st Value:
 2nd Value:
 Value Percent: **10.000**
 Continuous Index: **F06**
 Within 8" of Joint: **NO**
 Remarks:

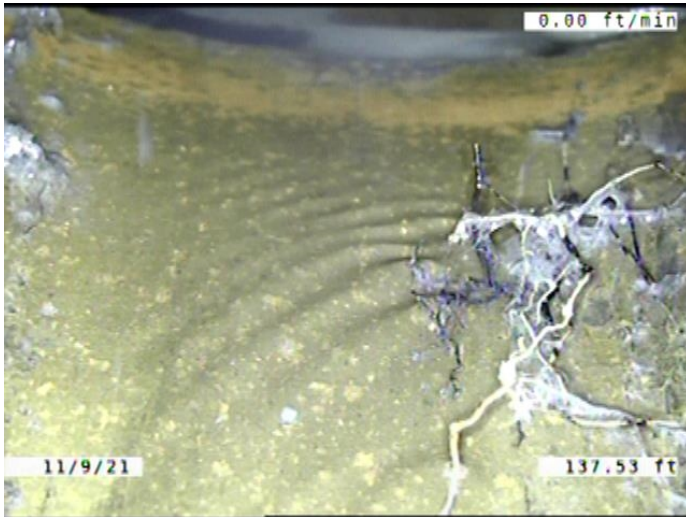
Code: **OBZ**
 Description: **Obstruction Other**

Distance (ft): **137.5**
 Structural Grade: **0**
 O&M Grade: **2**
 Clock Start/From: **5**
 Clock To: **7**
 1st Value:
 2nd Value:
 Value Percent: **5.000**
 Continuous Index: **S07**
 Within 8" of Joint: **YES**
 Remarks: **ROOTS THAT HAVE BEEN CUT**

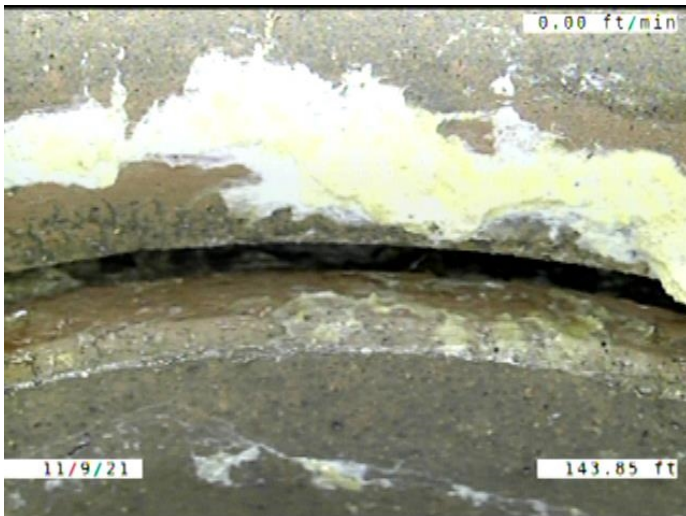
Code: **DAE**
 Description: **Deposits Attached Encrustation**

Distance (ft): **143.8**
 Structural Grade: **0**
 O&M Grade: **2**
 Clock Start/From: **8**
 Clock To: **4**
 1st Value:
 2nd Value:
 Value Percent: **5.000**
 Continuous Index:
 Within 8" of Joint: **YES**
 Remarks:

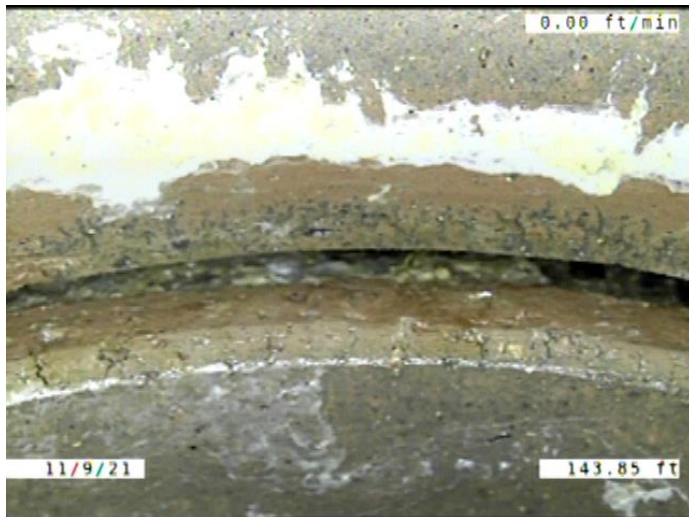
Code: **JOSD**
 Description: **Joint Offset Small Defective**

Distance (ft): **143.8**
 Structural Grade: **0**
 O&M Grade: **0**
 Clock Start/From:
 Clock To:
 1st Value:
 2nd Value:
 Value Percent:
 Continuous Index:
 Within 8" of Joint: **NO**
 Remarks: **SOIL VISIBLE**

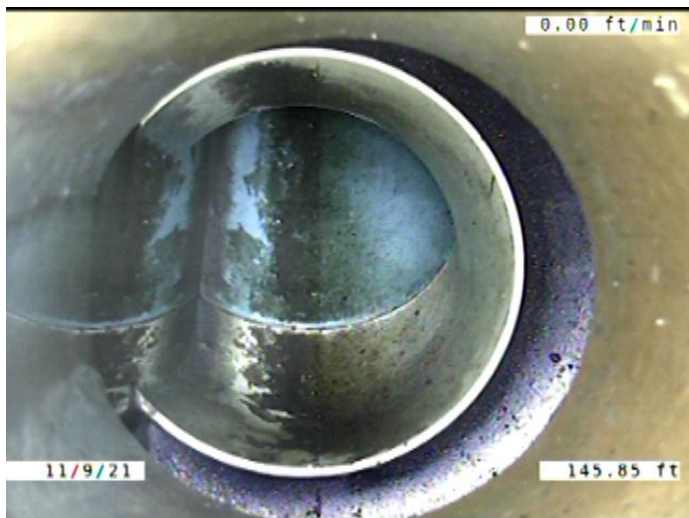
Code: **TF**
 Description: **Tap Factory**

Distance (ft): **145.8**
 Structural Grade: **0**
 O&M Grade: **0**
 Clock Start/From: **9**
 Clock To:
 1st Value: **6.000**
 2nd Value:
 Value Percent:
 Continuous Index:
 Within 8" of Joint: **YES**
 Remarks:

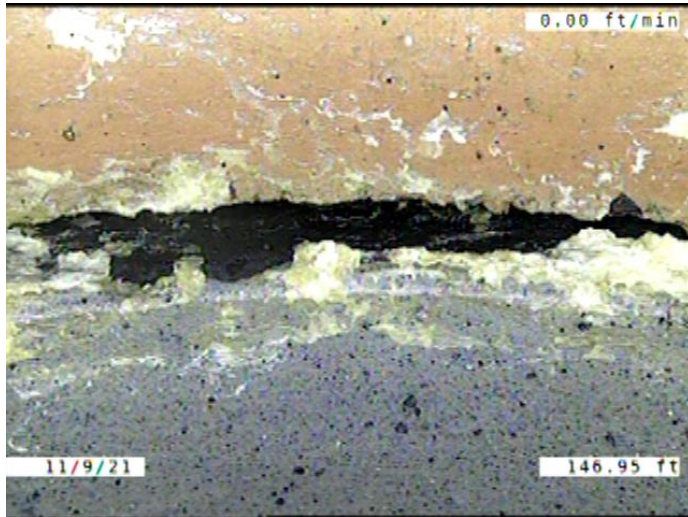
Code: **DAE**
 Description: **Deposits Attached Encrustation**

Distance (ft): **146.9**
 Structural Grade: **0**
 O&M Grade: **2**
 Clock Start/From: **8**
 Clock To: **4**
 1st Value:
 2nd Value:
 Value Percent: **5.000**
 Continuous Index:
 Within 8" of Joint: **YES**
 Remarks:

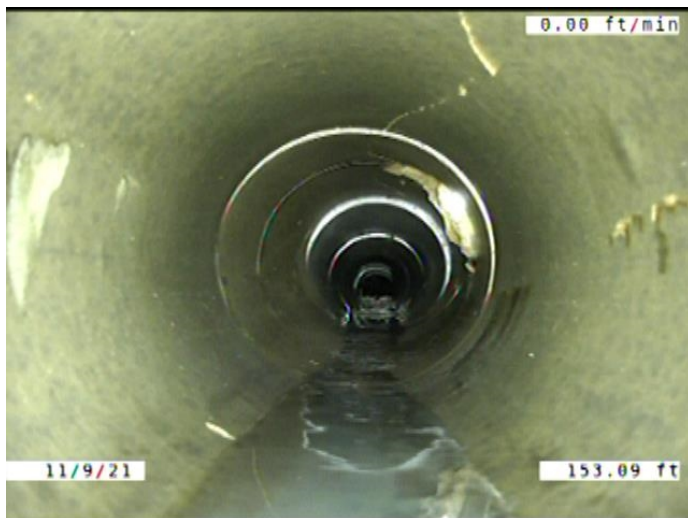
Code: **B**
 Description: **Broken**

Distance (ft): **153.1**
 Structural Grade: **4**
 O&M Grade: **0**
 Clock Start/From: **12**
 Clock To: **12**
 1st Value:
 2nd Value:
 Value Percent:
 Continuous Index: **S08**
 Within 8" of Joint: **YES**
 Remarks:

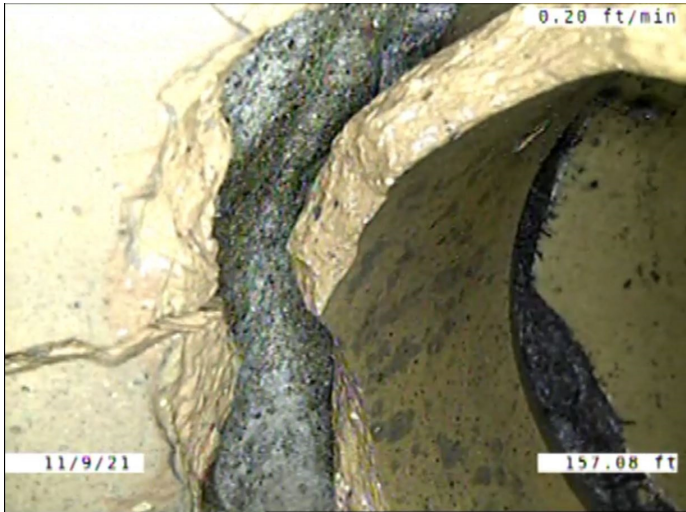
Code: **SSS**
Description: **Surface Damage Surface Spalling**

Distance (ft): **157.1**
Structural Grade: **2**
O&M Grade: **0**
Clock Start/From: **1**
Clock To: **3**
1st Value:
2nd Value:
Value Percent:
Continuous Index:
Within 8" of Joint: **NO**
Remarks:

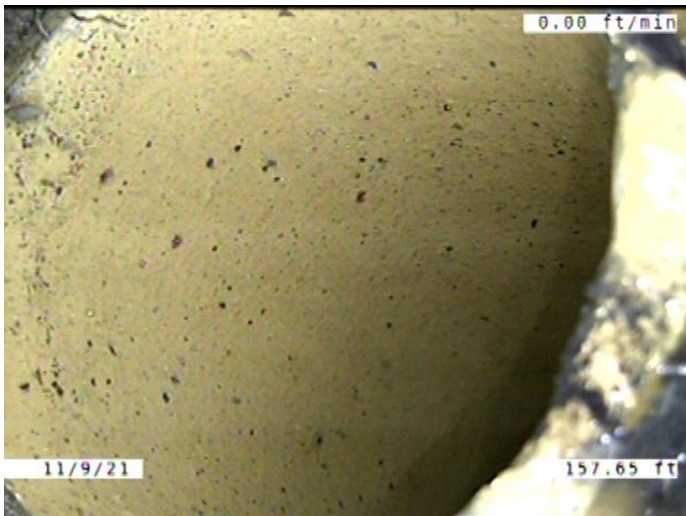
Code: **TBI**
Description: **Tap Break-in Intruding**

Distance (ft): **157.7**
Structural Grade: **0**
O&M Grade: **2**
Clock Start/From: **2**
Clock To:
1st Value: **4.000**
2nd Value: **1.000**
Value Percent:
Continuous Index:
Within 8" of Joint: **YES**
Remarks: **CONSTANTLY RUNNING WATER.**

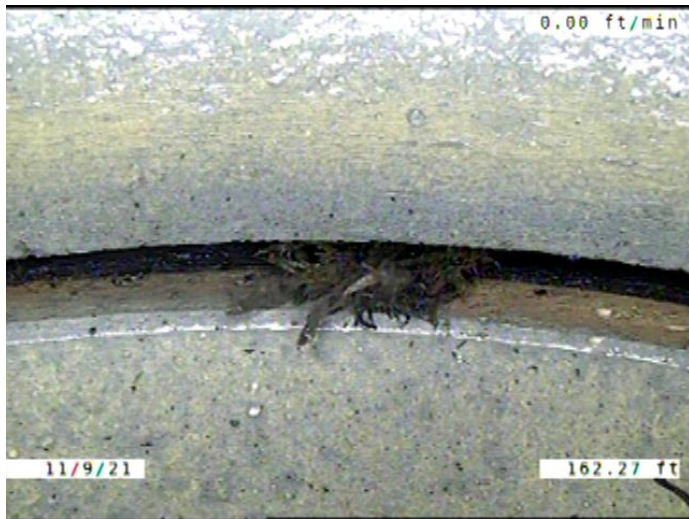
Code: **RFJ**
Description: **Roots Fine Joint**

Distance (ft): **162.3**
Structural Grade: **0**
O&M Grade: **1**
Clock Start/From: **12**
Clock To: **1**
1st Value:
2nd Value:
Value Percent:
Continuous Index:
Within 8" of Joint: **YES**
Remarks:

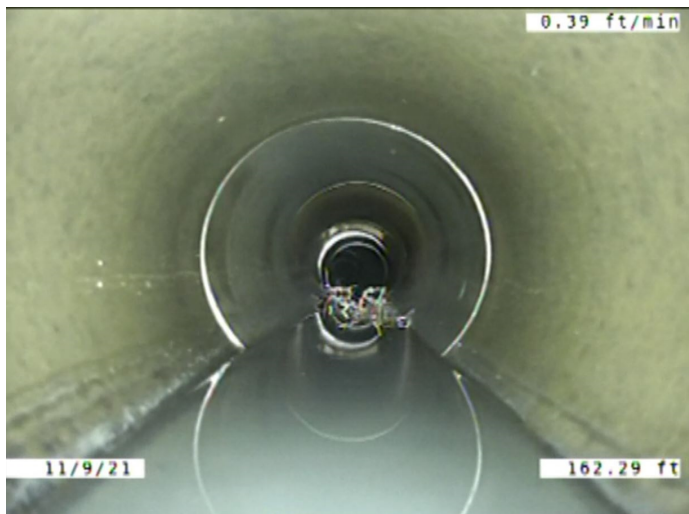
Code: **B**
Description: **Broken**

Distance (ft): **162.3**
Structural Grade: **4**
O&M Grade: **0**
Clock Start/From: **12**
Clock To: **12**
1st Value:
2nd Value:
Value Percent:
Continuous Index: **F08**
Within 8" of Joint: **YES**
Remarks:

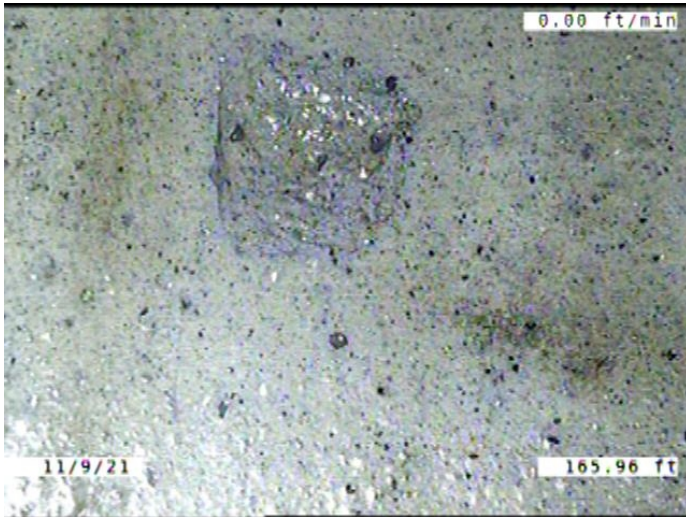
Code: **SSS**
Description: **Surface Damage Surface Spalling**

Distance (ft): **166.0**
Structural Grade: **2**
O&M Grade: **0**
Clock Start/From: **3**
Clock To:
1st Value:
2nd Value:
Value Percent:
Continuous Index:
Within 8" of Joint: **NO**
Remarks:

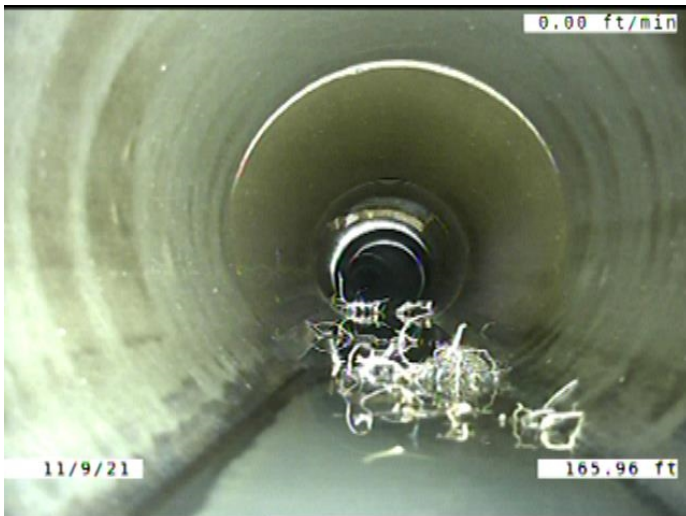
Code: **ISB**
Description: **Infiltration Stain Barrel**

Distance (ft): **166.0**
Structural Grade: **0**
O&M Grade: **1**
Clock Start/From: **7**
Clock To: **9**
1st Value:
2nd Value:
Value Percent:
Continuous Index: **F03**
Within 8" of Joint: **YES**
Remarks:
