Profile/Photo Observation Report

Date:	11/09/2021	Weather:		Coding:	PACP 7.0
Pipe Length (ft):	173.1	Owner:	City of Hobart	Pre Clean:	Heavy Cleaning
P.O.#:	YES502259	Surveyor:	Steven Bucklin	PSR:	P-604-111-107
Customer:	City of Hobart, IN (Red	Clean Date:	11/09/2021	Shape:	C

Street:	North Ash Street	Flow Control:	Not Controlled
City:	City of Hobart	Year Renewed:	
Location:	Local rural streets with light traffic, t	Tape/Media #:	
Purpose:	Routine Assessment	Dia/Height:	10"
Use:	Sanitary Sewage Pipe	Material:	VCP
Drain Area:		Lining:	None
Category:	NA		
Comment:			
Location Details:		Direction of Survey:	Upstream
US MH:	M-604-107	DS MH:	M-604-111
		Total Length Surveyed (ft):	173.1

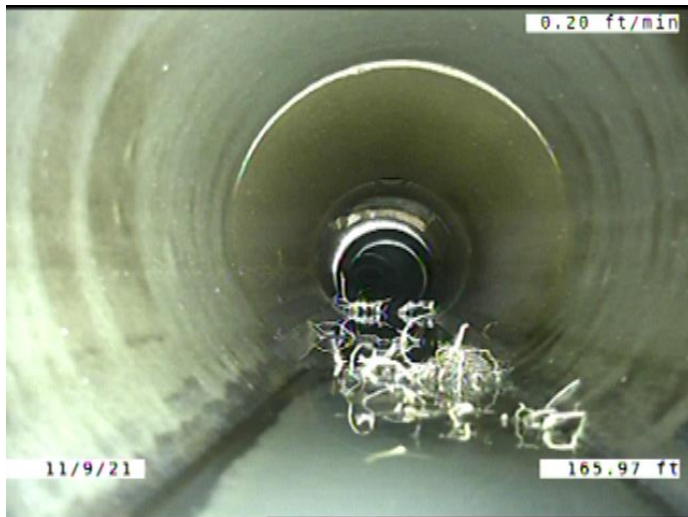
Code: **ISB**
 Description: **Infiltration Stain Barrel**

Distance (ft): **166.0**
 Structural Grade: **0**
 O&M Grade: **1**
 Clock Start/From: **3**
 Clock To: **5**
 1st Value:
 2nd Value:
 Value Percent:
 Continuous Index: **F02**
 Within 8" of Joint: **YES**
 Remarks:

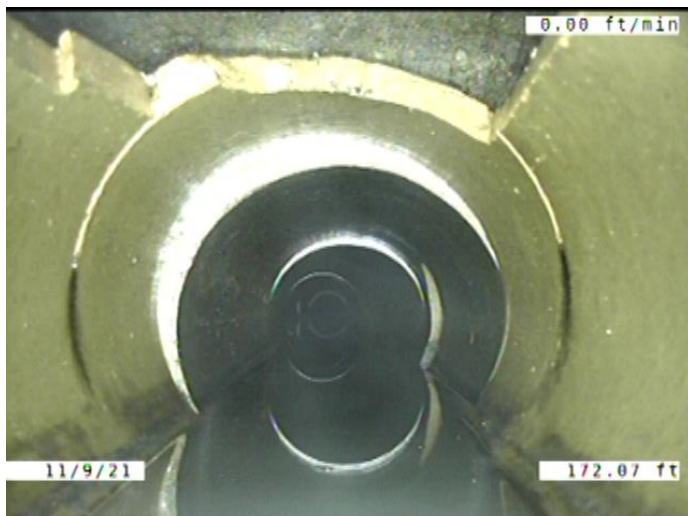
Code: **OBZ**
 Description: **Obstruction Other**

Distance (ft): **172.1**
 Structural Grade: **0**
 O&M Grade: **2**
 Clock Start/From: **5**
 Clock To: **7**
 1st Value:
 2nd Value:
 Value Percent: **5.000**
 Continuous Index: **F07**
 Within 8" of Joint: **YES**
 Remarks: **ROOTS THAT HAVE BEEN CUT**

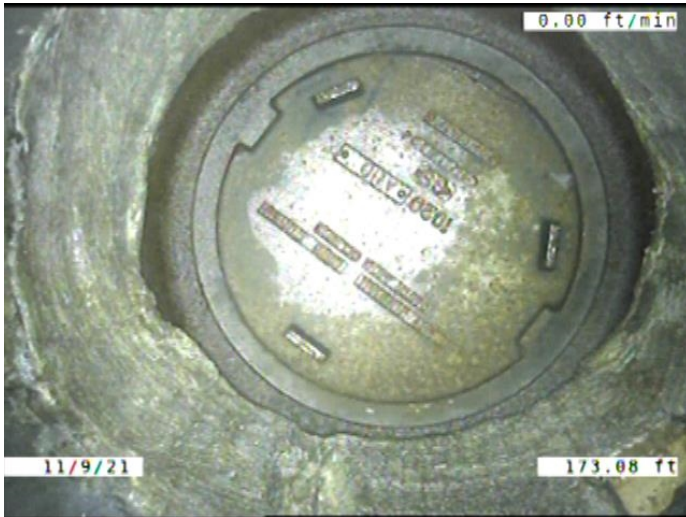
Code:	AMH
Description:	Manhole
Distance (ft):	173.1
Structural Grade:	0
O&M Grade:	0
Clock Start/From:	
Clock To:	
1st Value:	
2nd Value:	
Value Percent:	
Continuous Index:	
Within 8" of Joint:	NO
Remarks:	M-604-107
