Profile/Photo Observation Report

Date:	04/24/2018	Weather:		Coding:	PACP 6.0
Pipe Length (ft):	173.4	Owner:	NA	Pre Clean:	Not Known
P.O.#:		Surveyor:	Jen Costello	PSR:	P-604-108-111
Customer:		Clean Date:	01/01/1900	Shape:	C

Street:	N ASH ST	Flow Control:	Not Controlled
City:	Hobart, IN	Year Renewed:	
Location:	Other	Tape/Media #:	
Purpose:	Not Known	Dia/Height:	12"
Use:	Sanitary	Material:	VCP
Drain Area:	NA	Lining:	
Category:	NA		
Comment:

Location Details:		Direction of Survey:	Downstream
US MH:	M-604-111	DS MH:	M-604-108
		Total Length Surveyed (ft):	25.7

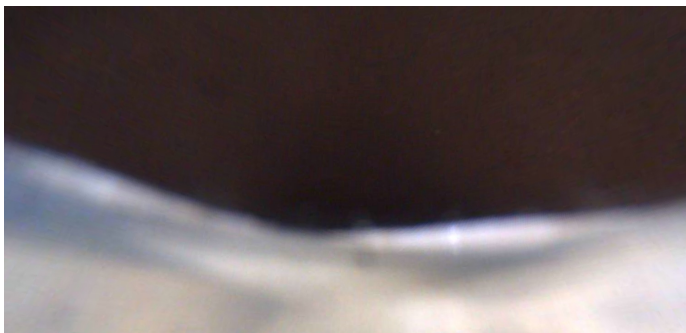
Code: **AMH**
Description: **Manhole**

Distance (ft): **.0**
Structural Grade: **0**
O&M Grade: **0**
Clock Start/From:
Clock To:
1st Value:
2nd Value:
Value Percent:
Continuous Index:
Within 8" of Joint: **NO**
Remarks: **M-604-111**

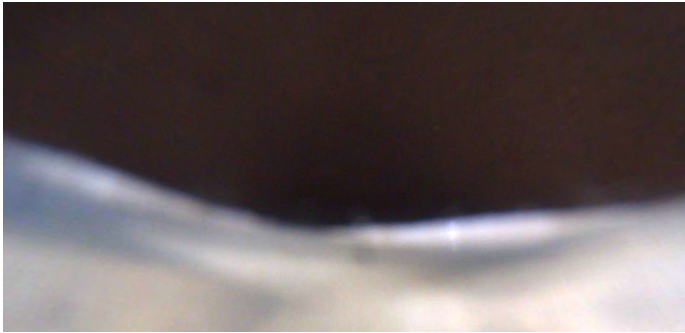
Code:	MWL
Description:	Water Level

Distance (ft):	.0
Structural Grade:	0
O&M Grade:	0
Clock Start/From:	
Clock To:	
1st Value:	
2nd Value:	
Value Percent:	40.000
Continuous Index:	
Within 8" of Joint:	NO
Remarks:

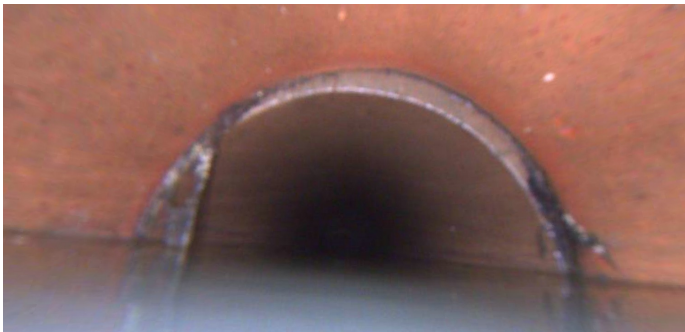
Code:	RFJ
Description:	Roots Fine Joint

Distance (ft):	2.6
Structural Grade:	0
O&M Grade:	1
Clock Start/From:	8
Clock To:	4
1st Value:	
2nd Value:	
Value Percent:	
Continuous Index:	
Within 8" of Joint:	YES
Remarks:

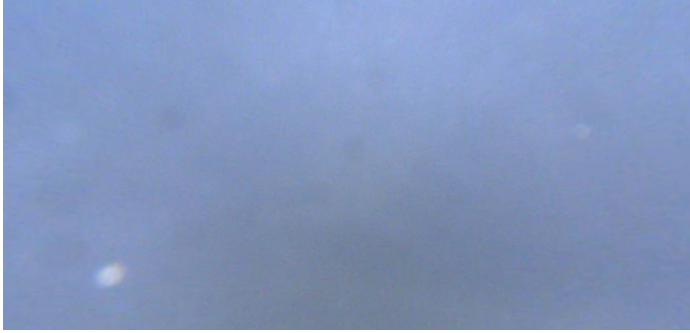
Code:	MSA
Description:	Abandoned Survey
Distance (ft):	25.7
Structural Grade:	0
O&M Grade:	0
Clock Start/From:	
Clock To:	
1st Value:	
2nd Value:	
Value Percent:	
Continuous Index:	
Within 8" of Joint:	NO
Remarks:	mcu
